Radiated Emission Measurement

Condition : FCC\_part 15E RE\_Above 1GHz\_PK

EUT : W6M22409-23739

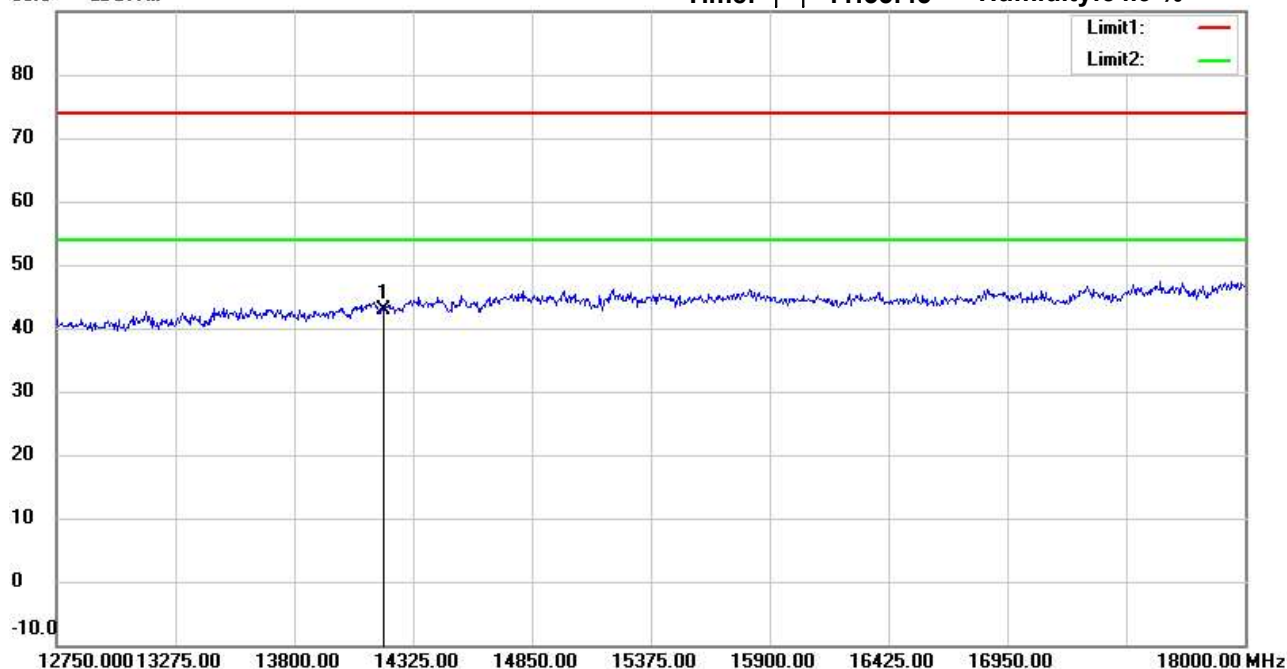
Test Mode : TX 802.11a CH229

Polarization: **Horizontal**

| Mk. | Frequency (MHz) | Reading (dBuV) | Detector | Corr. factor (dB/m) | Result (dBuV/m) | Limit (dBuV/m) | Ant.Pos (cm) | Tab.Pos (deg.) | Margin (dB) | Comment |
|---|---|---|---|---|---|---|---|---|---|---|
| * | 14190.000 | 20.93 | peak | 21.94 | 42.87 | 74.00 | 150 | 18 | -31.13 | |

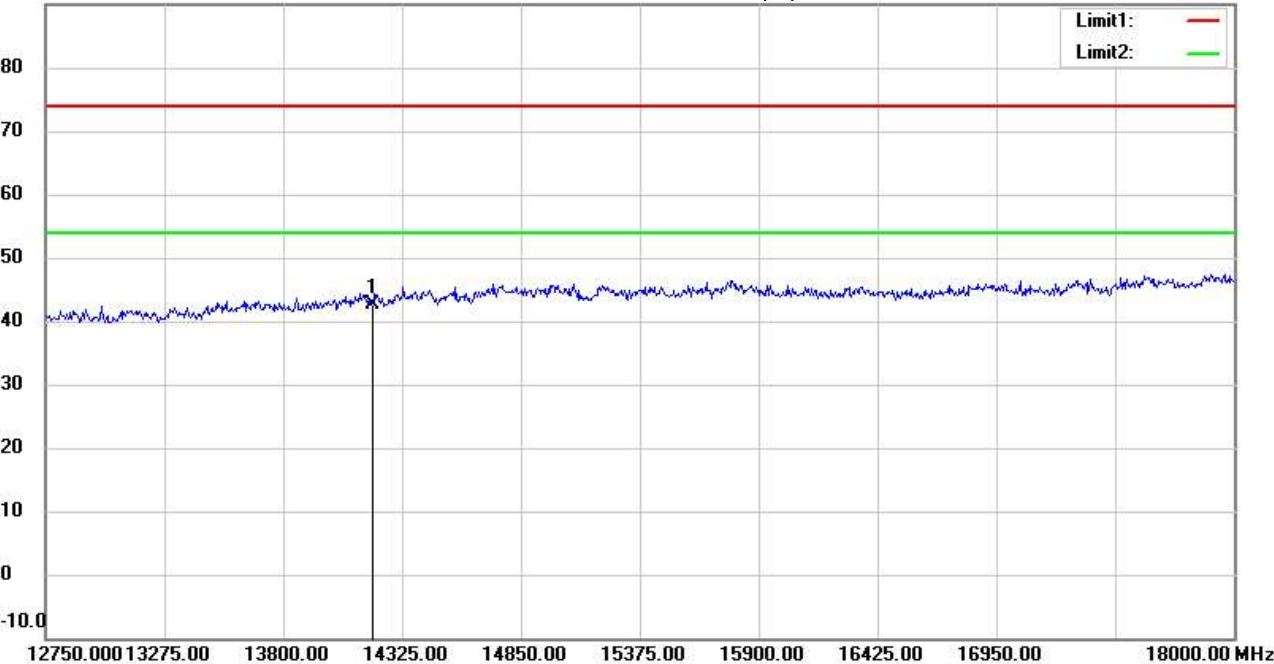
Site : 966A Chamber  
Condition : FCC\_part 15E RE\_Above 1GHz\_PK  
EUT : W6M22409-23739  
M/N:  
Test Mode : TX 802.11a CH229  
Note :

Polarization: Vertical  
Power : 120 Va.c.  
Distance: 3m

| Mk. | Frequency (MHz) | Reading (dBuV) | Detector | Corr. factor (dB/m) | Result (dBuV/m) | Limit (dBuV/m) | Ant.Pos (cm) | Tab.Pos (deg.) | Margin (dB) | Comment |
|---|---|---|---|---|---|---|---|---|---|---|
| * | 14190.000 | 20.70 | peak | 21.94 | 42.64 | 74.00 | 150 | 359 | -31.36 | |

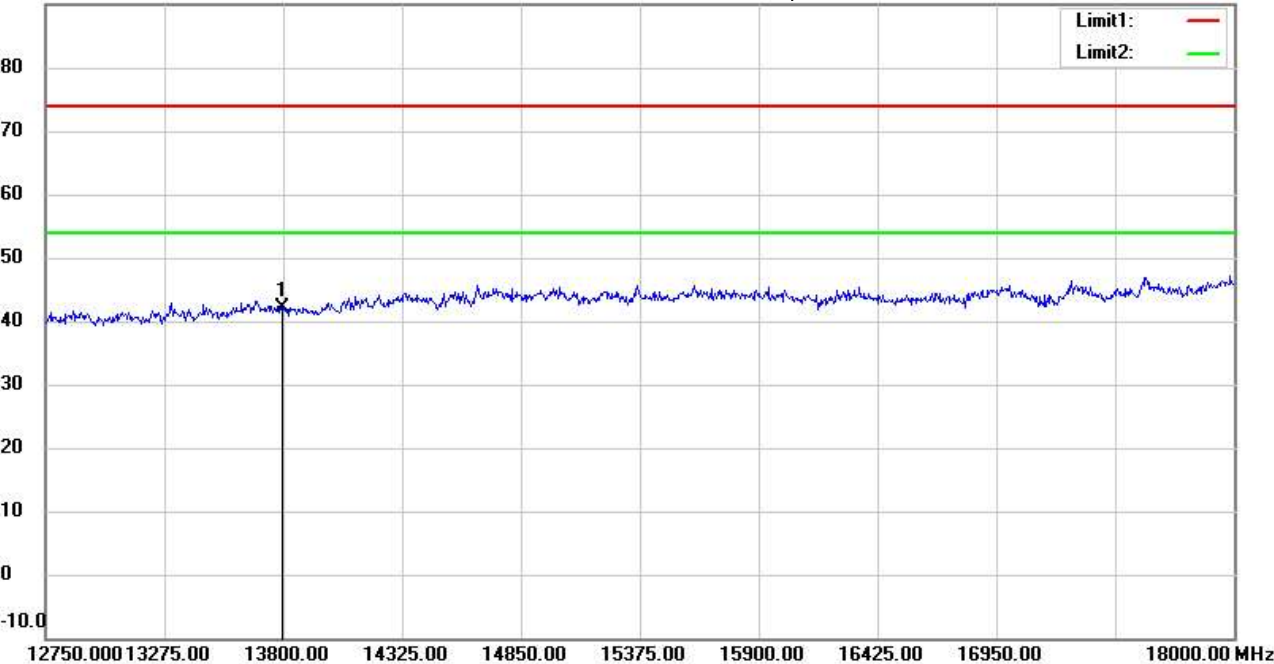
Test Mode : TX 802.11ax20 CH189

Polarization: **Horizontal**

| Mk. | Frequency (MHz) | Reading (dBuV) | Detector | Corr. factor (dB/m) | Result (dBuV/m) | Limit (dBuV/m) | Ant.Pos (cm) | Tab.Pos (deg.) | Margin (dB) | Comment |
|---|---|---|---|---|---|---|---|---|---|---|
| * | 13790.000 | 22.44 | peak | 19.59 | 42.03 | 74.00 | 150 | 227 | -31.97 | |

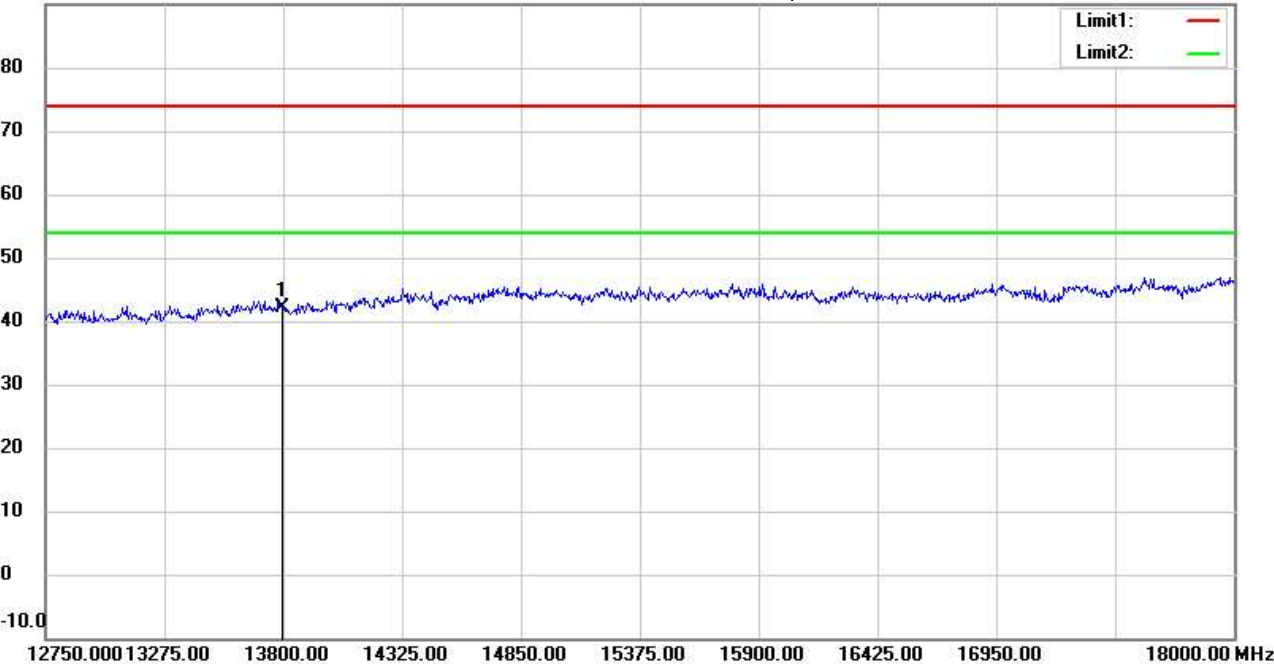
Test Mode : TX 802.11ax20 CH189

Polarization: Vertical

| Mk. | Frequency (MHz) | Reading (dBuV) | Detector | Corr. factor (dB/m) | Result (dBuV/m) | Limit (dBuV/m) | Ant.Pos (cm) | Tab.Pos (deg.) | Margin (dB) | Comment |
|---|---|---|---|---|---|---|---|---|---|---|
| * | 13790.000 | 22.58 | peak | 19.59 | 42.17 | 74.00 | 150 | 311 | -31.83 | |

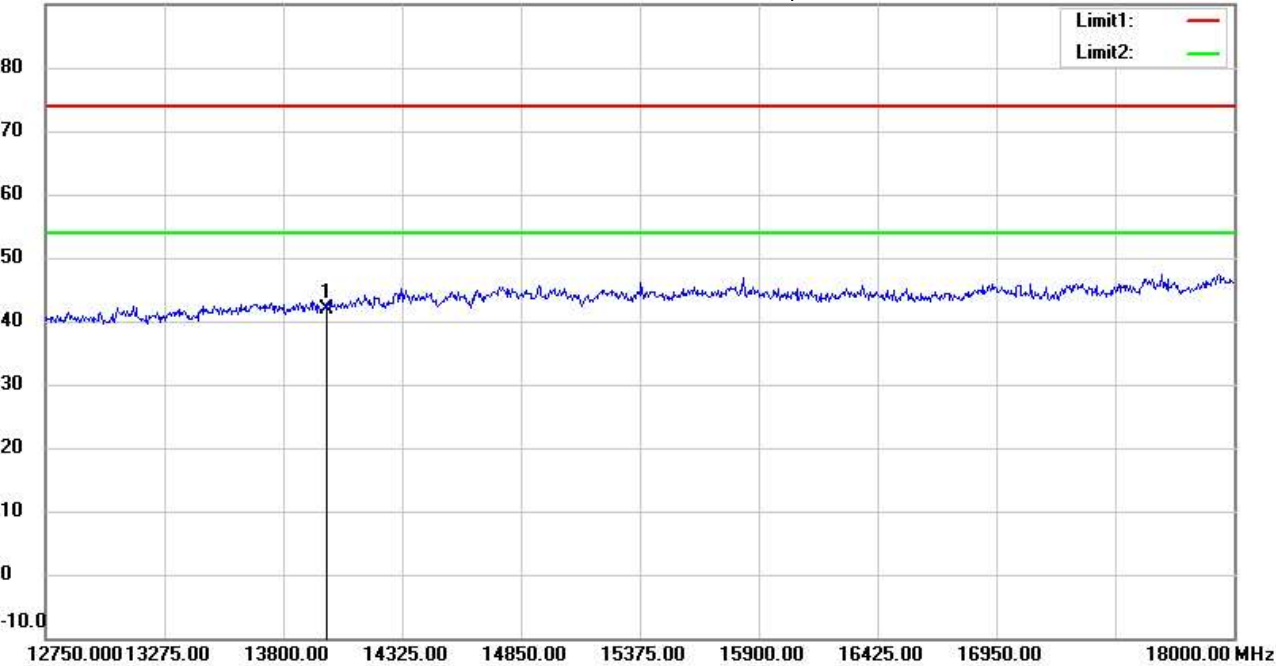
Test Mode : TX 802.11ax20 CH209

Polarization: **Horizontal**

| Mk. | Frequency (MHz) | Reading (dBuV) | Detector | Corr. factor (dB/m) | Result (dBuV/m) | Limit (dBuV/m) | Ant.Pos (cm) | Tab.Pos (deg.) | Margin (dB) | Comment |
|---|---|---|---|---|---|---|---|---|---|---|
| * | 13990.000 | 21.04 | peak | 20.93 | 41.97 | 74.00 | 150 | 100 | -32.03 | |
