### **APPENDIX 3: Photographs of test setup**

#### **Transmitter unwanted emissions in the spurious domain**

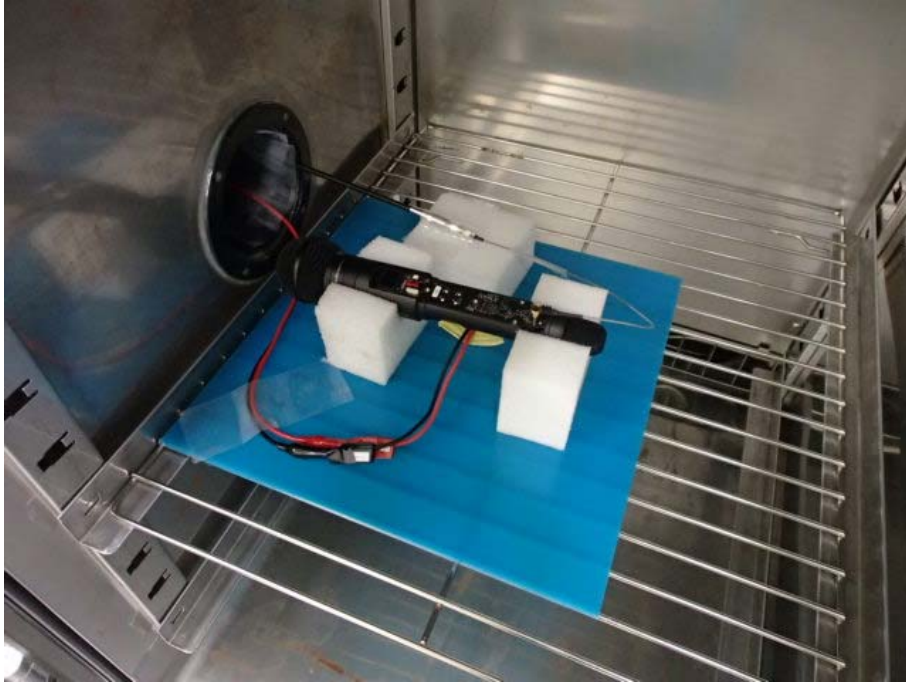
**Photo 1**

**Antenna Terminals Conducted**
