**Marine Approvals and Testing Service  
Type Test/Inspection Certificate  
RTCM SC110 EPIRB V2, Section 15**

**Cert. No.:** NTT-11/01-C01

The objective was to verify compliance with the Buoyancy requirements of section A15.0. In particular to prove that the Tron 40GPS does meet the excess buoyancy requirement.

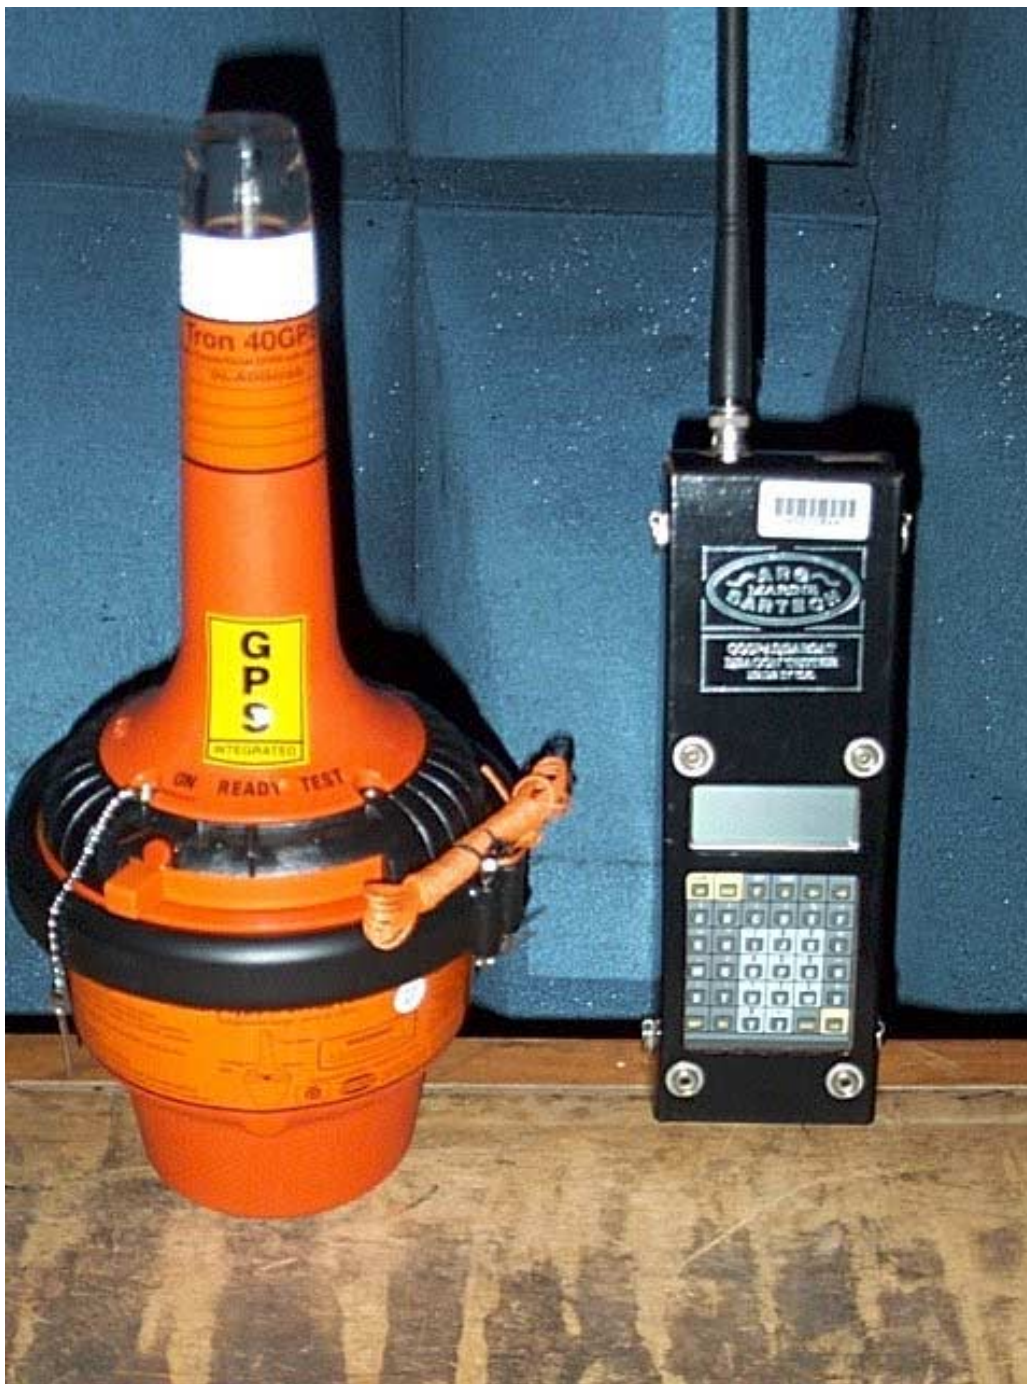
Annex A, Photograph 1.

Photo 1. The TRON 40GPS Beacon and the ARG/Sartech EPIRB Tester.

The beacon was examine and subjected to an "aliveness" test (test A11) to confirm that the sample under test was representative of the type and fully operational before testing commenced. This was conducted in an anechoic screened room. (Photo 1)

**Result:** It was confirmed the TRON 40GPS Beacon was a standard production unit and that it passed the aliveness test.

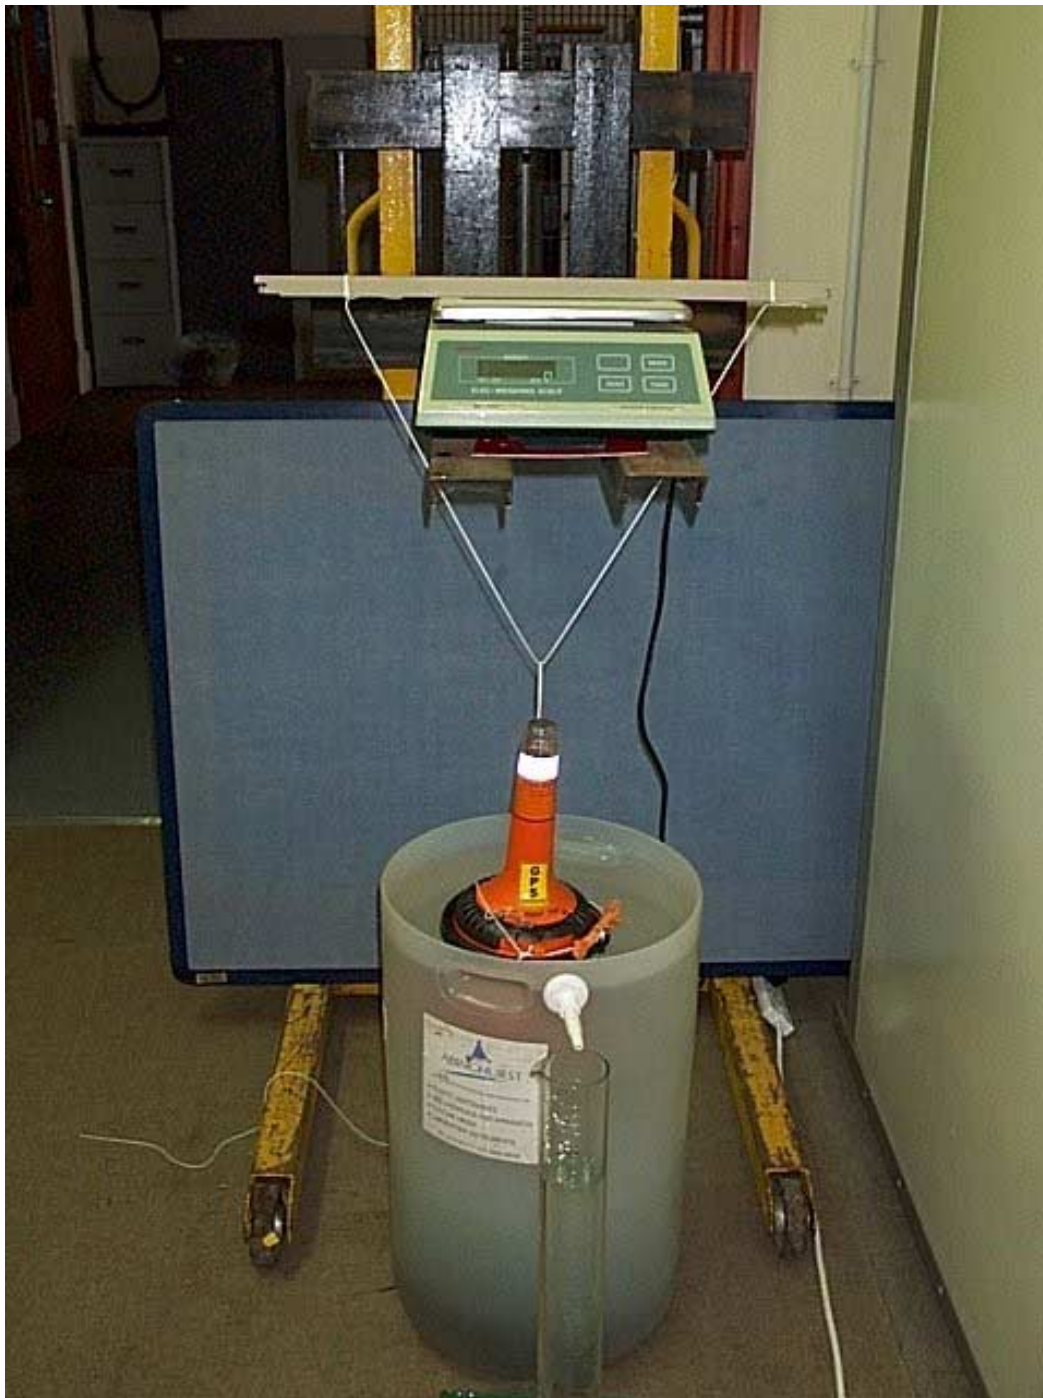
Annex A, Photograph 2.

Photo 2. The set-up for testing procedure 1 – Beacon floating naturally.

(note: a pull-force scale was not available so a platform scale with a yoke arrangement was used)

The EPIRB Beacon was then fitted with lightweight harness to enable it to be pulled under the water surface. This was connected by nylon cord through a small pulley fixed to the bottom of the test tank and then up out of the water and there connected to the weighing scales. The scales were positioned on the platform of a hydraulic lifting device.

The beacon was allowed to float naturally on the water in the test tank. See Photo 2.

The platform of the Hydraulic lift was raised slightly to take the slack out of the connecting cord but without introducing any tension. The weighing scales were zeroed with the Tare control.

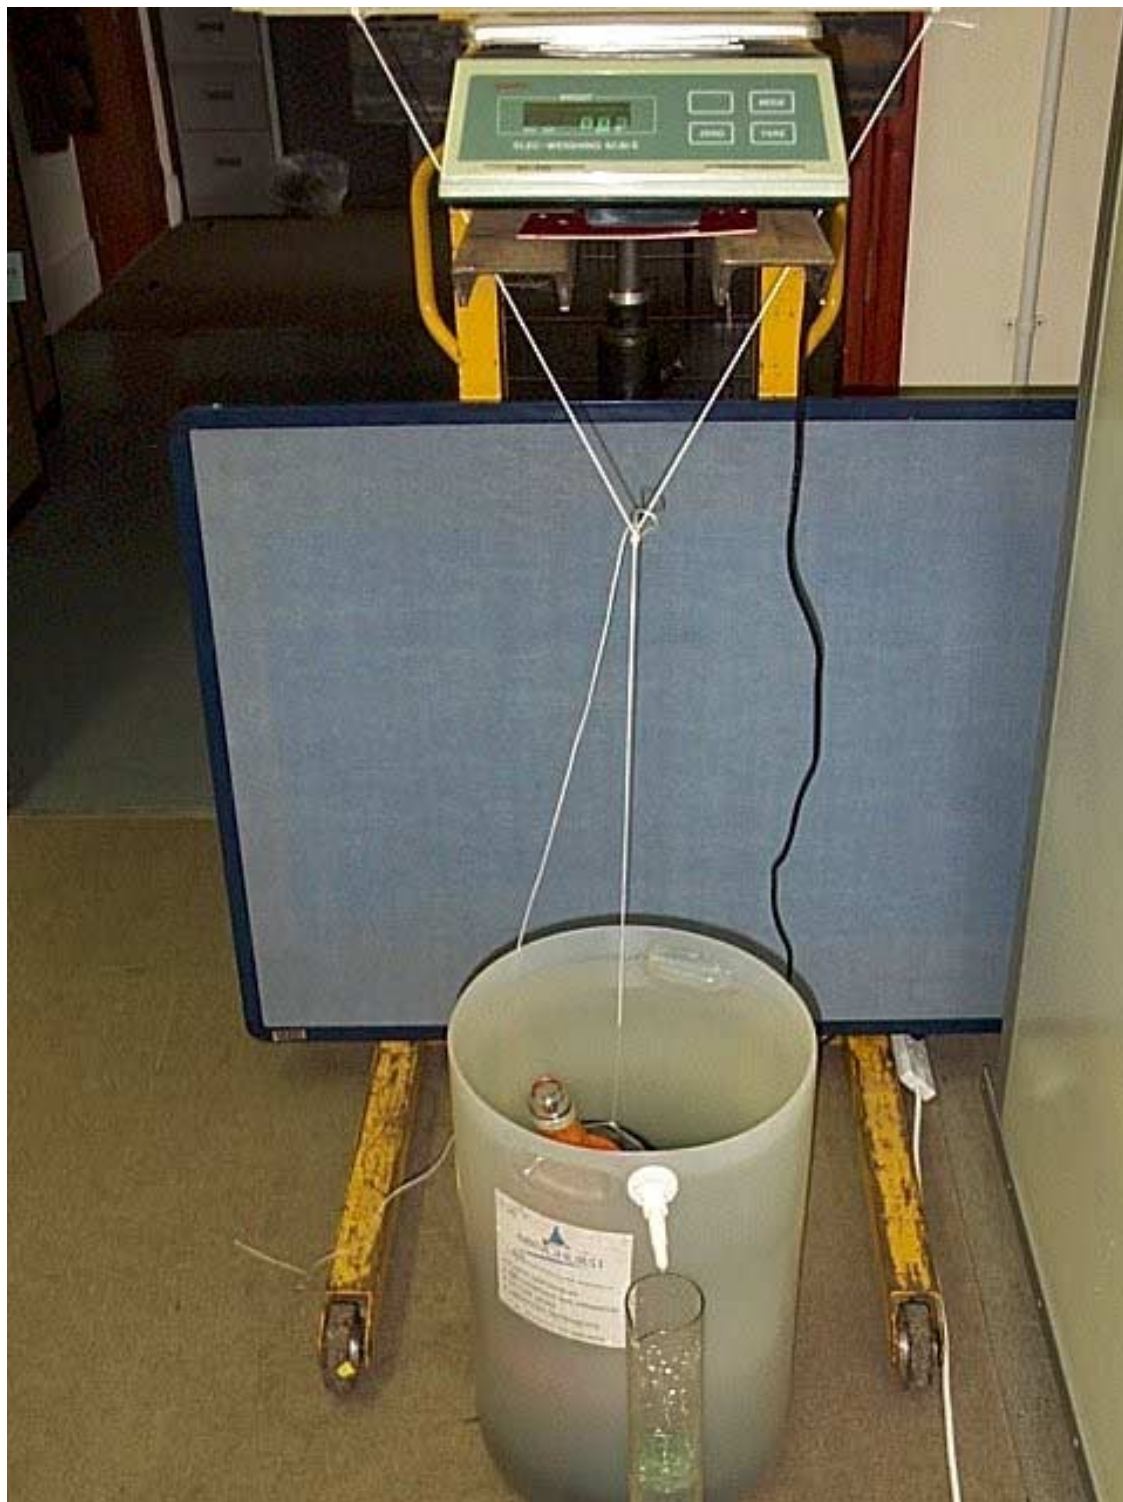
Annex A, Photograph 3.

Photo 3. Scale lift raised to submerge beacon.

The platform of the Hydraulic lift was then raised steadily until the beacon was just submerged. See Photo 3.

The reading on the digital readout of the weighing scale was recorded.

**Results:** Dry weight of beacon (mass) 2016 grams

Force needed to submerge beacon 883 grams

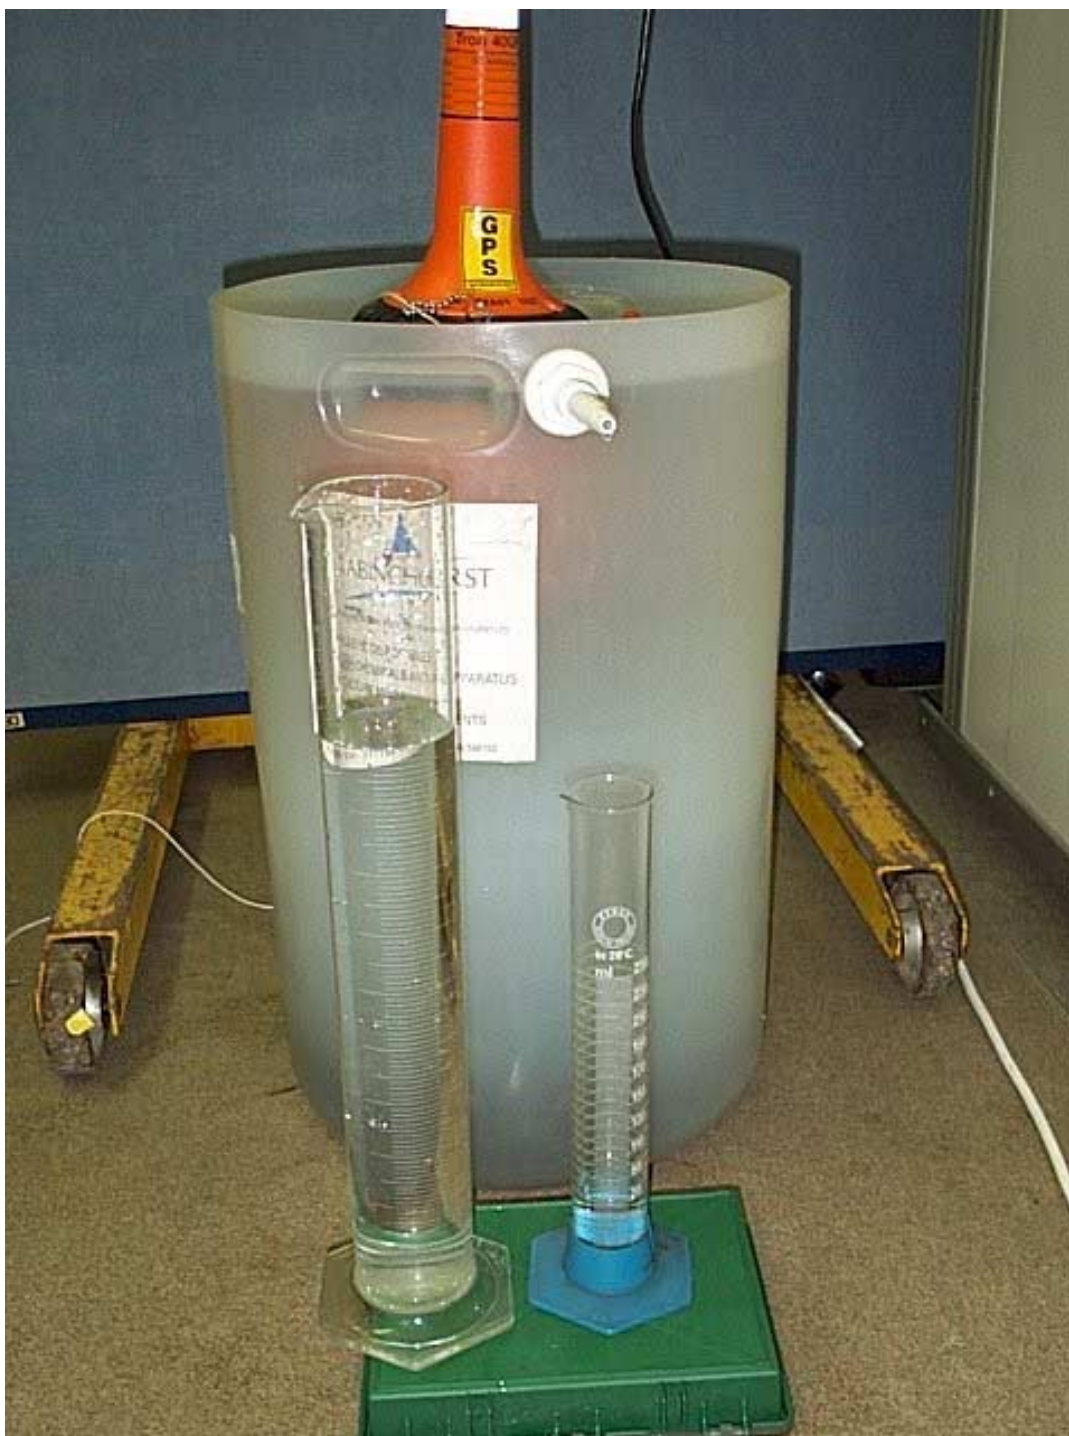
Annex A, Photograph 4.

Photo 4. The set-up for testing procedure 2 – Beacon floating naturally.

The EPIRB Beacon was then gently introduced into the test tank and allowed to float naturally on the water. The overflowing water from the overflow pipe was collected in a glass measuring flask. The water level was given sufficient time to allow it to normalise so that no further drips emerge from the overflow pipe. See Photo 4.

Then using controlled finger pressure on the top of the beacon it was lowered into the test tank such that it was just submerged. Again the water level was given sufficient time to allow it to normalise so that no further drips emerge from the overflow pipe. See Photo 4.

| <b>Results:</b> | Volume below waterline | 2065 millilitres. |
| | Volume above waterline | 895 millilitres. |

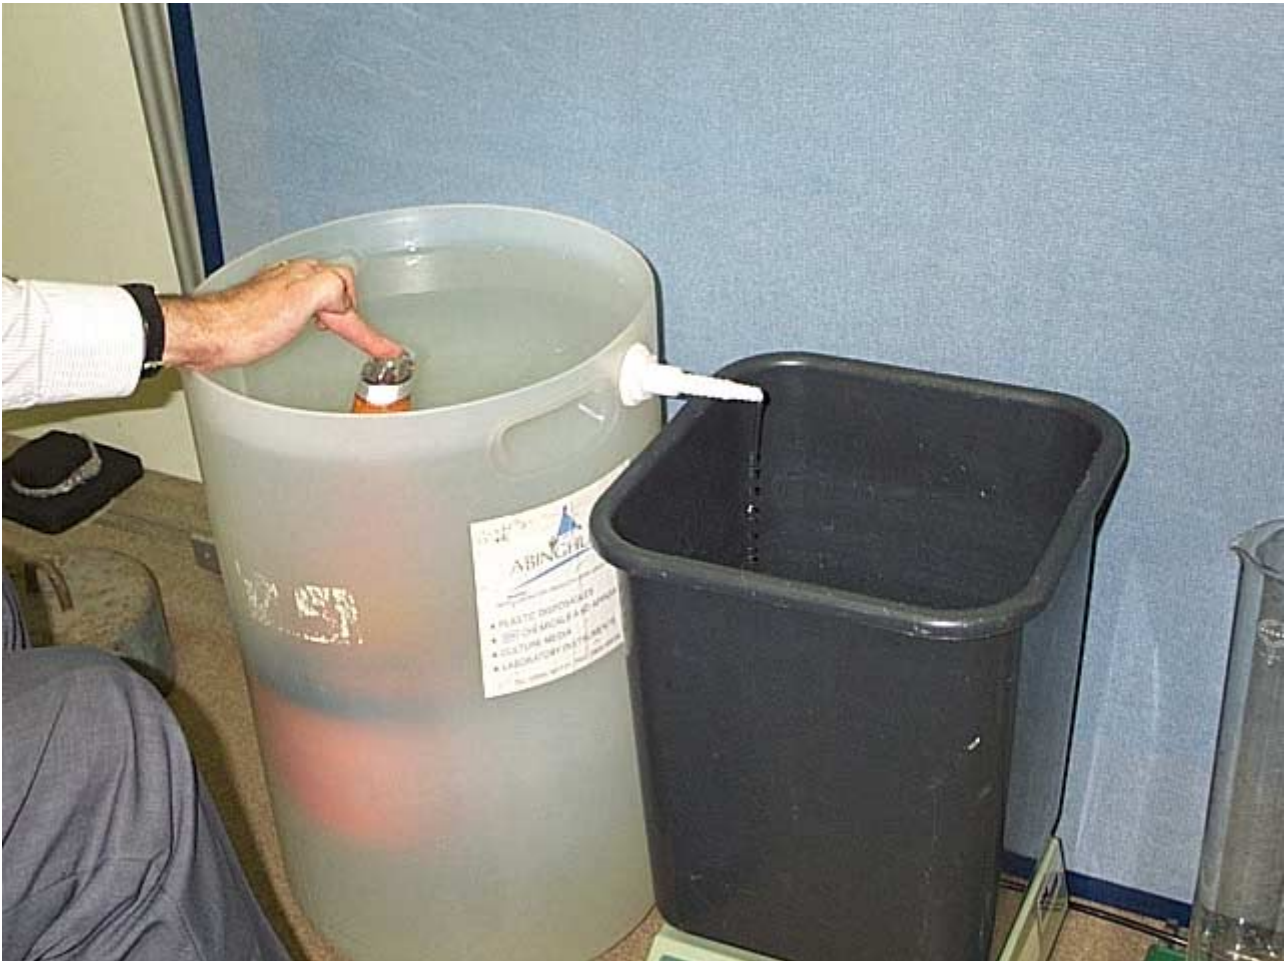
Annex A, Photograph 5.

Photo 5. The set-up for testing procedure 3 – Beacon submerged.

The EPIRB Beacon was then gently introduced into the test tank and allowed to float naturally on the water. The overflowing water from the overflow pipe goes into the container. The water level was given sufficient time to allow it to normalise so that no further drips emerge from the overflow pipe. See Photo 5.

Then using controlled finger pressure on the top of the beacon it was lowered into the test tank such that it was just submerged. Again the water level was given sufficient time to allow it to normalise so that no further drips emerge from the overflow pipe. See Photo 5. The total weight of water now in the container was then read from the scale and recorded.

| <b>Results:</b> | Weight of displaced water (naturally floating) | 2085 grams. |
| | Weight of displaced water (totally immersed) | 2996 grams. |
