# Annex C

Test setup photographs

***Test report no.:*** 25010978-44359-0

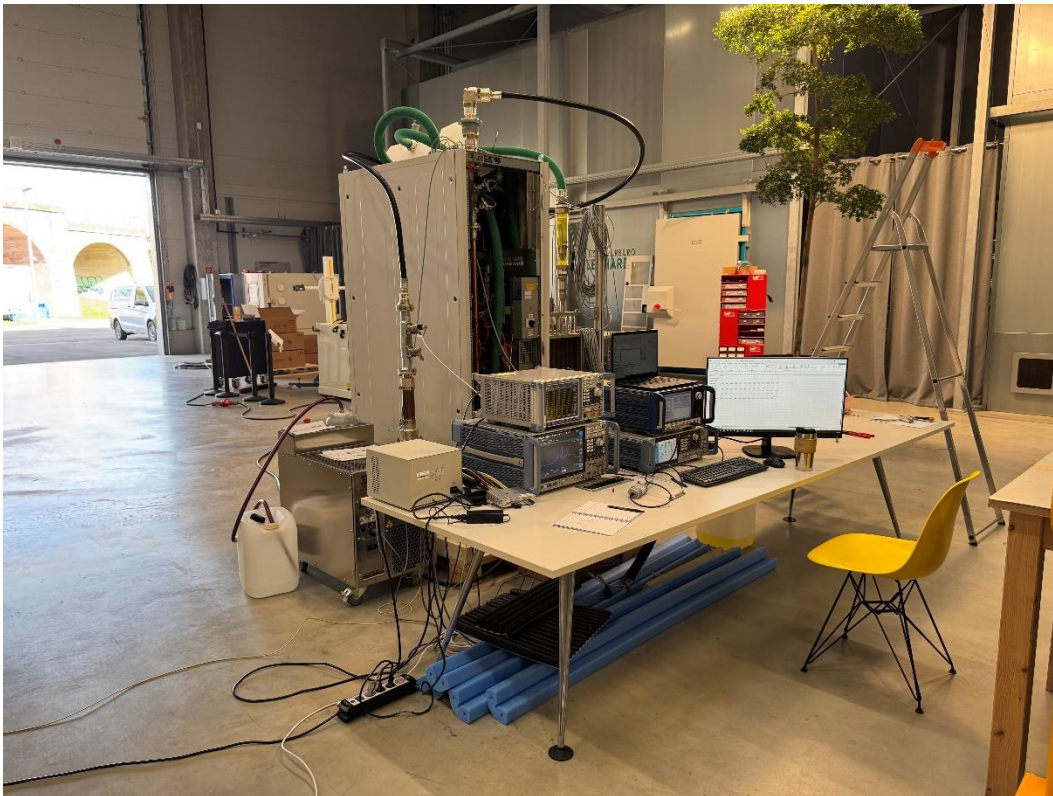
Photograph 1: Overall view, with spectrum analyzer and power meter.

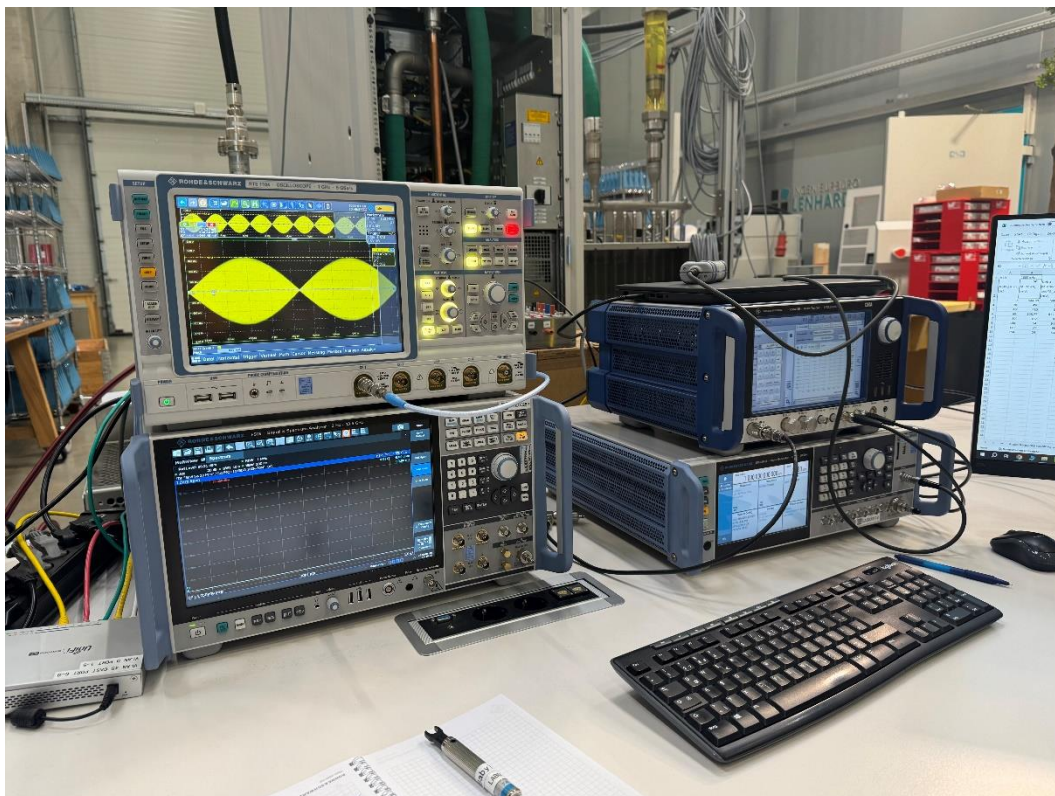
Photograph 2: Close view, with oscilloscope.

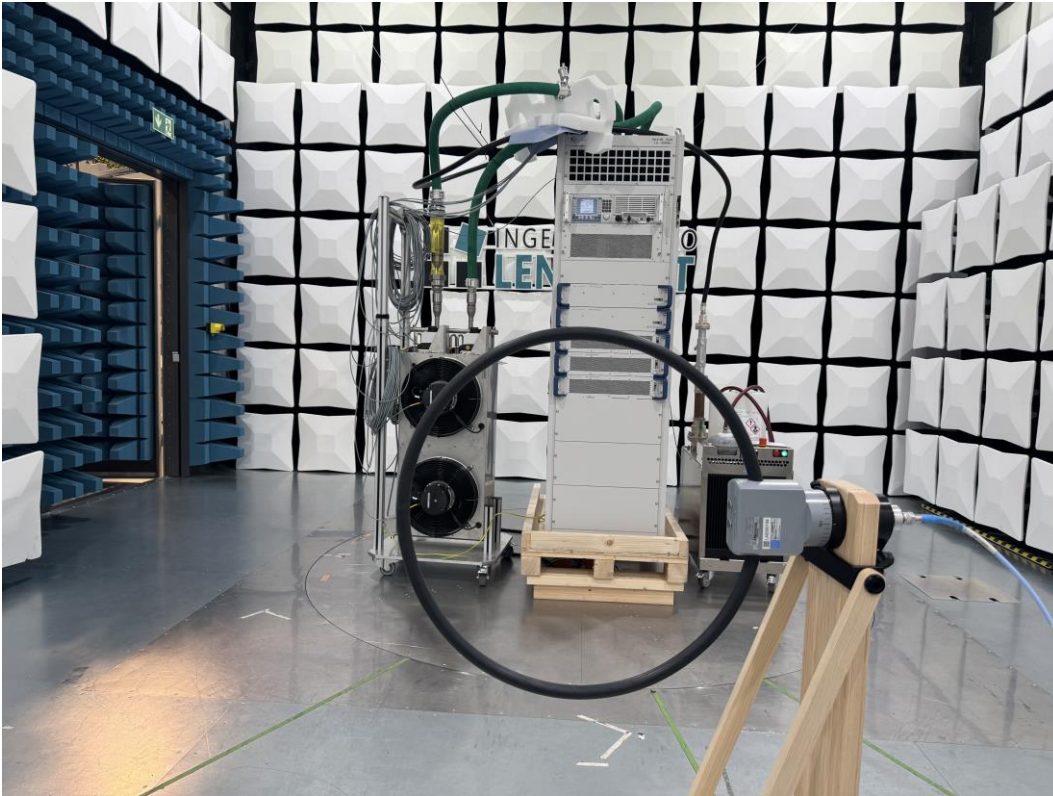
Photograph 3: Overall view 1. Radiated cabinet measurement with signal power on EUT 2 kW. The door of the chamber is closed. The power supply is provided through the socket in the turn table.

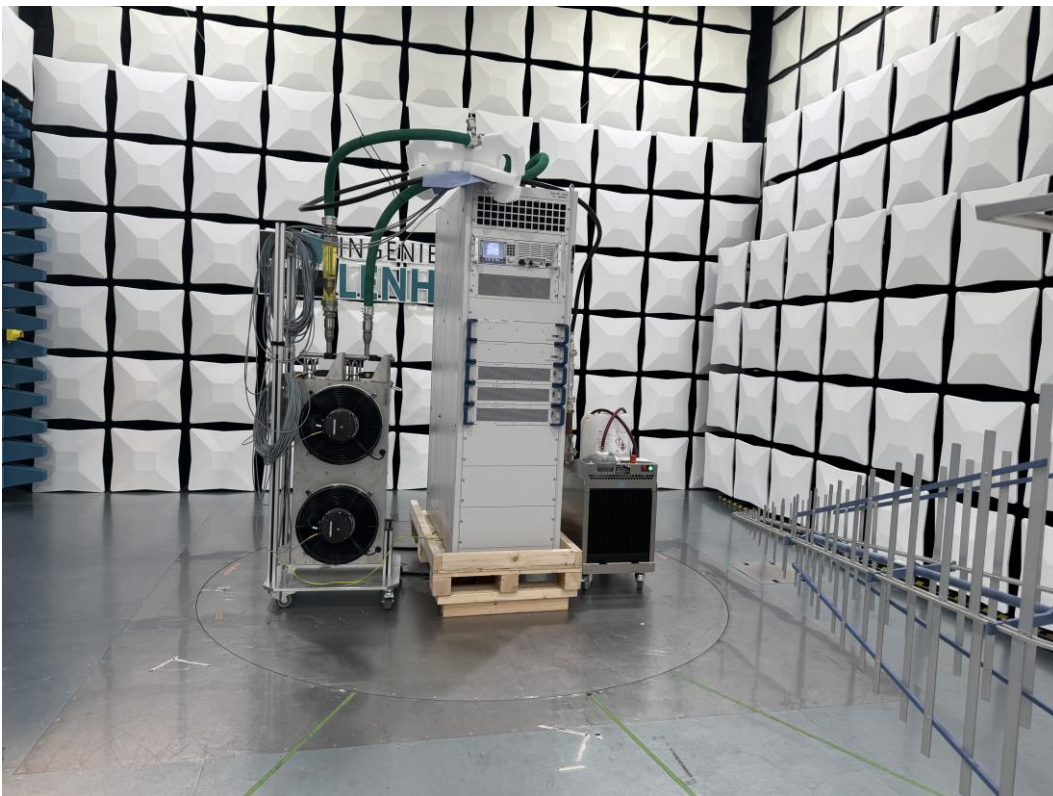
Photograph 4: Overall view 2. Radiated cabinet measurement with signal power on EUT 2 kW. The door of the chamber is closed. The power supply is provided through the socket in the turn table.

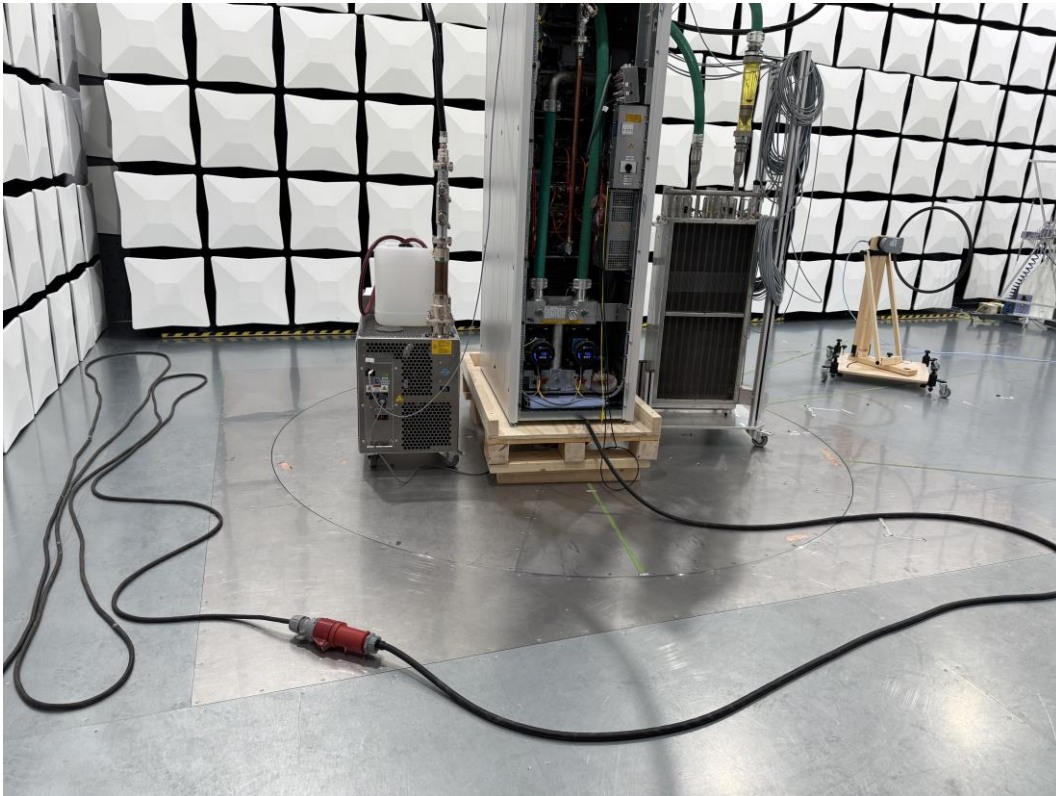
*Photograph 5: Overall view. Radiated cabinet measurement with signal power on EUT 5 kW. The door of the chamber is open to get the power supply cable in the chamber.*

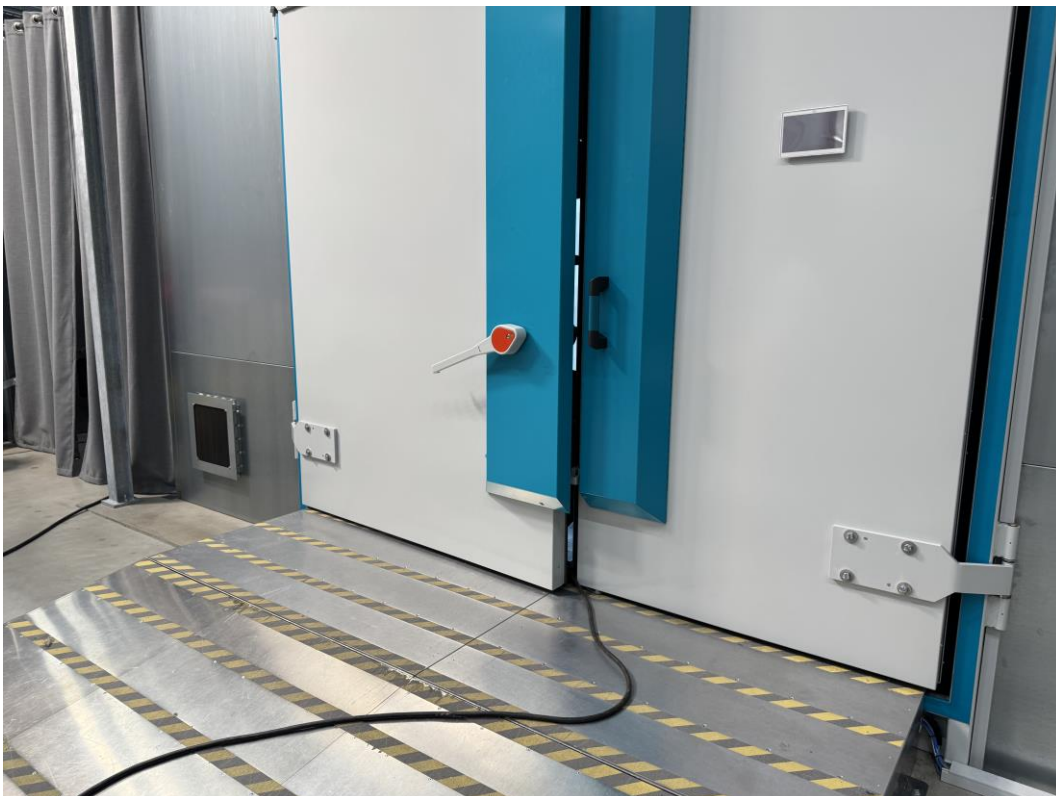
*Photograph 6: Overall view. Power supply cable going through the door in the chamber.*
