Report No.: 9907813

# Intertek Testing Services

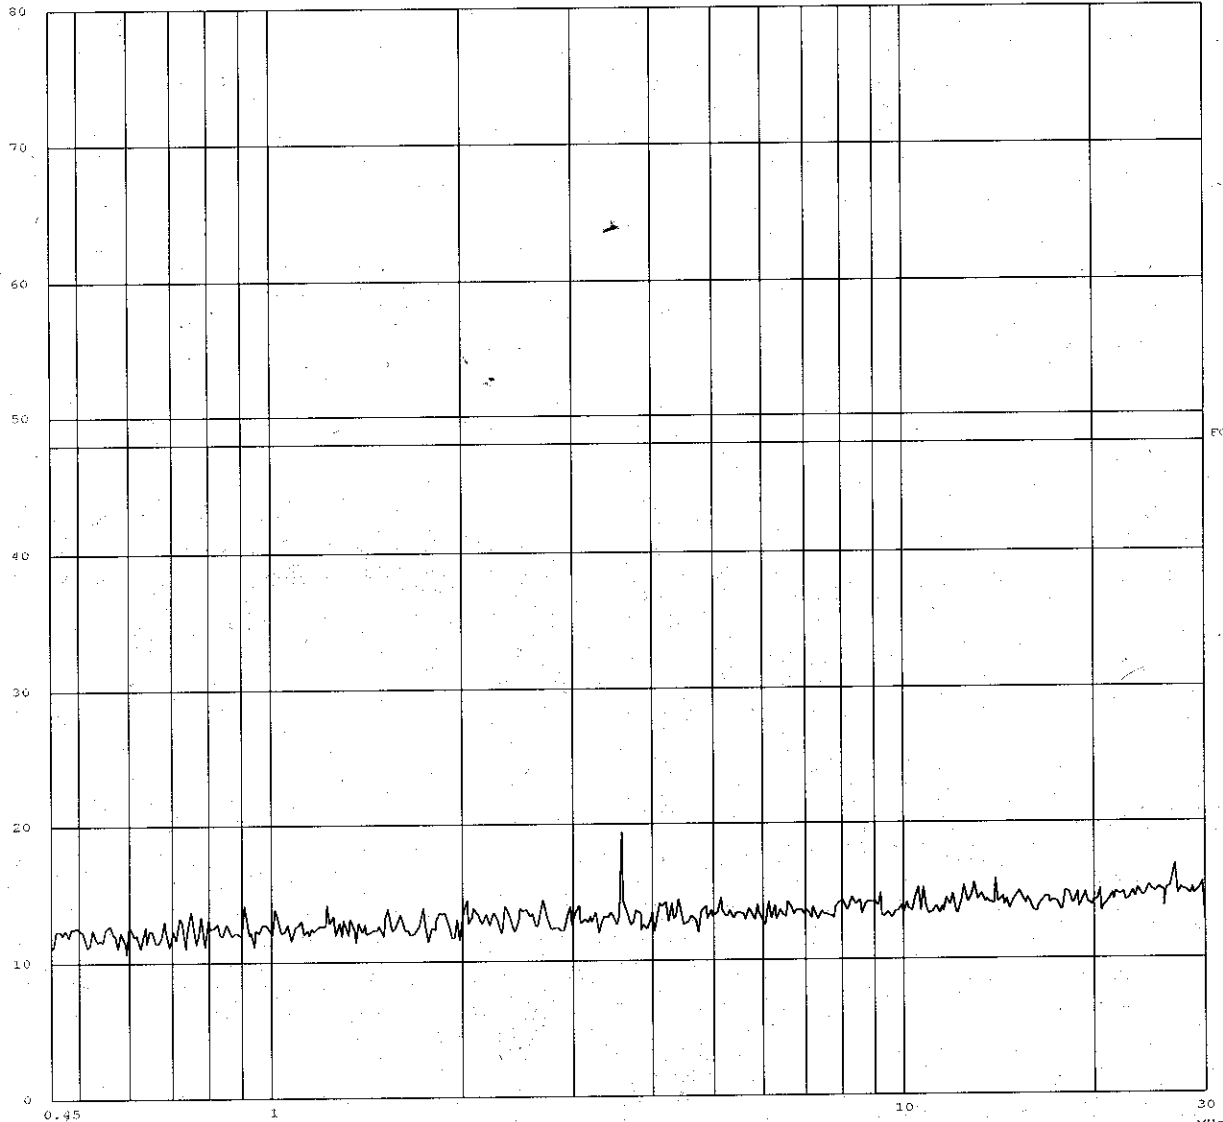
Scan Settings (1 Range)

| Frequencies | | | Receiver Settings | | | | | |
| Start | Stop | Step | IF BW | Detector | M-Time | Atten | Preamp | OpRge |
| 450k | 30M | 5k | 10k | PK | 20ms | AUTO | LN | OFF 60dB |

Final Measurement: X QP

| Transducer No. | Start | Stop | Name |
| 2 | 9k | 30M | EI078 |

Meas Time: 1 s  
Subranges: 16  
Acc Margin: 20dB

dBuV
