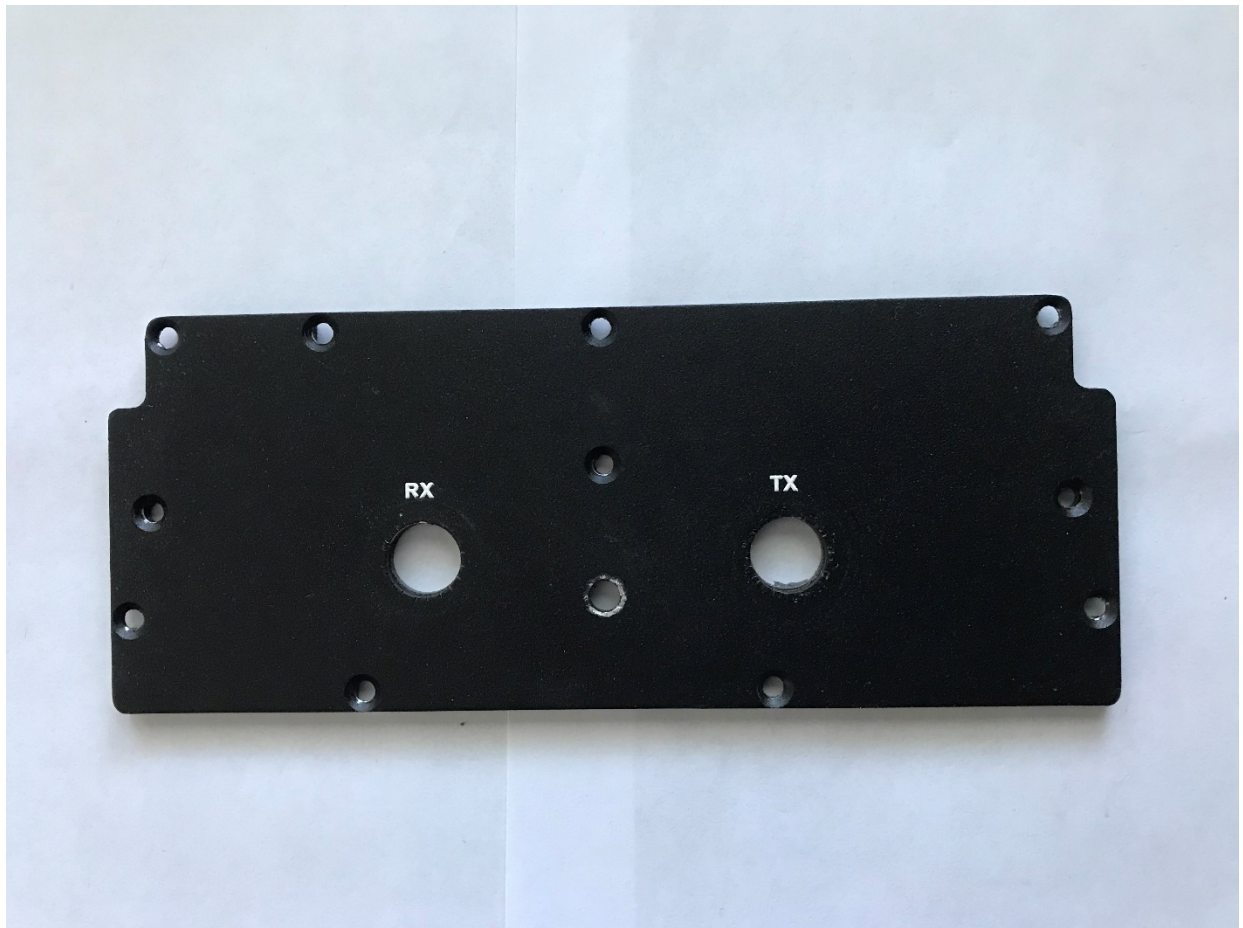
The cover is 4mm larger and the upper corner screws were added

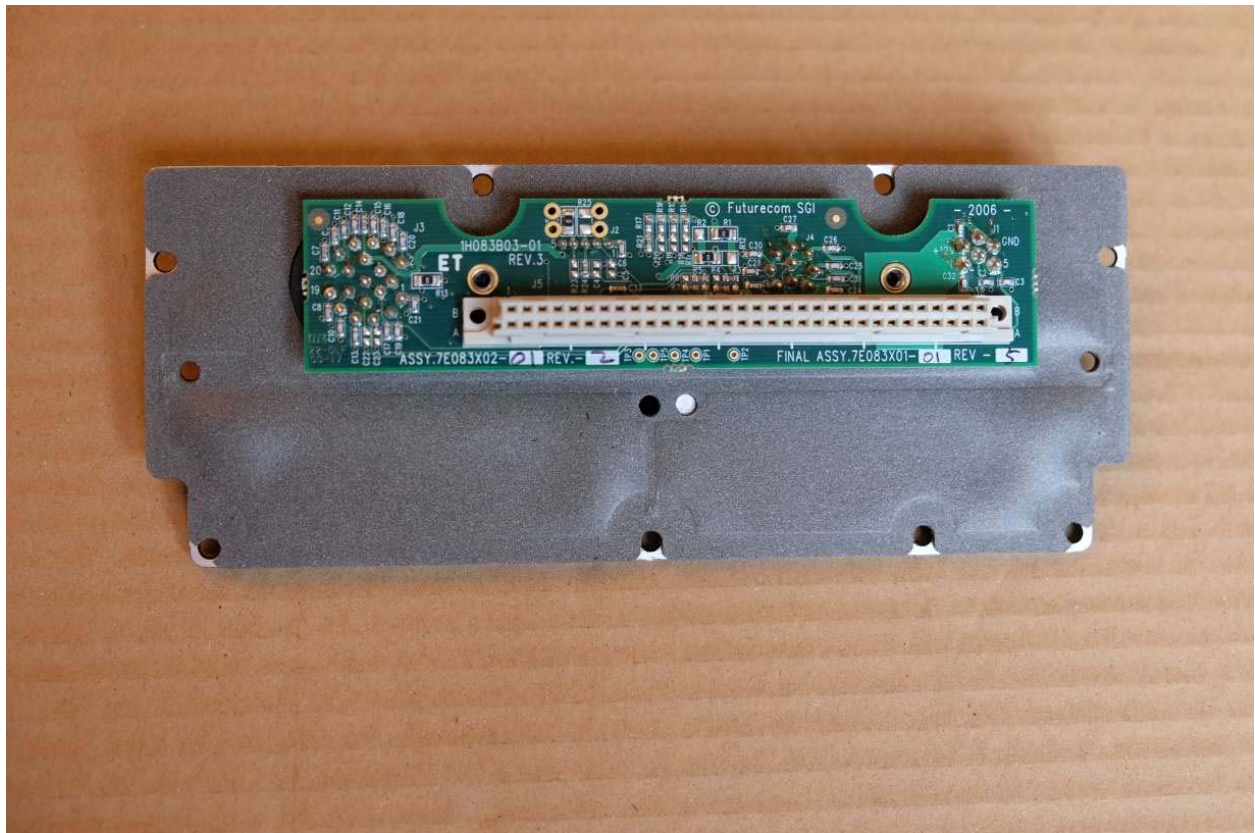
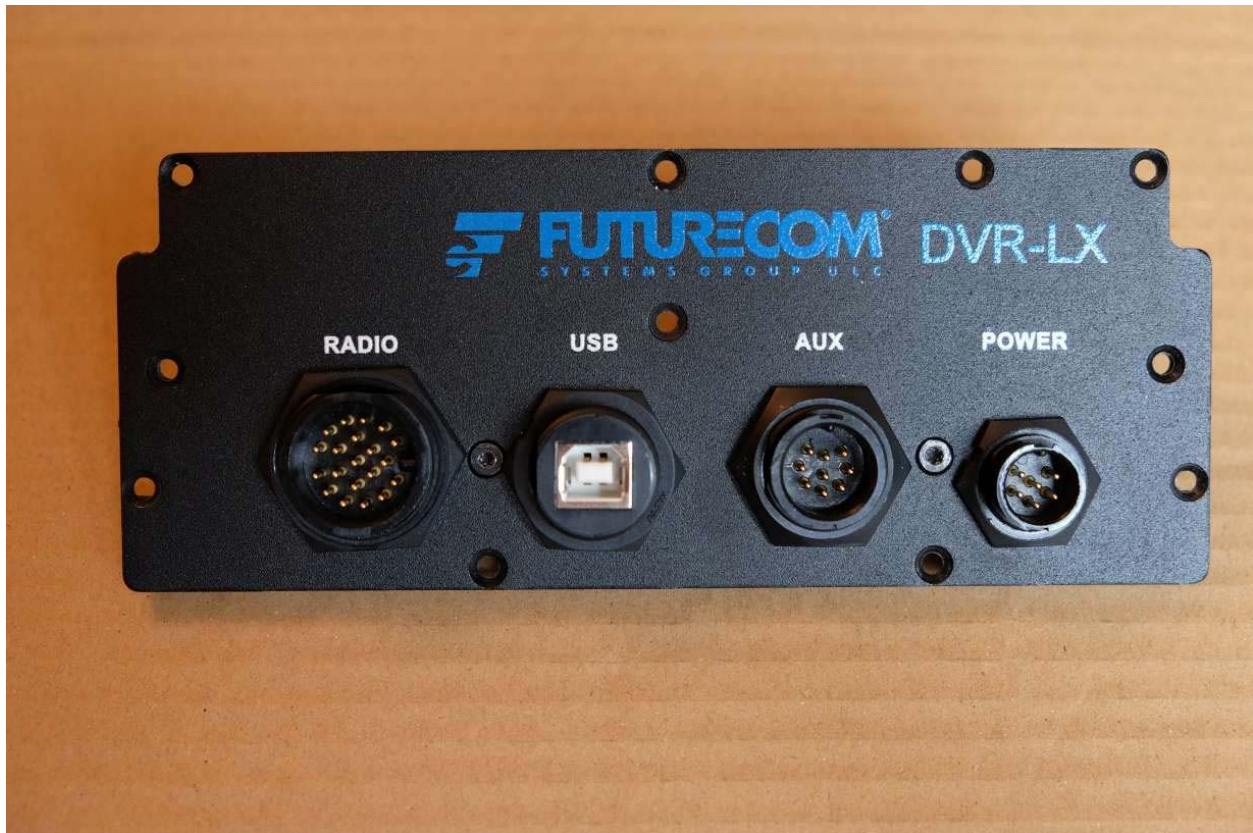
The cover is 4mm larger and screws were added in upper corners.

The cover now displays DVR-LX.

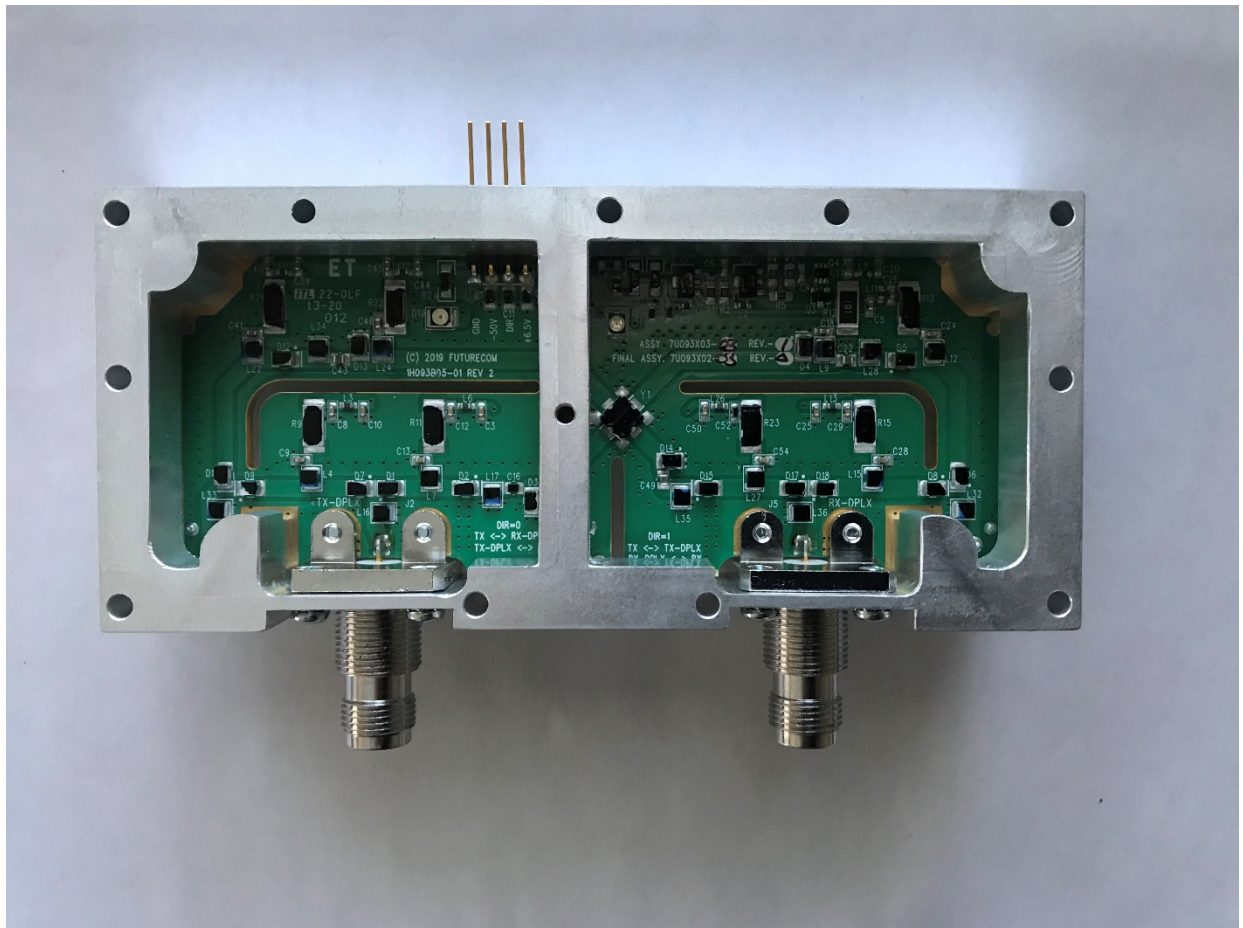
New TNC connectors.
