## **Accredited testing laboratory**

## **Appendix to the Report 2-3078-1-3/02 Photo documentation**

## Annex 3 Photo documentation

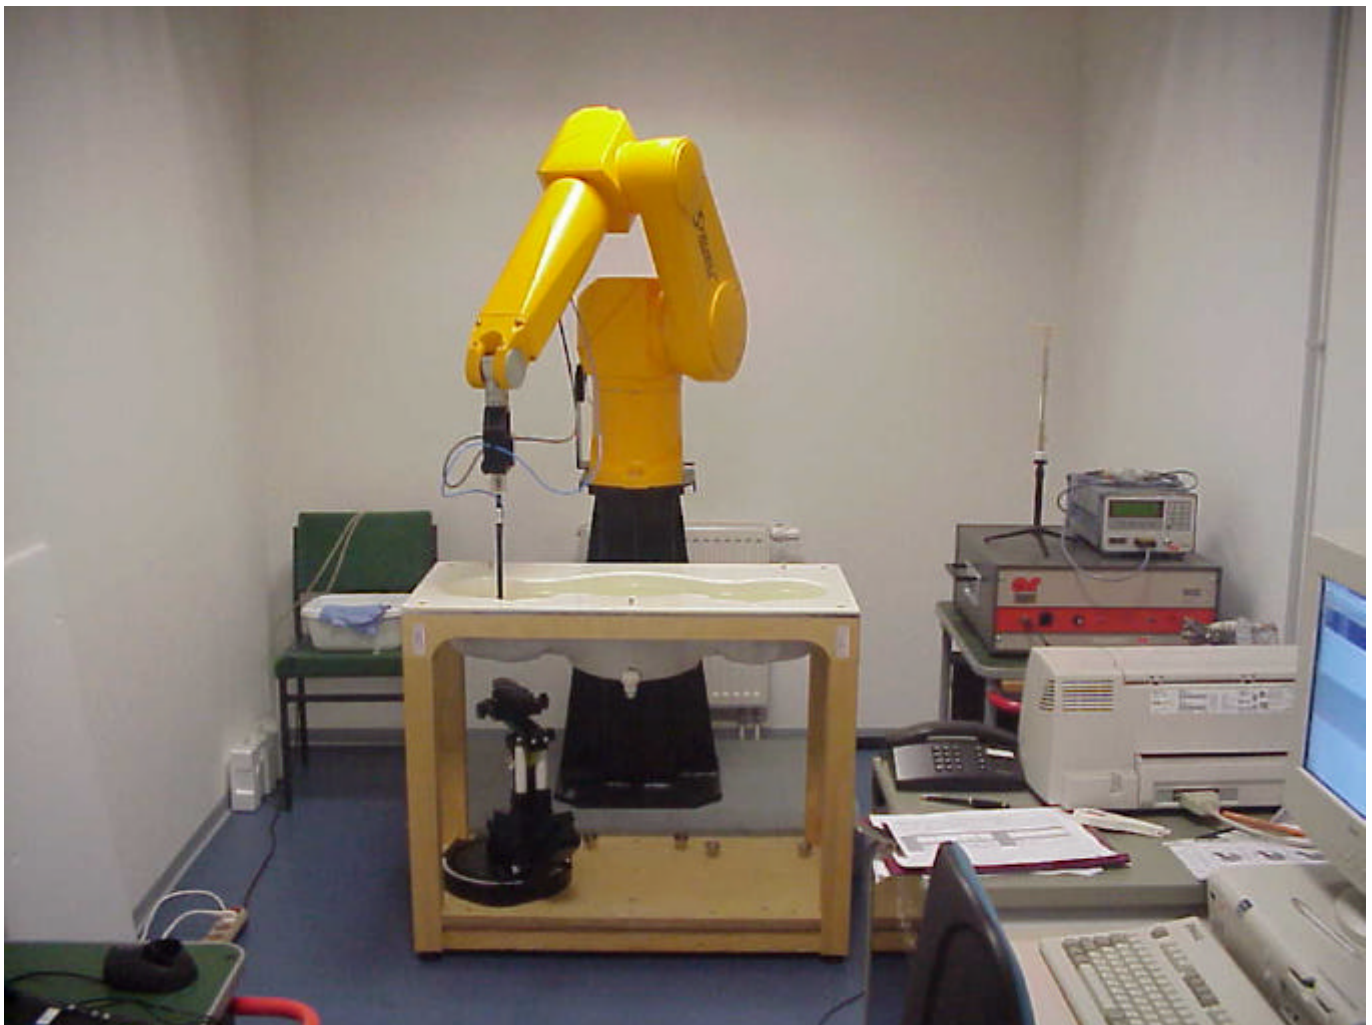
### Picture no. 1

Measurement System DASY 3

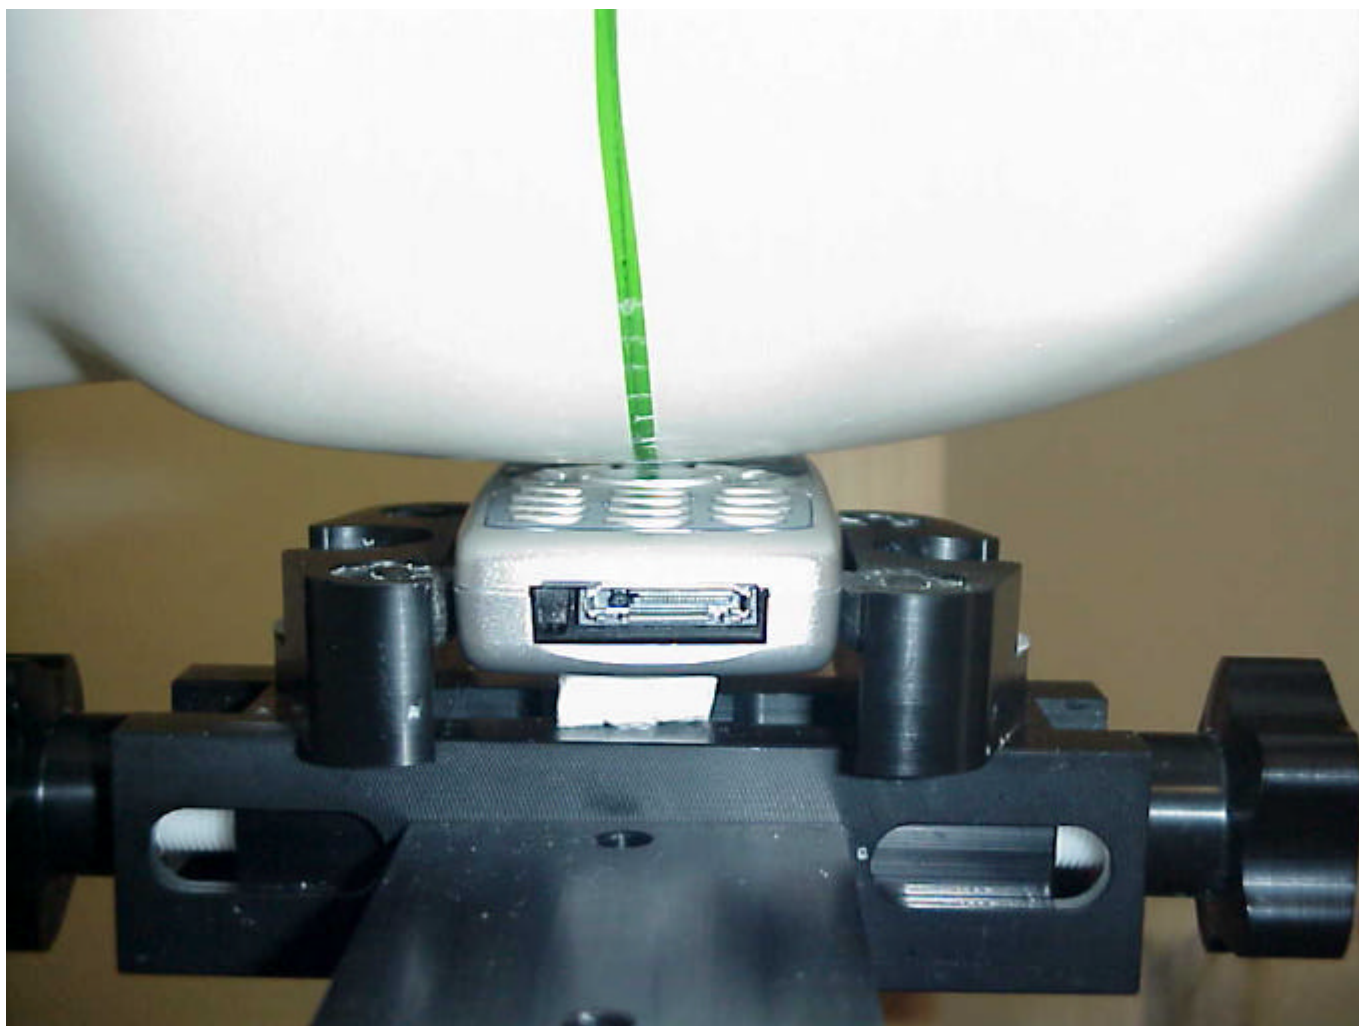
**Picture no. 2**

E2002p front touch left

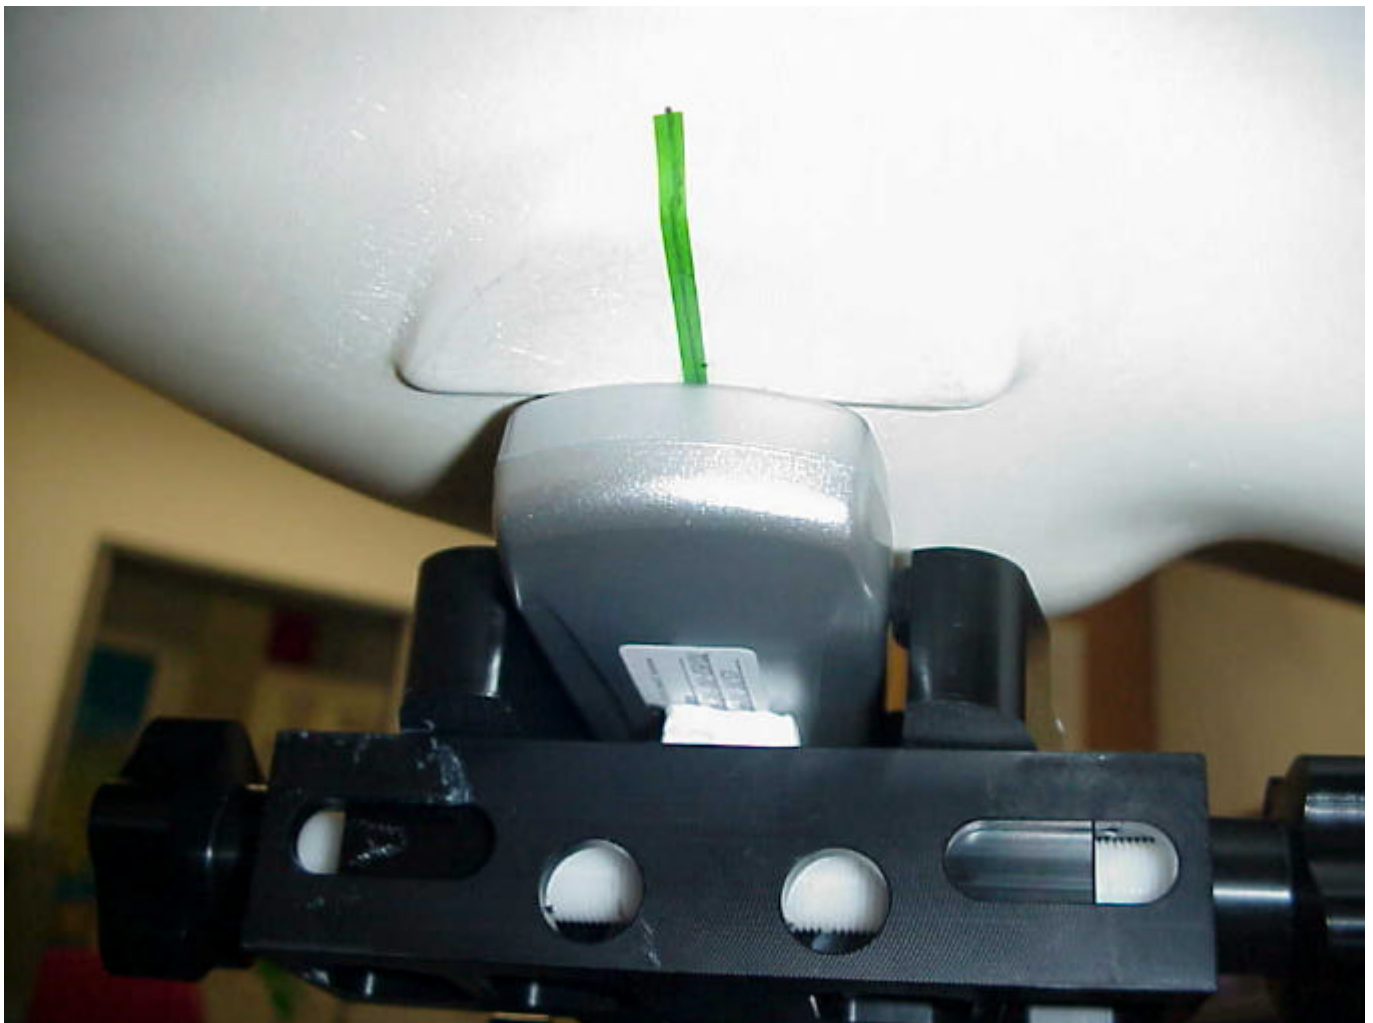
**Picture no. 3**

E2002p rear touch left

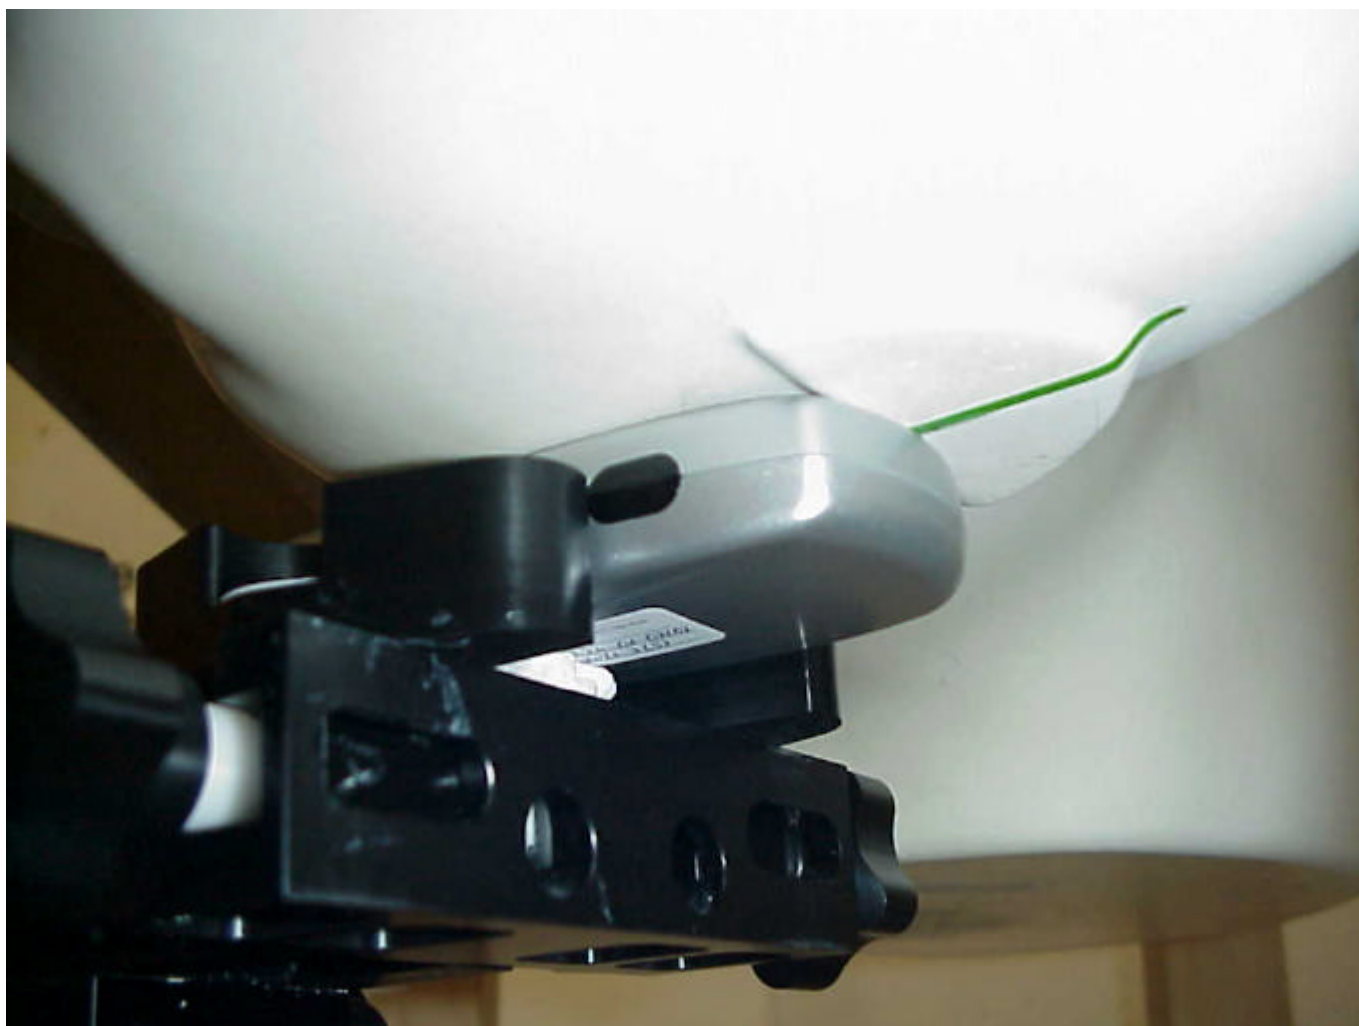
**Picture no. 4**

E2002p side touch left

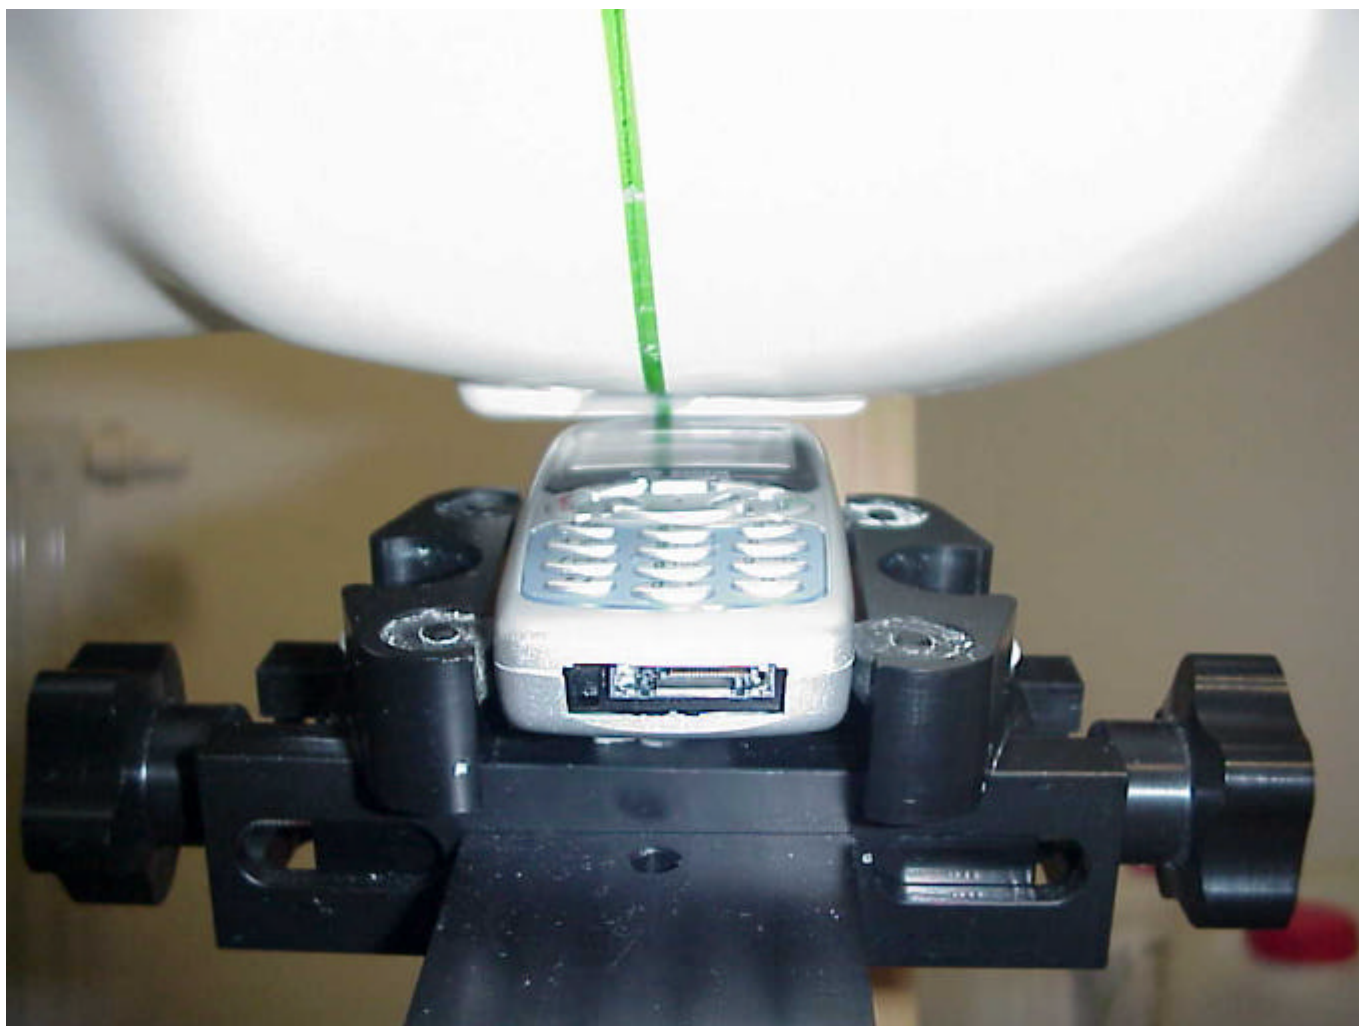
**Picture no. 5**

E2002p front tilted left

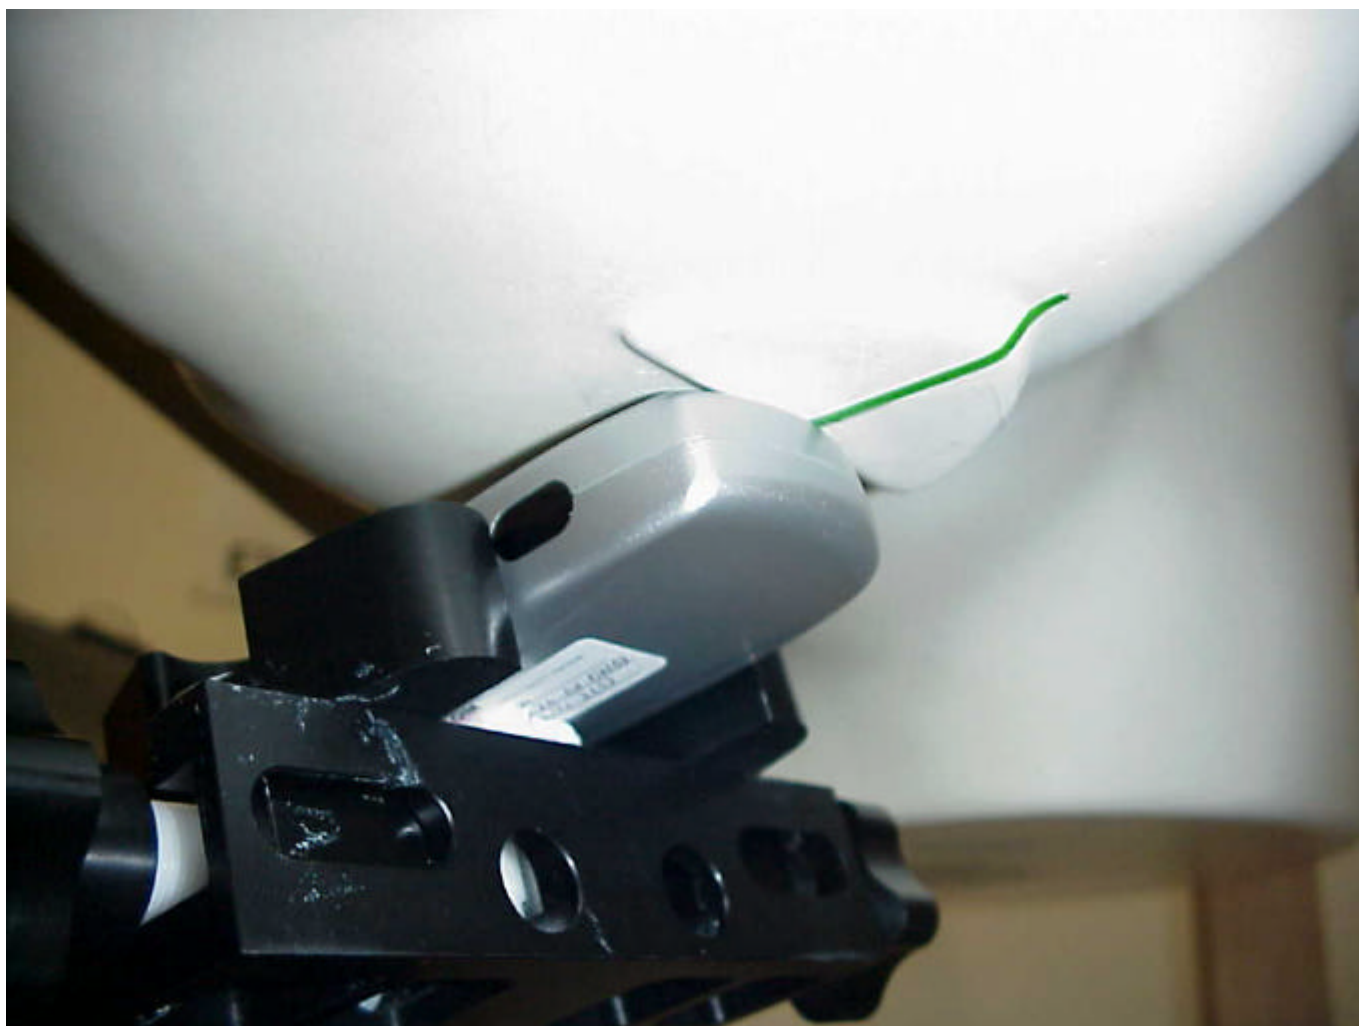
**Picture no. 6**

E2002p side tilted left

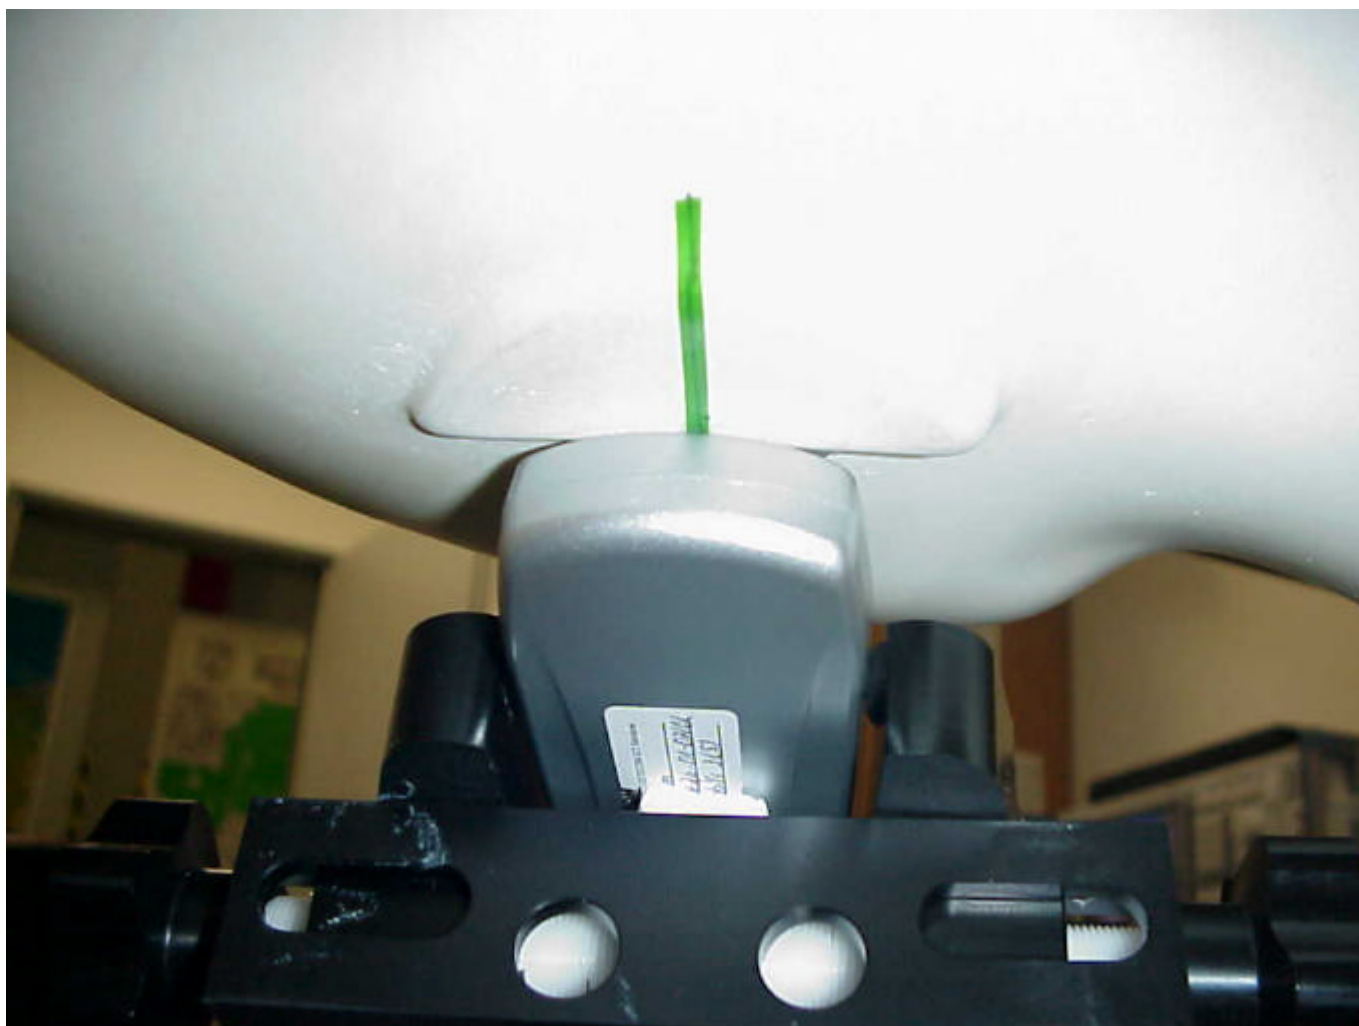
**Picture no. 7**

E2002p front tilted left

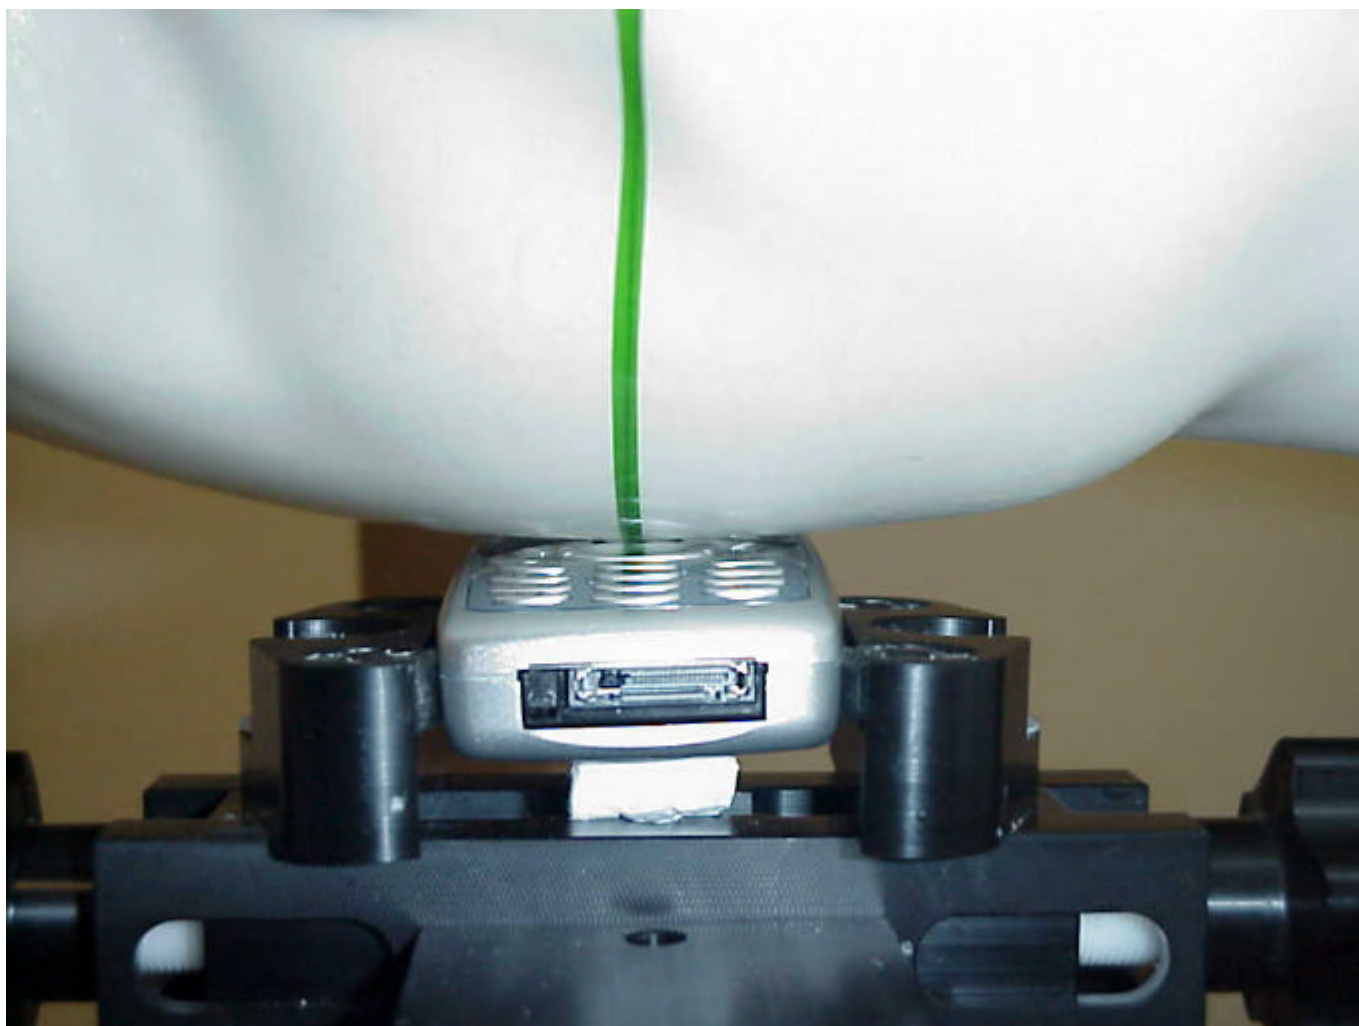
**Picture no. 8**

E2002p front touch right

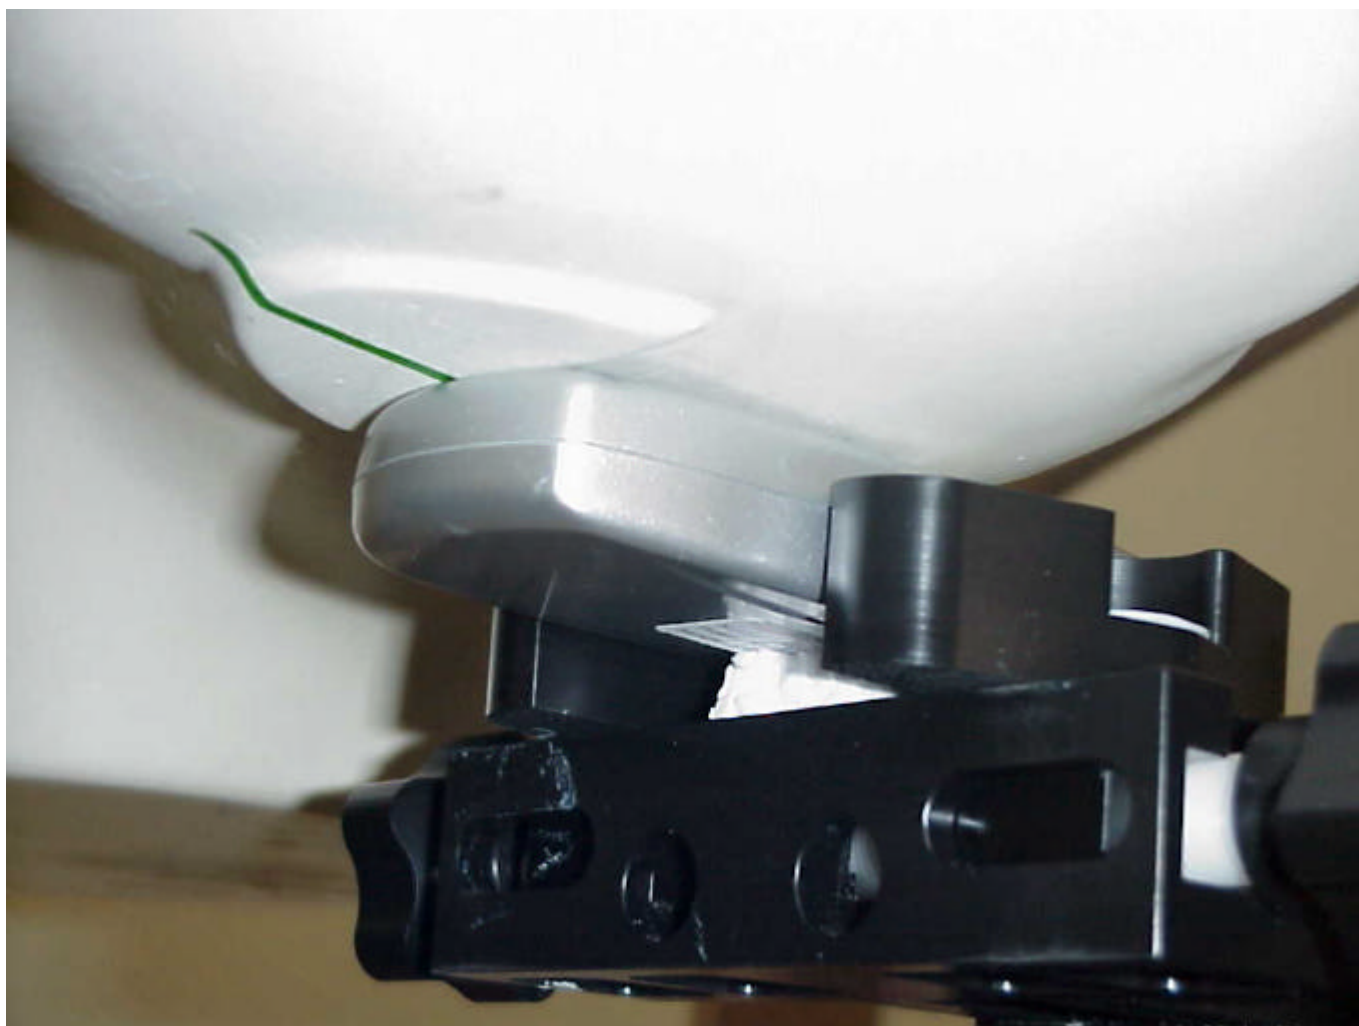
**Picture no. 9**

E2002p side touch right

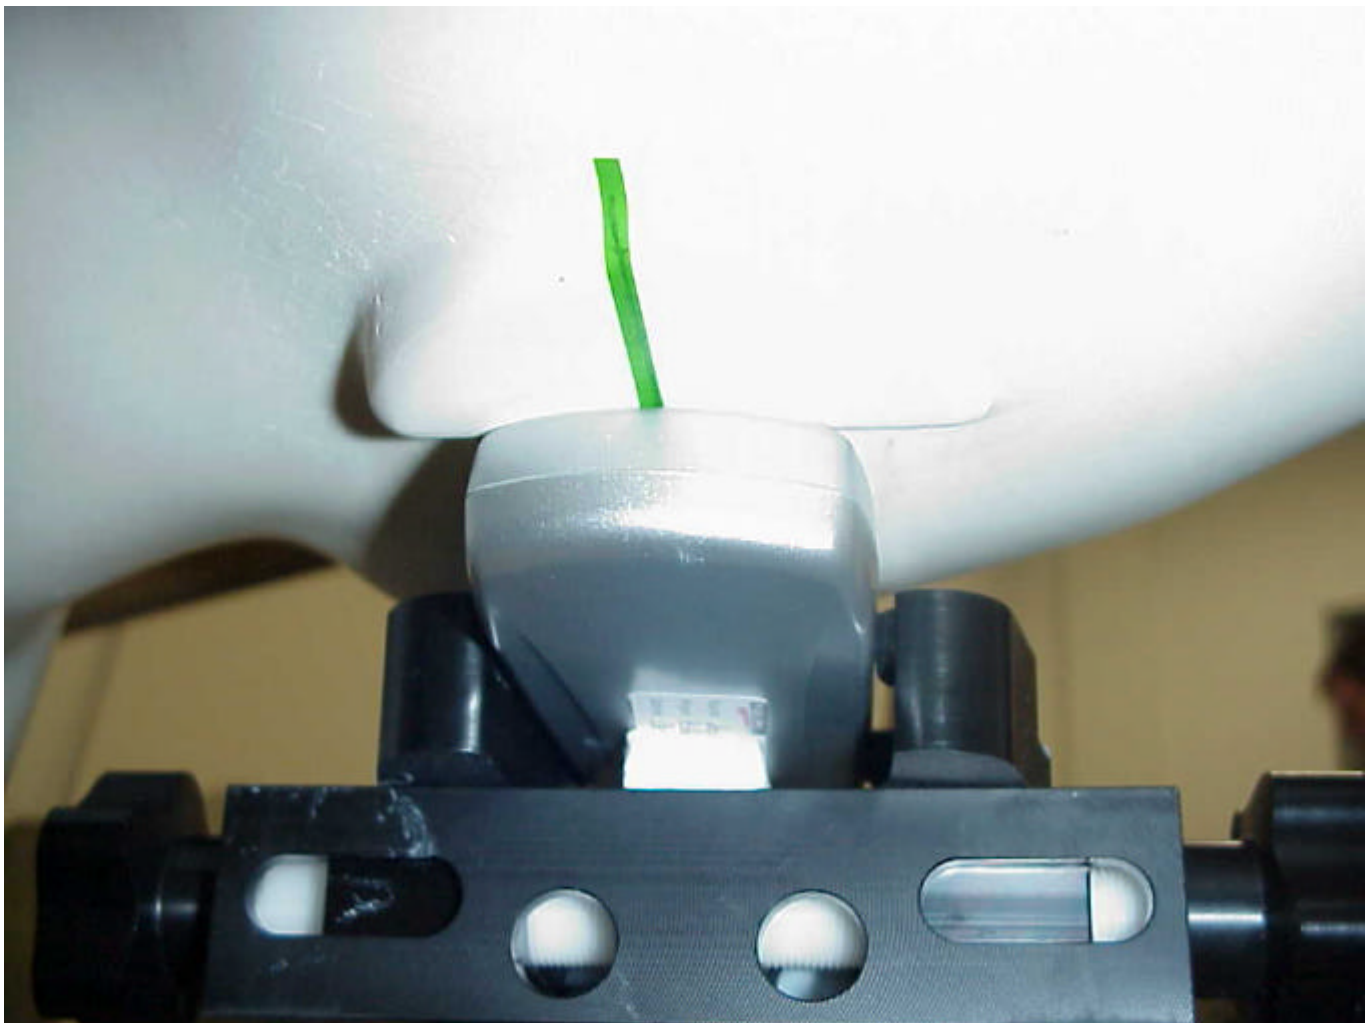
**Picture no. 10**

E2002p rear touch right

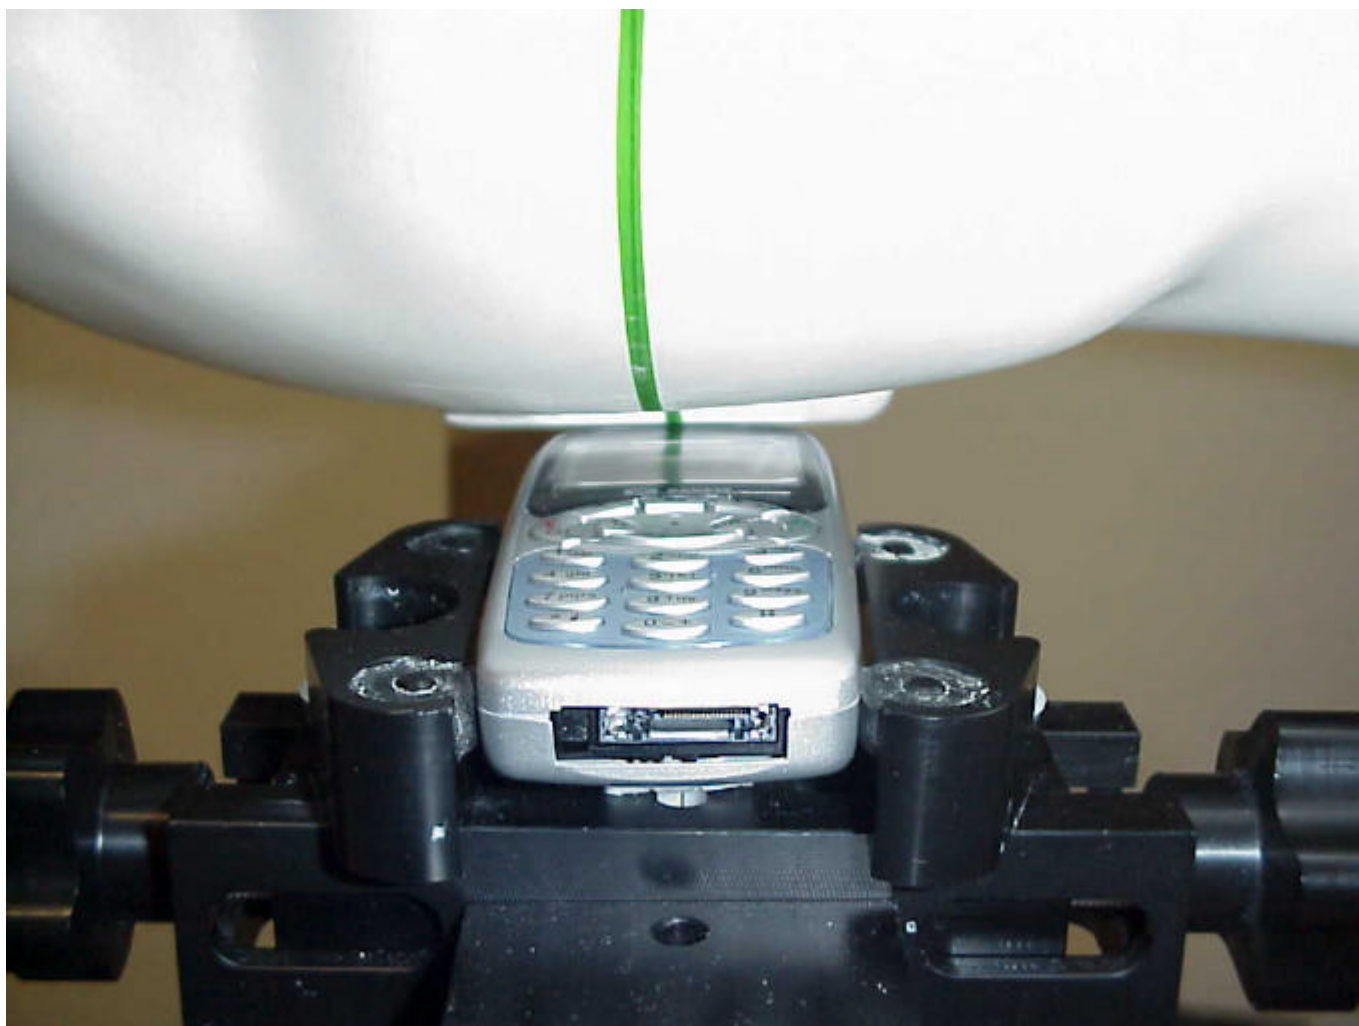
**Picture no. 11**

E2002p front tilted right

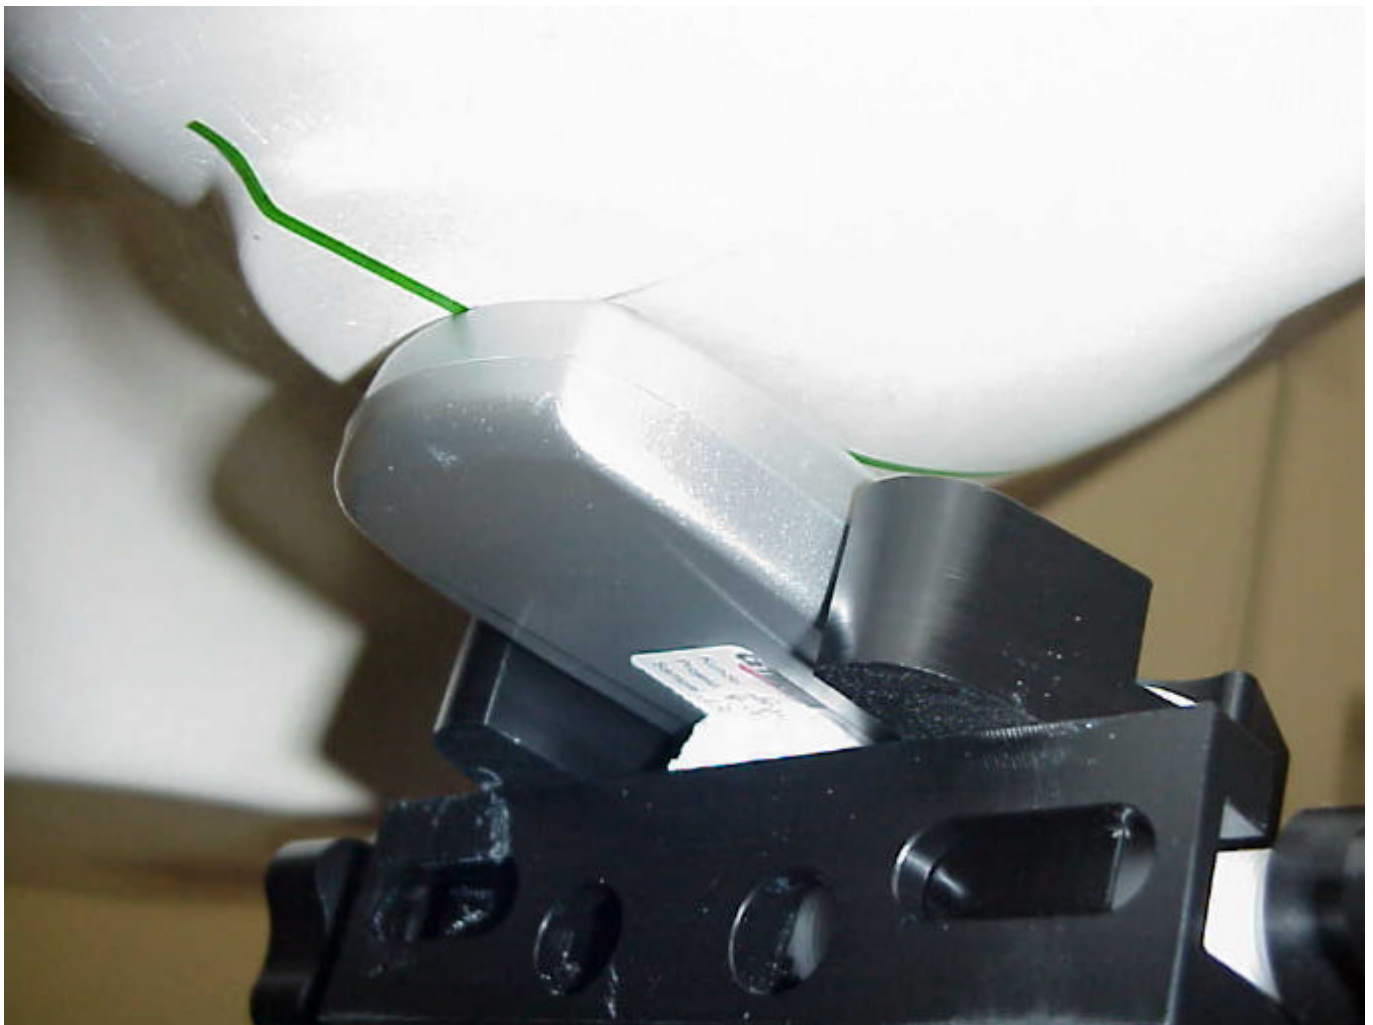
**Picture no. 12**

E2002p side tilted right

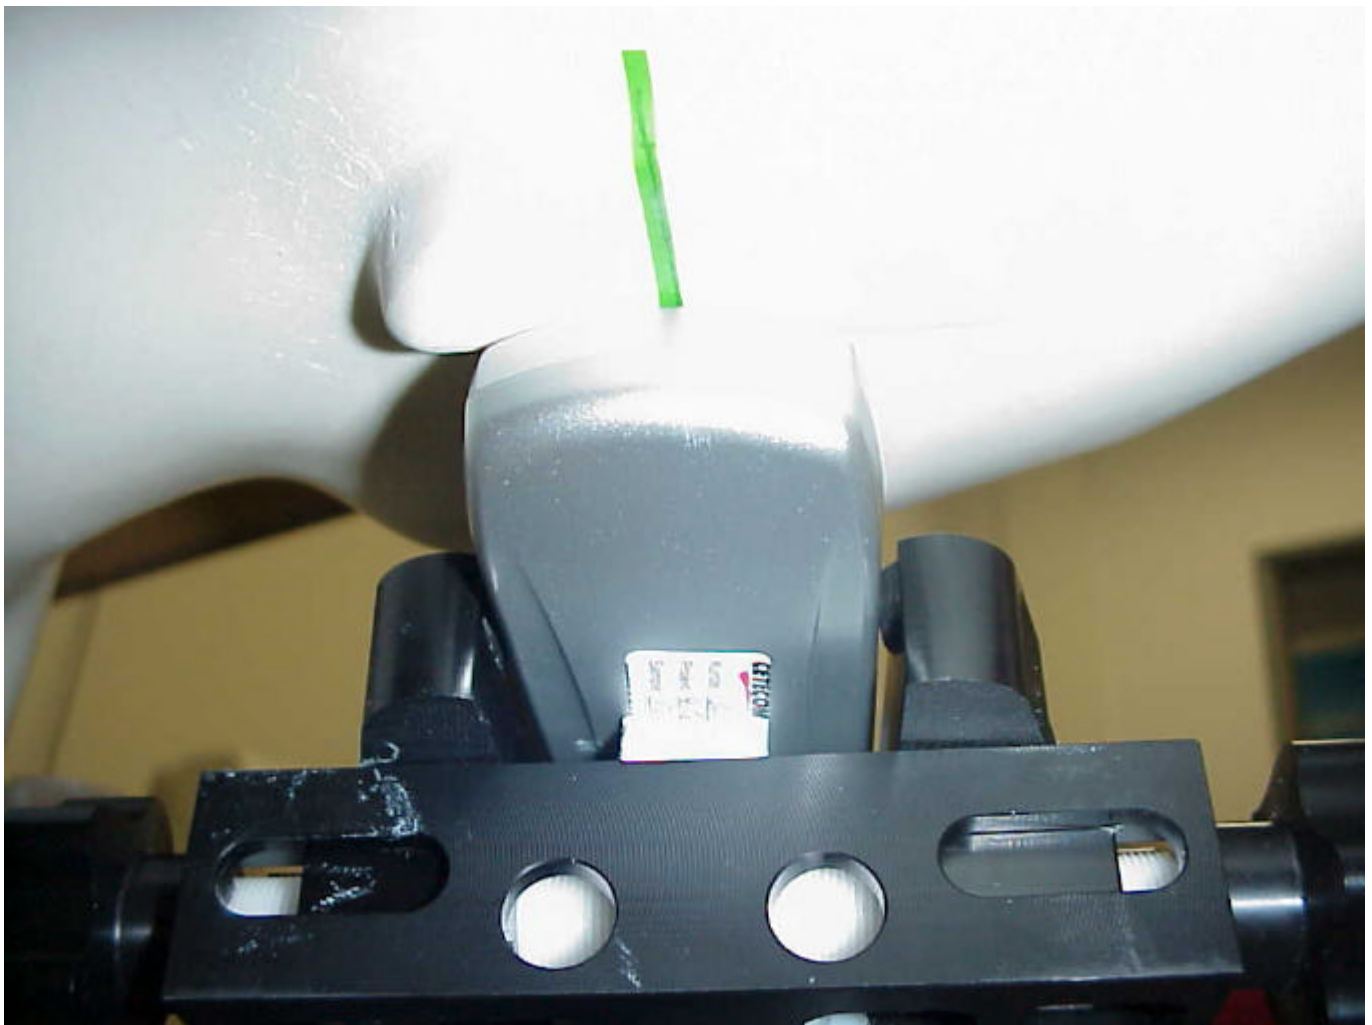
**Picture no. 13**

E2002p rear tilted right

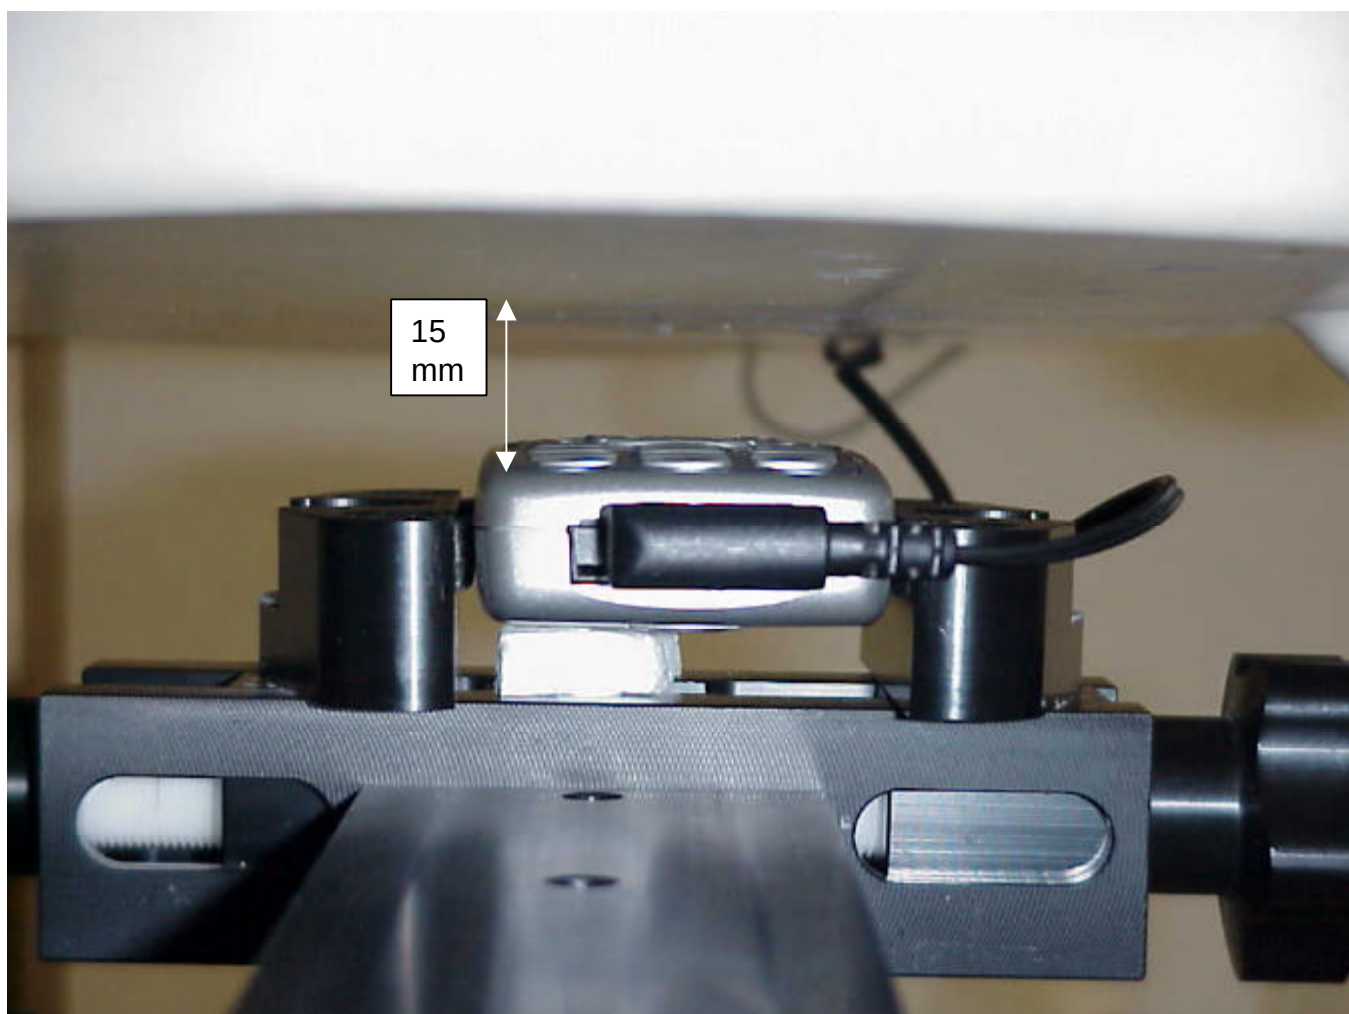
**Picture no. 14**

E2002p flat front 15mm

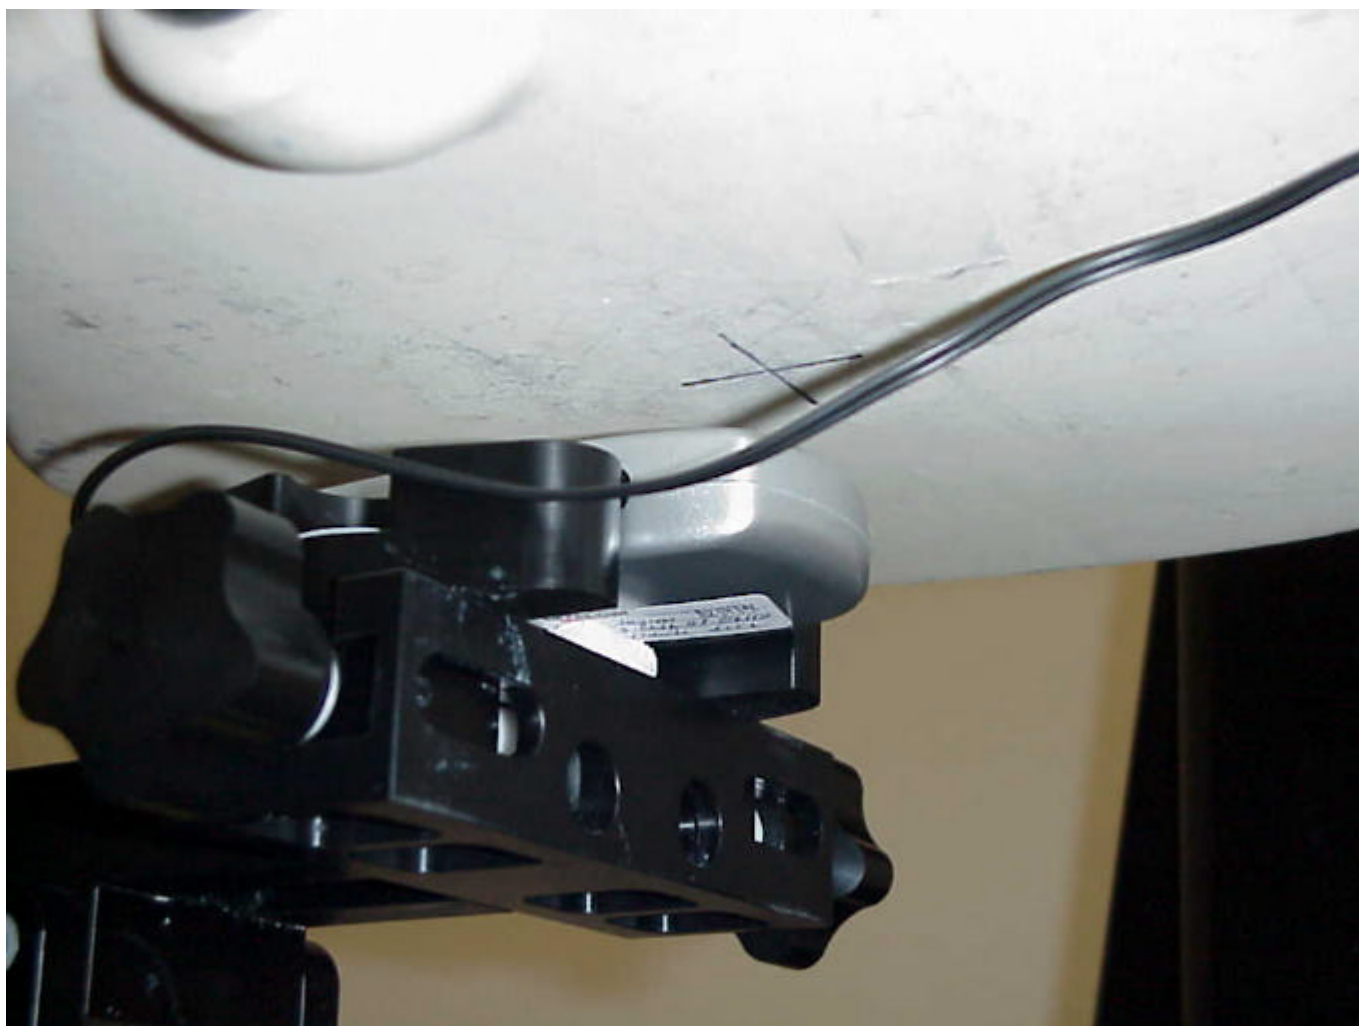
**Picture no. 15**

E2002p flat front 15mm

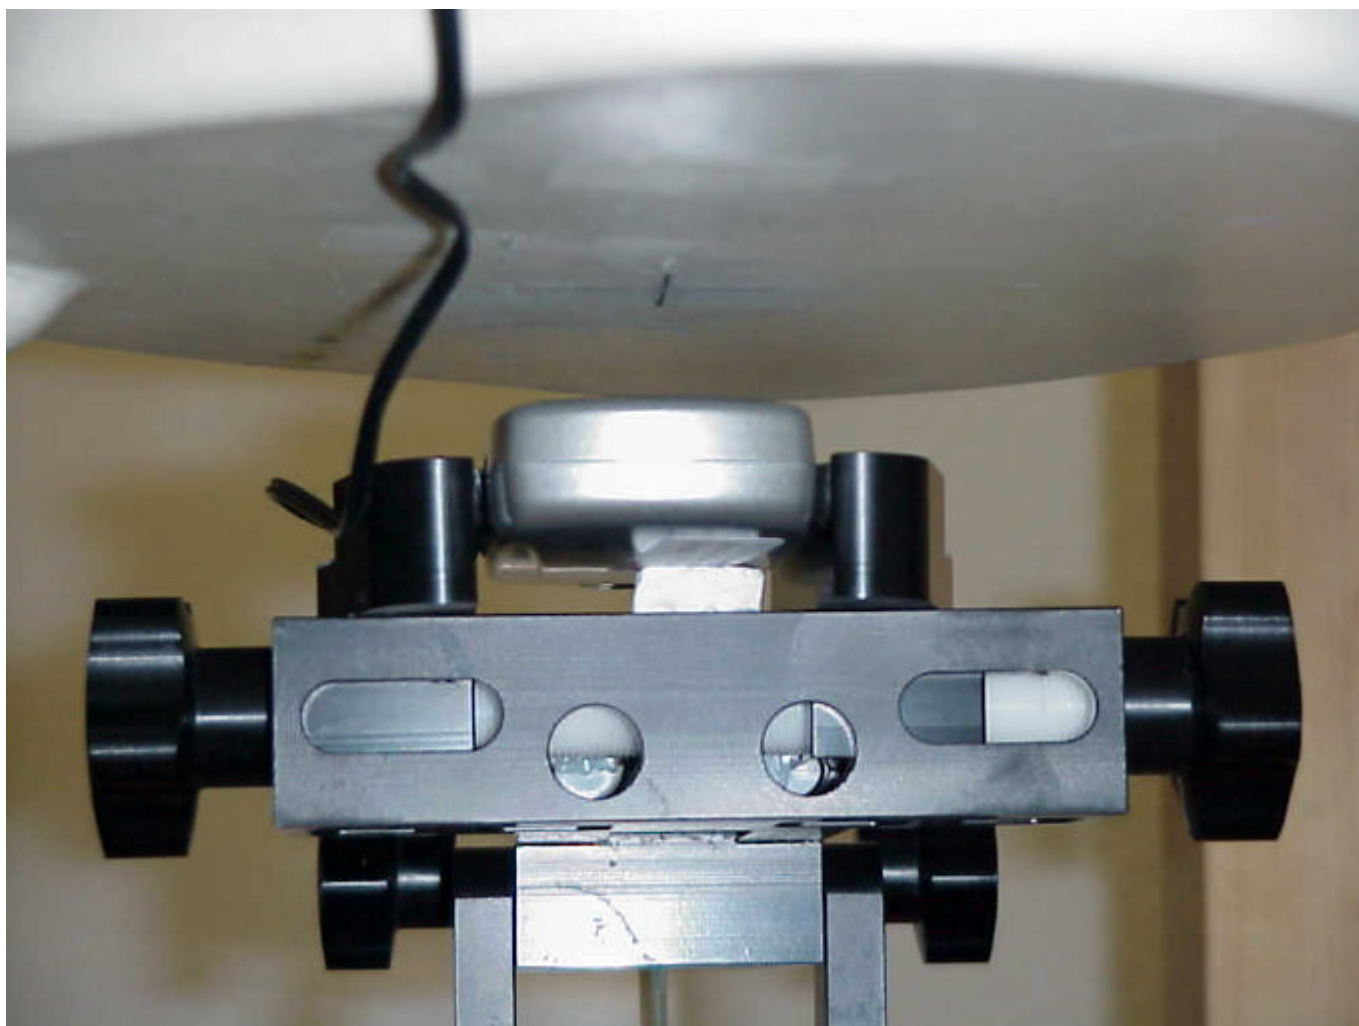
**Picture no. 16**

E2002p flat front 15mm
