## **Accredited testing laboratory**

## **Appendix to the Report 2-3078-1-3/02 Photo documentation**

## Annex 3 Photo documentation

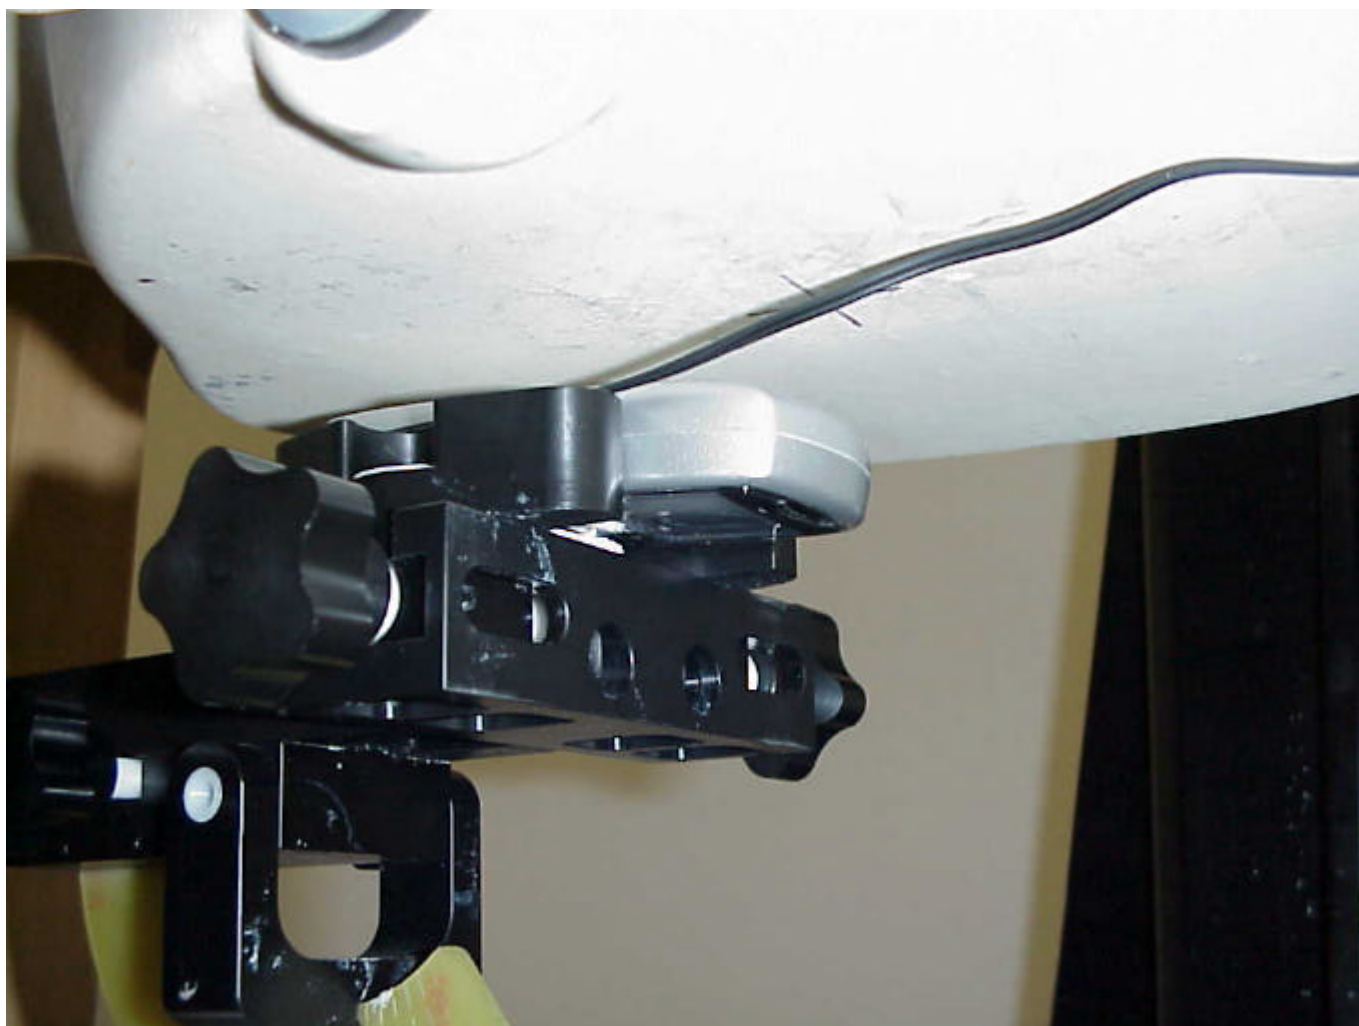
**Picture no. 17**

E2002p flat rear 15mm

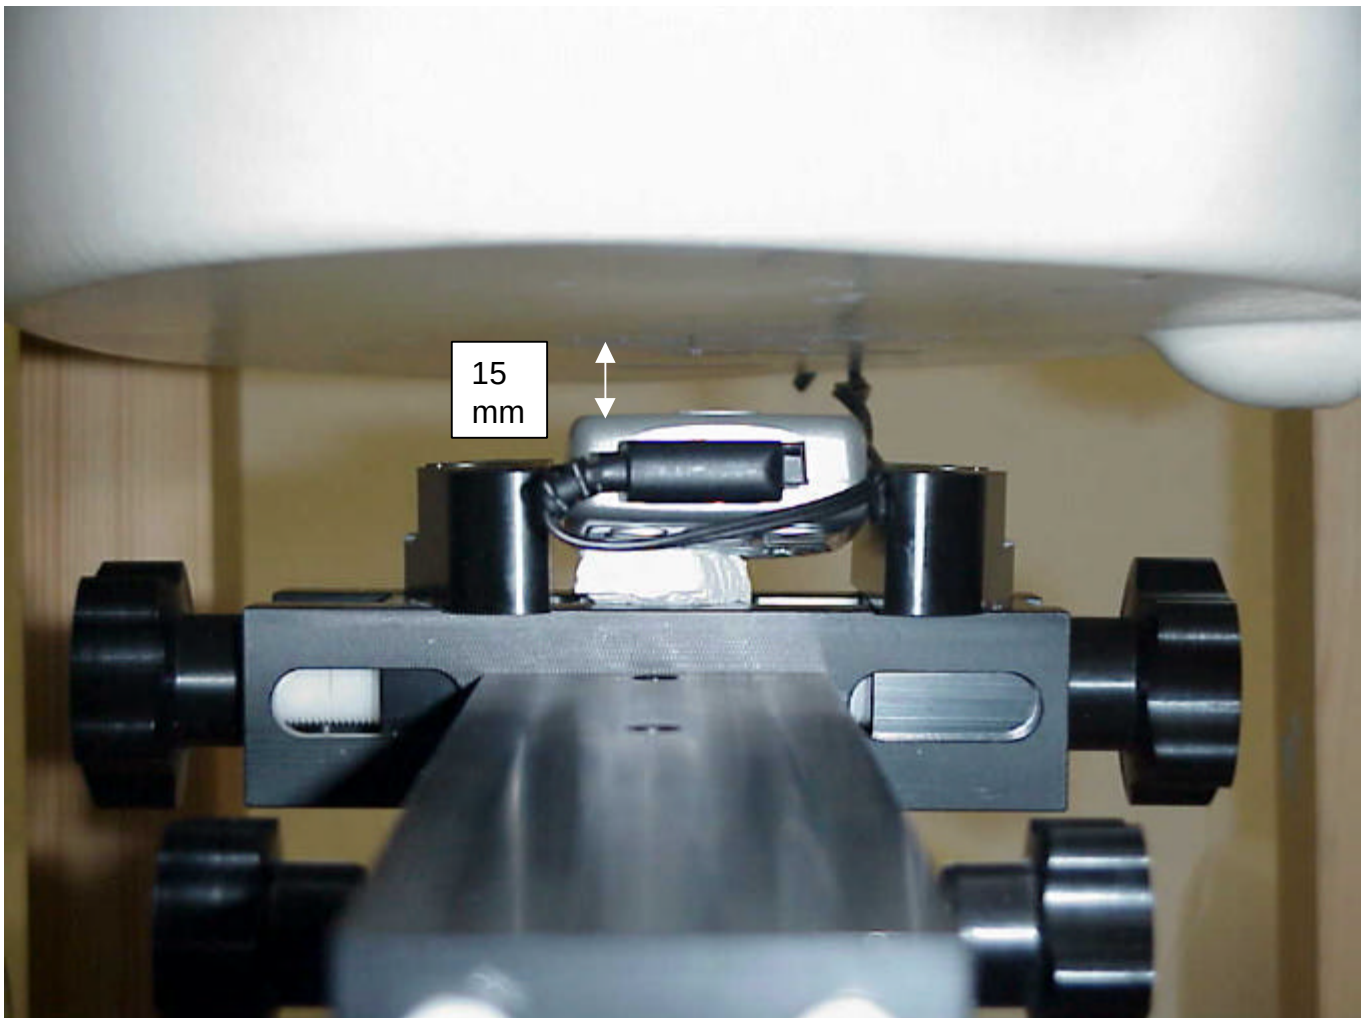
**Picture no. 18**

E2002p flat rear 15mm

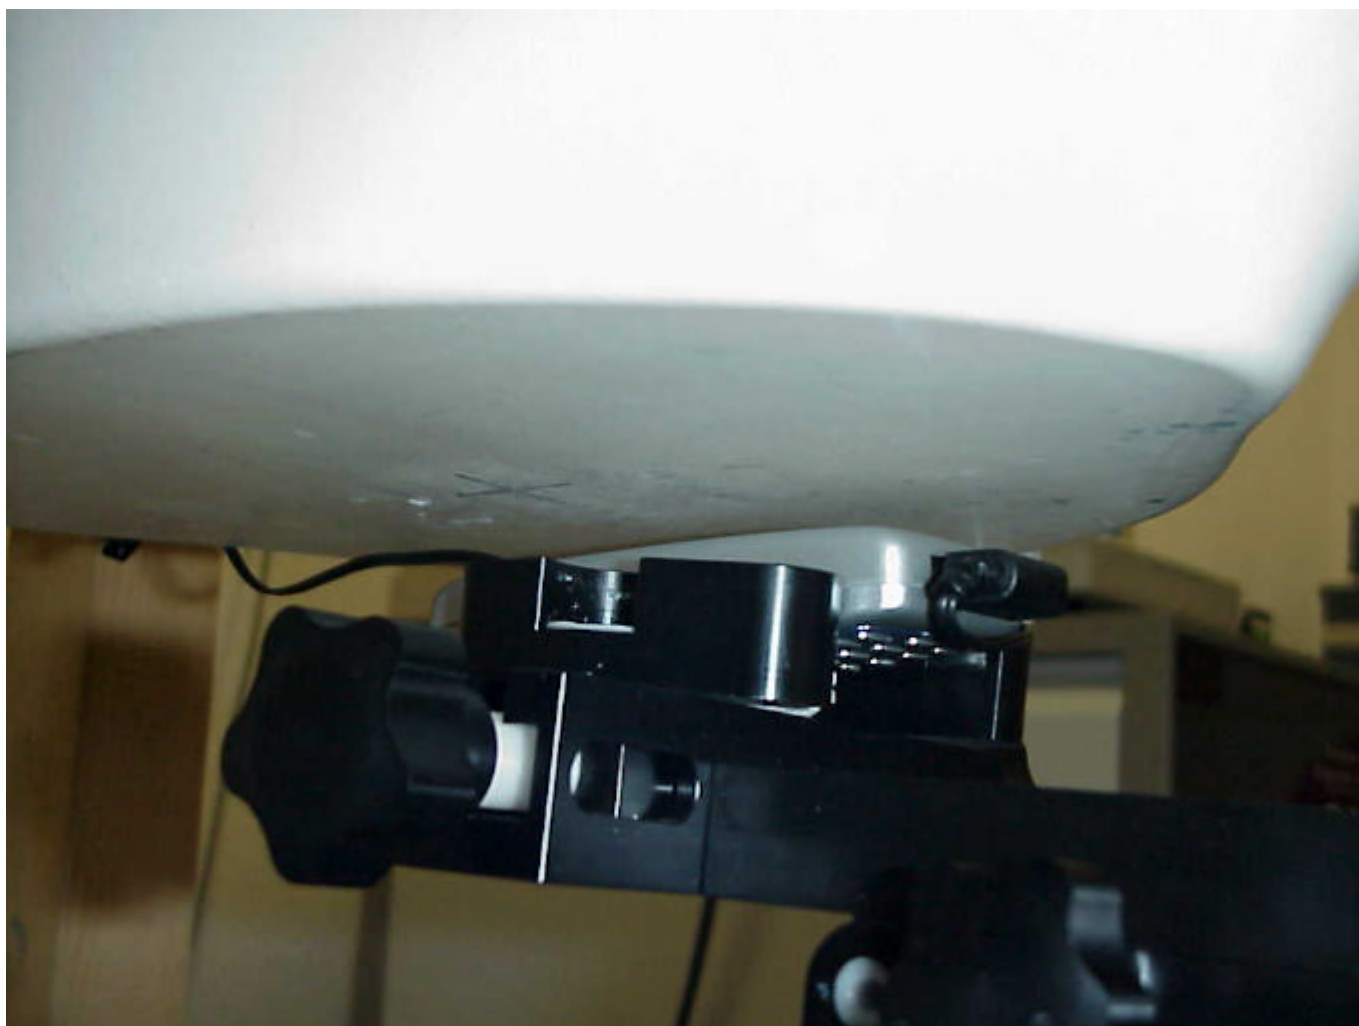
**Picture no. 19**

E2002p flat rear 15mm

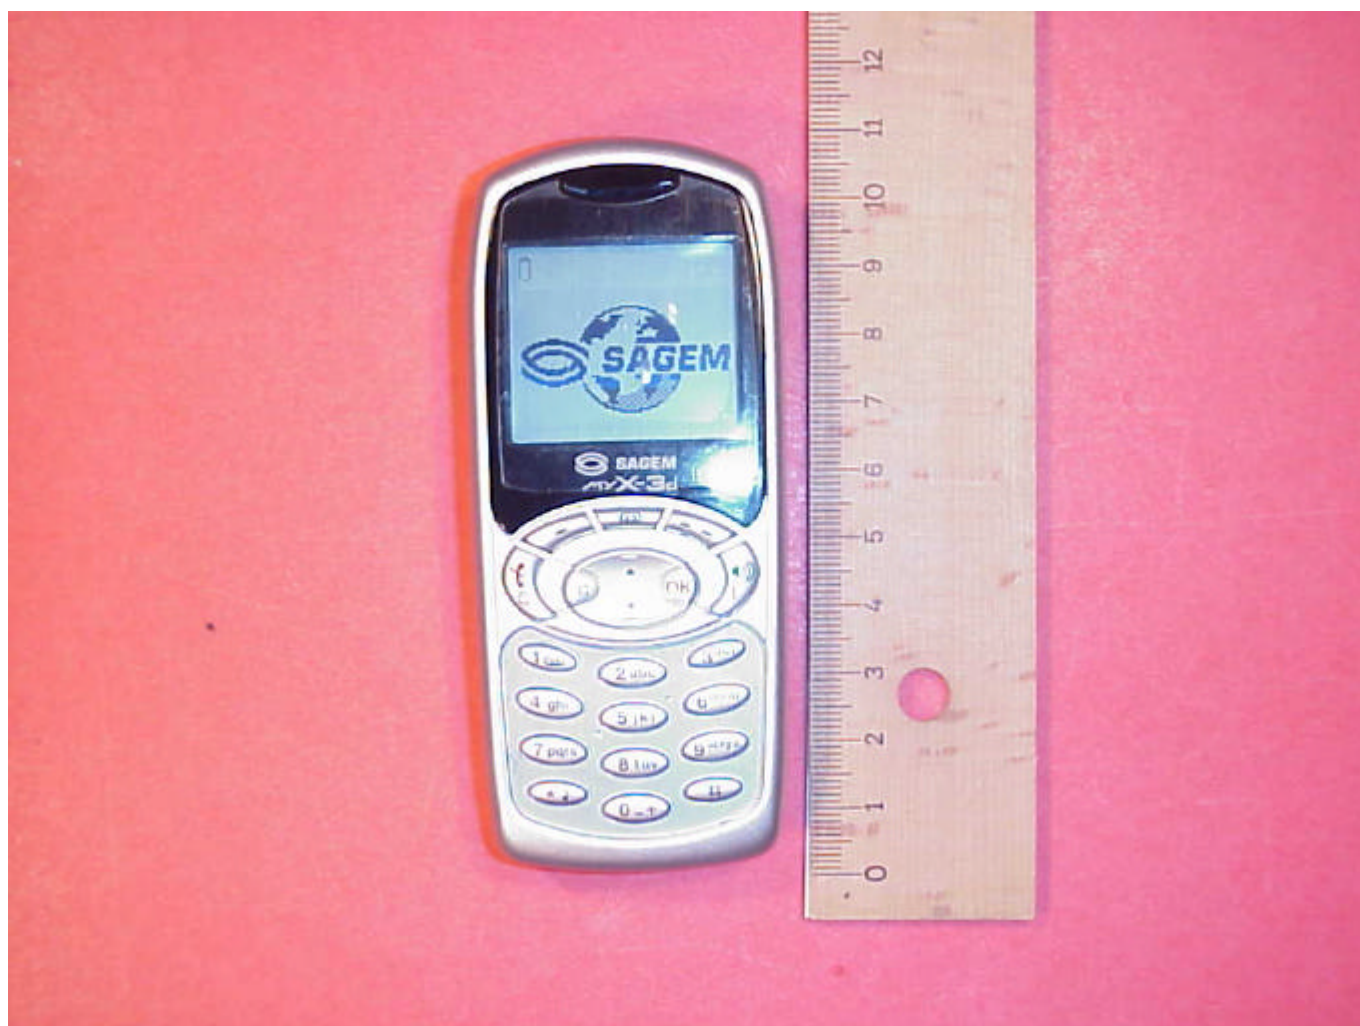
**Picture no. 20**

E2002p front

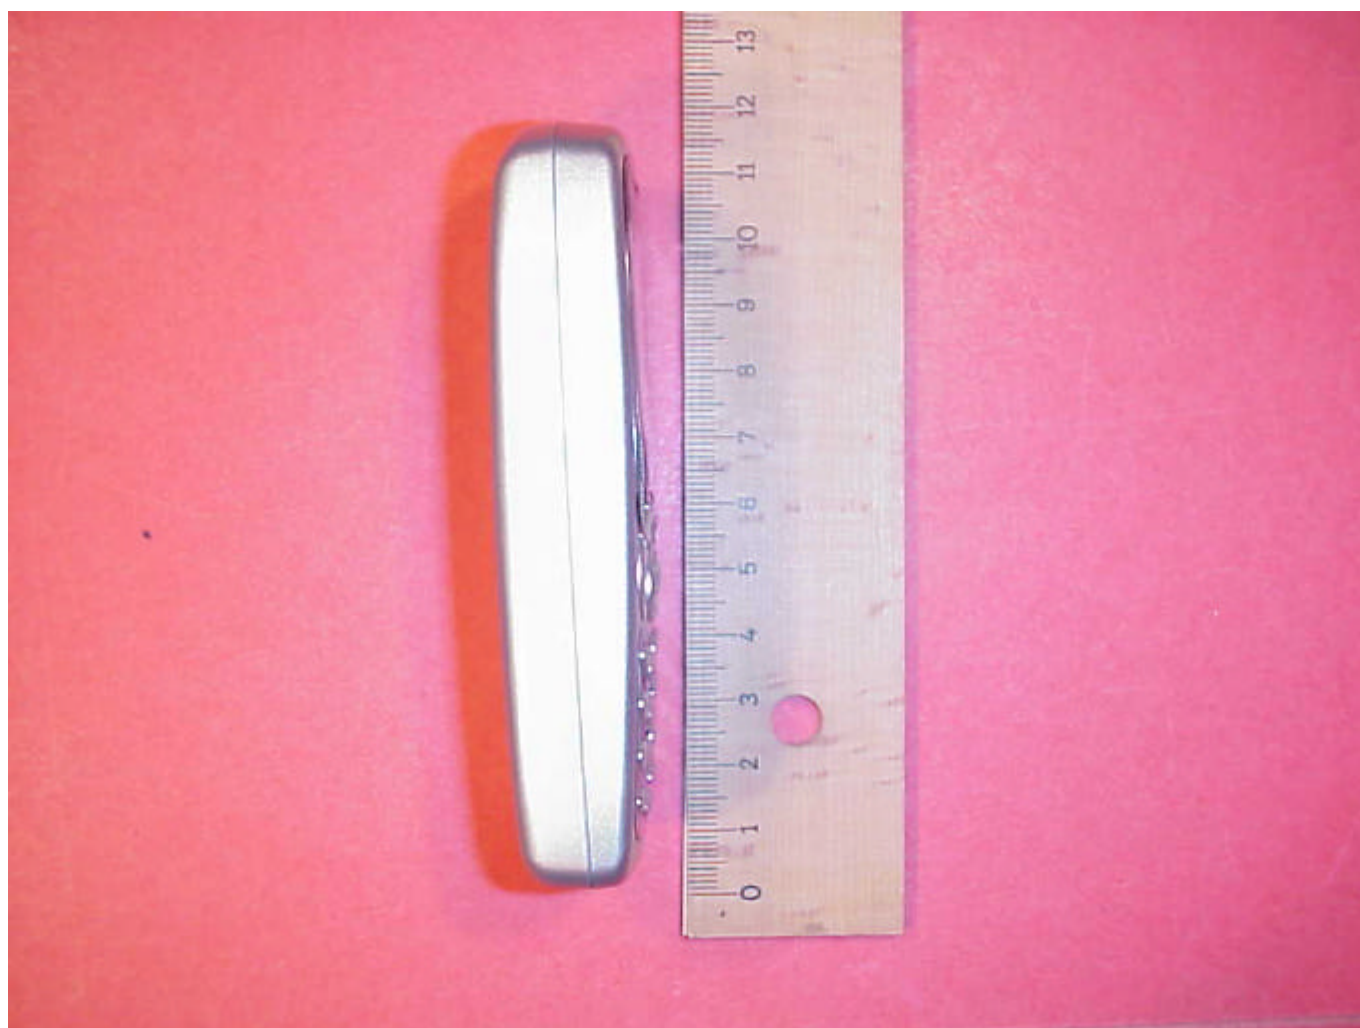
**Picture no. 21**

E2002p left side

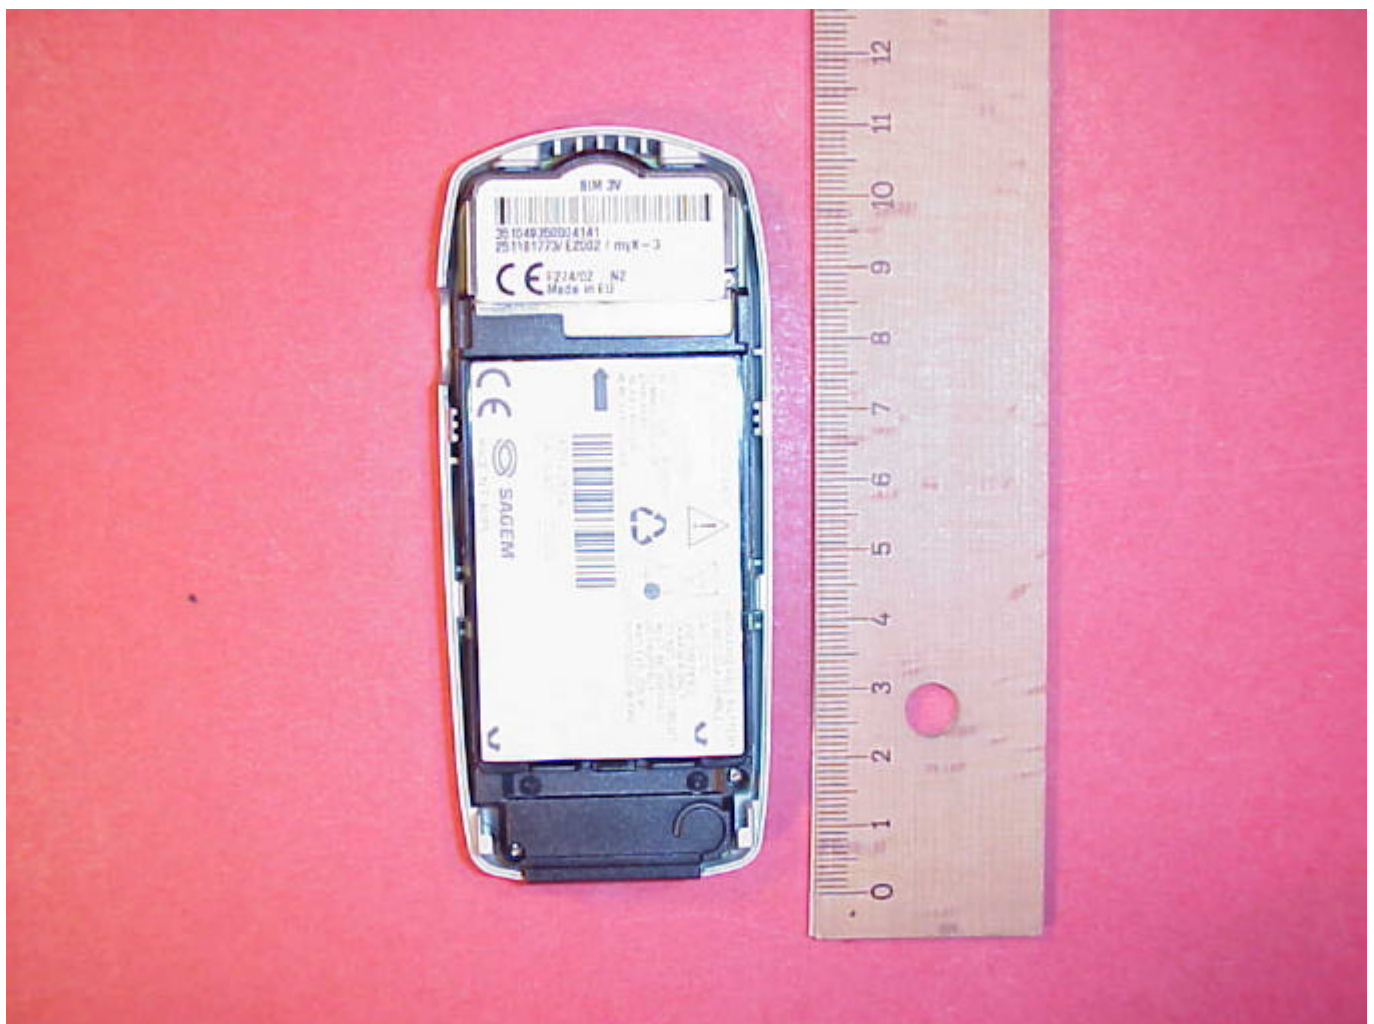
**Picture no. 22**

E2002p rear side with battery

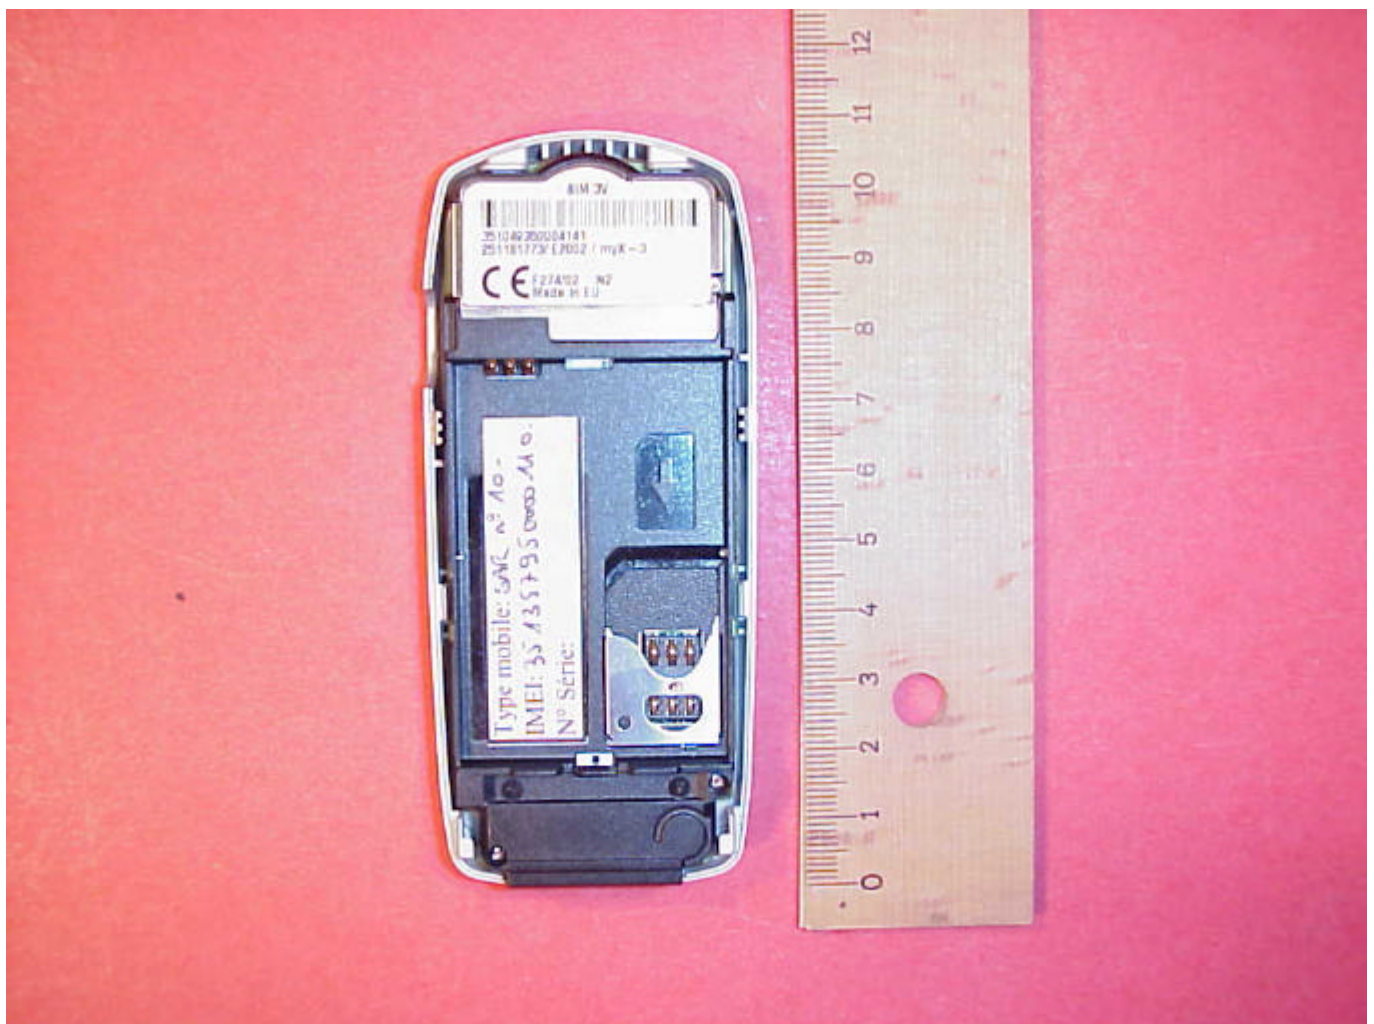
**Picture no. 23**

E2002p rear side without battery

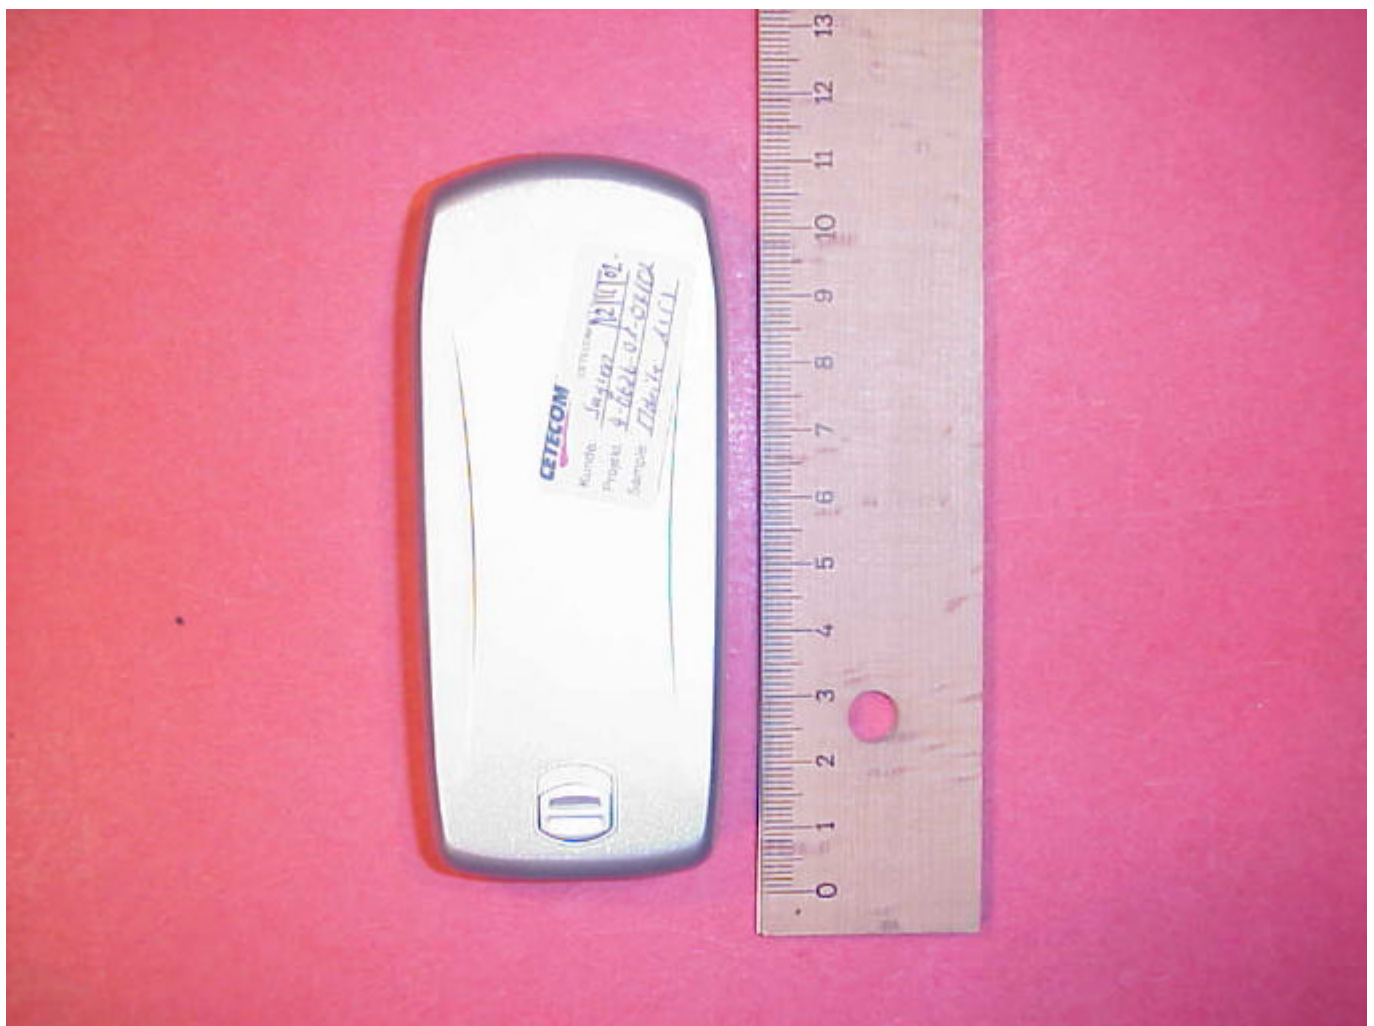
**Picture no. 24**

E2002p rear side

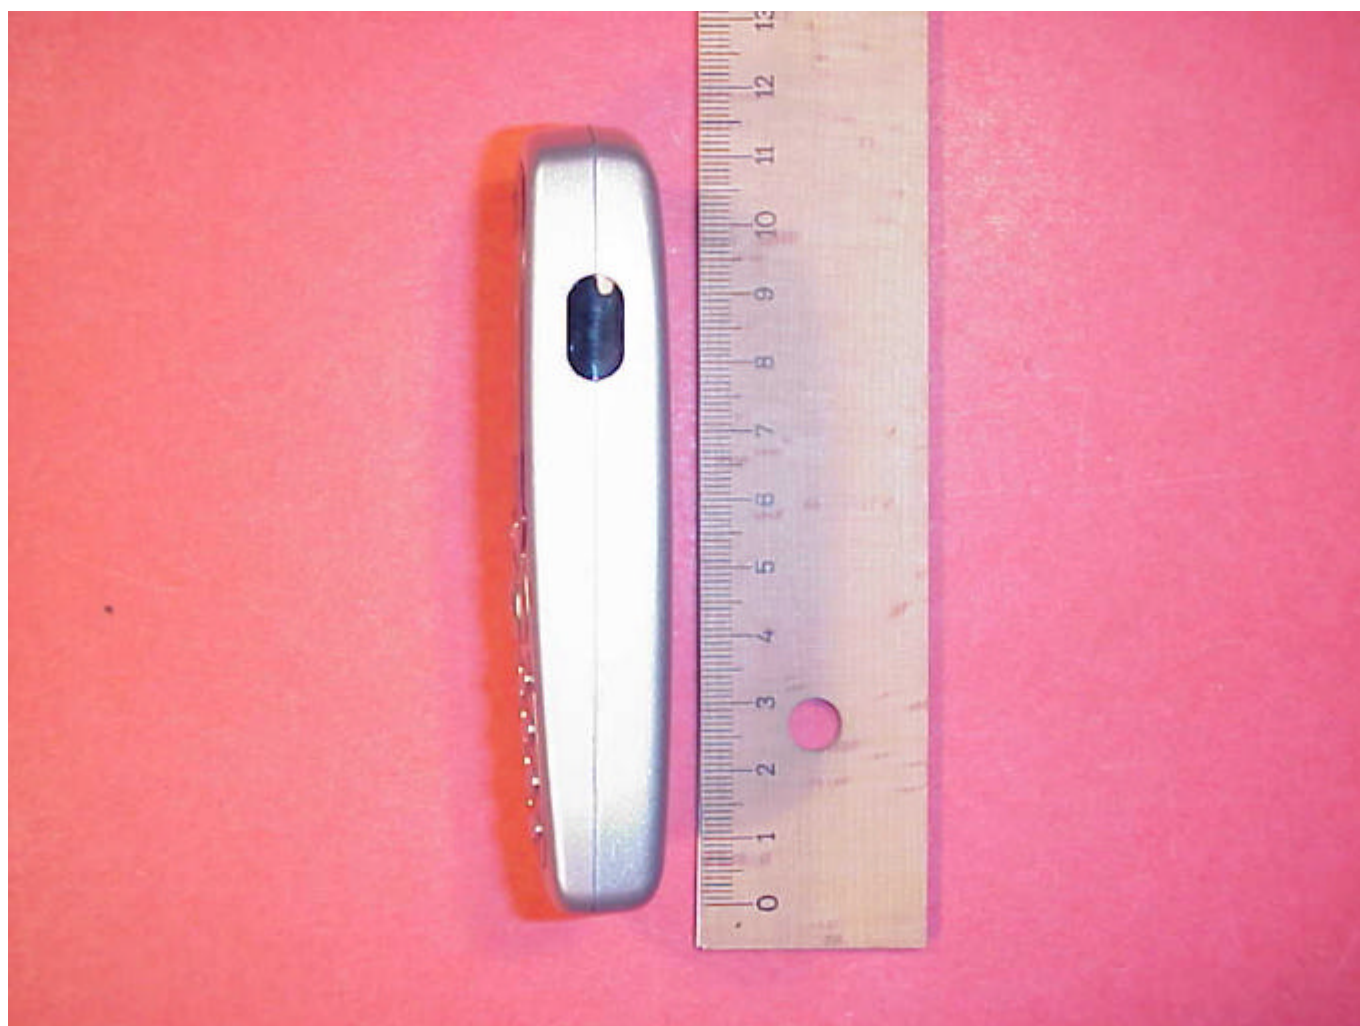
**Picture no. 25**

E2002p left side

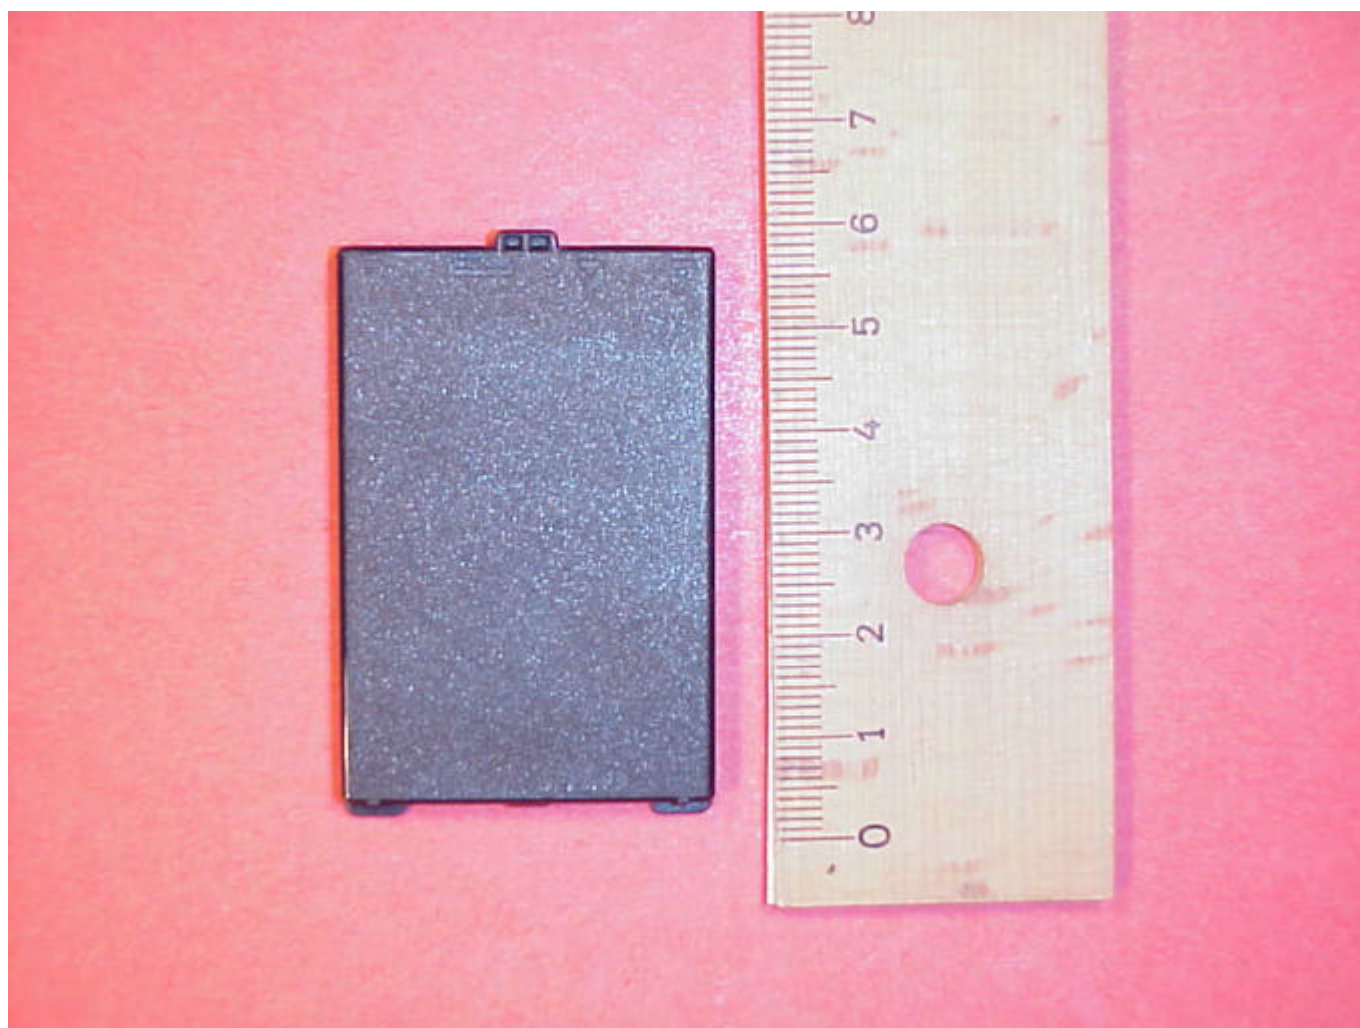
**Picture no. 27**

battery rear

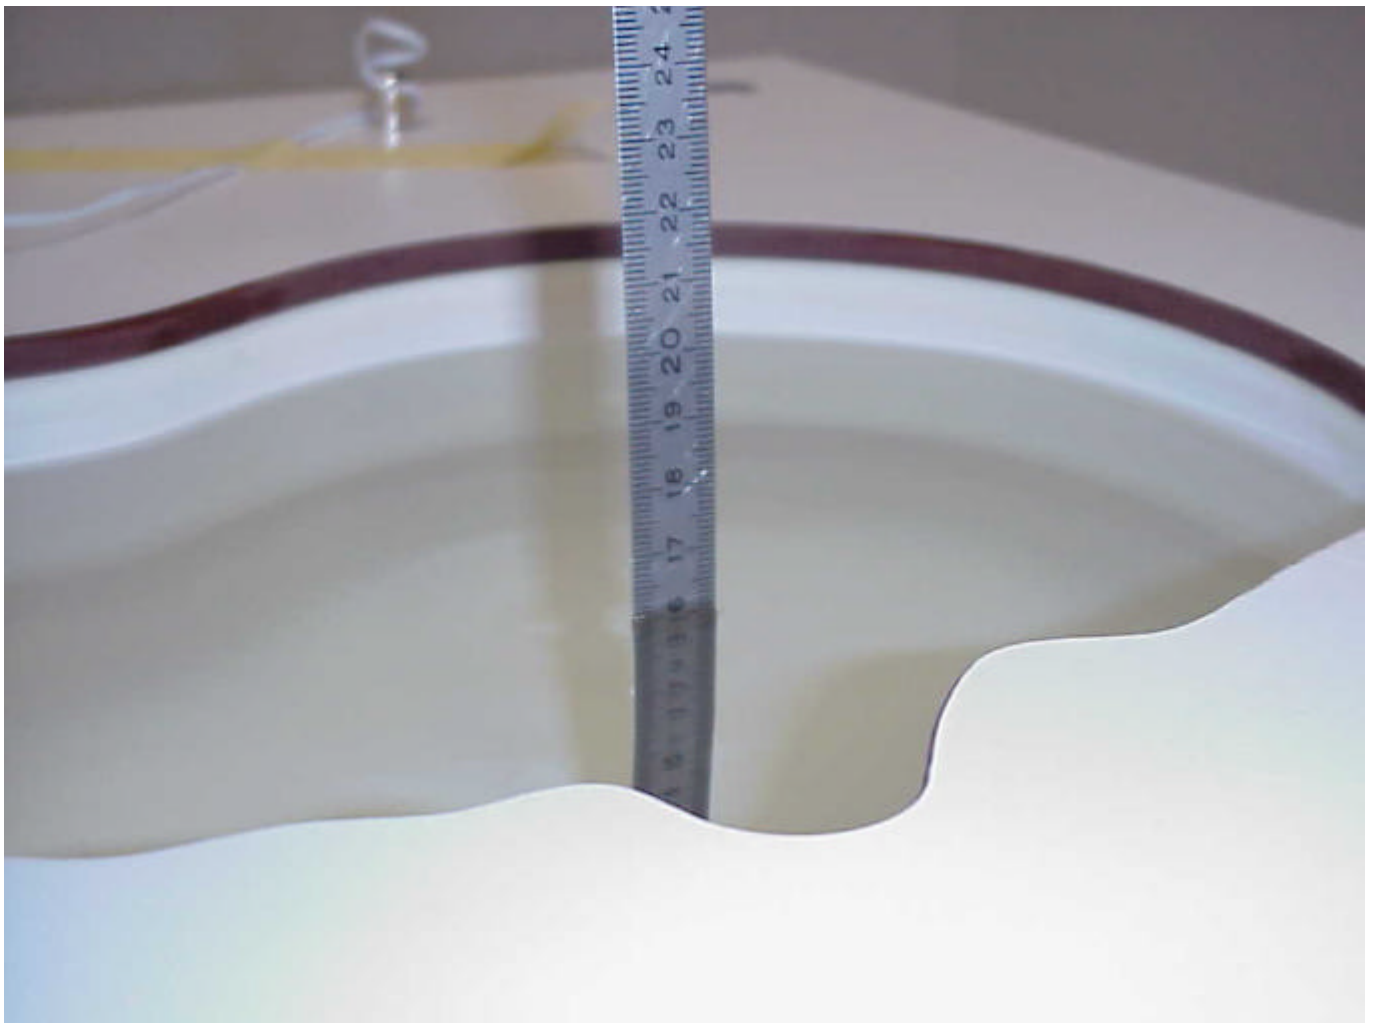
**Picture no. 28**

liquid depth head 1900 MHz

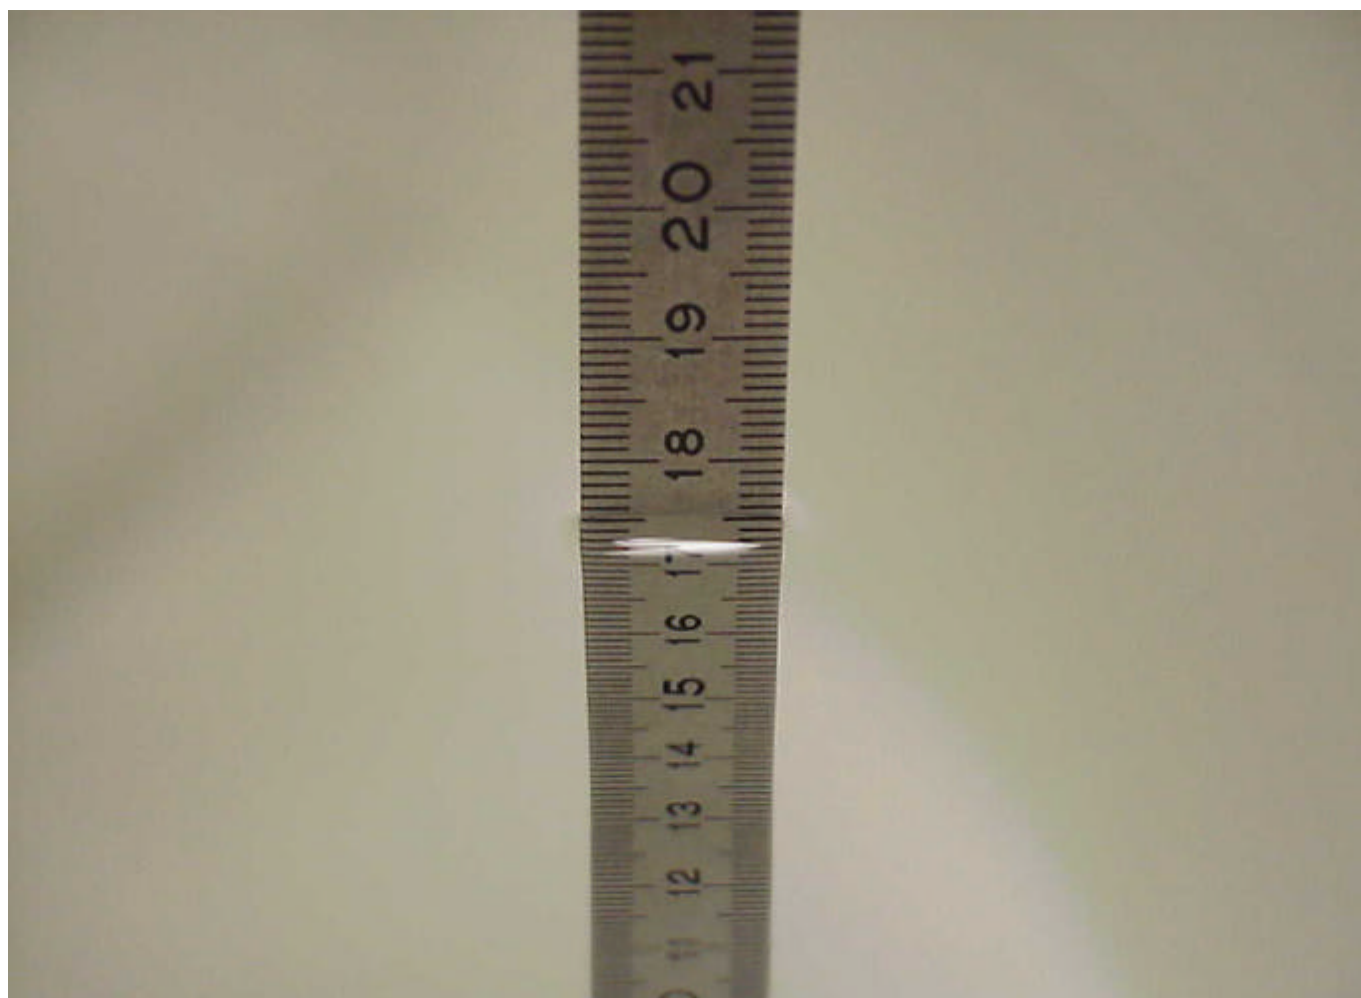
**Picture no. 29**

liquid depth body 1900 MHz
