Report No.: 99001971

Final Measurement: X QP

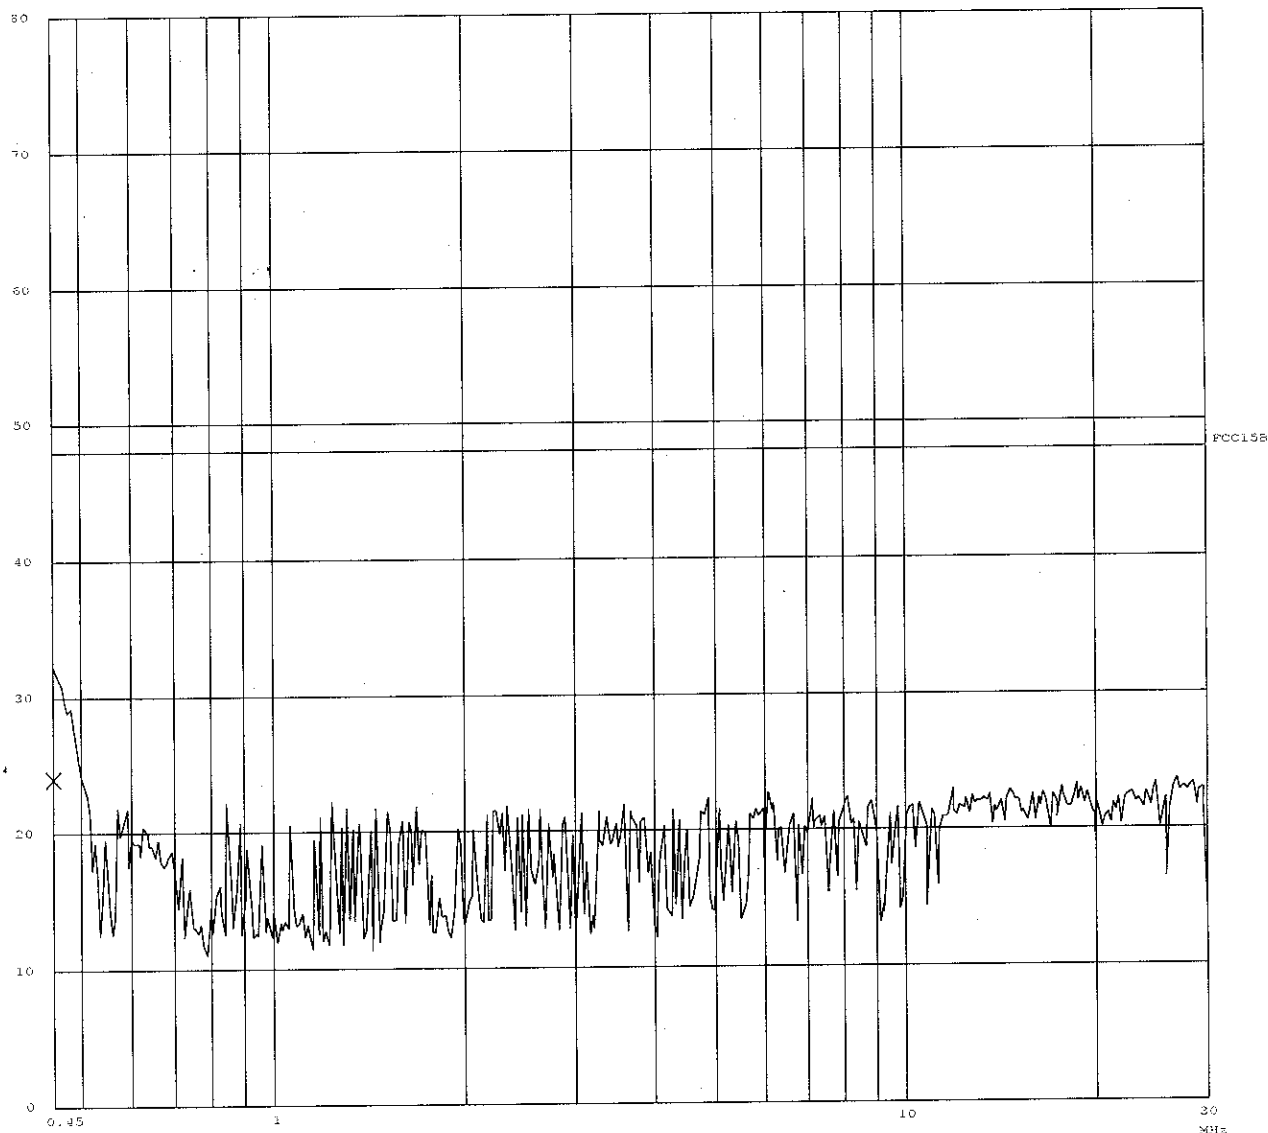
Scan Settings (1 Range)

| Start | Stop | Step | IF BW | Detector | M-Time | Atten | Preamp | OpRge |
|---|---|---|---|---|---|---|---|---|
| 450k | 30M | 5k | 10k | PK | 20ms | AUTO | LN OFF | 60dB |

Meas Time: 1 s  
Subranges: 16  
Acc Margin: 20dB

Final Measurement Results:

| Frequency<br>MHz | QP Level<br>dBuV | QP Limit<br>dBuV |
|---|---|---|
| 0.45000 | 24.0 | 48.0 |
