### **APPENDIX3: Photographs of test setup**

#### **Radiated Emission** **(Below 30MHz)**

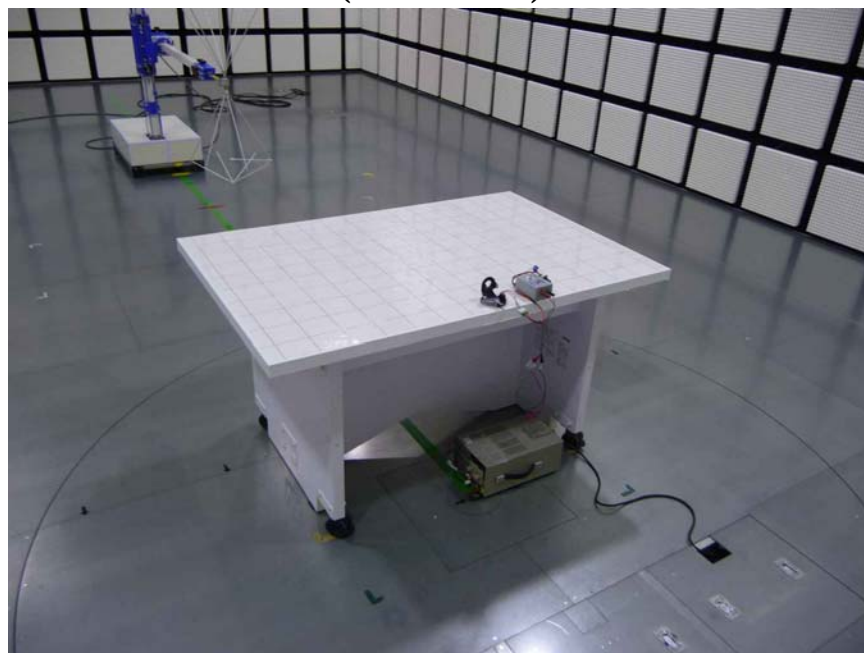
**Photo 1**

**Radiated Emission**  
**(Above 30MHz)**

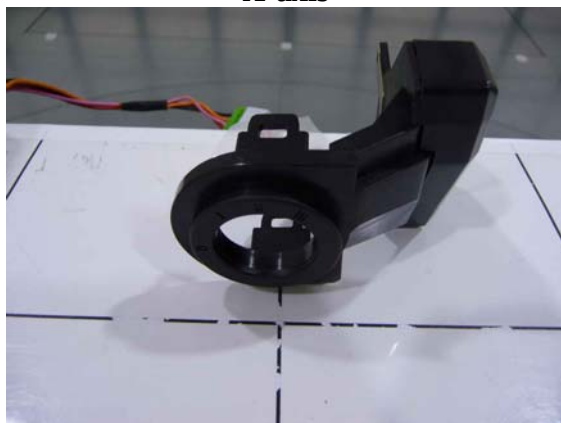
**X-axis**

### **Worst Case Position**

Below 30MHz: Horizontal: Z-axis, Vertical: X-axis  
Above 30MHz: Horizontal: Y-axis, Vertical: Y-axis
