## 11.12 Radiated Test Configuration

## 11.13 Conducted Test Configuration

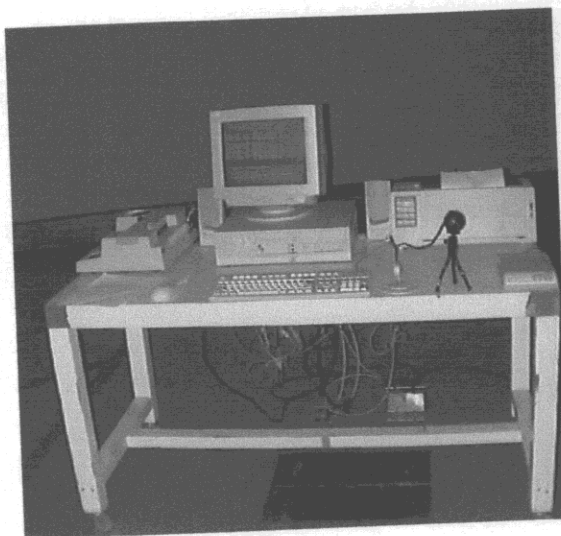
Free field front view

**NOTE:** these photographs were taken after the testing had completed and some of the bundling had come apart. During testing the cables were bundled in accordance with ANSI rules.

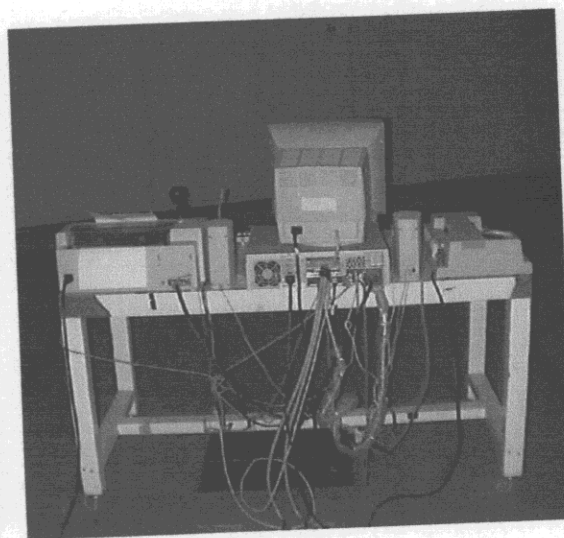
Free field rear view

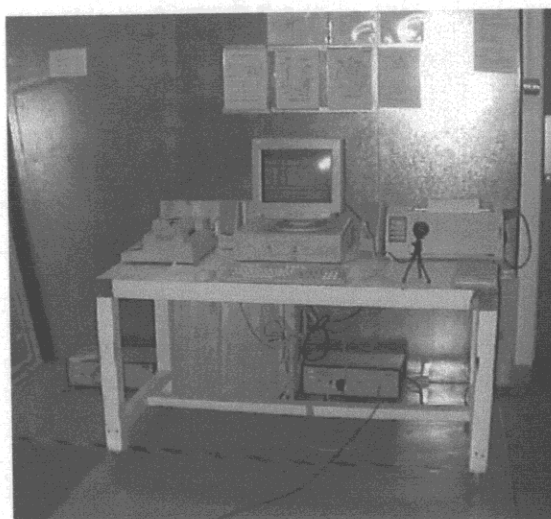
Conducted front view
