Report No.: 9806385

FCC ID: N3T9701R01

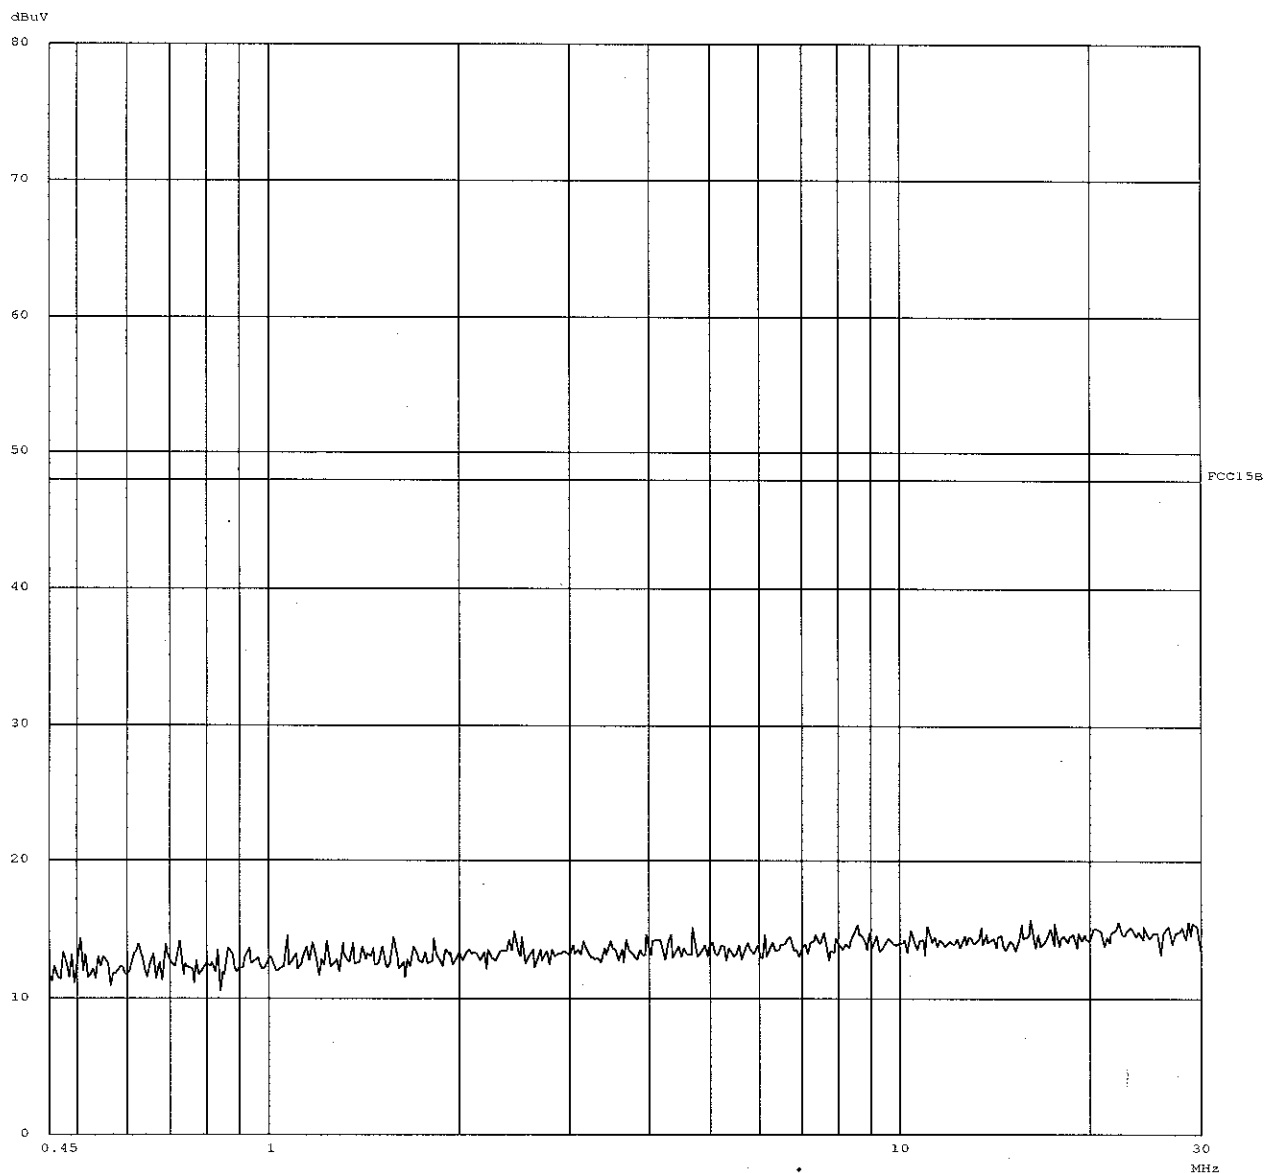
Channel A

Scan Settings (1 Range)

| Frequencies | | | Receiver Settings | | | | | |
|---|---|---|---|---|---|---|---|---|
| 450k | 30M | 5k | 10k | PK | 20ms | AUTO | LN OFF | 60dB |

Final Measurement: x QP

Meas Time: 1 s  
Subranges: 16  
Acc Margin: 20dB

| Transducer No. | Start | Stop | Name |
|---|---|---|---|
| 3 | 9k | 30M | EI078 |

Final Measurement Results:

no Results

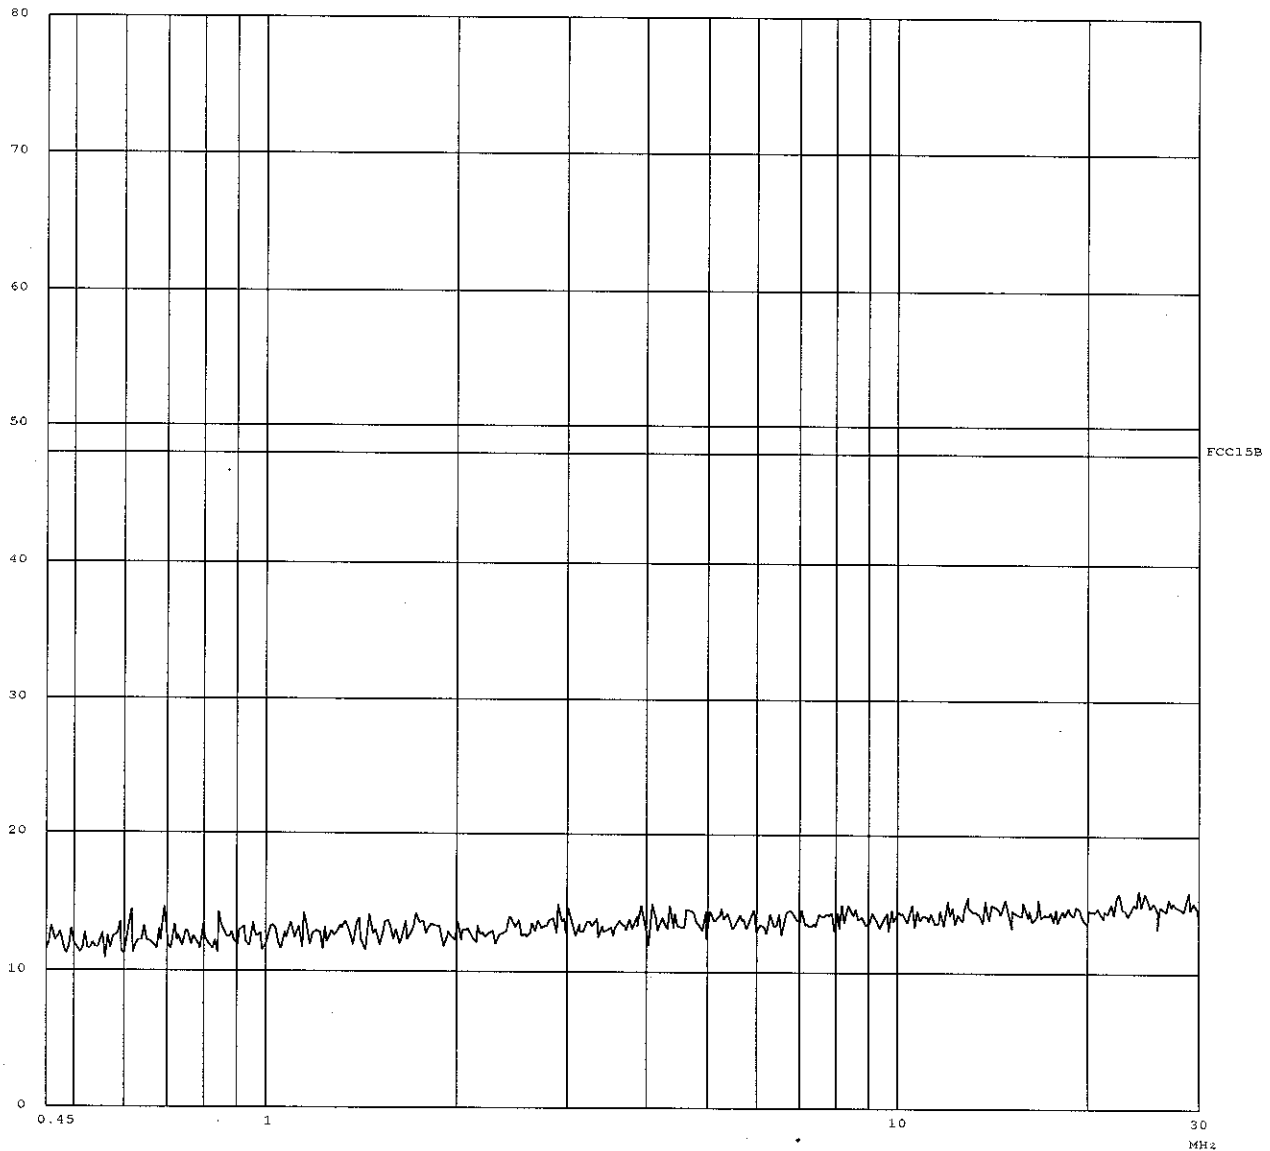
Channel B

Scan Settings (1 Range)

| Start | Stop | Step | IF BW | Detector | M-Time | Atten | Preamp | OpRge |
|---|---|---|---|---|---|---|---|---|
| 450k | 30M | 5k | 10k | PK | 20ms | AUTO | LN OFF | 60dB |

Final Measurement: x QP

| Transducer No. | Start | Stop | Name |
|---|---|---|---|
| 3 | 9k | 30M | EI078 |

dBuV

Final Measurement Results:

no Results
