Report No.: 9806384

Channel A

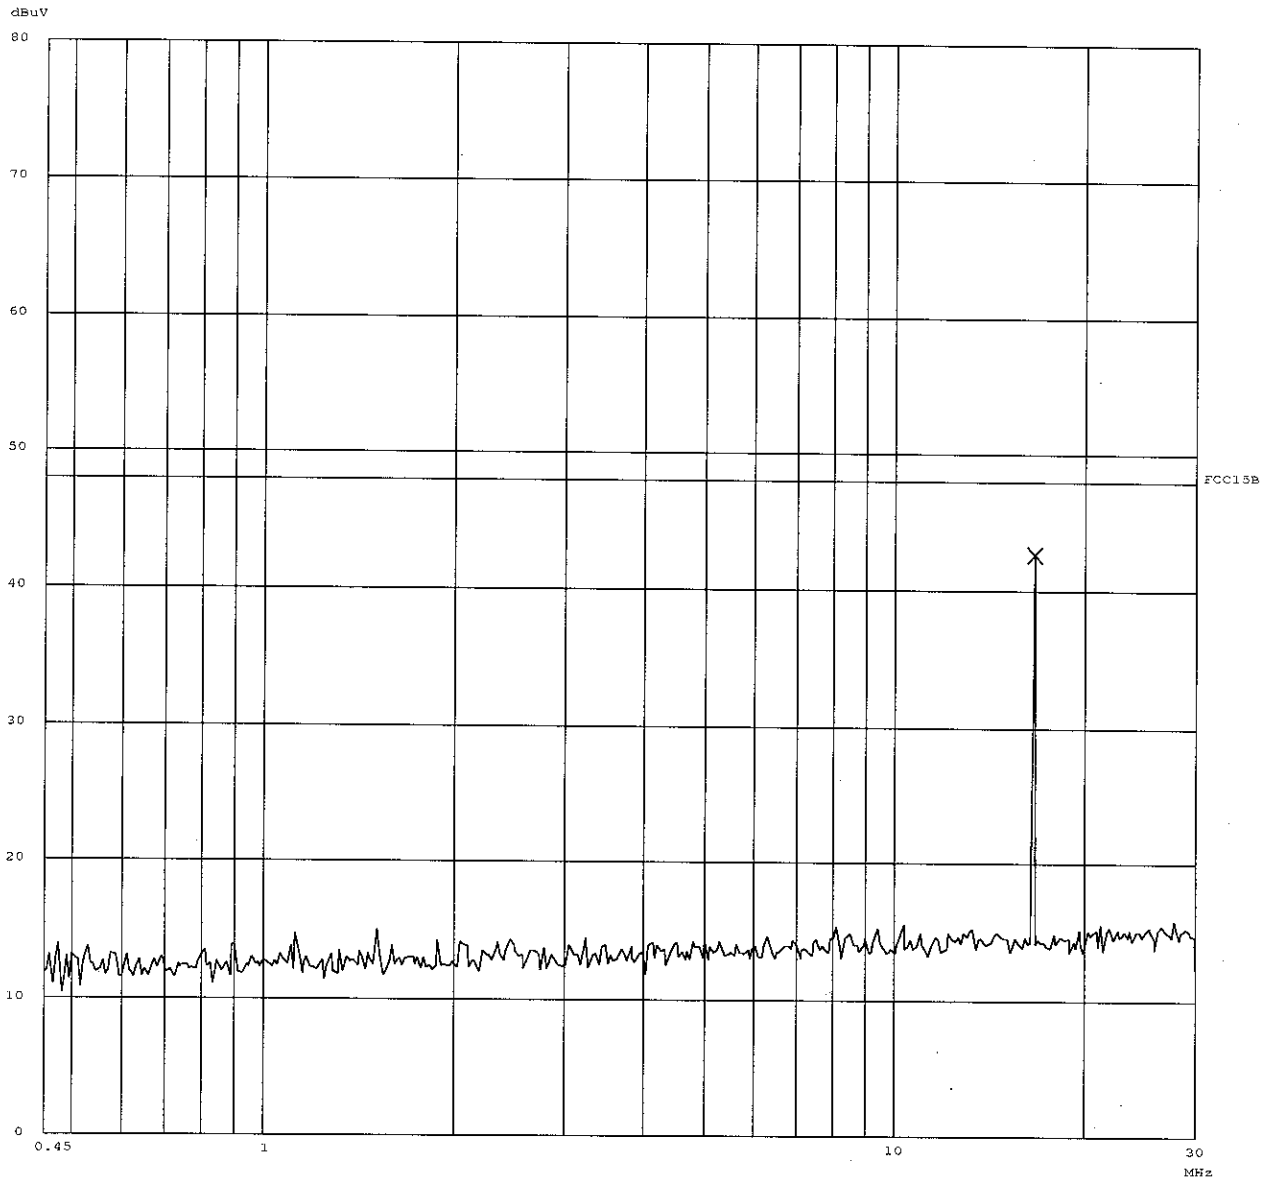
Scan Settings (1 Range)

| Start | Stop | Step | IF BW | Detector | M-Time | Atten | Preamp | OpRge |
|---|---|---|---|---|---|---|---|---|
| 450k | 30M | 5k | 10k | PK | 20ms | AUTO | LN OFF | 60dB |

Final Measurement: x QP

Acc Margin: 20dB

| Frequency<br>MHz | QP Level<br>dBuV | QP Limit<br>dBuV |
|---|---|---|
| 16.61500 | 42.6 | 48.0 |

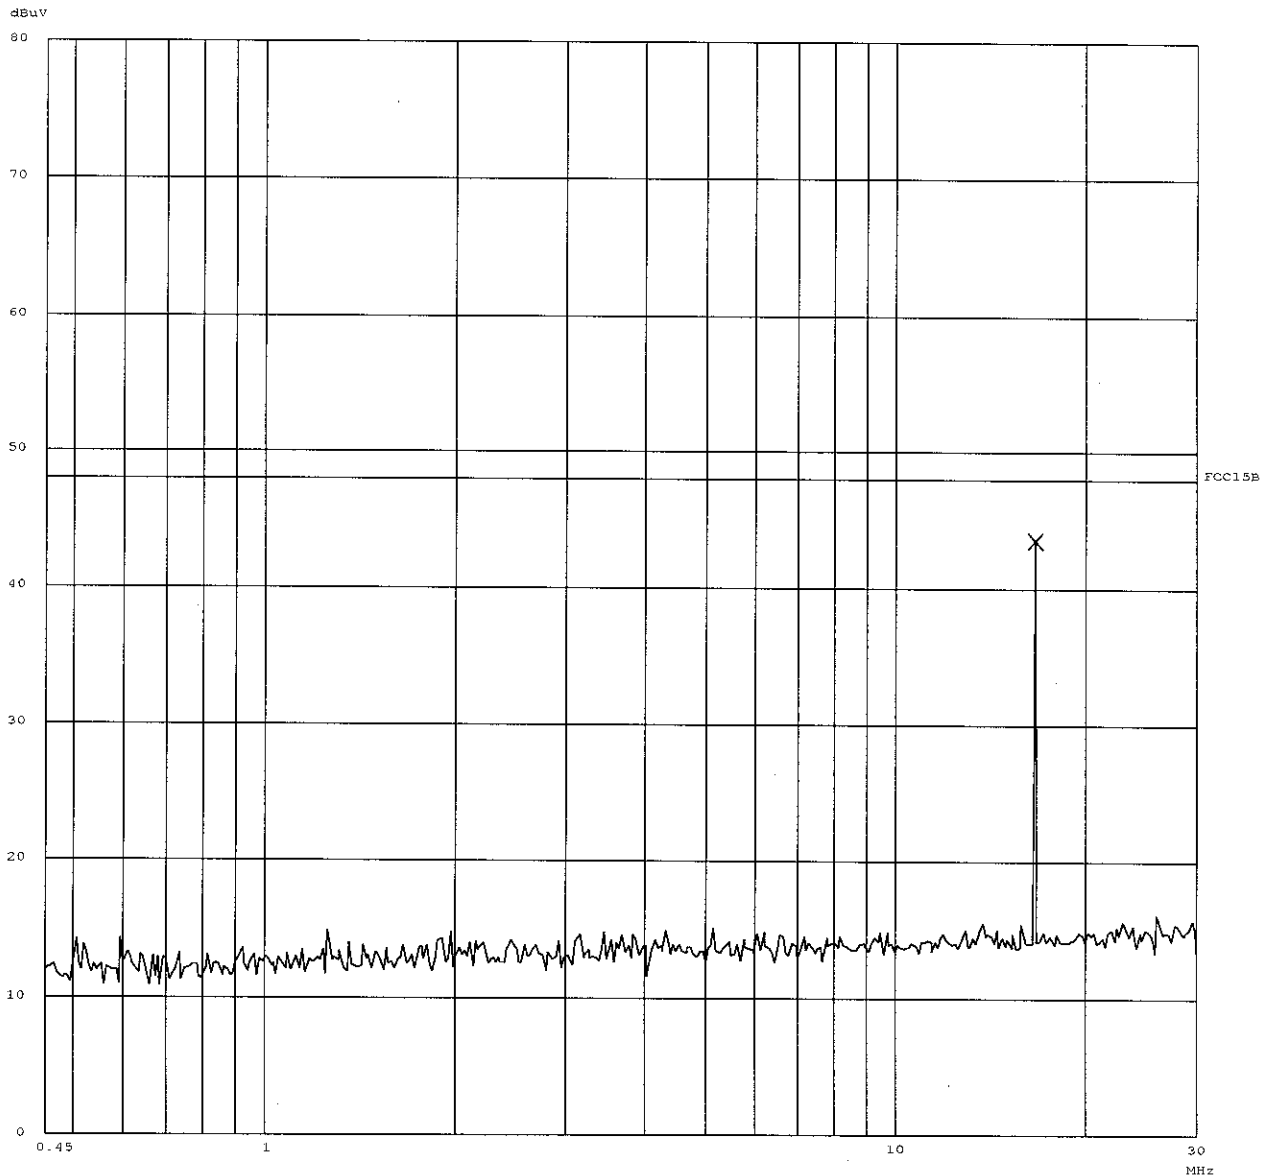
Channel B

Scan Settings (1 Range)

| Frequencies | | | | Receiver Settings | | | | | |
|---|---|---|---|---|---|---|---|---|--|
| 430k | 30M | 5k | 10k | PK | 20ms | AUTO | LN OFF | 60dB | |

Final Measurement: x QP

Meas Time: 1 s  
Subranges: 16  
Acc Margin: 20dB

| Frequency<br>MHz | QP Level<br>dBuV | QP Limit<br>dBuV |
|---|---|---|
| 16.62500 | 43.5 | 48.0 |
