### **APPENDIX 3: Photographs of test setup**

#### **Radiated Emission**

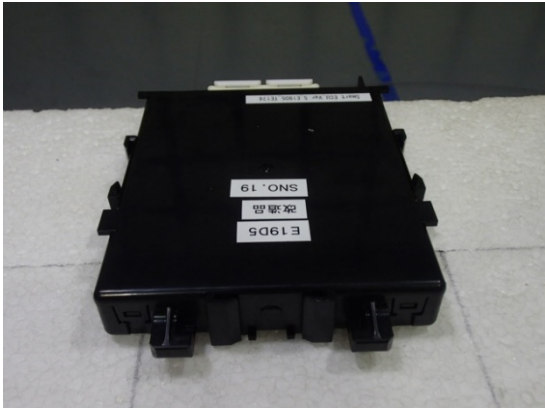
**X-axis**

**ECU**

Below 30 MHz: X-axis  
Above 30 MHz: Horizontal: X-axis /  
Vertical: X-axis

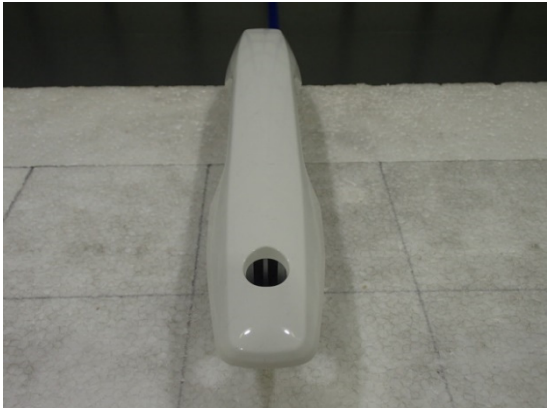
**X-axis**

**Outside Antenna**

Below 30 MHz: X-axis  
Above 30 MHz: Horizontal: X-axis /  
Vertical: X-axis

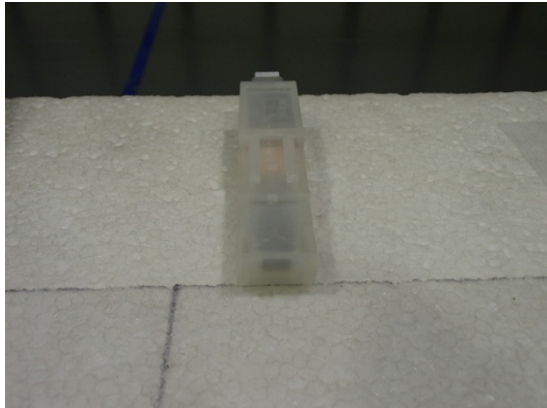
**X-axis**

**Inside Antenna Var.3**  
(LF transmission mode or Immobilizer  
communication mode)  
Below 30 MHz  
X-axis  
Above 30 MHz  
Horizontal: X-axis / Vertical: X-axis

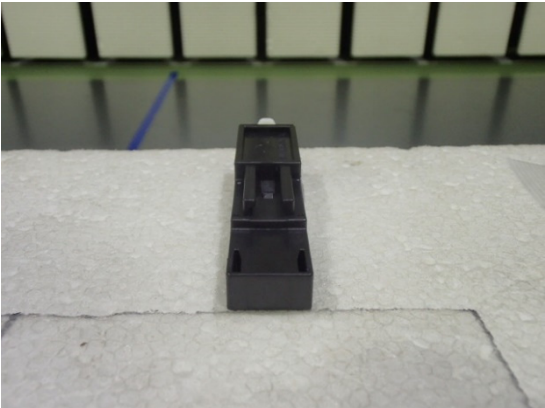
**X-axis**

**Inside Antenna Var.1**  
Below 30 MHz  
X-axis  
Above 30 MHz  
Horizontal: X-axis / Vertical: X-axis

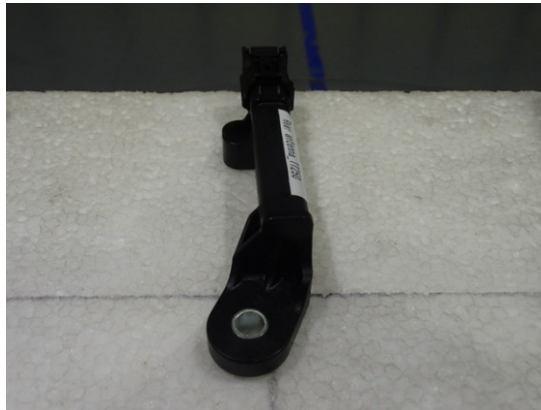
**X-axis**

Rear Antenna

Below 30 MHz

X-axis

Above 30 MHz

Horizontal: X-axis / Vertical: X-axis

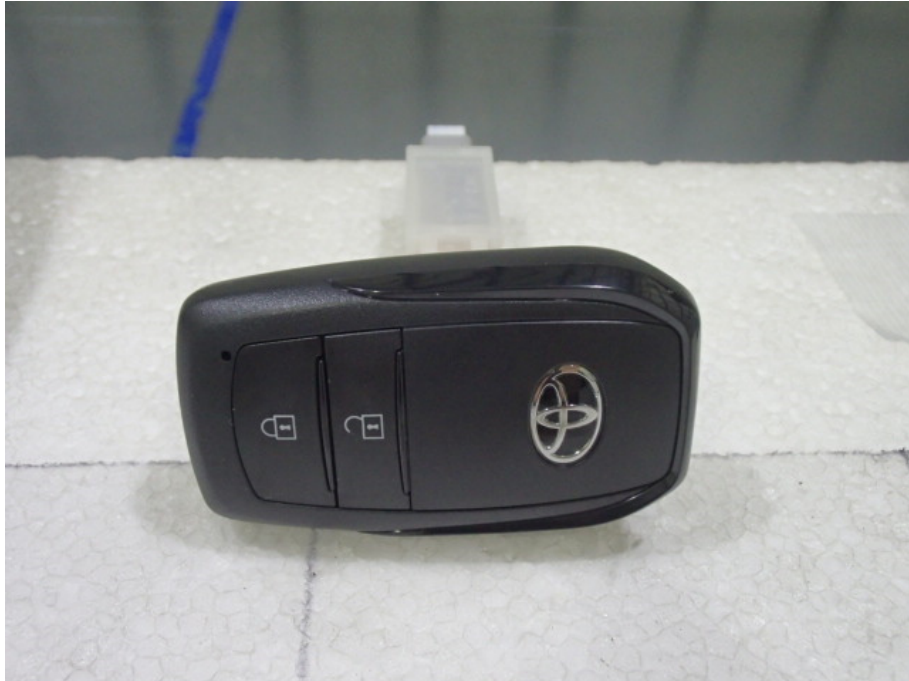
**With transponder key attached**

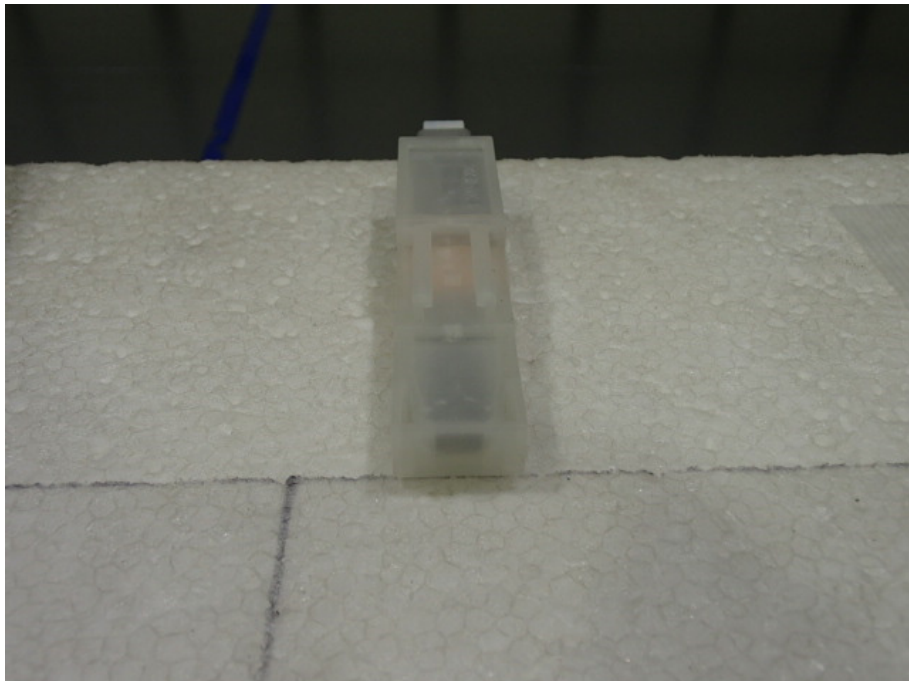
**Without transponder key attached (Worst)**
