### **APPENDIX 3: Photographs of test setup**

#### **Radiated Emission**

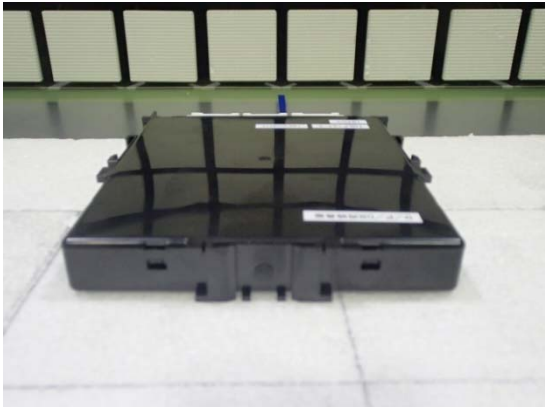
ECU  
Below 30 MHz  
X-axis  
Above 30 MHz  
Horizontal: X-axis / Vertical: X-axis

X-axis

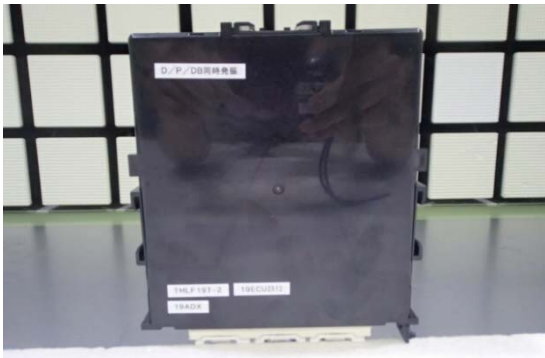
Y-axis

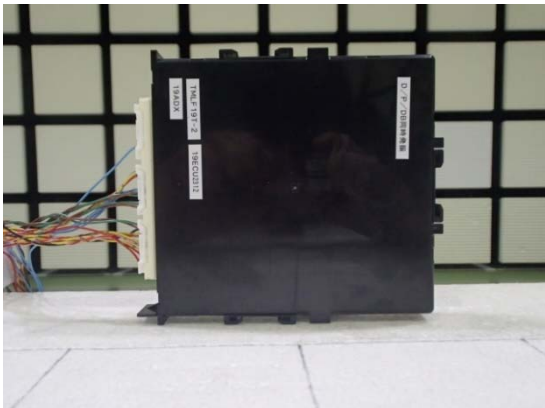
Z-axis

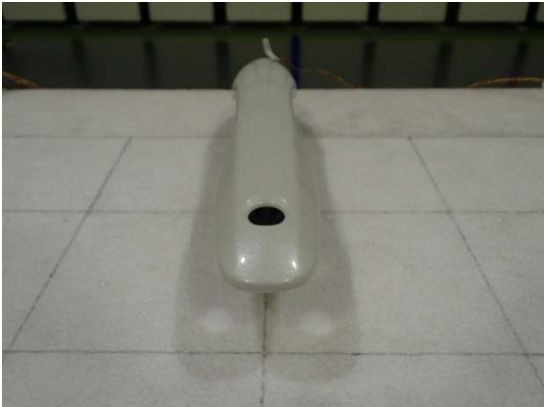
Door Antenna  
Below 30 MHz  
X-axis  
Above 30 MHz  
Horizontal: X-axis / Vertical: X-axis

X-axis

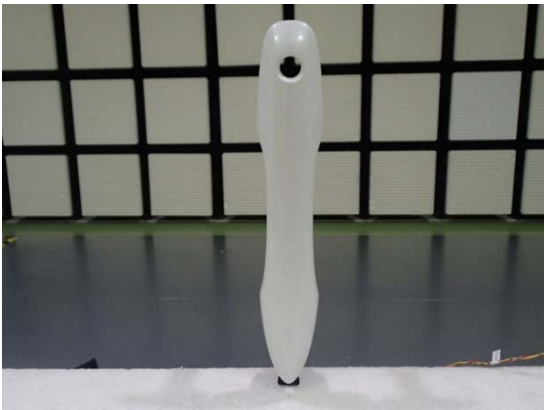
Y-axis

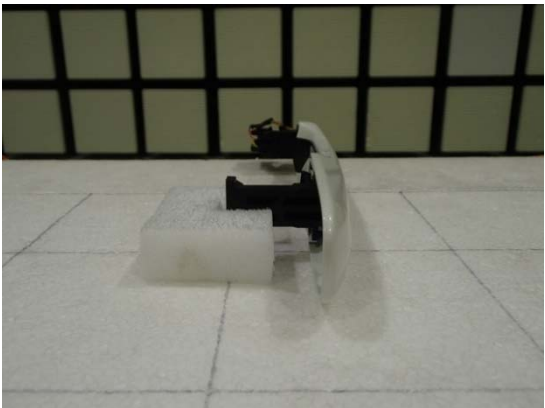
Z-axis

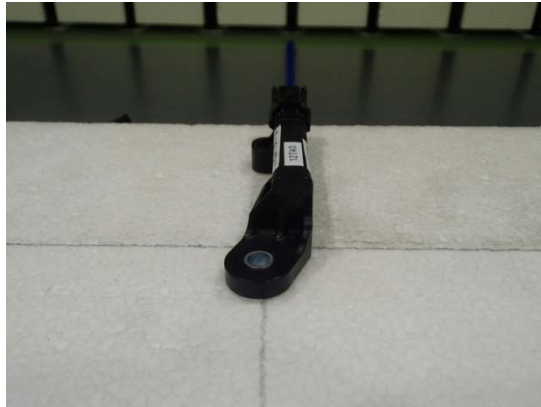
#### Back Door Antenna

X-axis

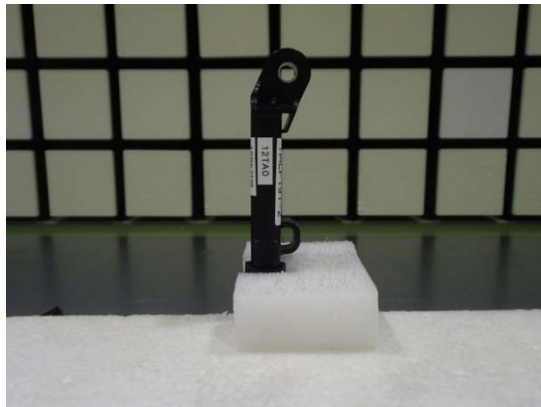
Y-axis

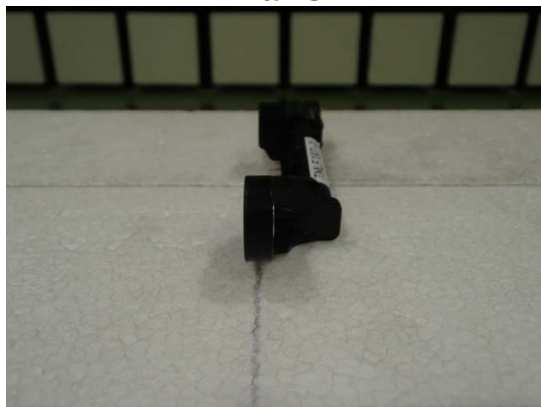
Z-axis
