## **11.MODIFICATIO TO EUT**

## 13.PHOTOGRAPHS

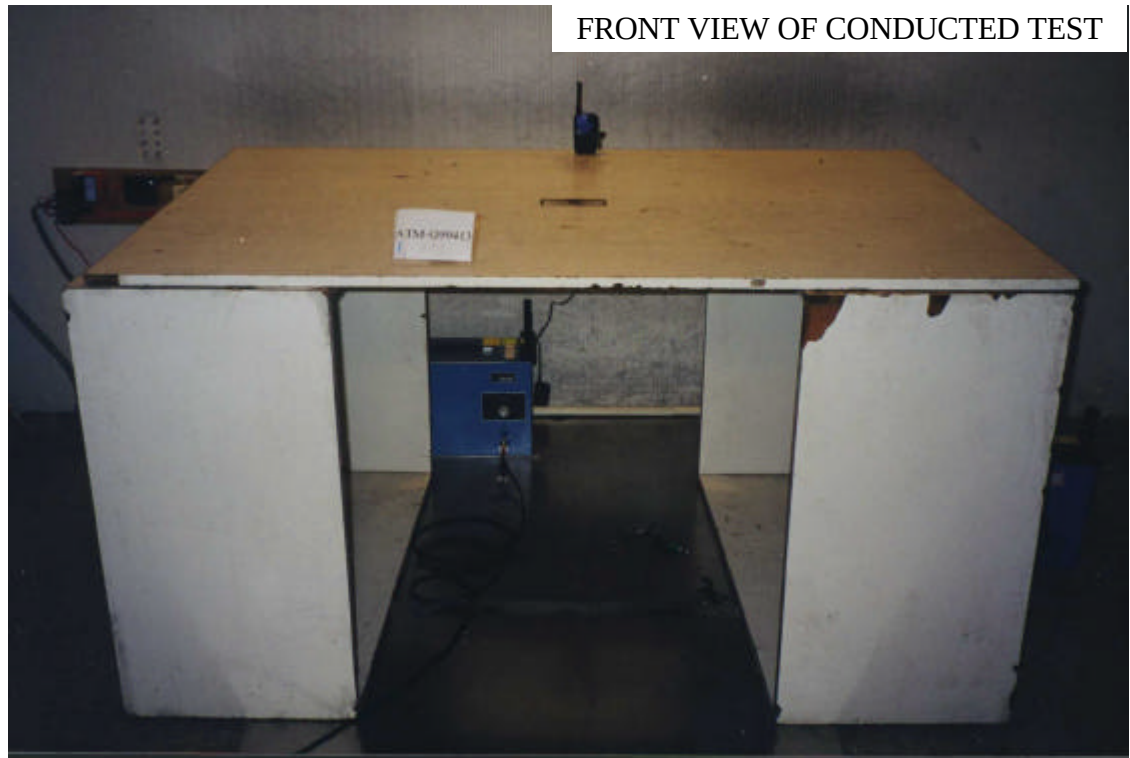
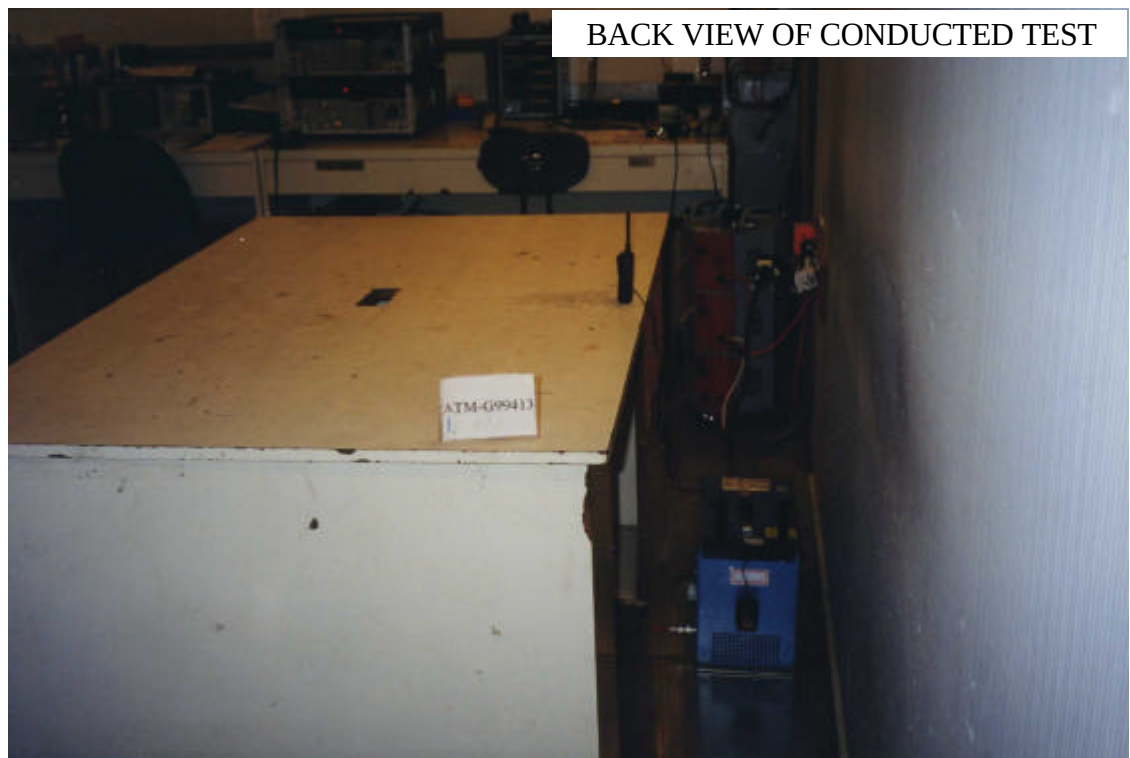
### 13.1.Photos of Powerline Conducted Measurement

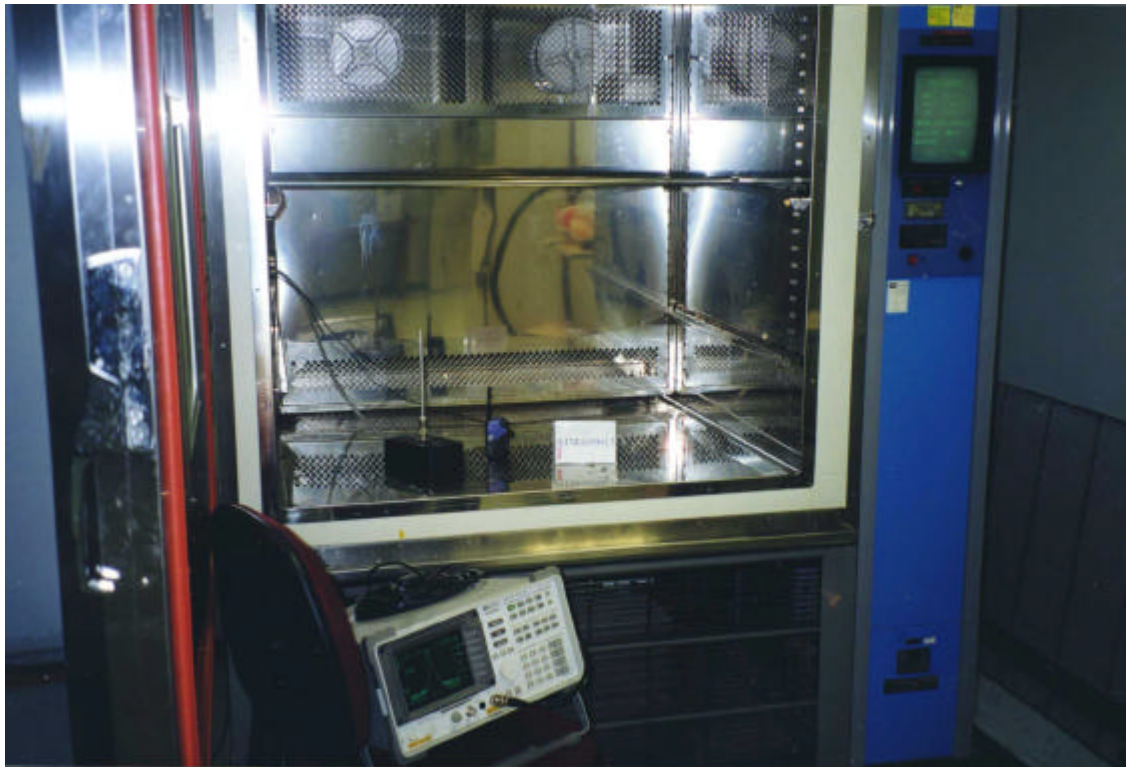
### 13.2.1. Temperature Variation Measurement

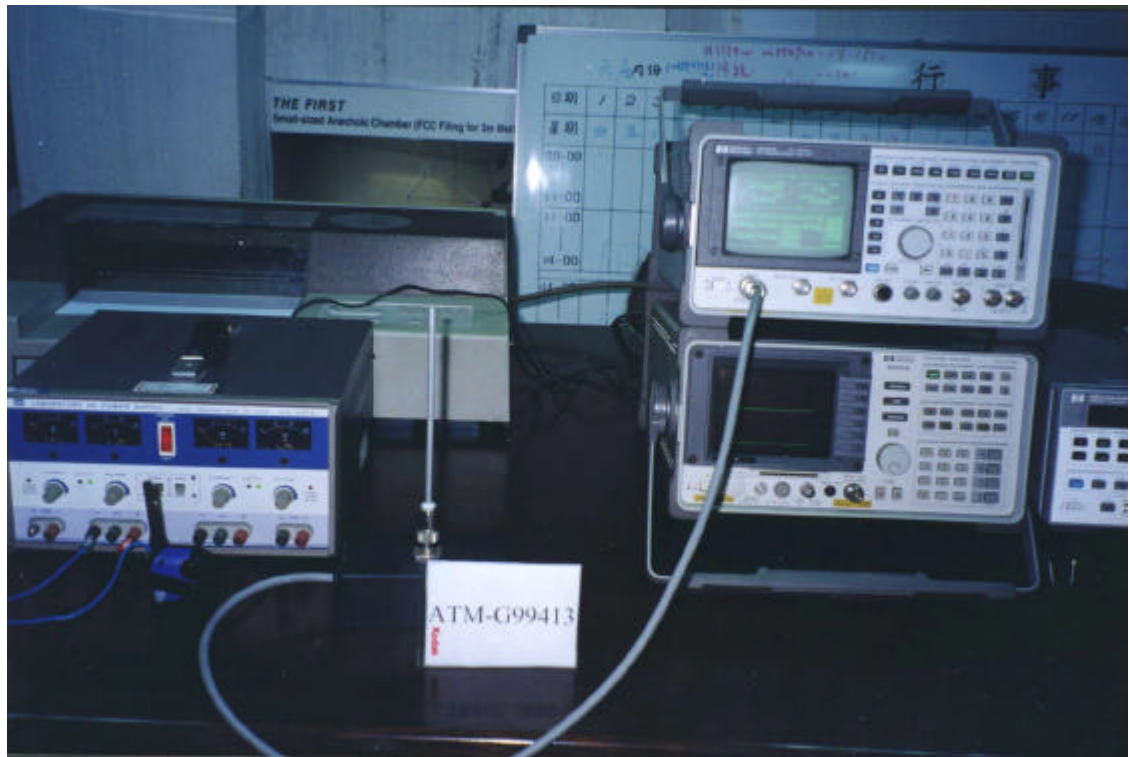
### 13.2.2. Primary Supply Voltage Variation Measurement

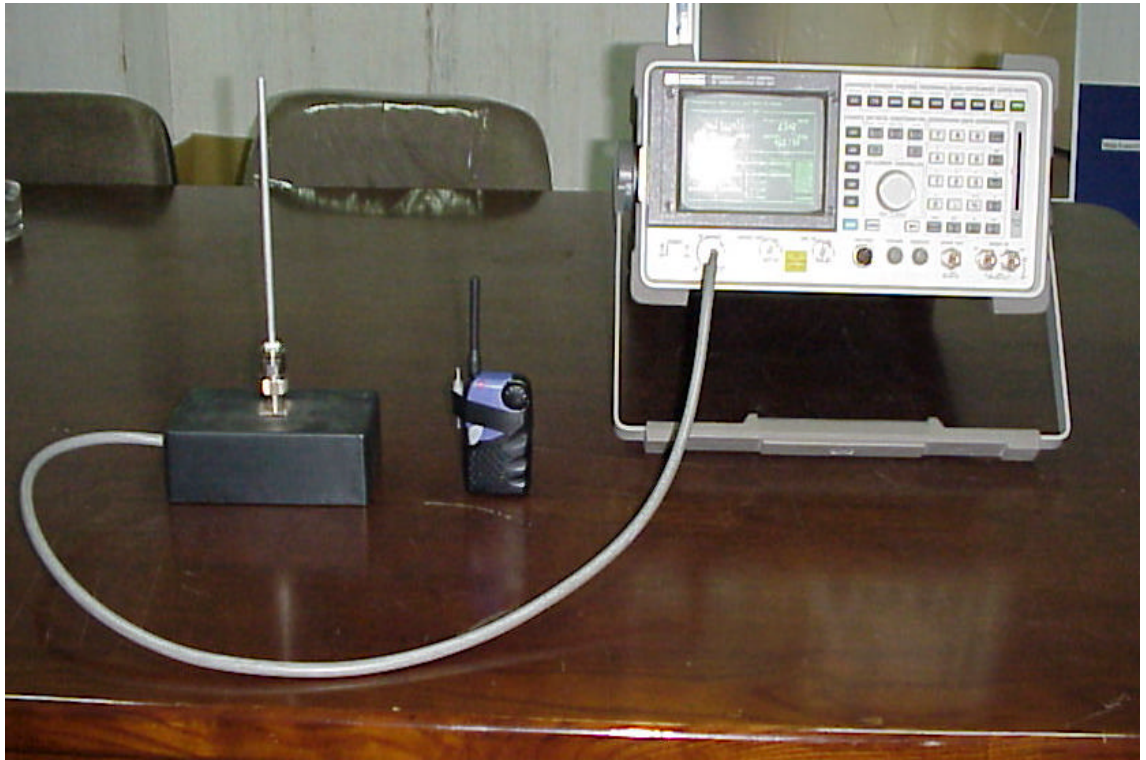
### 13.3. Photos of Frequencies and Channels Measurement

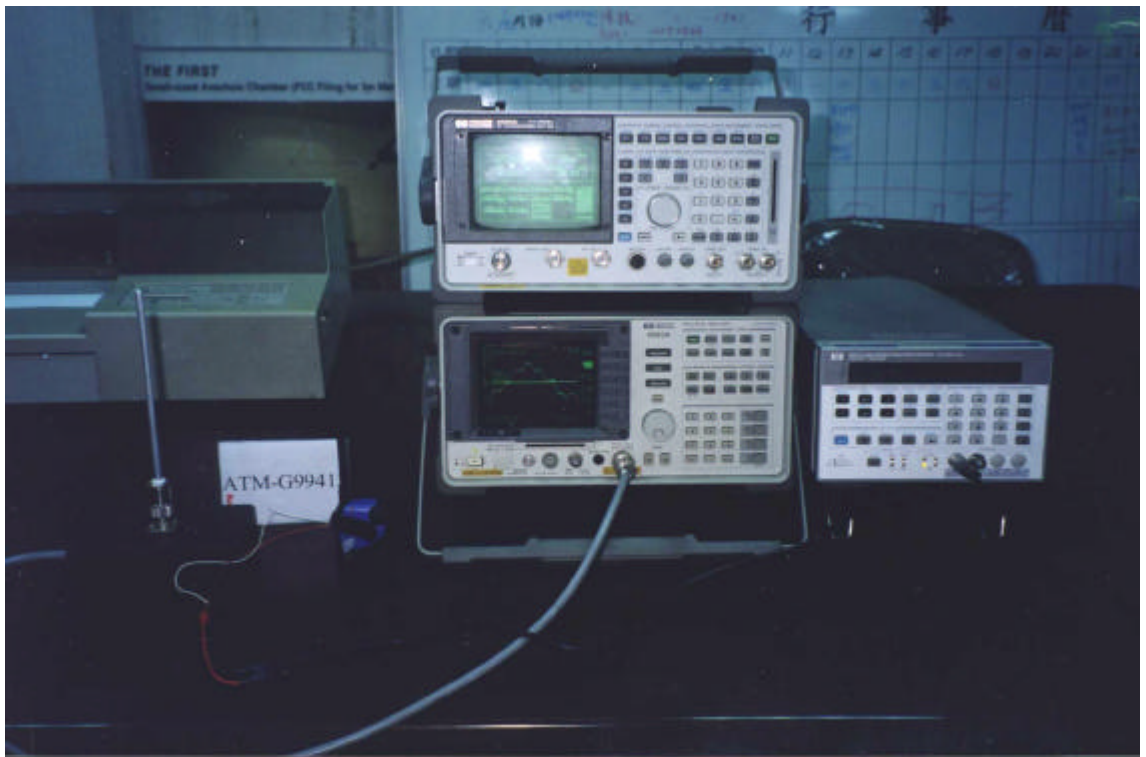
### 13.4. Photos of Emission Bandwidth Measurement

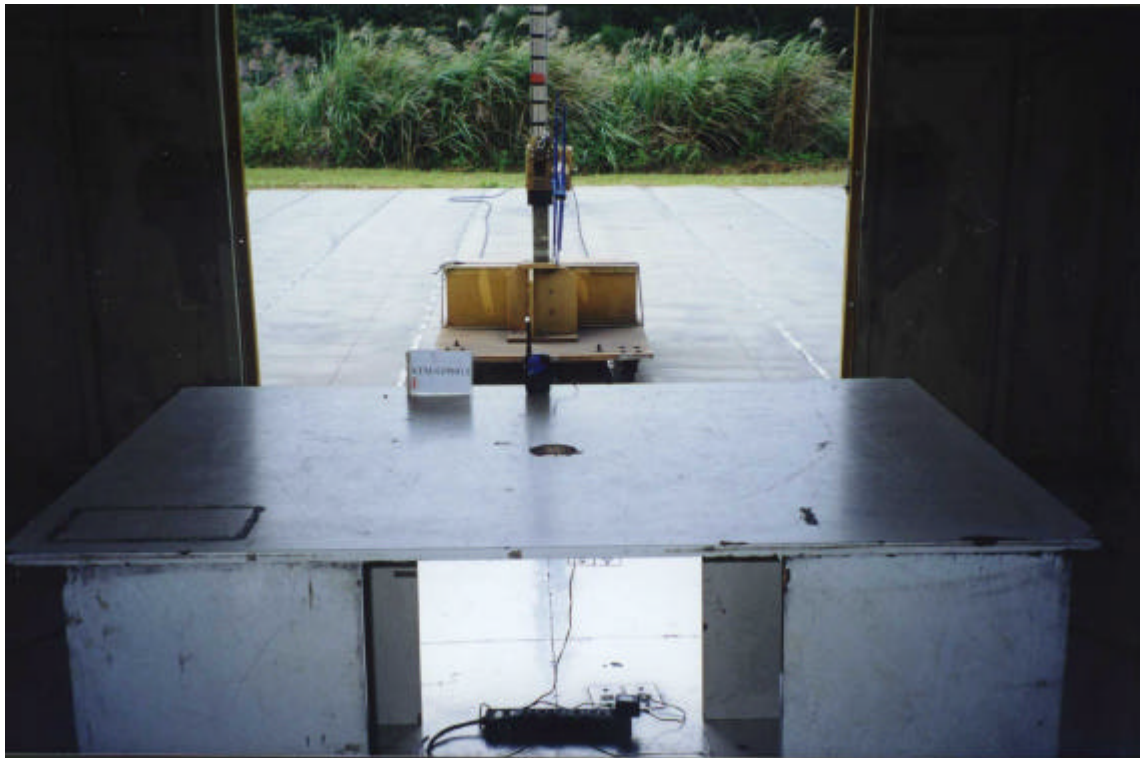
#### 13.5.1. For 30~1000MHz Frequency Range Measurement

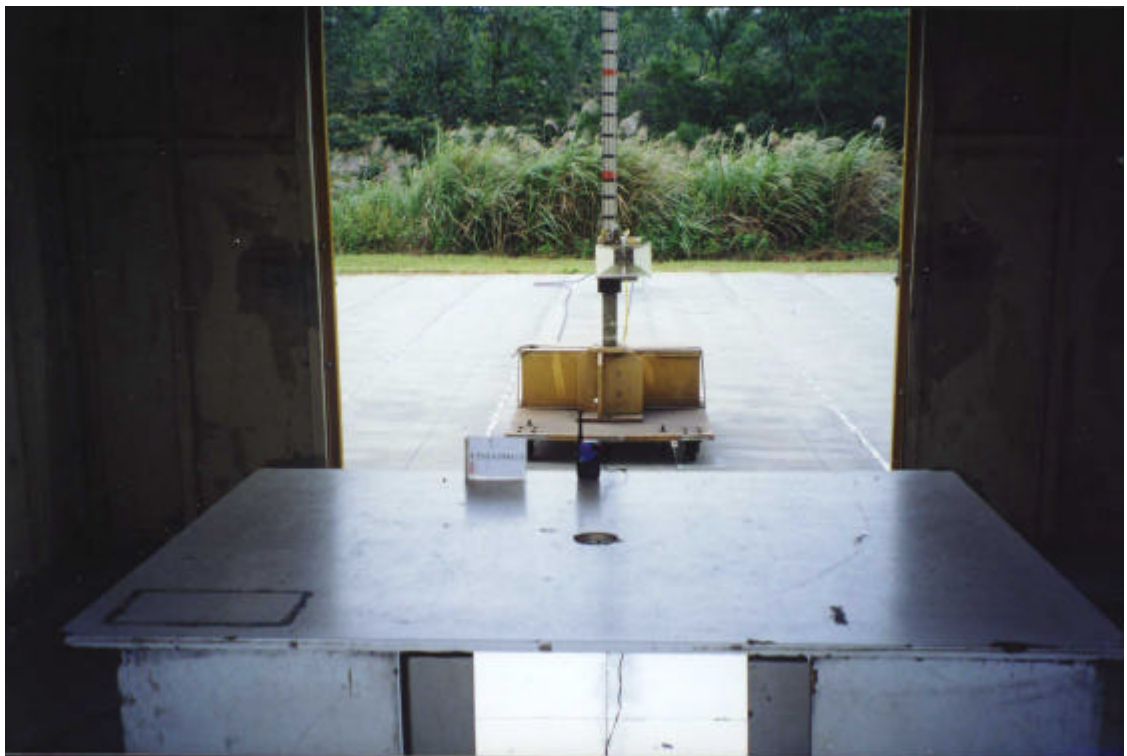
#### 13.5.2. For 1~6GHz Frequency Range Measurement

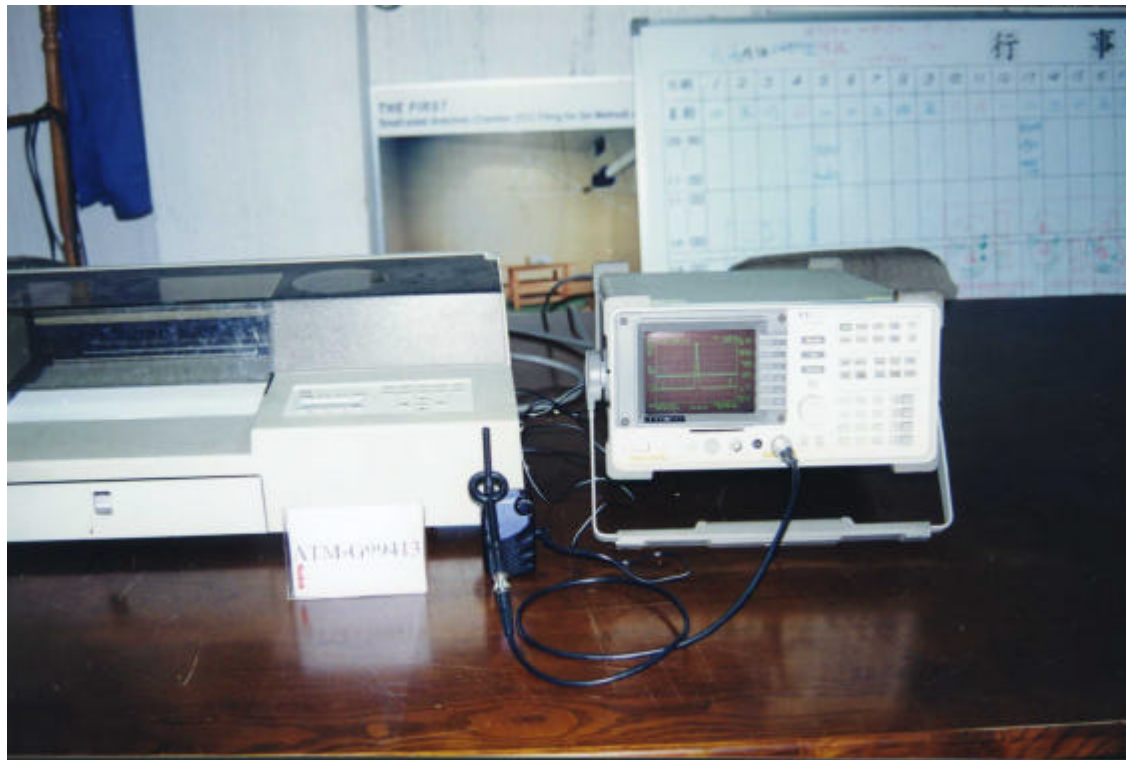
### 13.5.3. For Channel Center Attenuation Measurement

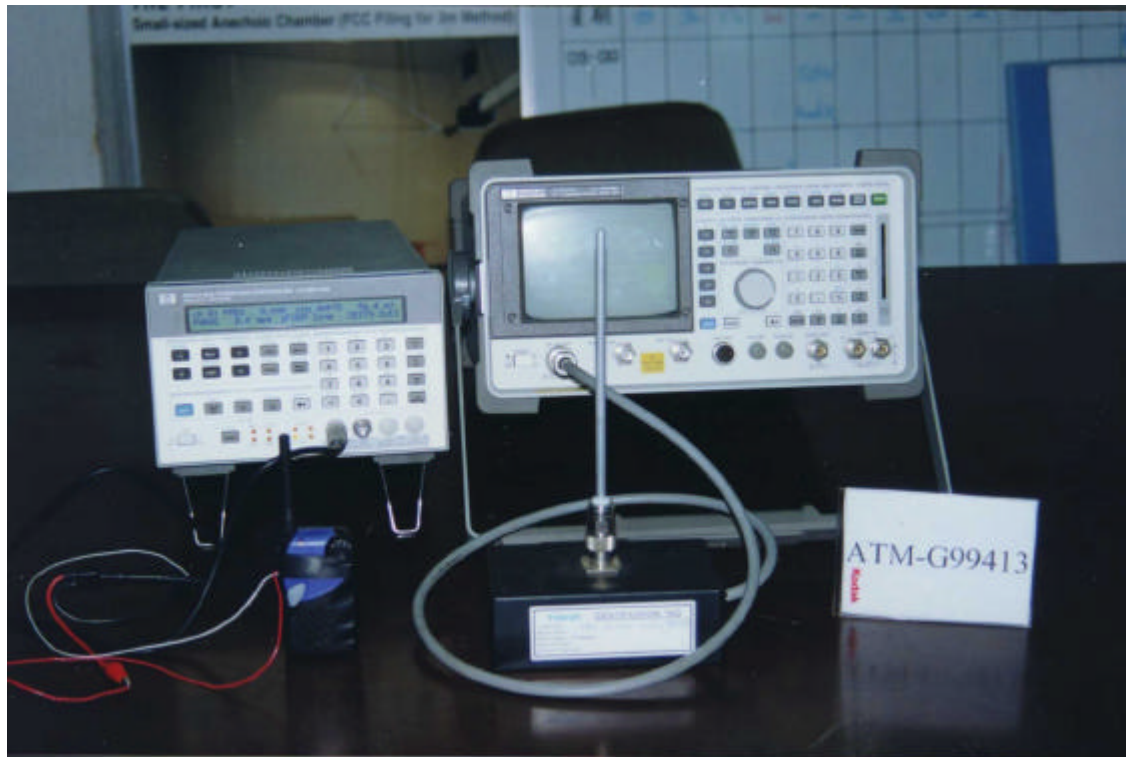
### 13.6. Photos of Peak Frequency Measurement

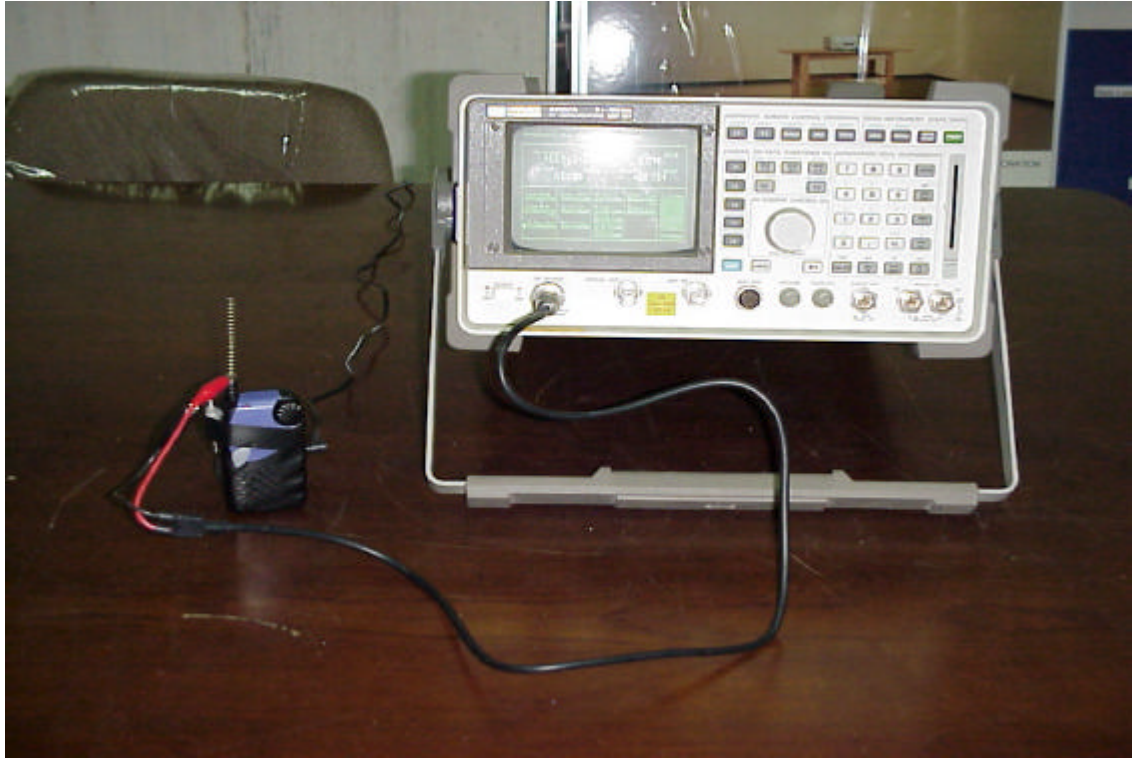
### 13.7. Photos of Maximum Transmitter Power Measurement

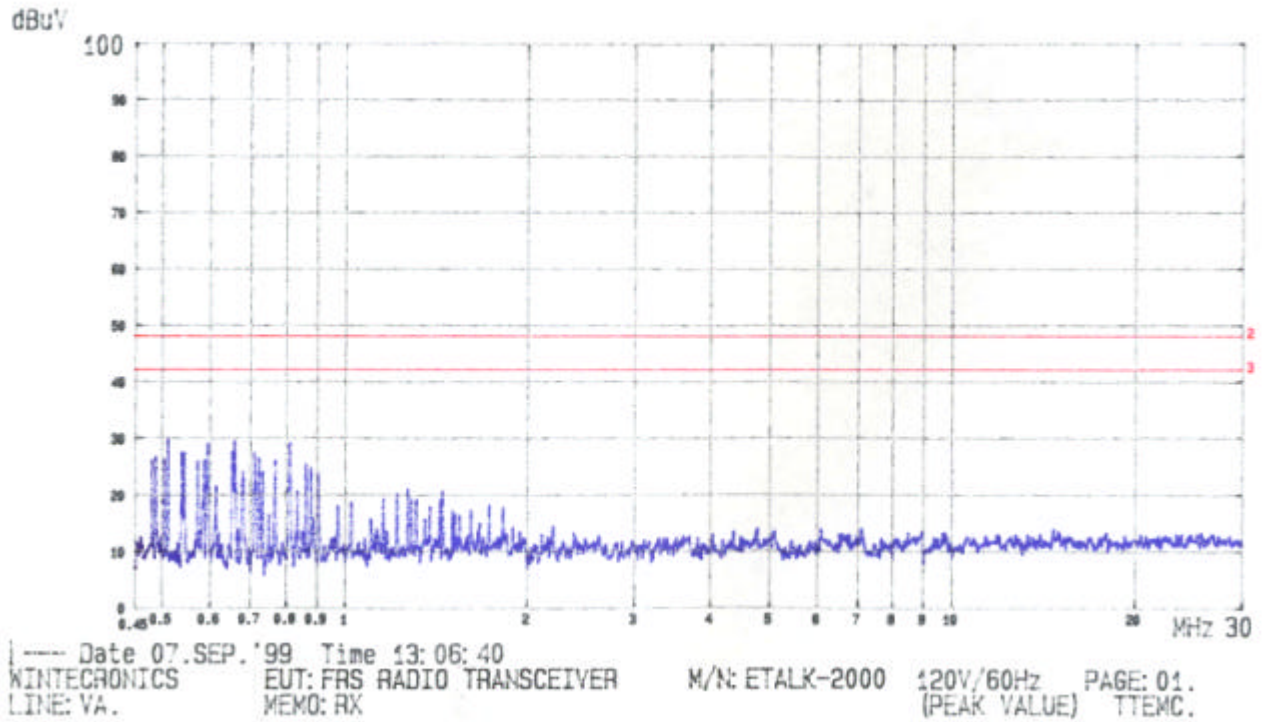
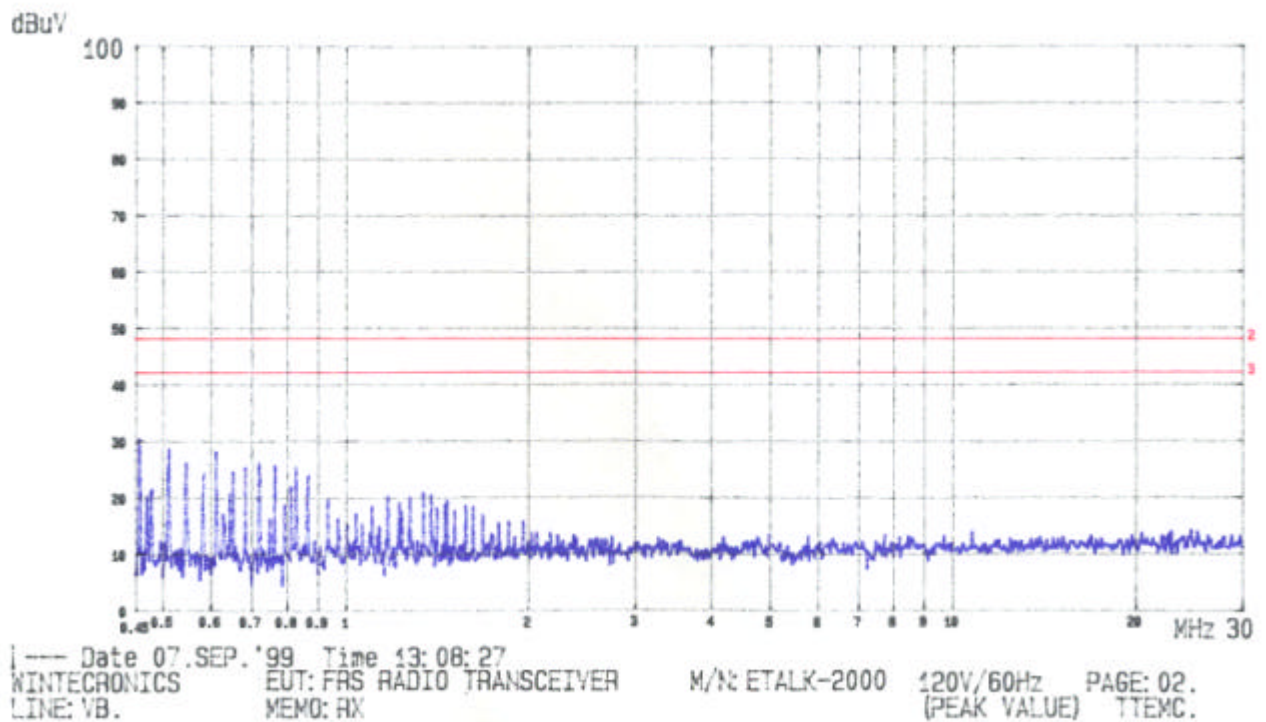
## (Conducted Test Data)

Test Mode: Channel 1, Receiver / Receiving Mode
