Report No.: 9809825

# Intertek Testing Services

ETL Testing Laboratories

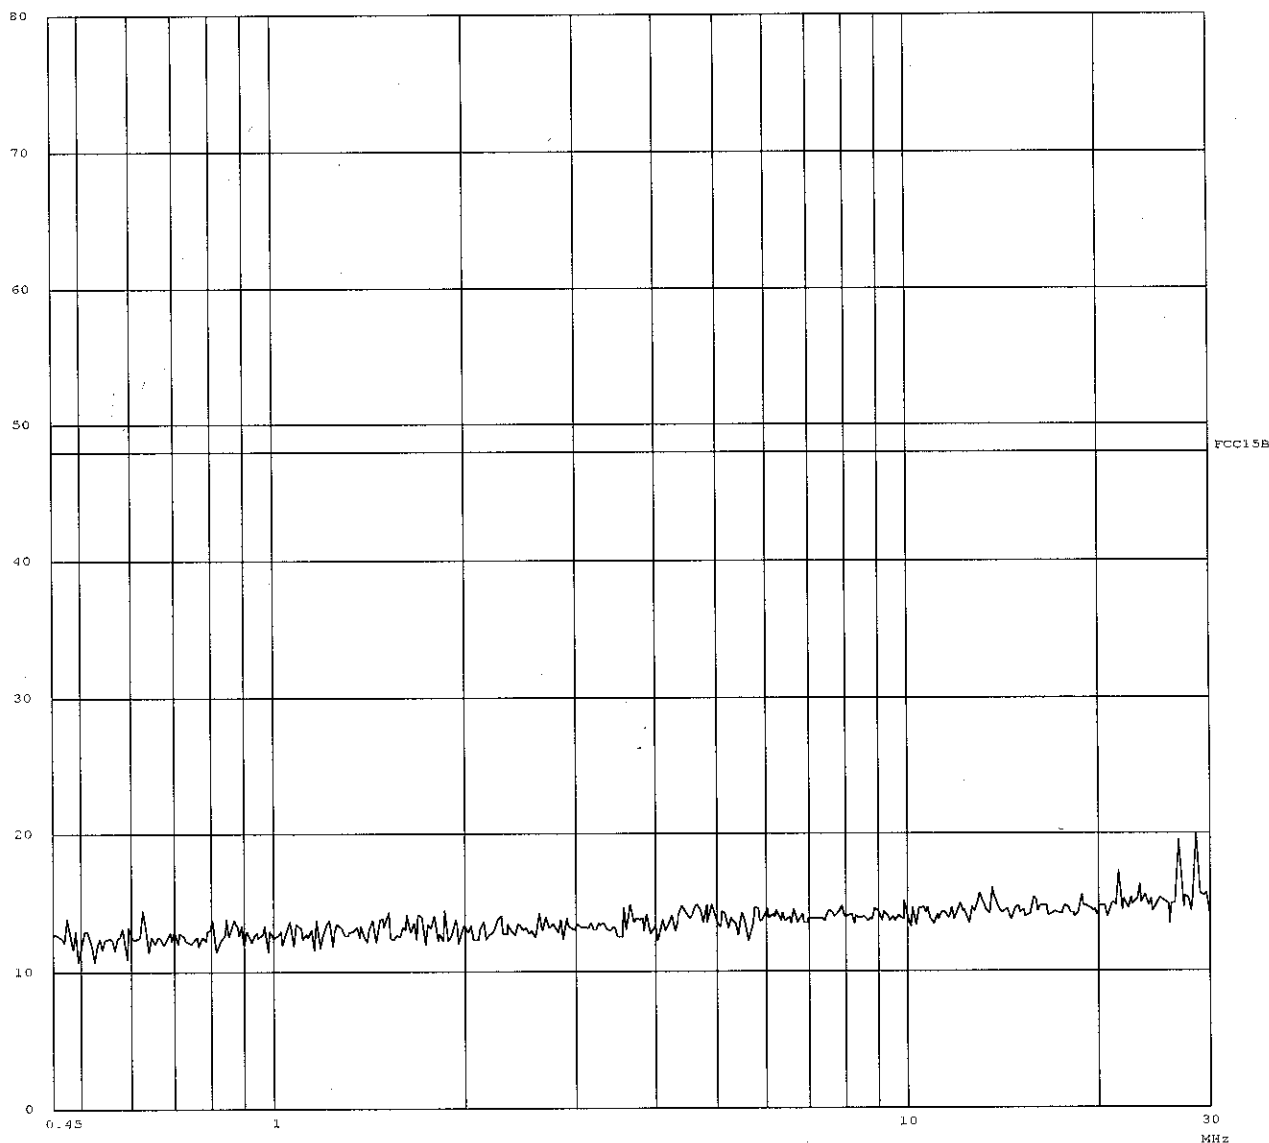
Mode = TX

Scan Settings (1 Range)

----- Frequencies ----- ||----- Receiver Settings -----|

| Start | Stop | Step | IF BW | Detector | M-Time | Atten | Preamp | OpRge |
| 450k | 30M | 5k | 10k | PK | 20ms | AUTO | LN OFF | 60dB |

Final Measurement: X QP

| Transducer No. | Start | Stop | Name |
| 3 | 9k | 30M | EI078 |

Meas Time: 1 s  
Subranges: 16  
Acc Margin: 20dB

dBuV

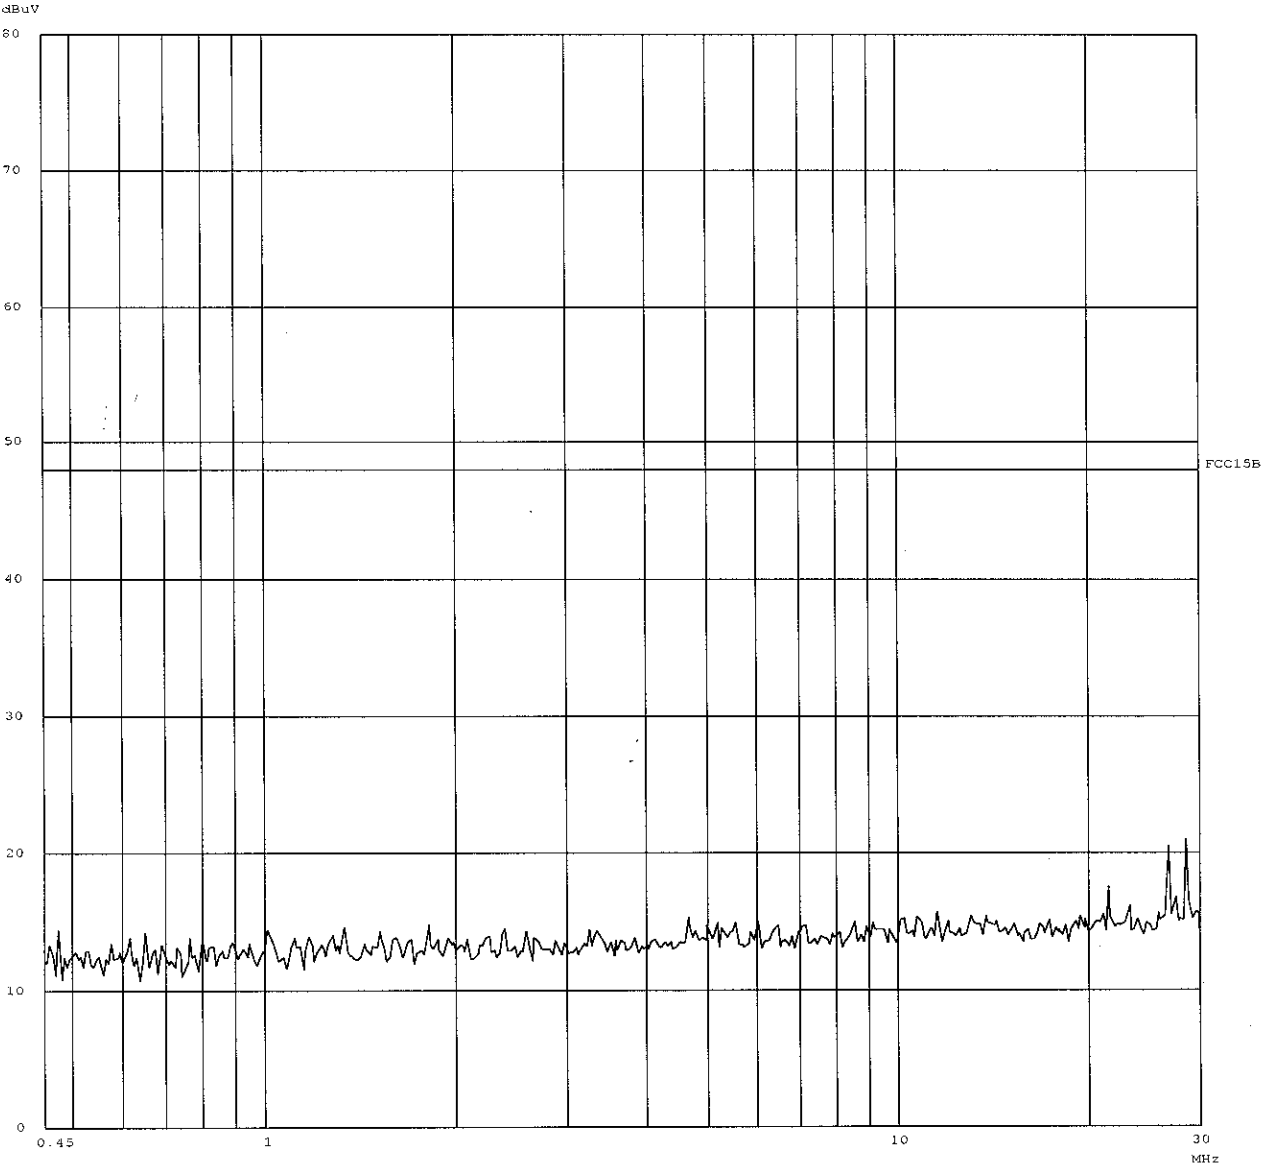
Mode= Standby

Scan Settings (1 Range)

| Frequencies | | | | Receiver Settings | | | | |
| Start | Stop | Step | IF BW | Detector | M-Time | Atten | Preamp | OpRge |
| 450k | 30M | 5k | 10k | PK | 20ms | AUTO | LN OFF | 60dB |

| Final Measurement: X QP | | | | Transducer No. | Start | Stop | Name |
| Meas Time: 1 s | | | | 2 | 9k | 30M | EI078 |
| Subranges: 16 | | | | | | | |
| Acc Margin: 20dB | | | | | | | |

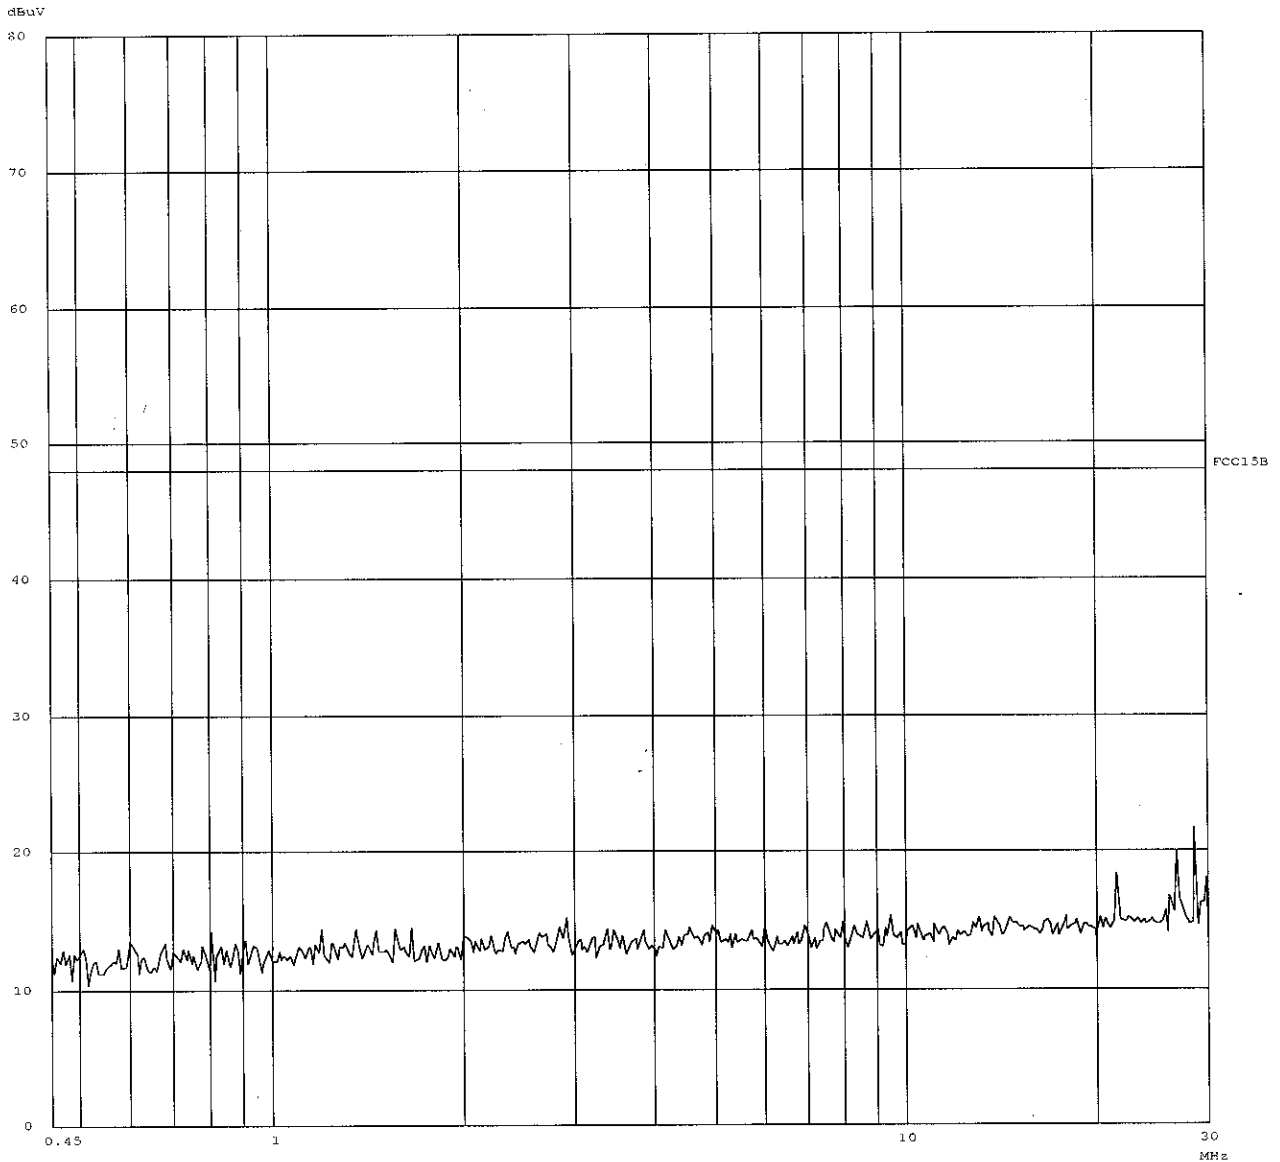
Mode = Charging

Scan Settings (1 Range)

| Frequencies | | | | Receiver Settings | | | |
| Start | Stop | Step | IF BW | Detector | M-Time | Atten | Preamp OpRge |
| 450k | 30M | 5k | 10k | PK | 20ms | AUTO | LN OFF 60dB |

Final Measurement: 2 QF

| Transducer No. | Start | Stop | Name |
| 3 | 9k | 30M | EI078 |

Meas Time: 1 s  
Subranges: 16  
Acc Margin: 20dB
