# Intertek Testing Services

Report No.: 9904580

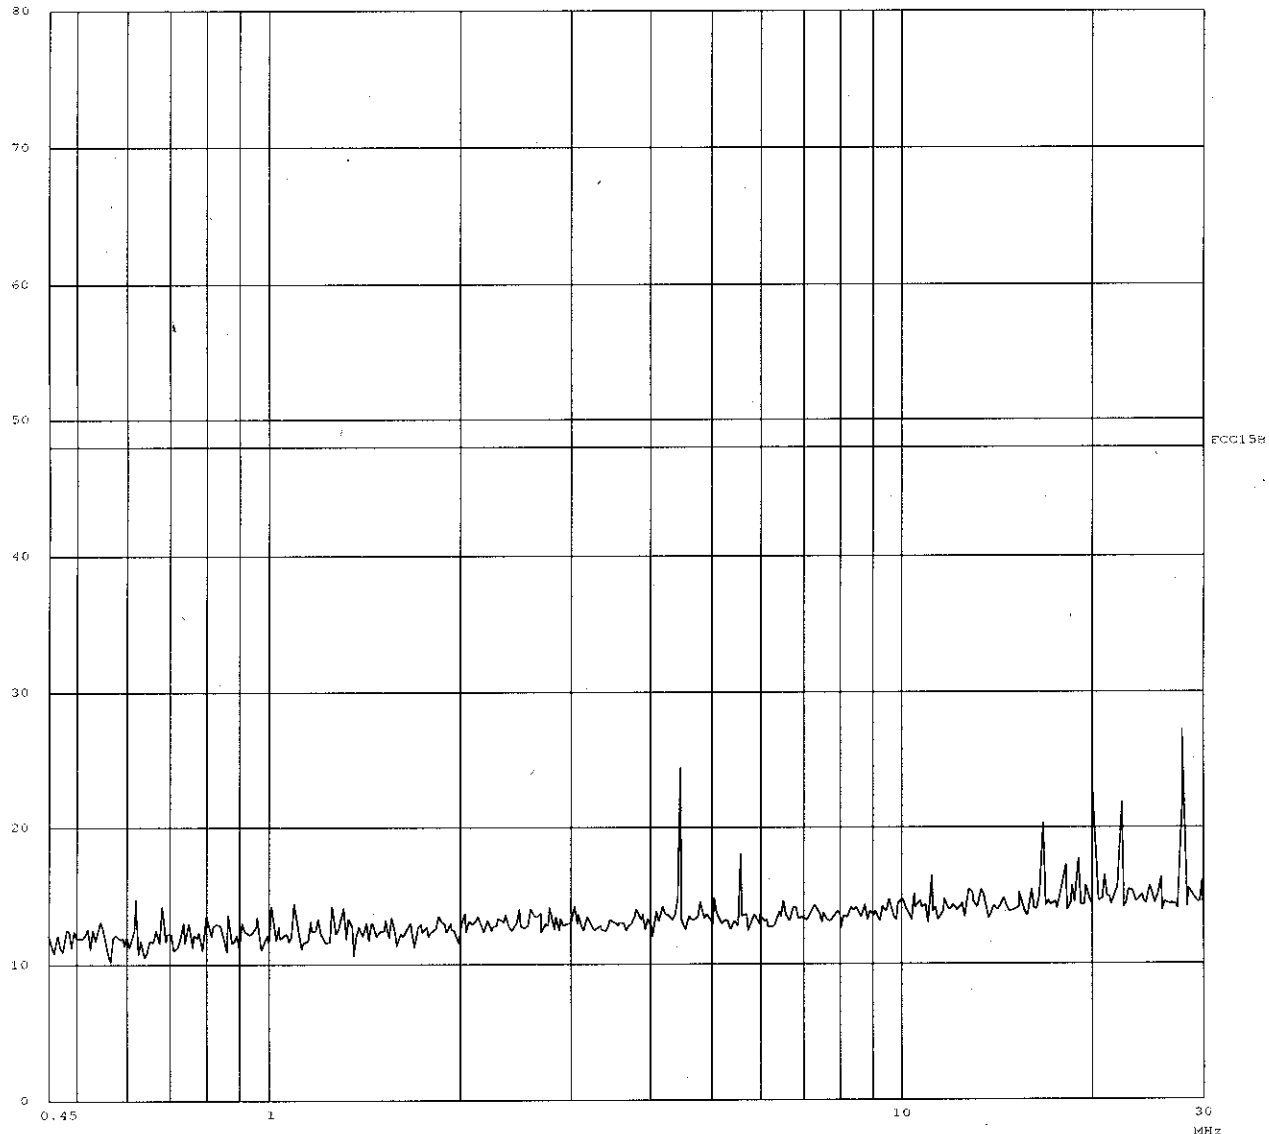
Mode: Charging

| Frequencies | | | Receiver Settings | | | | | |
|---|---|---|---|---|---|---|---|---|
| 450k | 30M | 5k | 10k | PK | 20ms | AUTO | LN | OFF 60dB |

Final Measurement: X QP

3 9k 30M EI078

Meas Time: 1 s

Subranges: 16

Acc Margin: 20dB

Final Measurement Results:

no Results

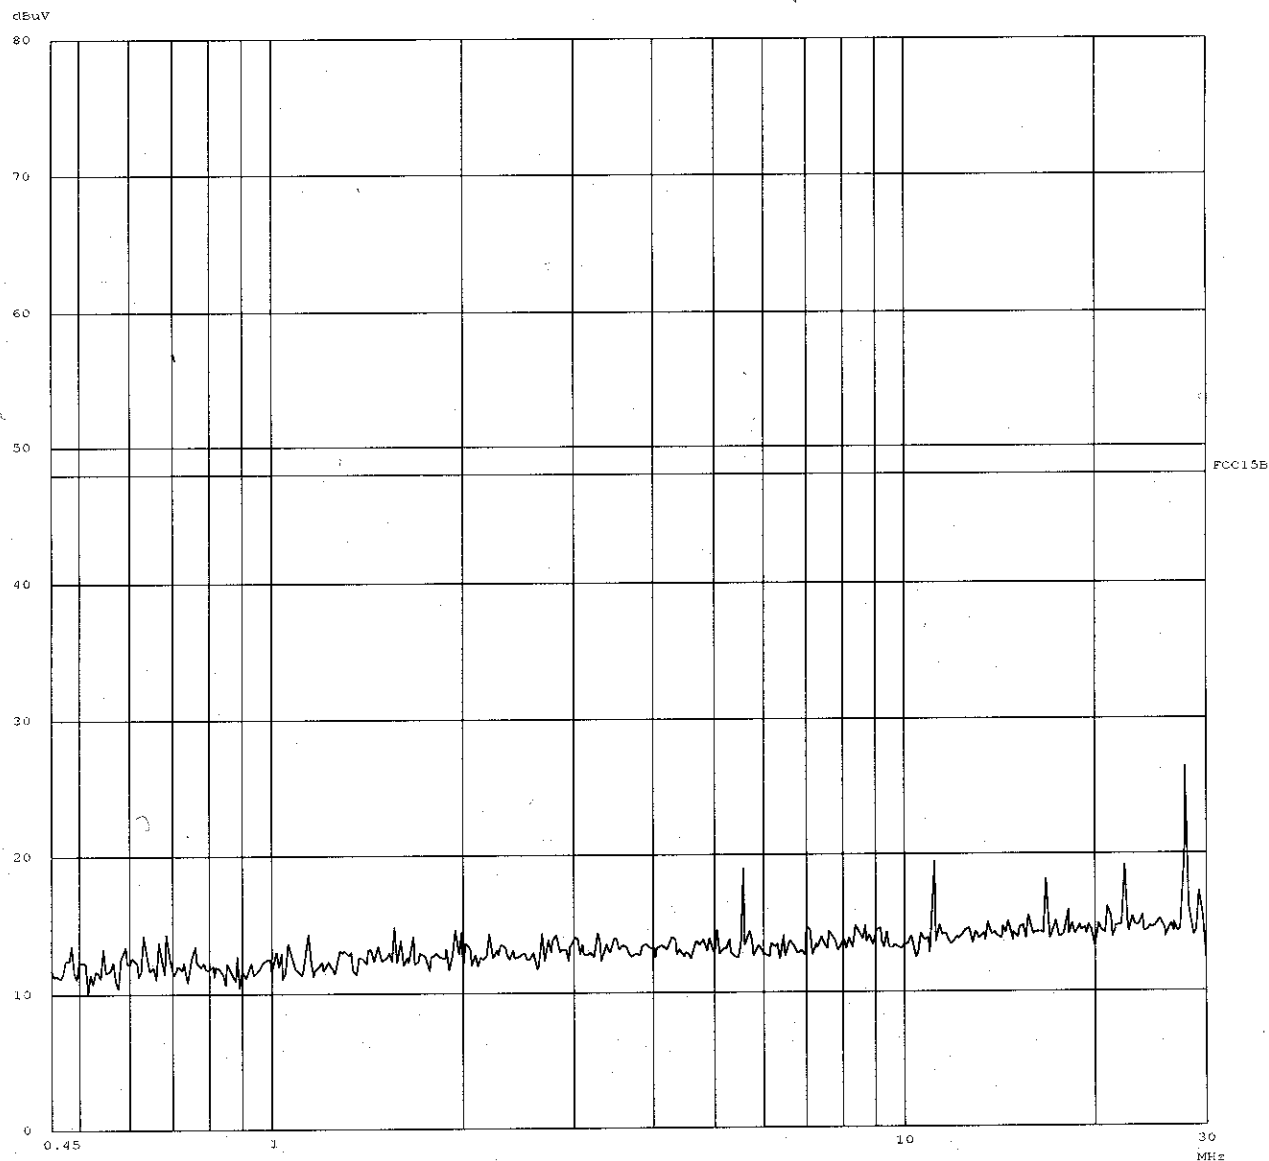
Mode: Standby

| Frequencies | | Receiver Settings | | | | | | |
|---|---|---|---|---|---|---|---|---|
| 450k | 30M | 5k | 10k | PK | 20ms | AUTO | LN OFF | 60dB |

Final Measurement: X QP

| Transducer No. | Start | Stop | Name |
|---|---|---|---|
| 3 | 9k | 30M | EI078 |

Meas Time: 1 s  
Subranges: 16  
Acc Margin: 20dB

Final Measurement Results:

no Results

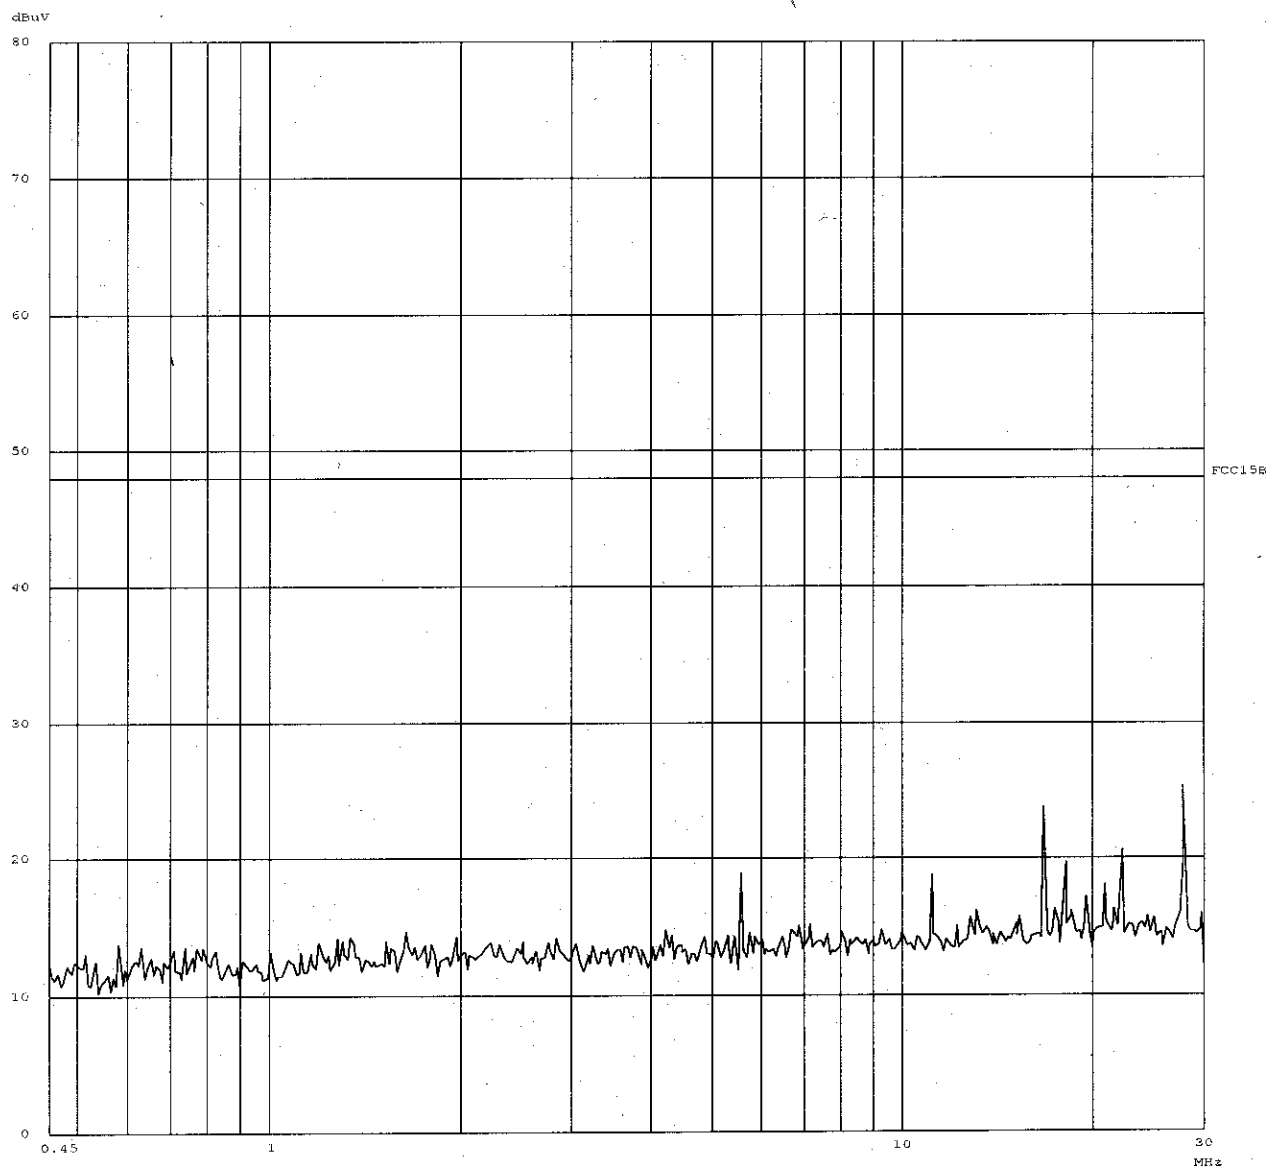
Report No.: 9904580  
Mode: Transmission

| Frequencies | | | Receiver Settings | | | | | |
|---|---|---|---|---|---|---|---|---|
| 450k | 30M | 5k | 10k | PK | 20ms | AUTO | LN OFF | 60dB |

Final Measurement: X QF

| Transducer No. | Start | Stop | Name |
|---|---|---|---|
| 3 | 9k | 30M | EI078 |

Meas Time: 1 s  
Subranges: 16  
Acc Margin: -20dB

Final Measurement Results:

no Results
