# Intertek Testing Services

Report No.: 9904647  
Mode: Charging

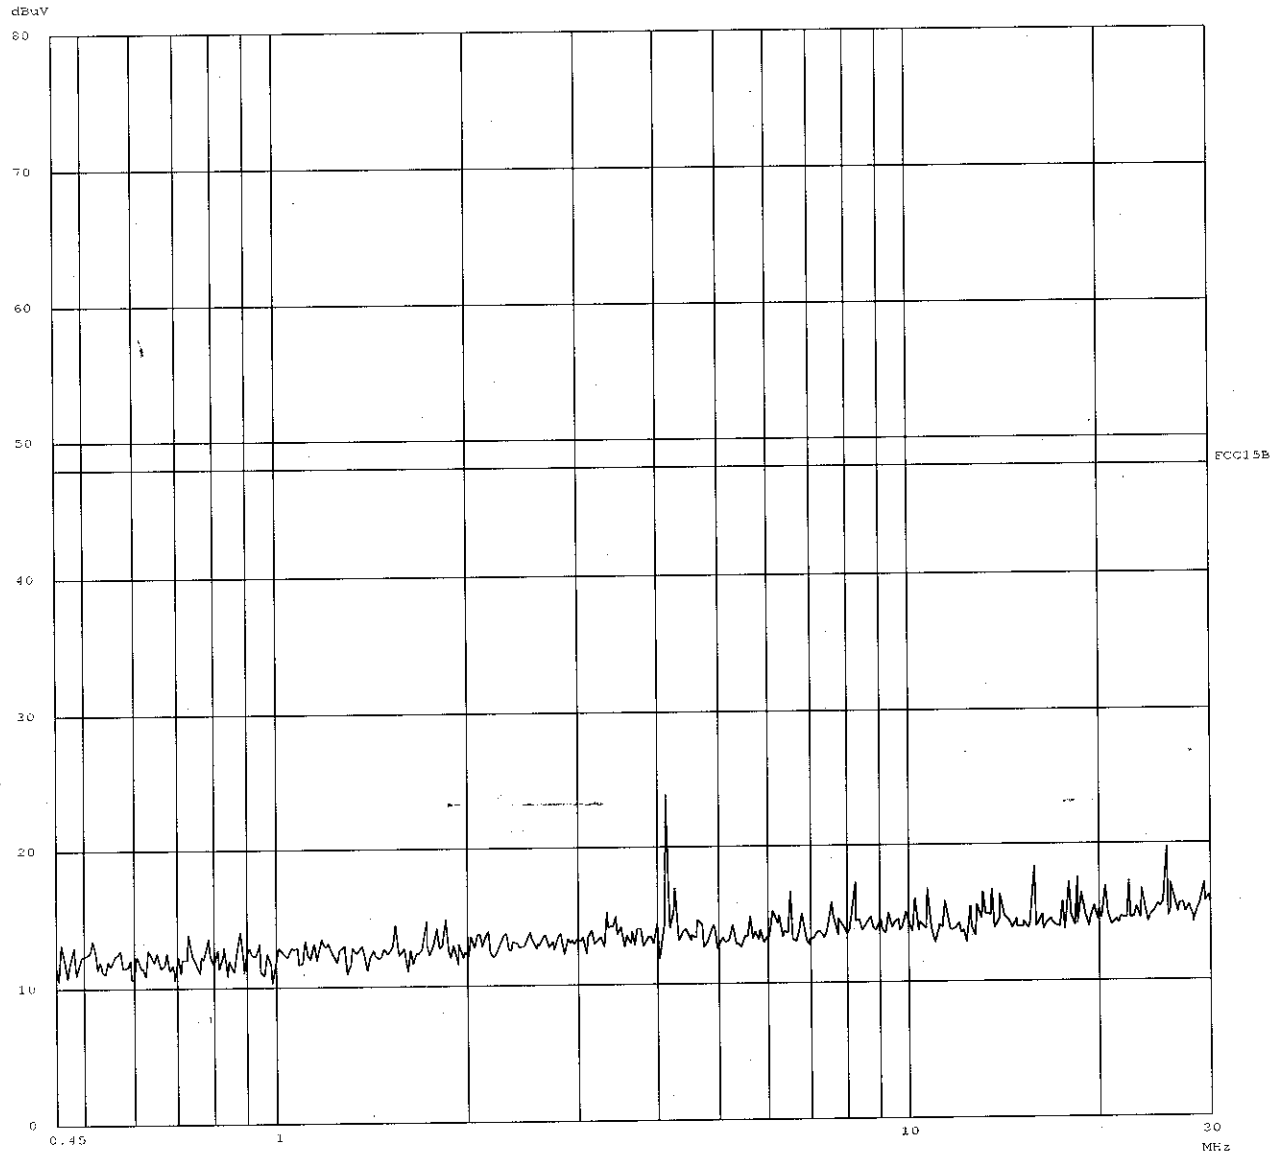
Scan Settings (1 Range)

| Frequencies | | | Receiver Settings | | | | | | |
|---|---|---|---|---|---|---|---|---|--|
| 450k | 30M | 5k | 10k | PK | 20ms | AUTO | LN OFF | 60dB | |

Final Measurement: N QF

Meas Time: 1 s  
Subranges: 16  
Acc Margin: 20dB

| Transducer No. | Start | Stop | Name |
|---|---|---|---|
| 3 | 9k | 30M | SI078 |

no Results

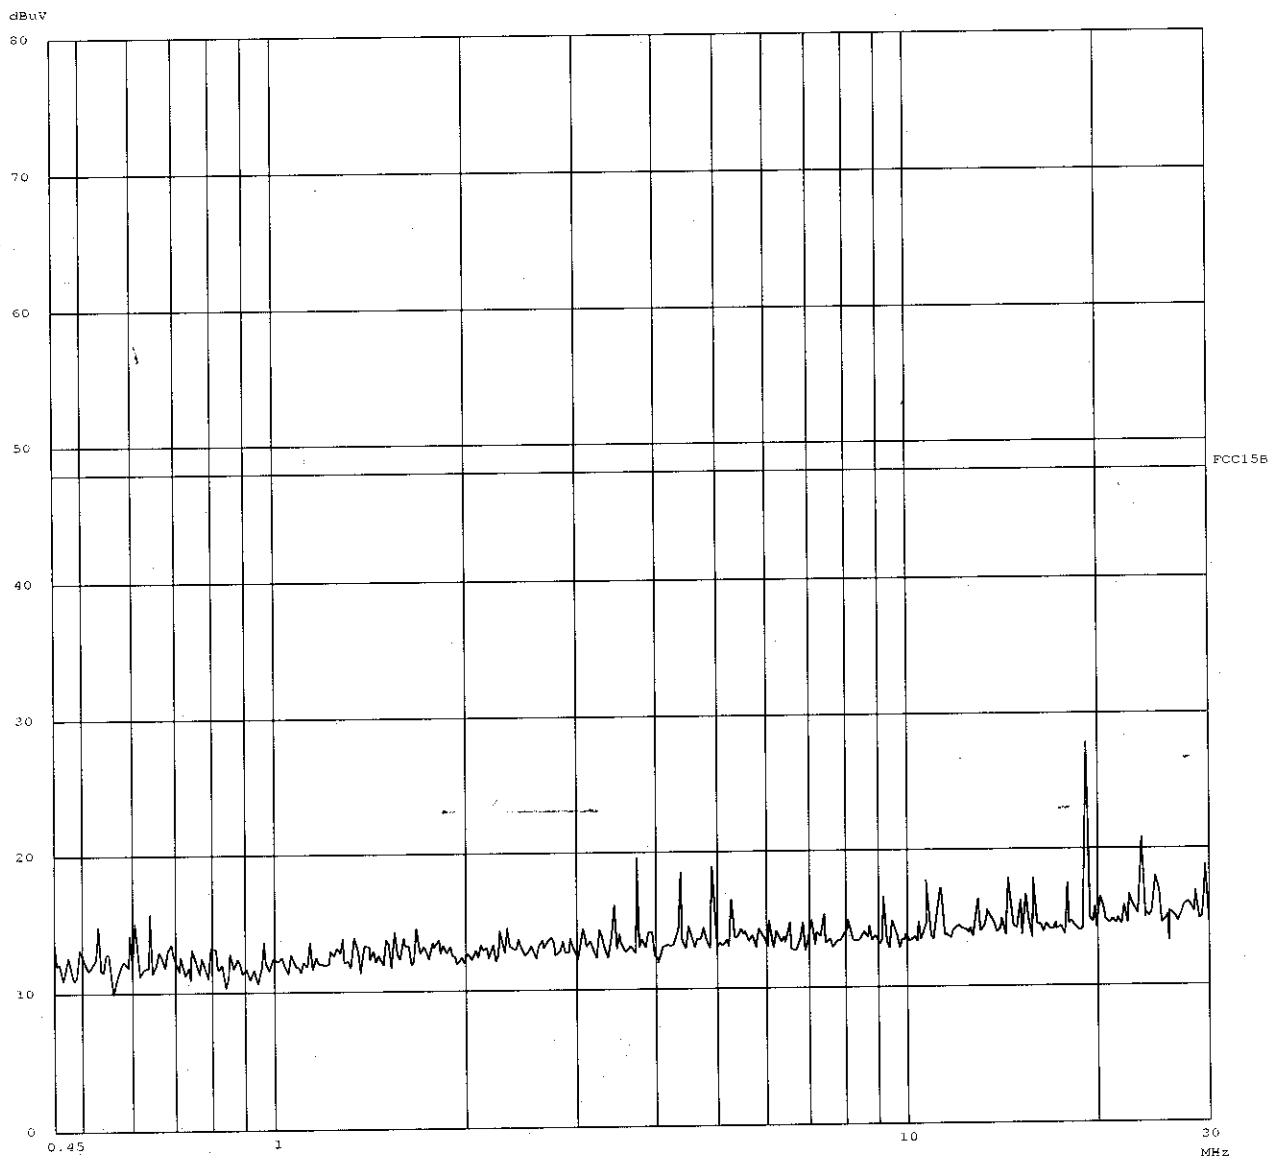
Mode: Standby

Scan Settings (1 Range)

| Frequencies | | | Receiver Settings | | | | | |
|---|---|---|---|---|---|---|---|---|
| 450k | 30M | 5k | 10k | PK | 20ms | AUTO | LN OFF | 60dB |

Final Measurement: X QP

| Transducer No. | Start | Stop | Name |
|---|---|---|---|
| 3 | 9k | 30M | EI078 |

Meas Time: 1 s

Subranges: 16

Acc Margin: 20dB

no Results

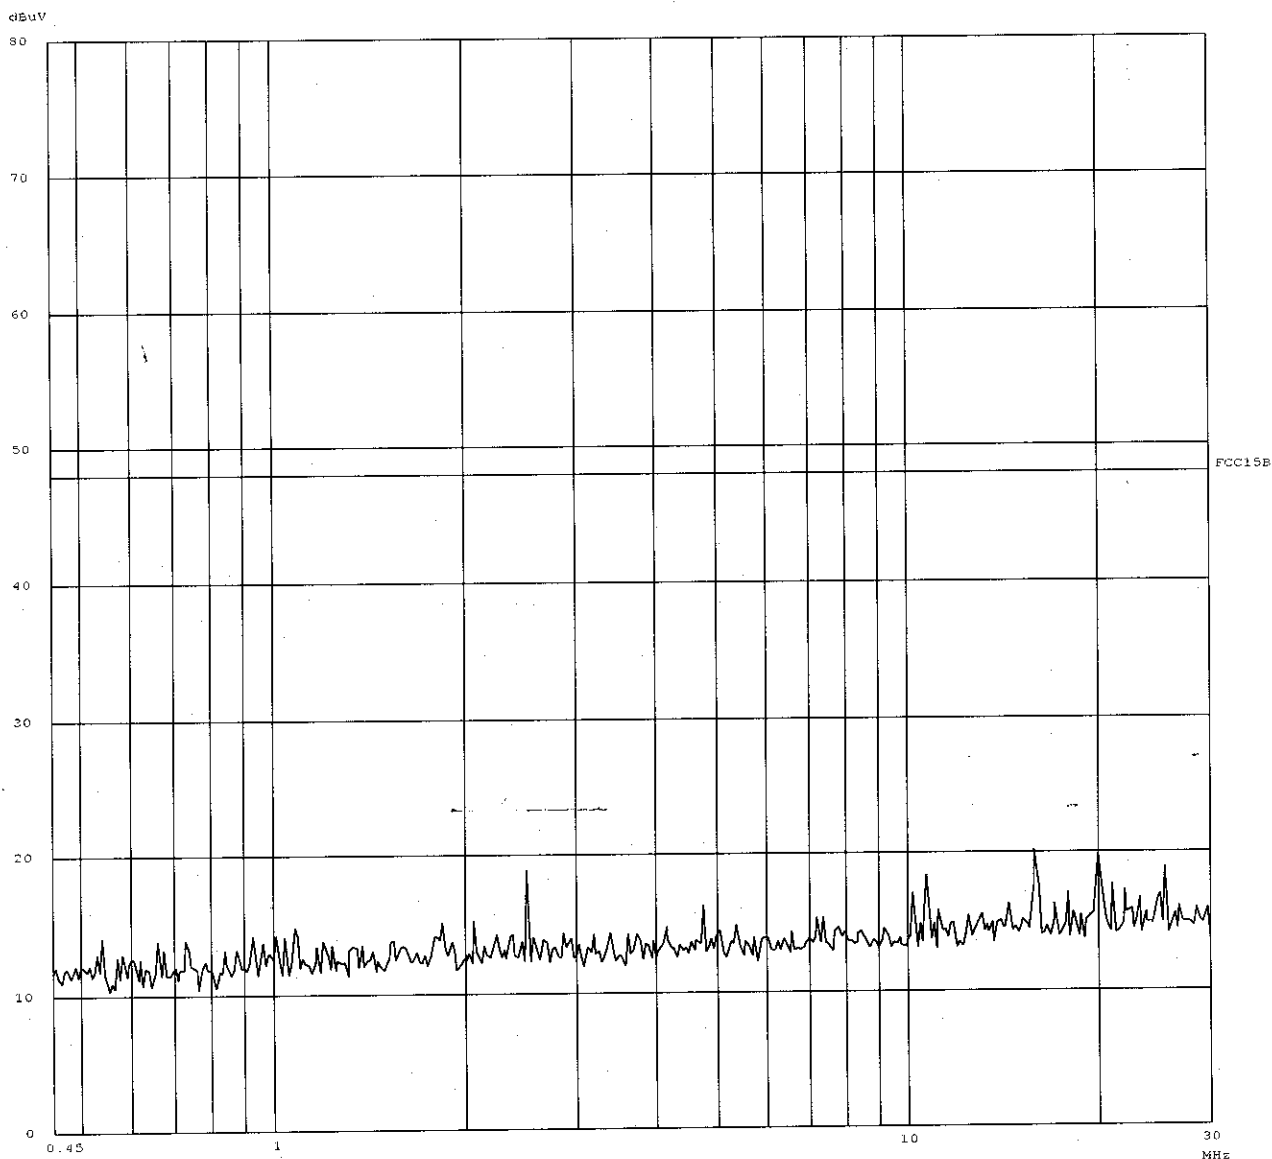
Mode: Transmission

Scan Settings (1 Range)

| Frequencies | | | Receiver Settings | | | | | |
|---|---|---|---|---|---|---|---|---|
| 450k | 30M | 5k | 10k | PK | 20ms | AUTO | LN OFF | 60dB |

Final Measurement: X QP

| Transducer No. | Start | Stop | Name |
|---|---|---|---|
| 3 | 9k | 30M | E1078 |

Meas Time: 1 s  
Subranges: 16  
Acc Margin: 20dB

no Results
