# Intertek Testing Services

Report No.: 9904160

Mode: Charging

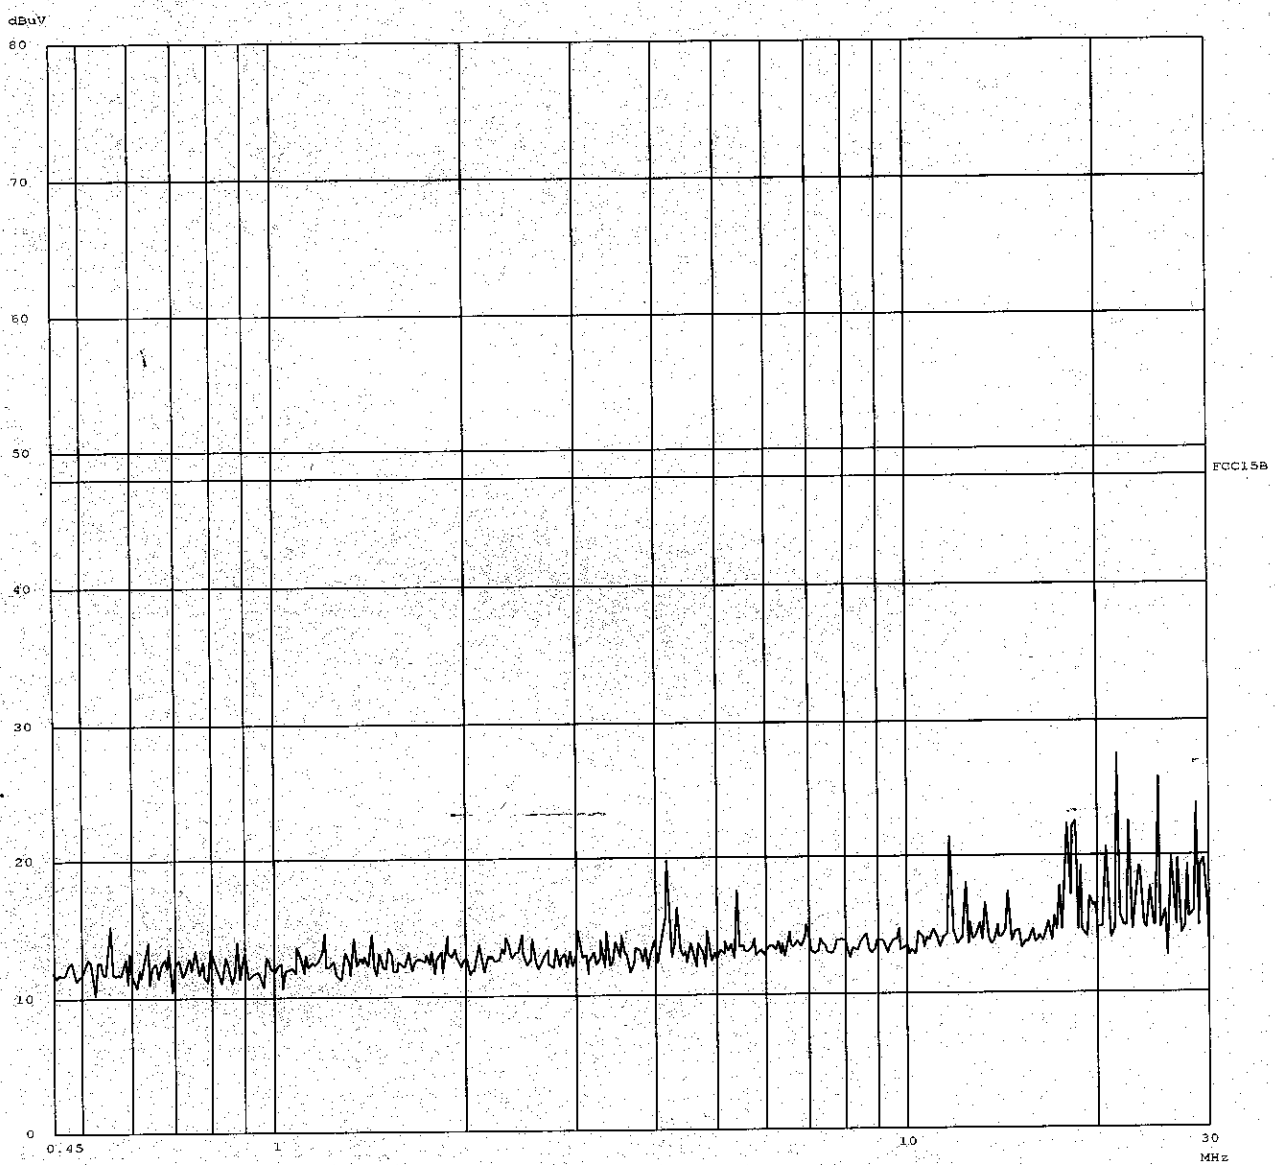
Tested By: Hong, Report No.: 9904160  
Scan Settings (1 Range)

| Frequencies | | | Receiver Settings | | | | | |
|---|---|---|---|---|---|---|---|---|
| 450k | 30M | 5k | 10k | PK | 20ms | AUTO | LN | OFF |

Meas Time: 1 s  
Subranges: 16  
Acc Margin: 20dB

no Results

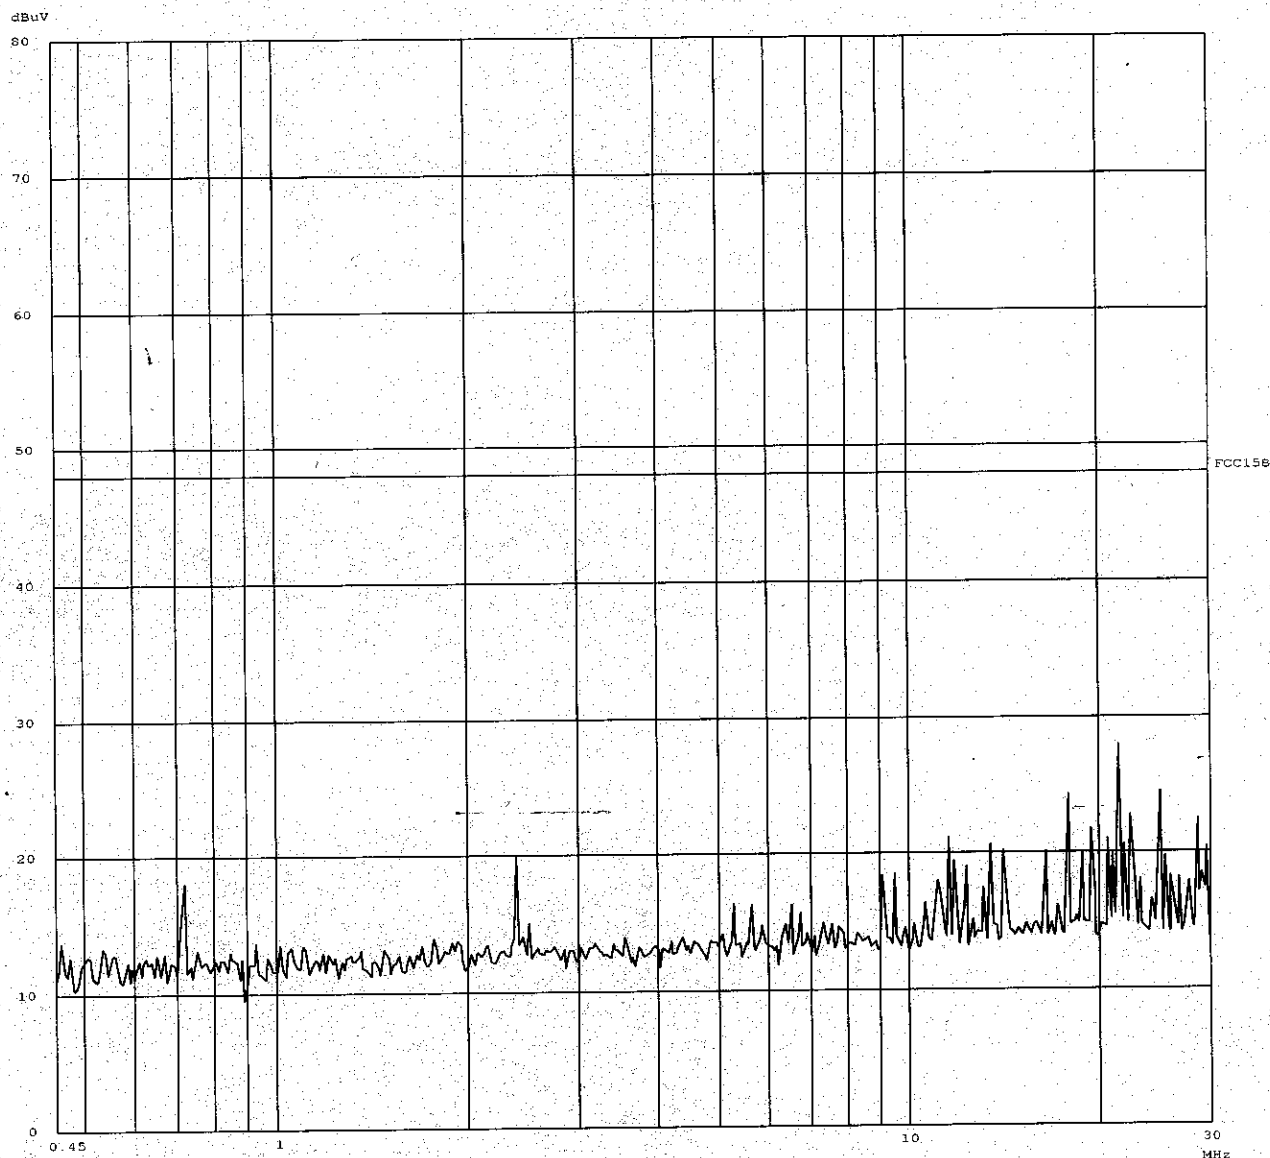
Mode: Standby

| Frequencies | | | Receiver Settings | | | | | |
|---|---|---|---|---|---|---|---|---|
| 450k | 30M | 5k | 10k | PK | 20ms | AUTO | LN OFF | 60dB |

| Final Measurement: X QP | | Transducer No. | Start | Stop | Name |

no Results

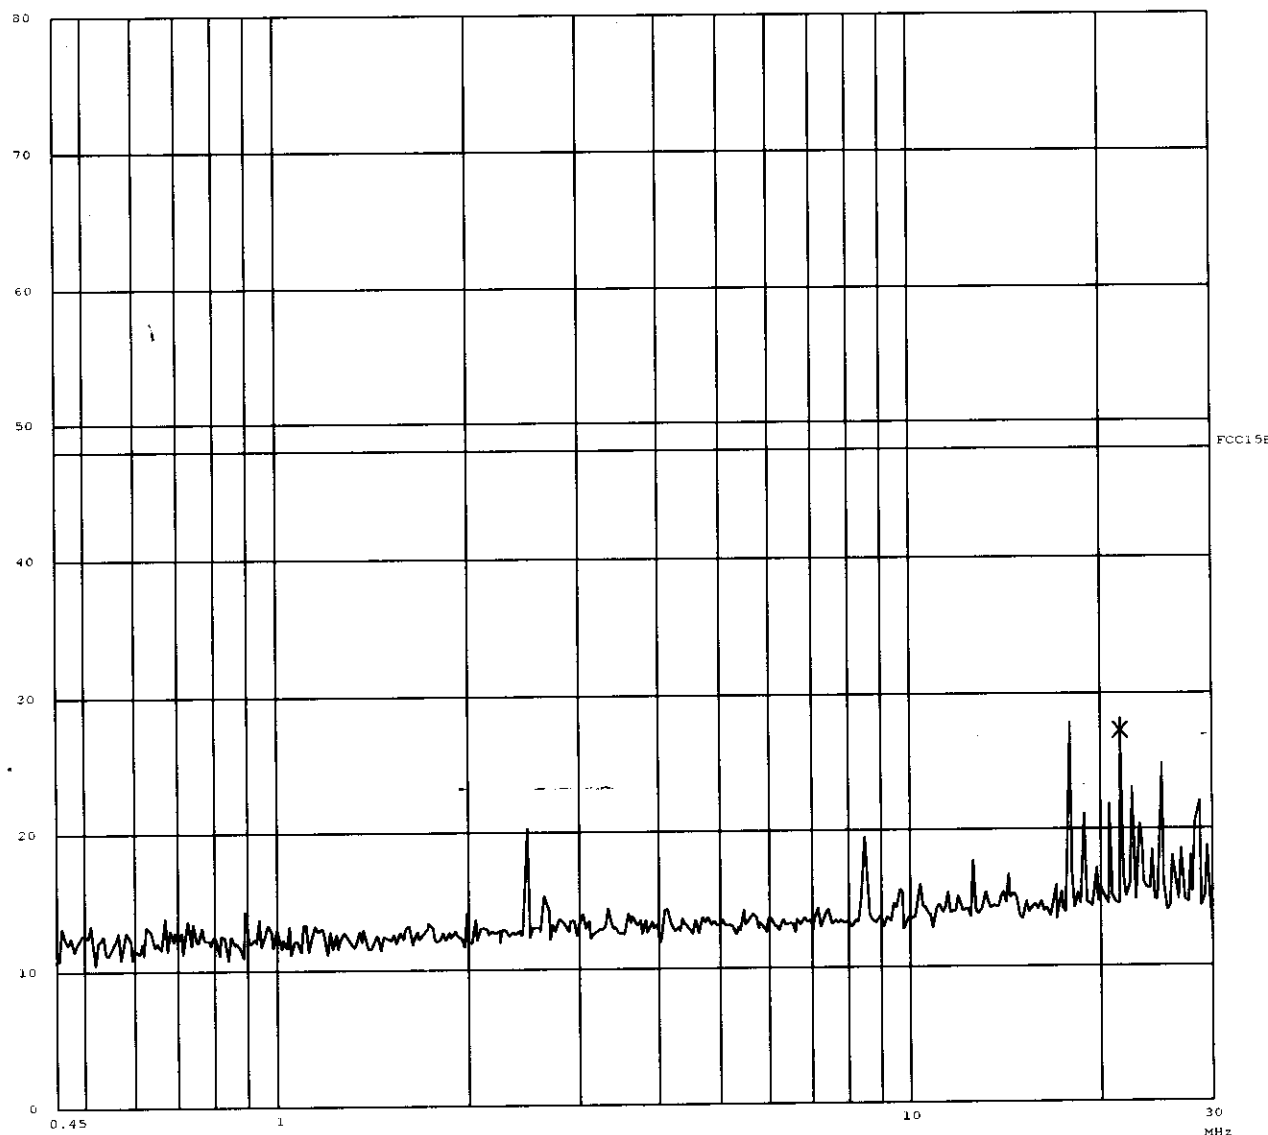
Mode: Transmission

| Frequencies | | | Receiver Settings | | | | | |
|---|---|---|---|---|---|---|---|---|
| 450k | 30M | 5k | 10k | PK | 20ms | AUTO | LN OFF | 60dB |

Final Measurement: \* QP

| Transducer No. | Start | Stop | Name |
| 3 | 9k | 30M | EI078 |

| Frequency<br>MHz | QP Level<br>dBuV | QP Limit<br>dBuV |
| 21.49500 | 27.2 | 48.0 |
