## Appendix B: photographs of test setup

Reference to the test report no. BLA-EMC-202508-A7401

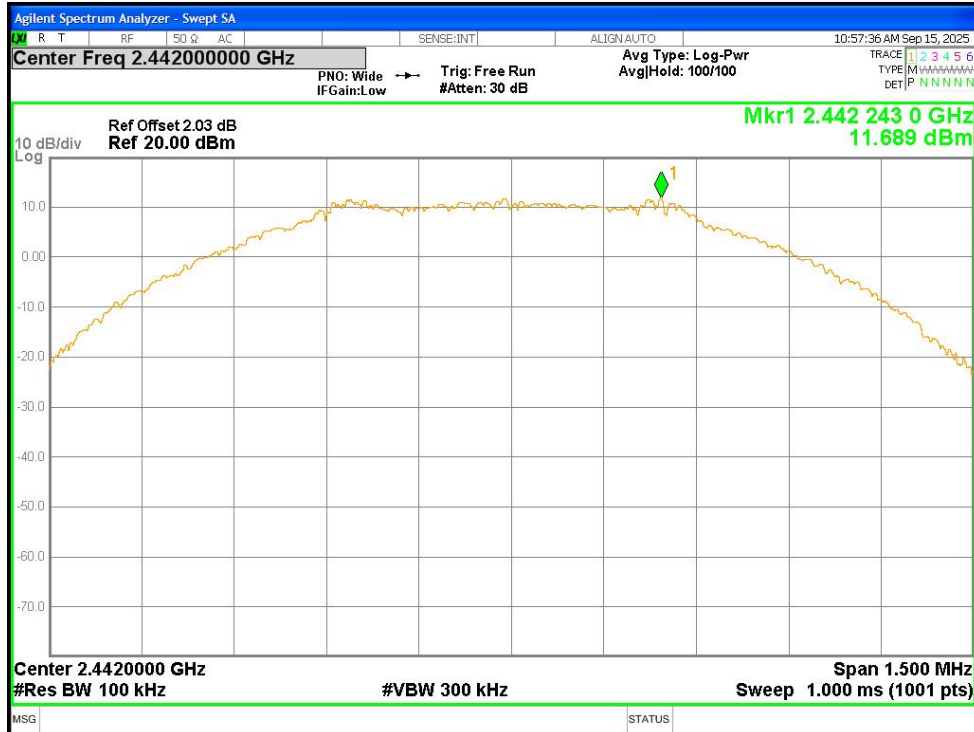
Tx. Spurious NVNT BLE 1M 2442MHz Ant1 Ref

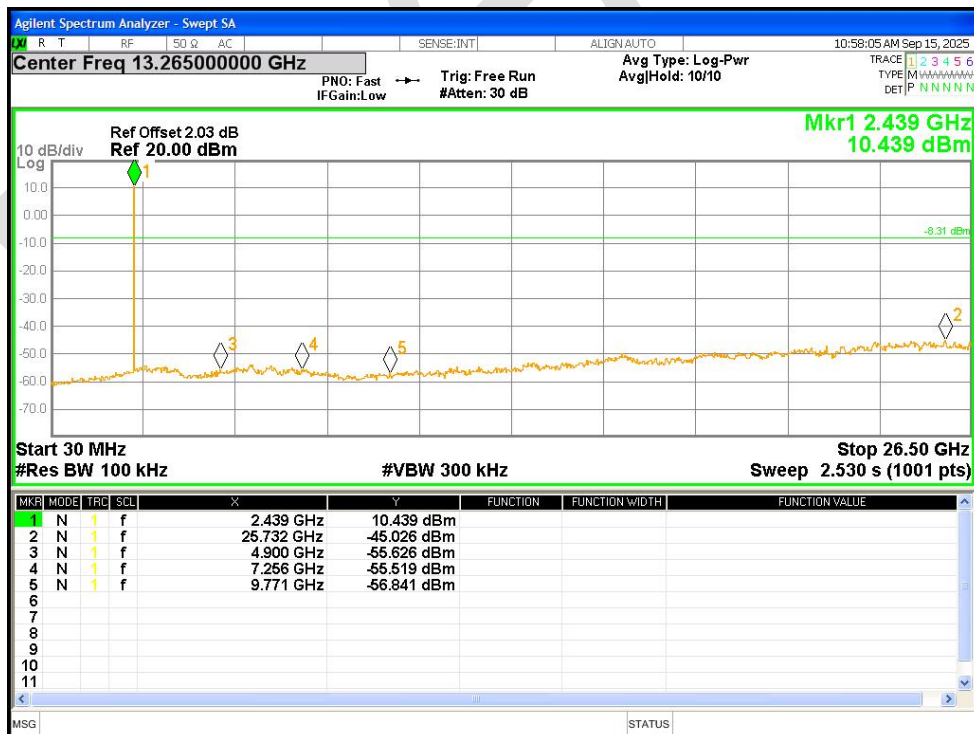
Tx. Spurious NVNT BLE 1M 2442MHz Ant1 Emission

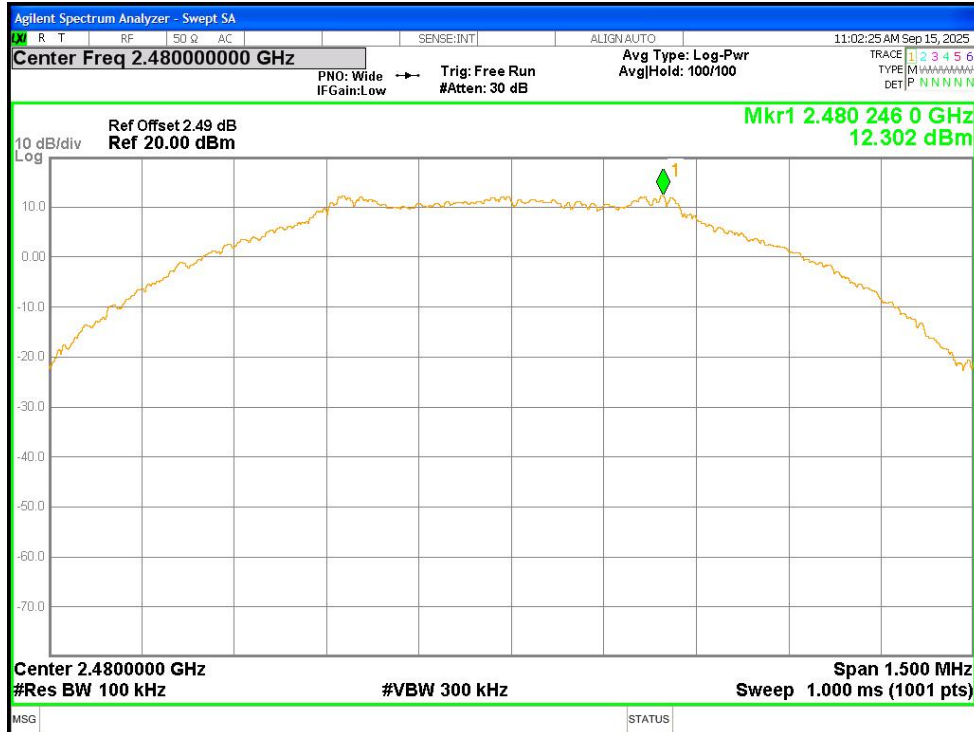
Tx. Spurious NVNT BLE 1M 2480MHz Ant1 Ref

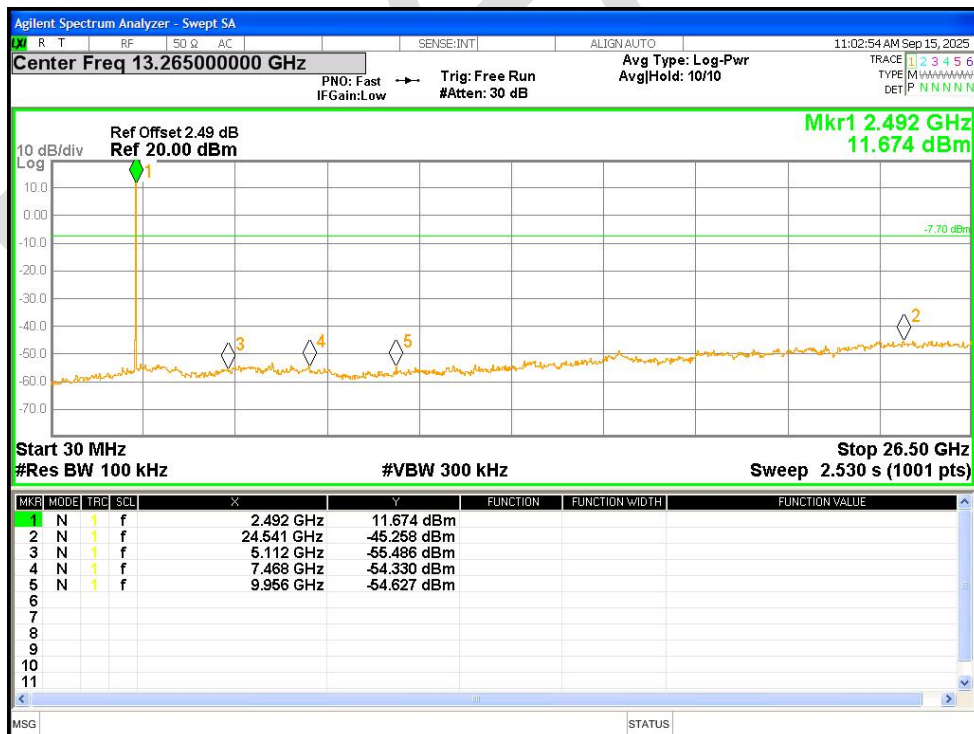
Tx. Spurious NVNT BLE 1M 2480MHz Ant1 Emission

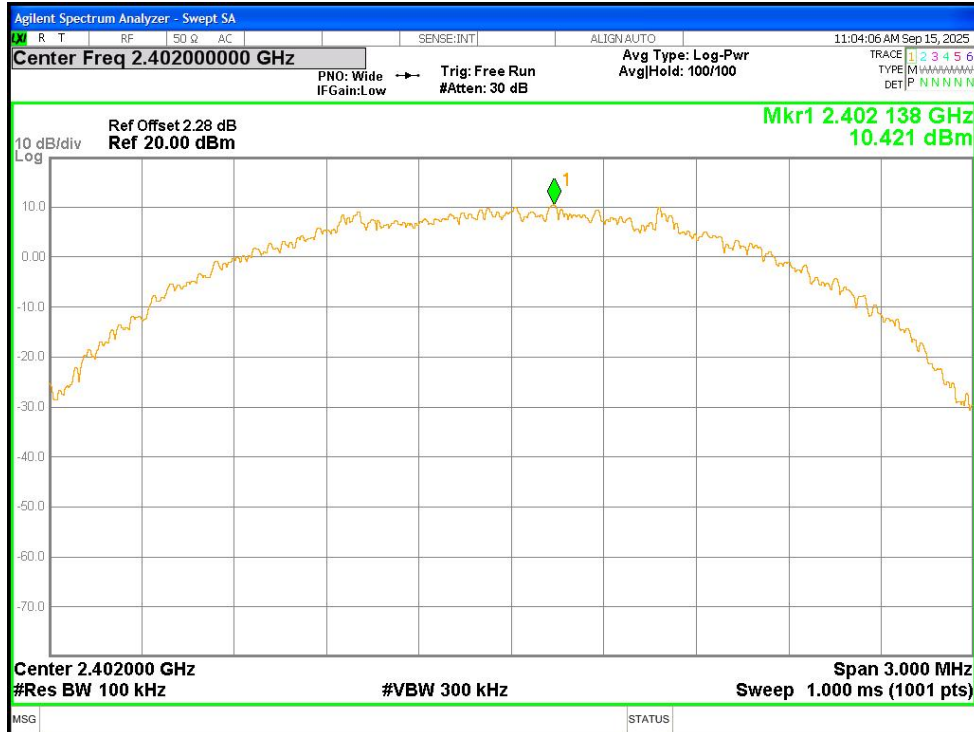
Tx. Spurious NVNT BLE 2M 2402MHz Ant1 Ref

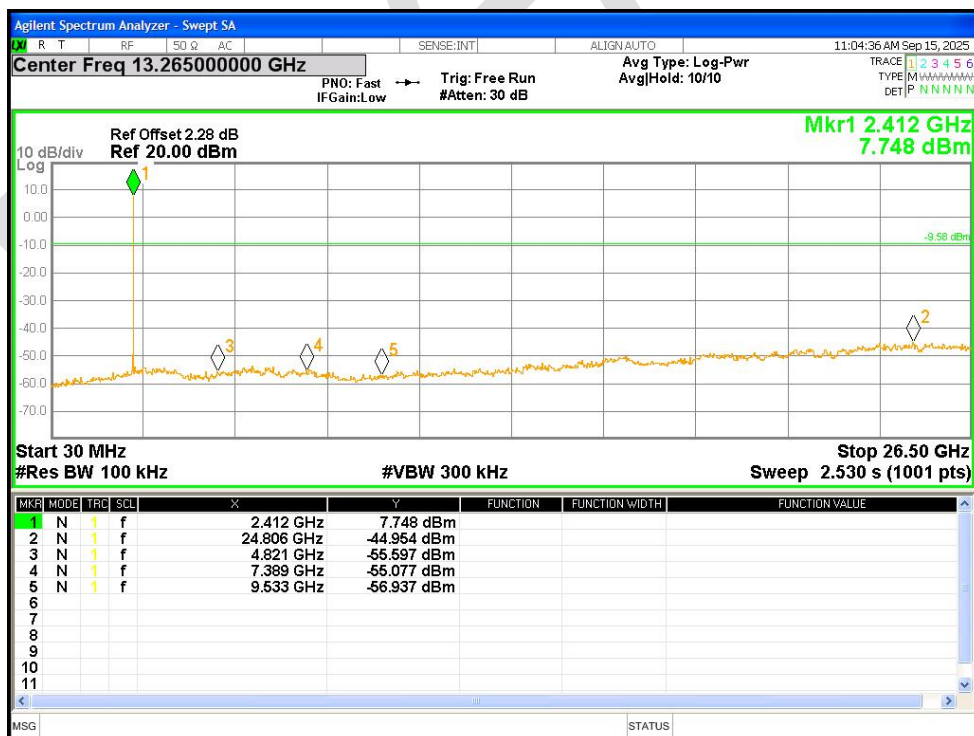
Tx. Spurious NVNT BLE 2M 2402MHz Ant1 Emission

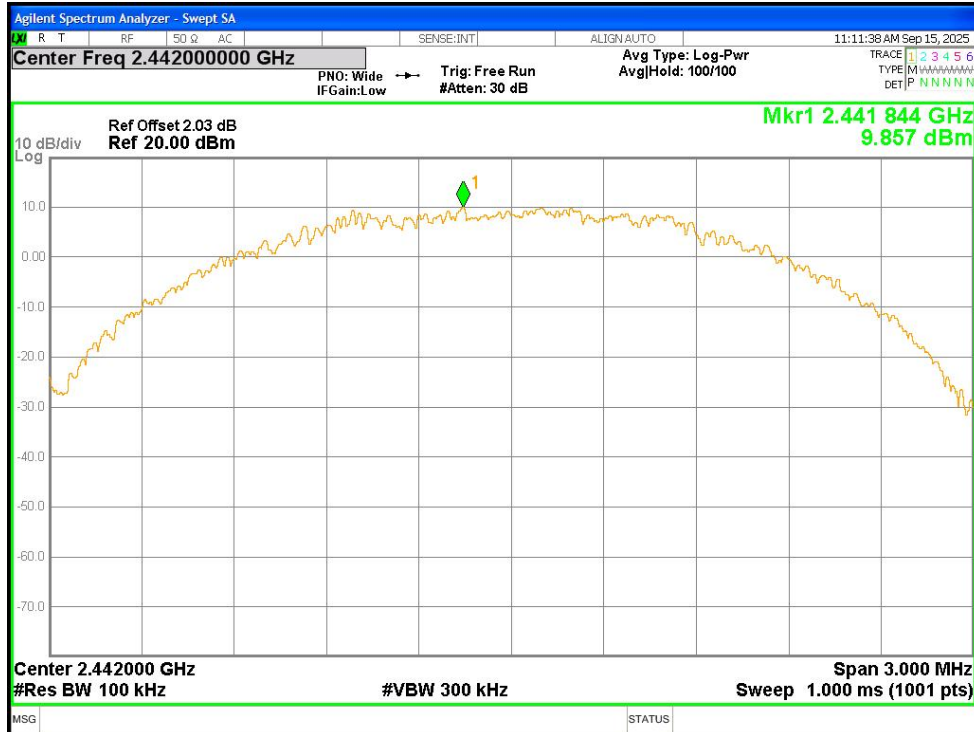
## Tx. Spurious NVNT BLE 2M 2442MHz Ant1 Ref

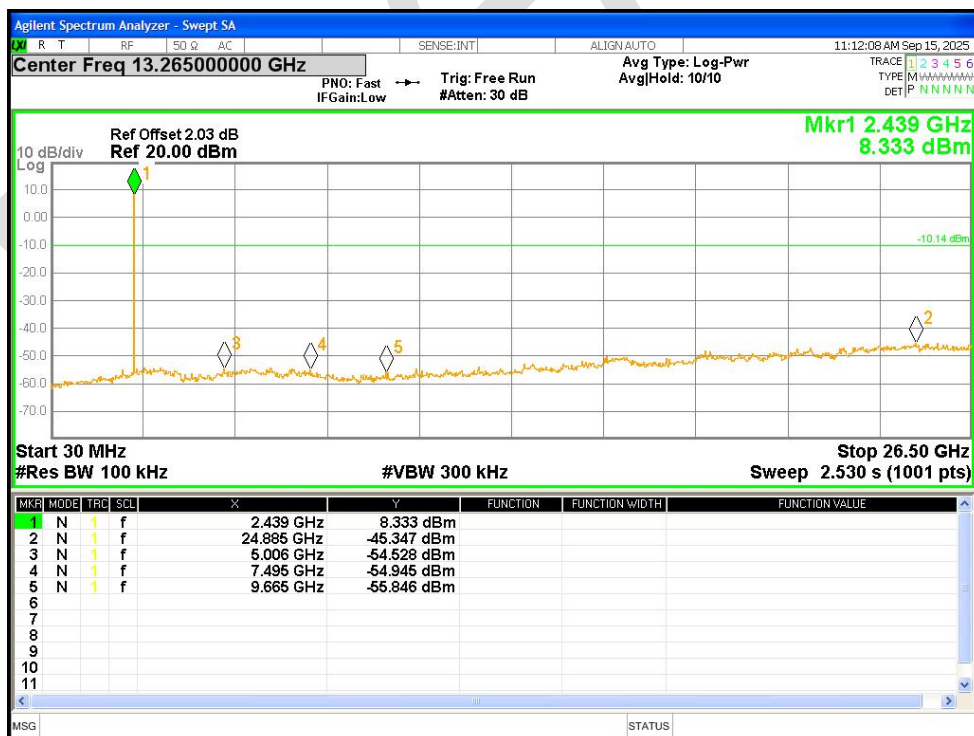
## Tx. Spurious NVNT BLE 2M 2442MHz Ant1 Emission

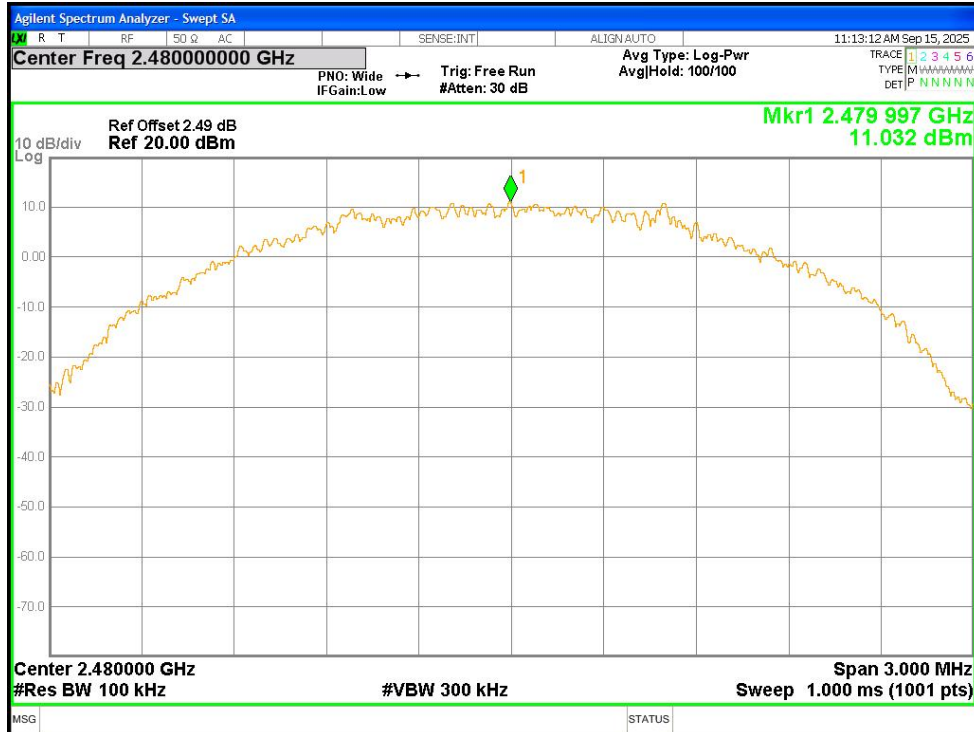
### Tx. Spurious NVNT BLE 2M 2480MHz Ant1 Ref

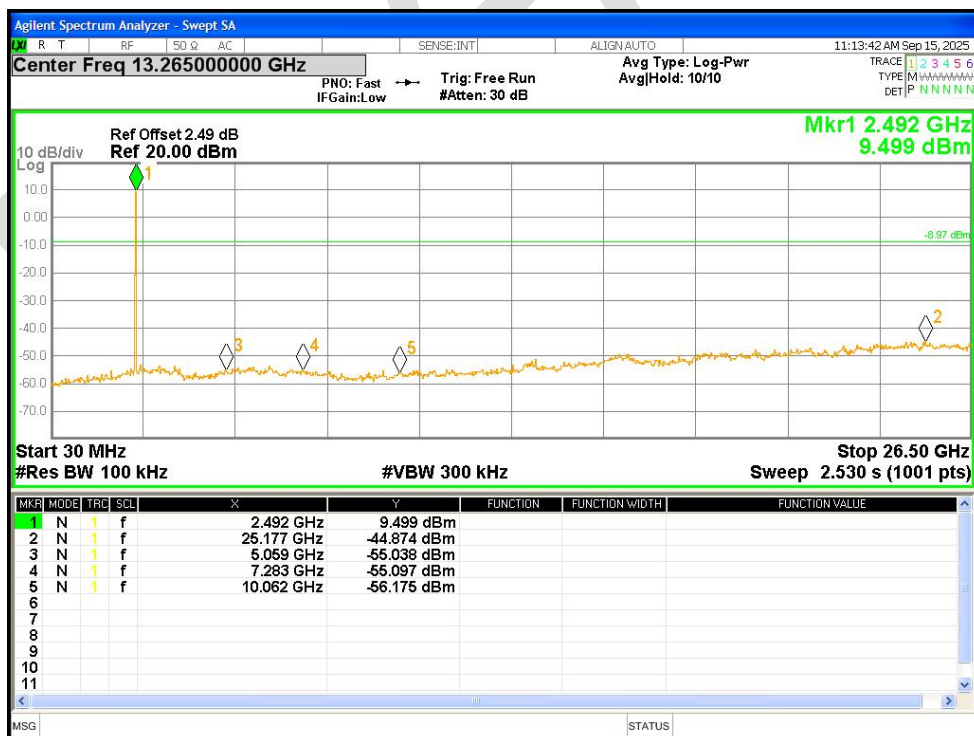
### Tx. Spurious NVNT BLE 2M 2480MHz Ant1 Emission

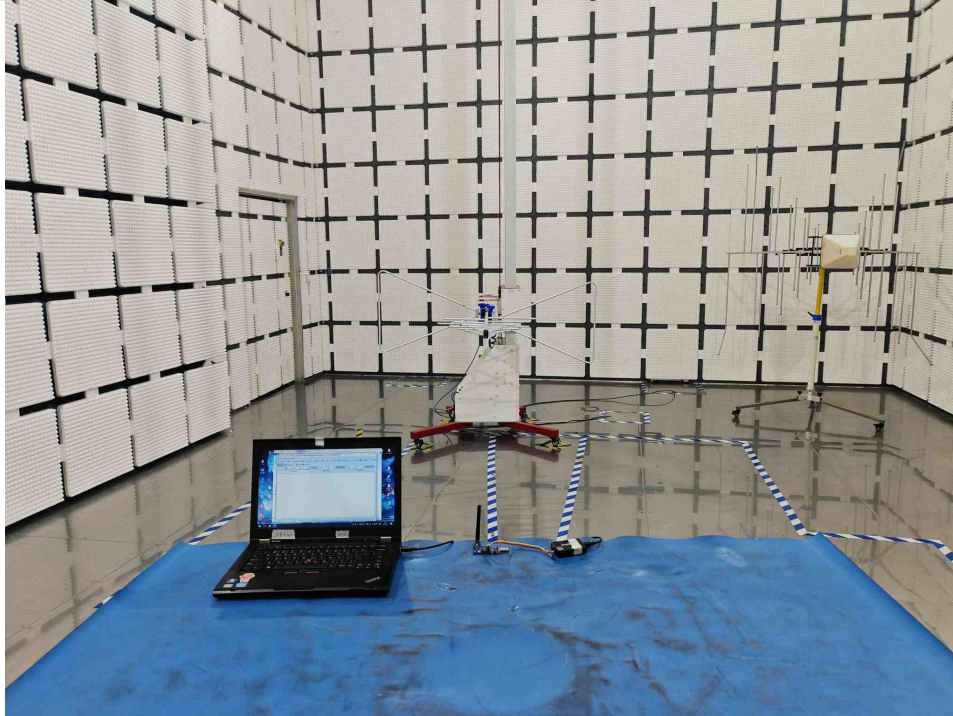
Radiated Emissions (30MHz-1GHz)

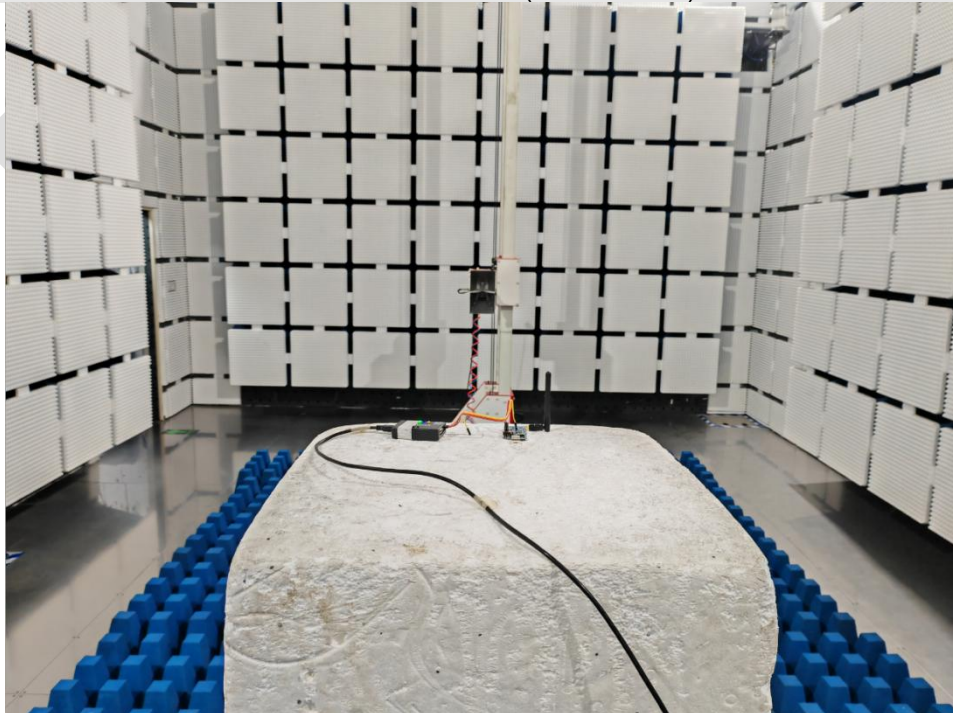
Radiated Emissions (above 1GHz)
