## 7.6 Conducted RF Spurious Emission

## Appendix B: photographs of test setup

## Appendix C: photographs of EUT

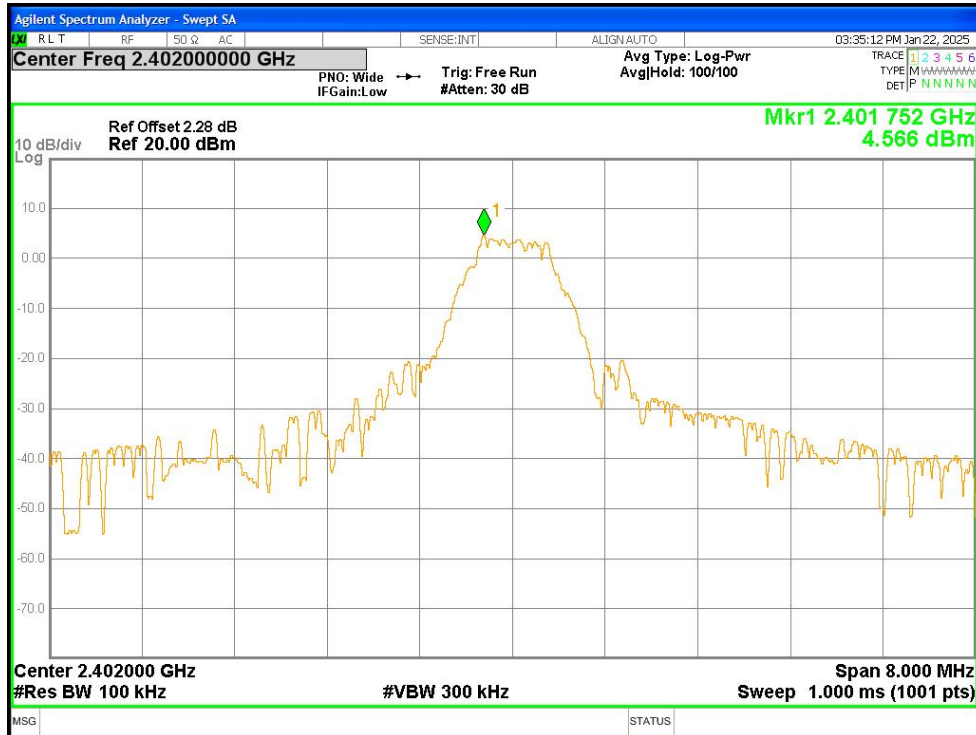
Band Edge NVNT BLE 1M 2402MHz Ant1 Ref

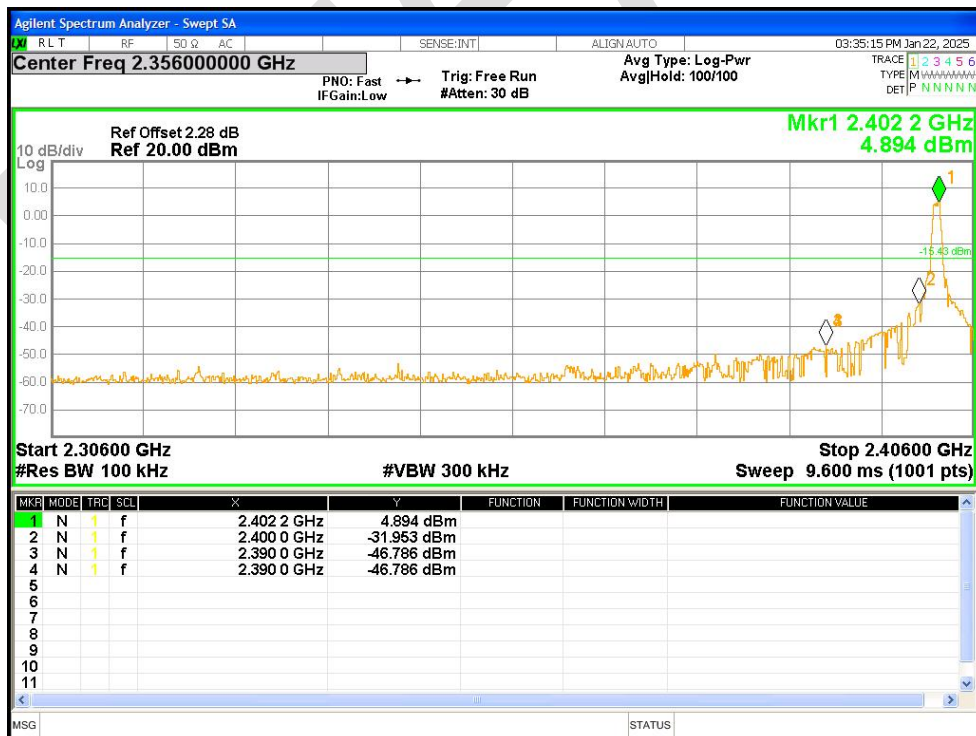
Band Edge NVNT BLE 1M 2402MHz Ant1 Emission

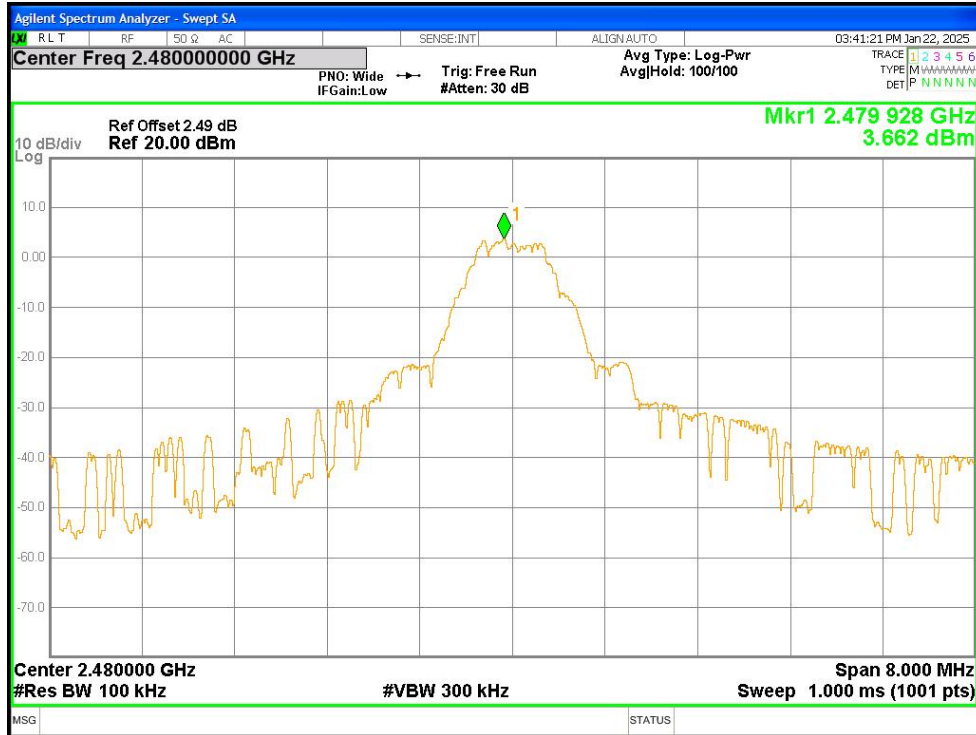
Band Edge NVNT BLE 1M 2480MHz Ant1 Ref

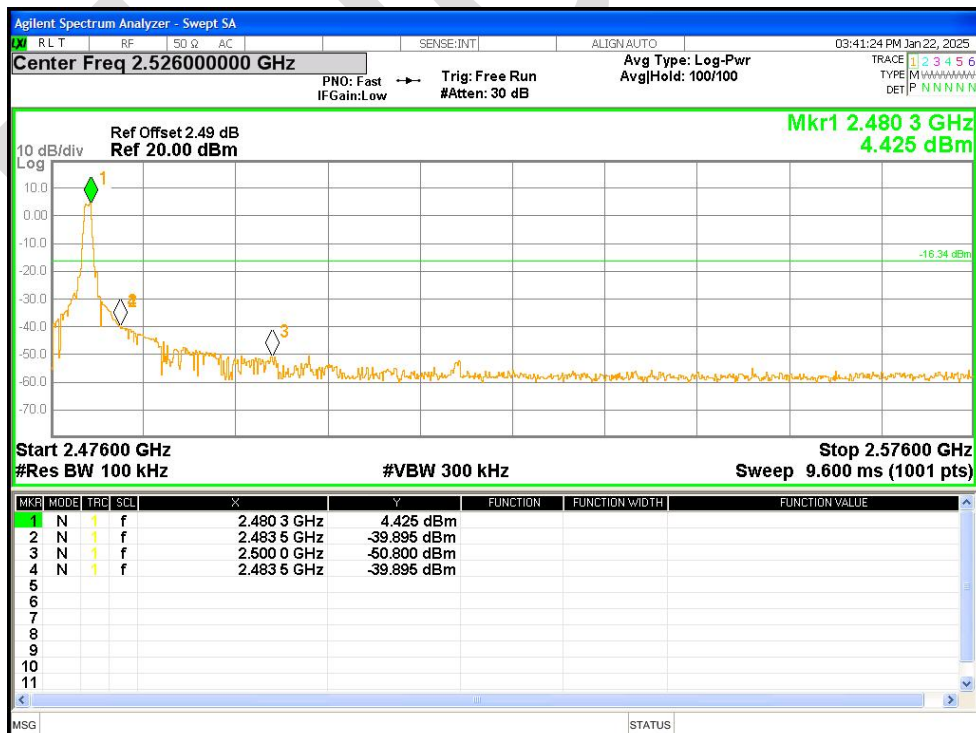
Band Edge NVNT BLE 1M 2480MHz Ant1 Emission

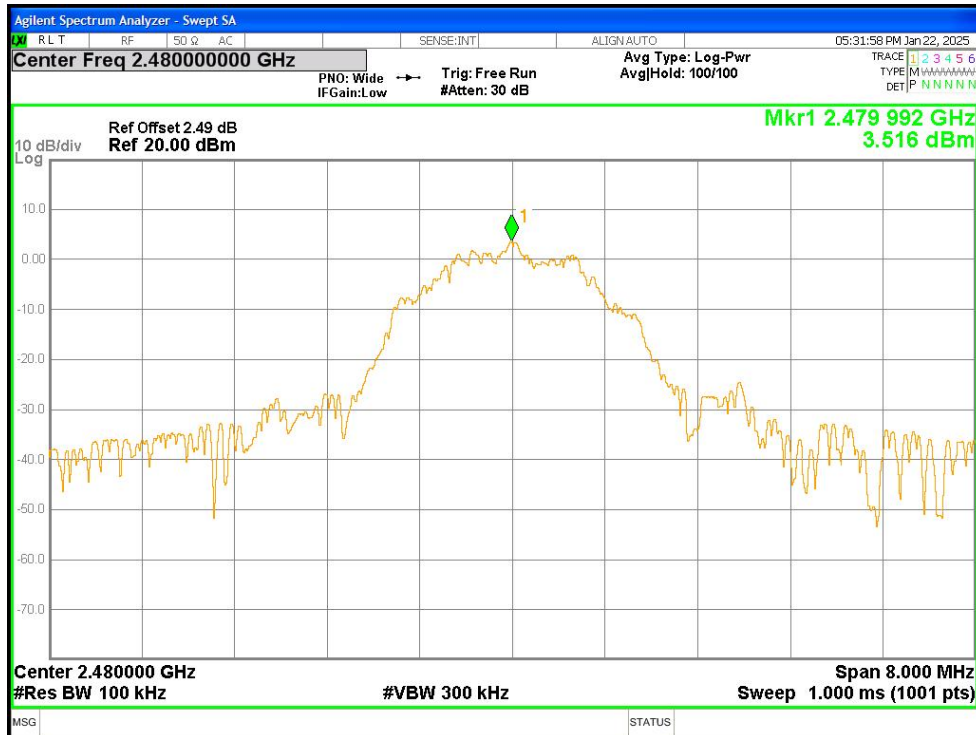
Band Edge NVNT BLE 2M 2480MHz Ant1 Ref

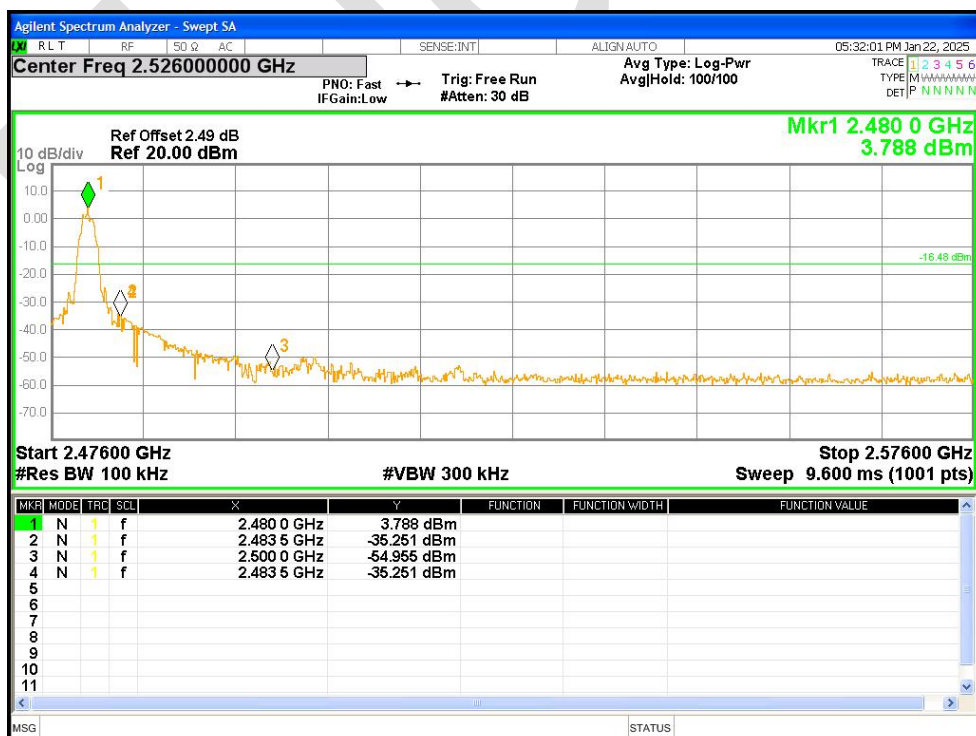
Band Edge NVNT BLE 2M 2480MHz Ant1 Emission

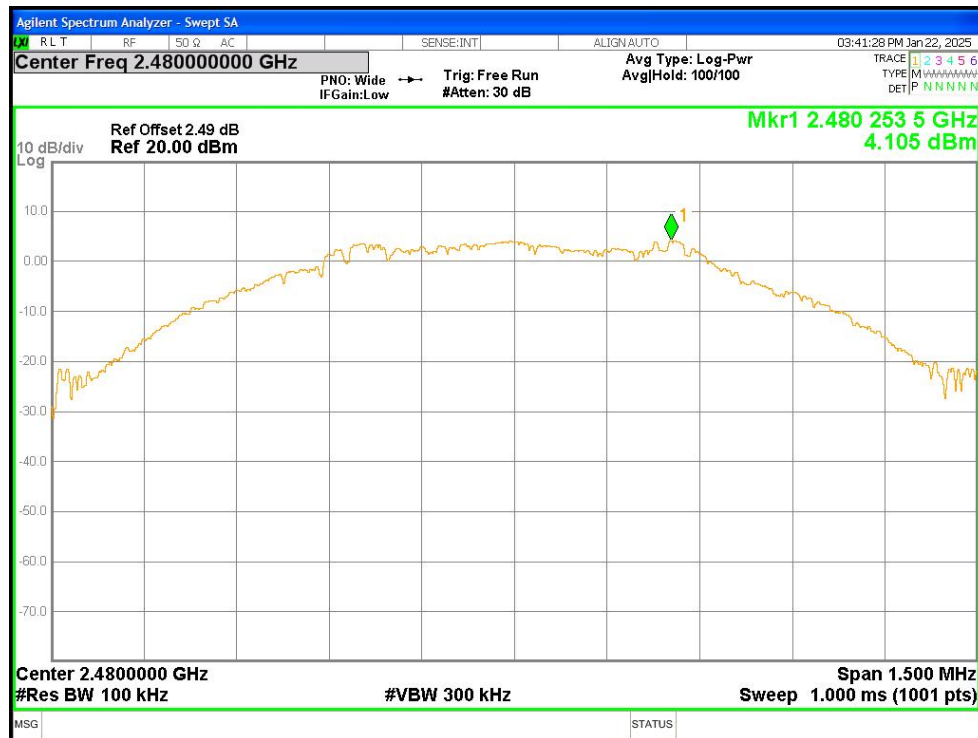
Tx. Spurious NVNT BLE 1M 2480MHz Ant1 Ref

| Condition | Mode | Frequency (MHz) | Antenna | Max Value (dBc) | Limit (dBc) | Verdict |
|---|---|---|---|---|---|---|
| NVNT | BLE 1M | 2480 | Ant1 | -49.6 | -20 | Pass |

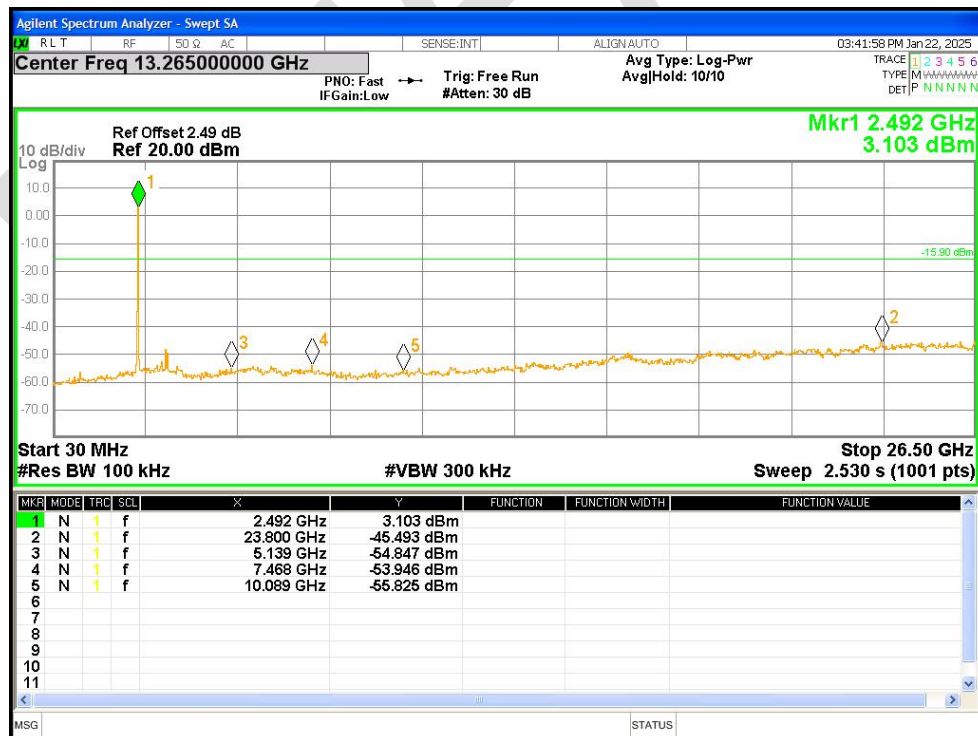
Tx. Spurious NVNT BLE 1M 2480MHz Ant1 Emission

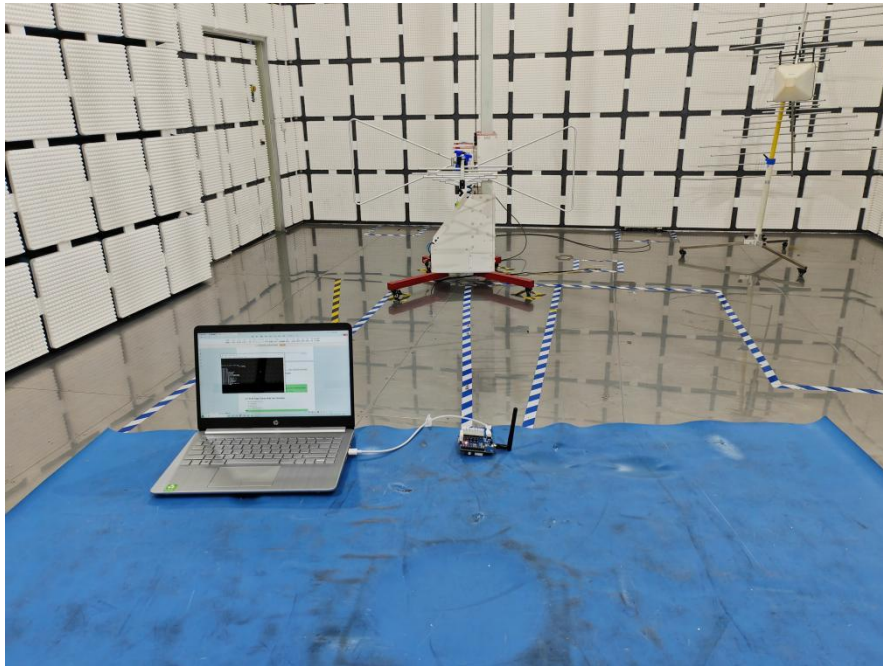
Radiated Emissions (30MHz-1GHz)

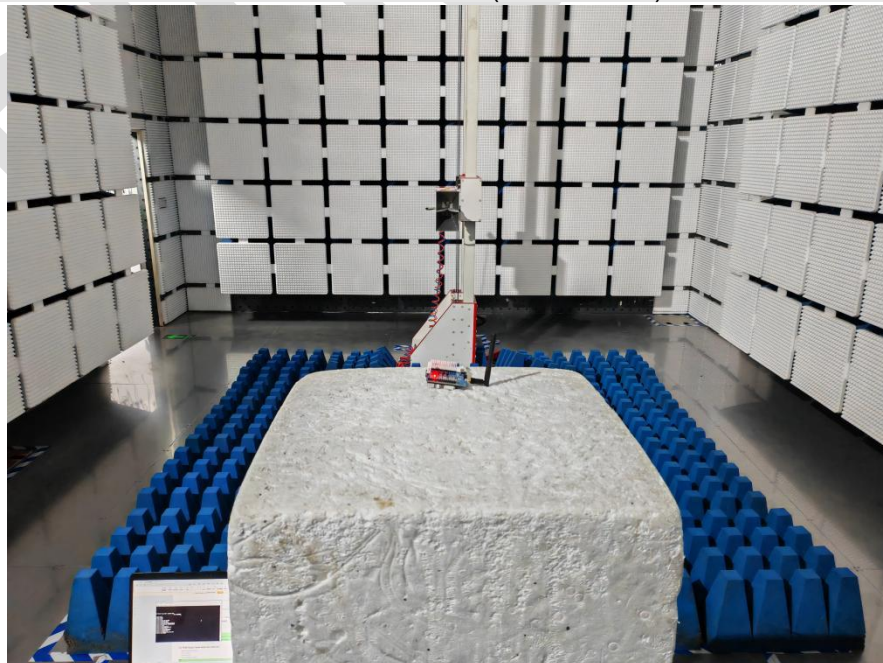
Radiated Emissions (above 1GHz)

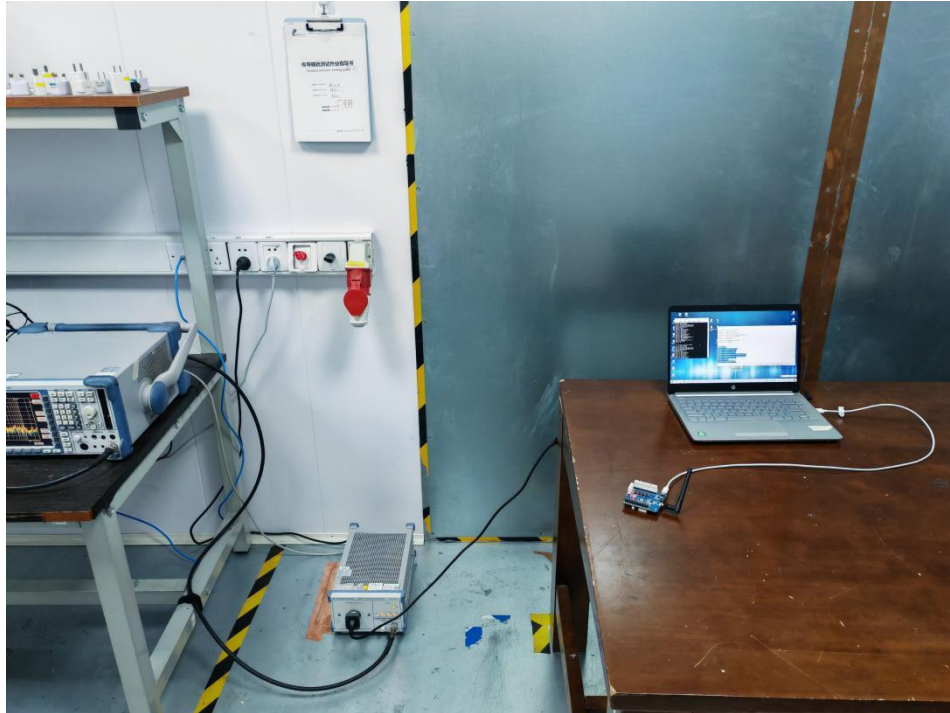
Conducted Emissions at Mains Terminals (150 kHz-30MHz)
