**GE Photos Taken During Radiated Emission Testing**  
**FCC ID# OU52014748**

**Photos of the EUT during Radiated Emission Testing in the 3 Meter FCC Listed Chamber**

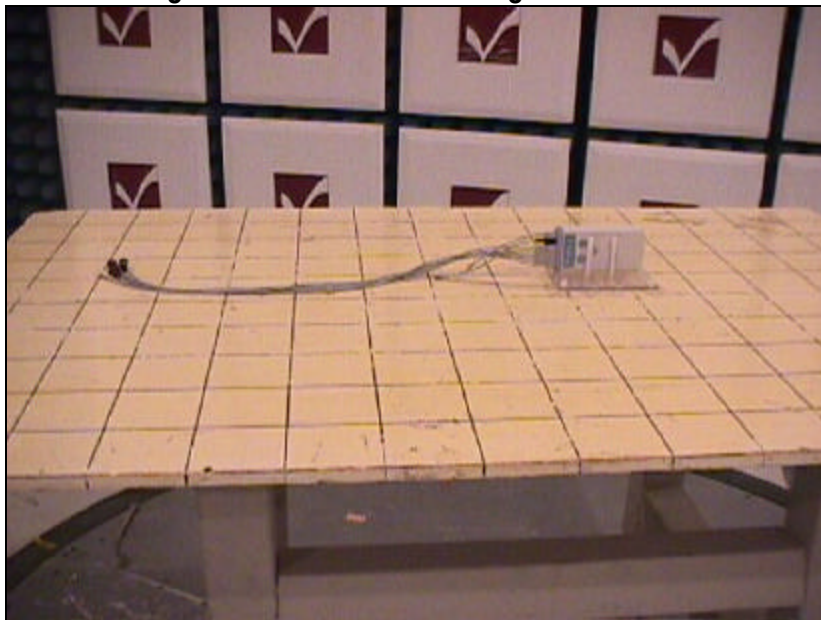
**Highest emissions noted were with the device in the side orientation as shown here.**

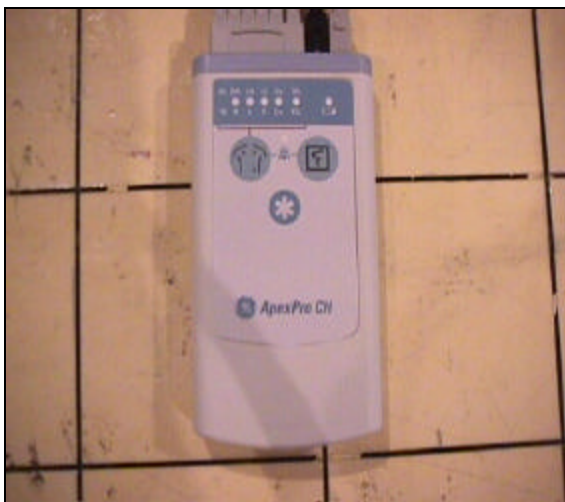
**Close up view, front of the device.**

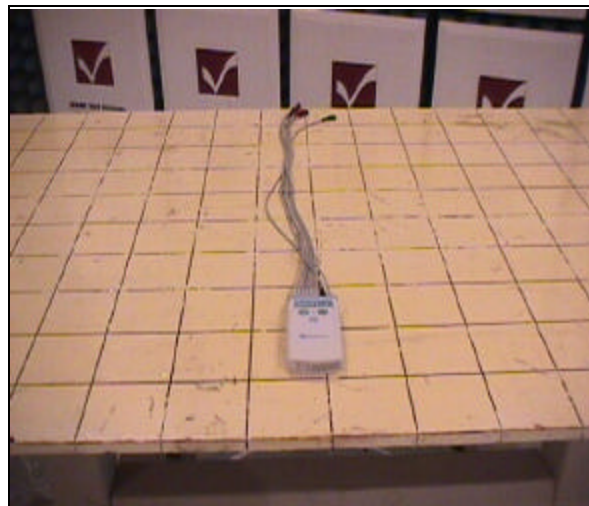
**Device pictured in horizontal orientation.**
