### **APPENDIX 3: Photographs of test setup**

#### **Radiated Emission** LF ANT (Front)

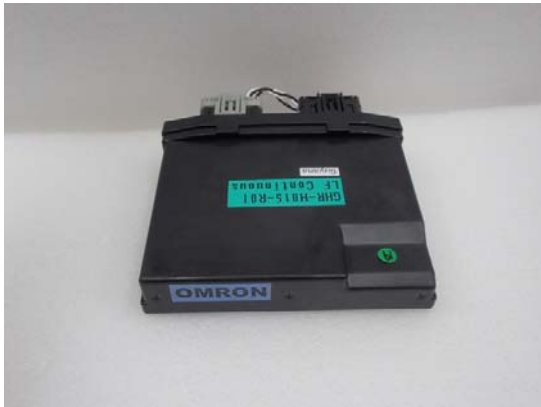
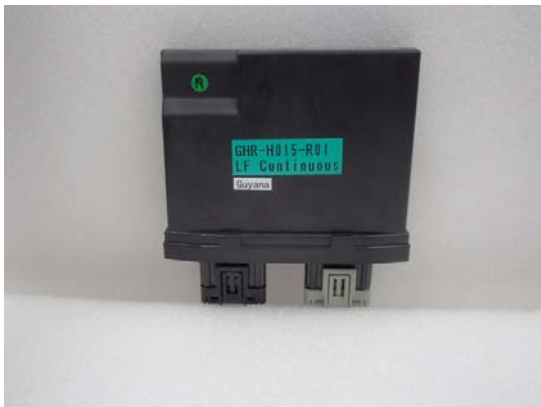
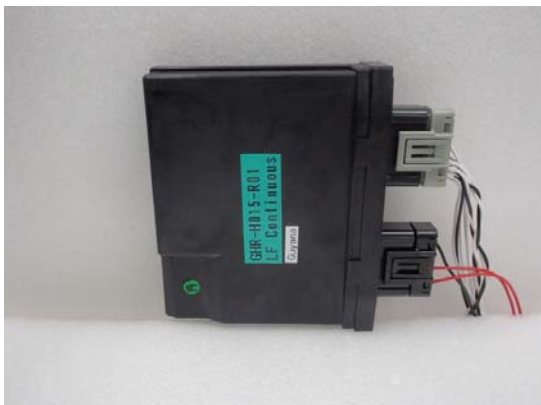
**BCM**  
Below 30MHz  
X-axis  
Above 30MHz  
Horizontal:Z-axis / Vertical:Z-axis  
X-axis

**Y-axis**

**Z-axis**

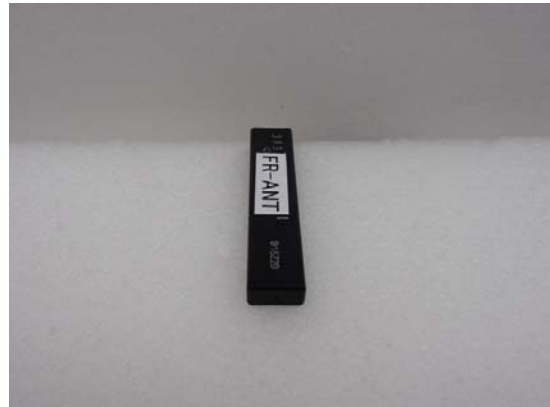
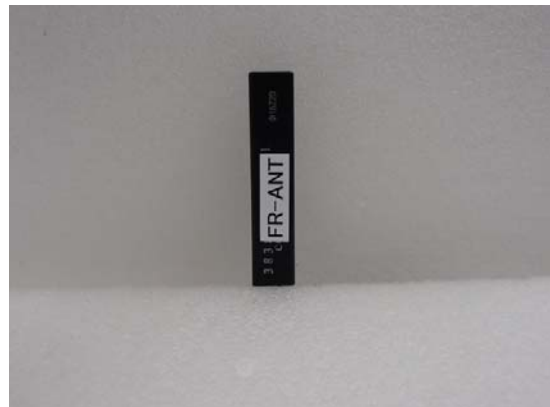
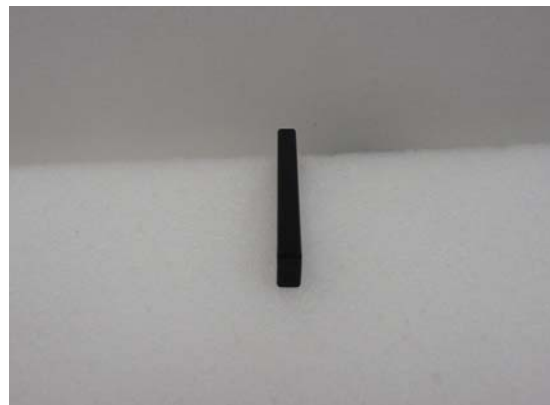
**LF ANT (Front)**  
Below 30MHz  
X-axis  
Above 30MHz  
Horizontal:X-axis / Vertical:X-axis  
X-axis

**Y-axis**

**Z-axis**

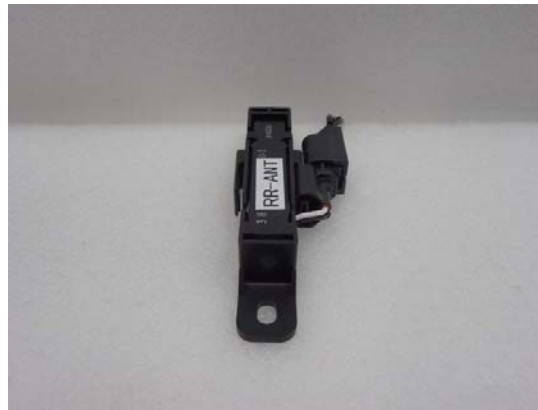
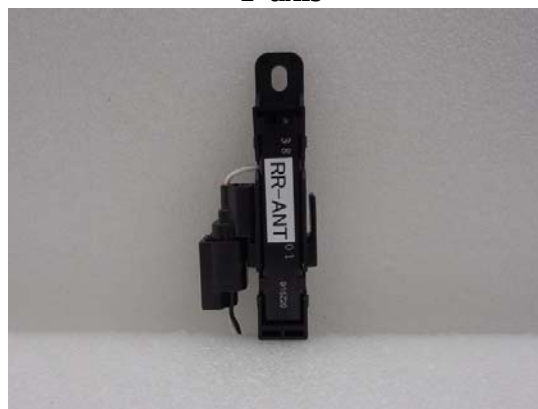
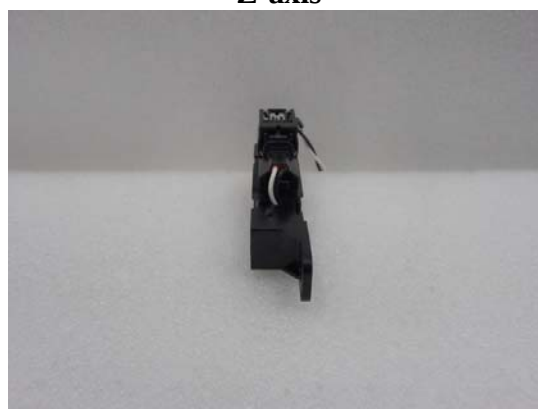
**LF ANT (Rear)**

**Below 30MHz**

**X-axis**

**Above 30MHz**

**Horizontal:X-axis / Vertical:X-axis**

**Y-axis**

**Z-axis**
