PEP Testing Laboratory

## 6. PHOTOS OF TESTED EUT

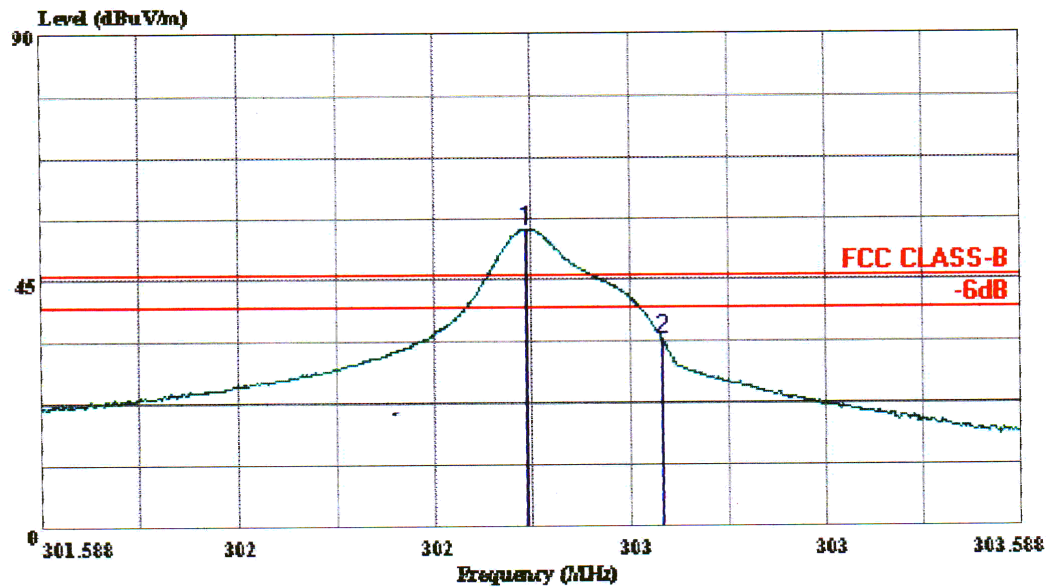
Figure 5.4 Occupied Bandwidth

PEP Testing Laboratory (Chamber No.1)

Condition: FCC CLASS-B 3m 3142B.H3 HORIZONTAL

cut : RC-01

power: DC12V
