### 3.5. DTS Bandwidth

FCC CFR Title 47 Part 15 Subpart C Section 15.247 (a)(2) / RSS-247 5.2 a

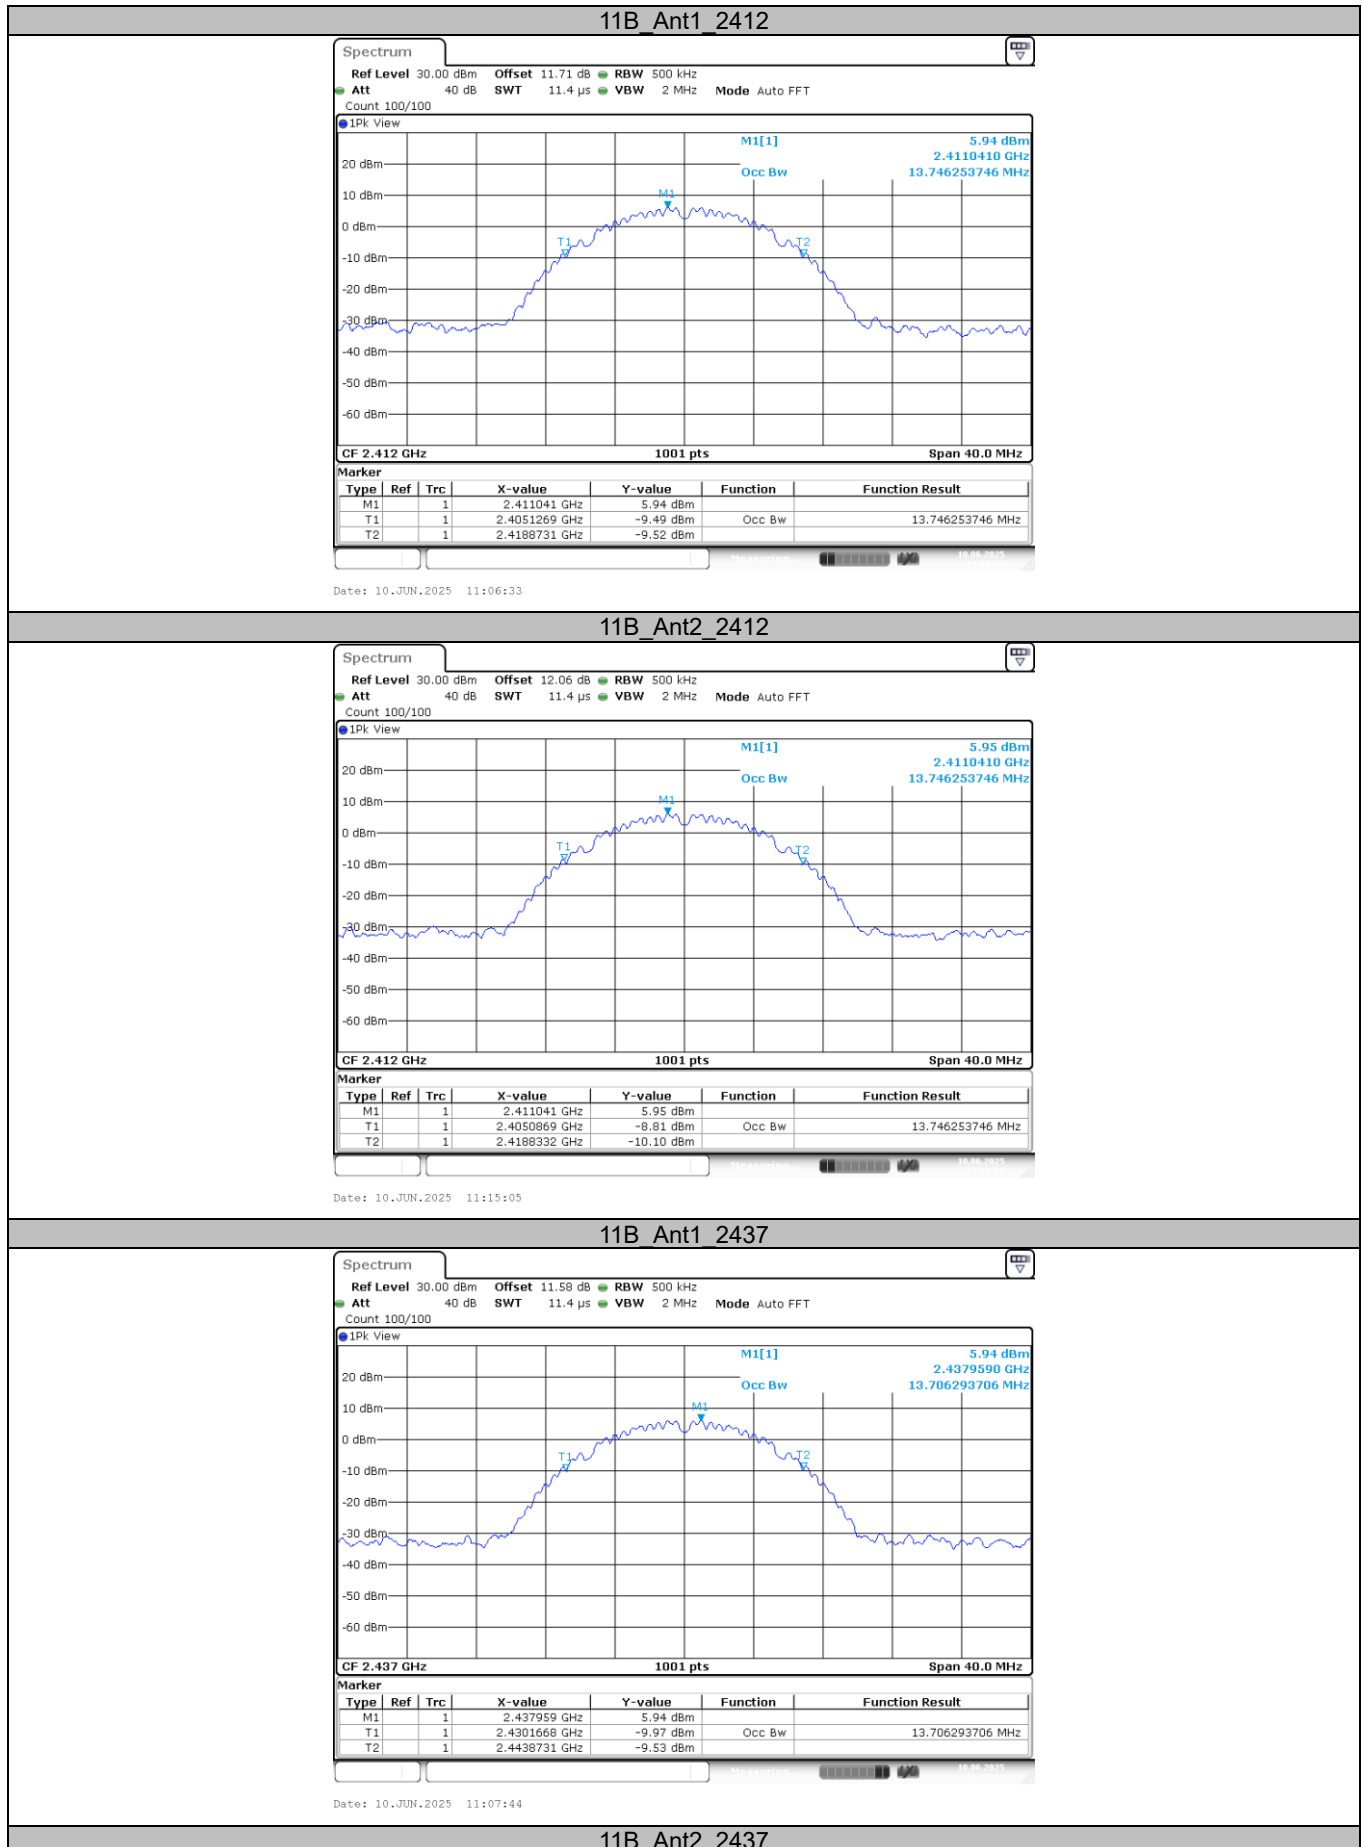
99% Bandwidth:

1. The EUT was directly connected to the spectrum analyzer and antenna output port as show in the block diagram above.
2. DTS Spectrum Setting:
  - (1) Set RBW = 100 kHz.
  - (2) Set the video bandwidth (VBW)  $\geq 3$  RBW.
  - (3) Detector = Peak.
  - (4) Trace mode = Max hold.
  - (5) Sweep = Auto couple.OCB Spectrum Setting:
  - (1) Set RBW = 1% ~ 5% occupied bandwidth.
  - (2) Set the video bandwidth (VBW)  $\geq 3$  RBW.
  - (3) Detector = Peak.
  - (4) Trace mode = Max hold.
  - (5) Sweep = Auto couple.
