## Annex C Photo documentation

Appendix to Test Report No.: 1-6965/13-16-02

#### **CETECOM ICT Services GmbH**

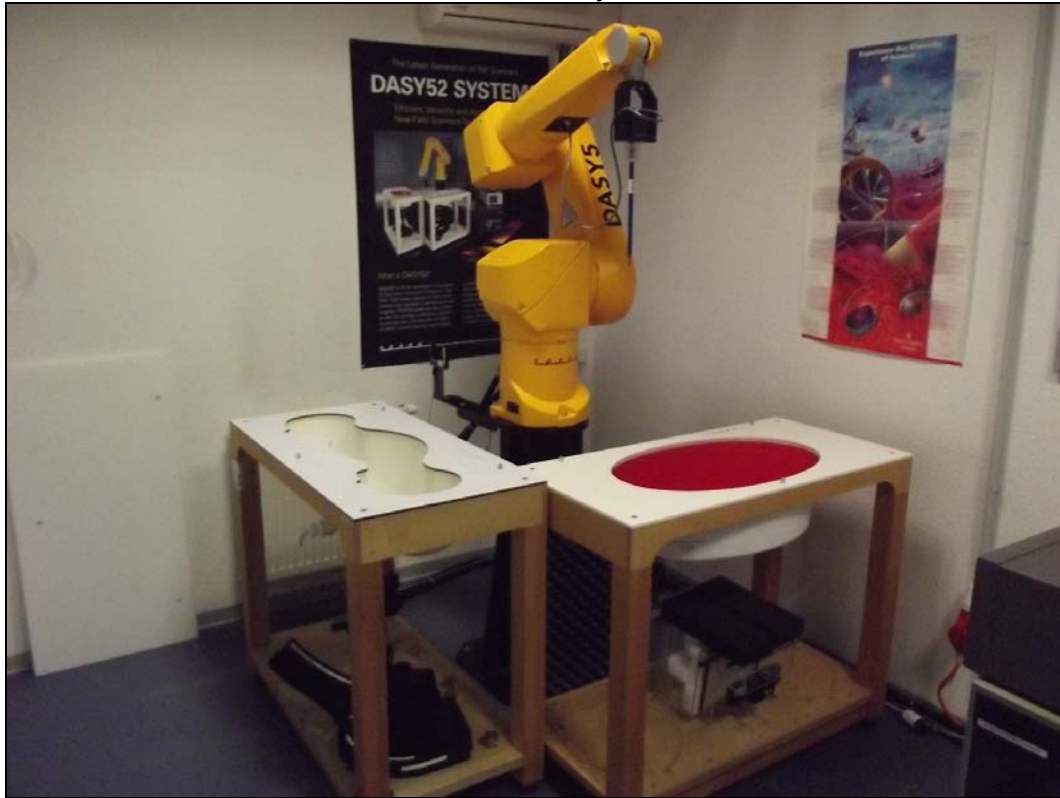
Photo 1: Measurement System DASY 5

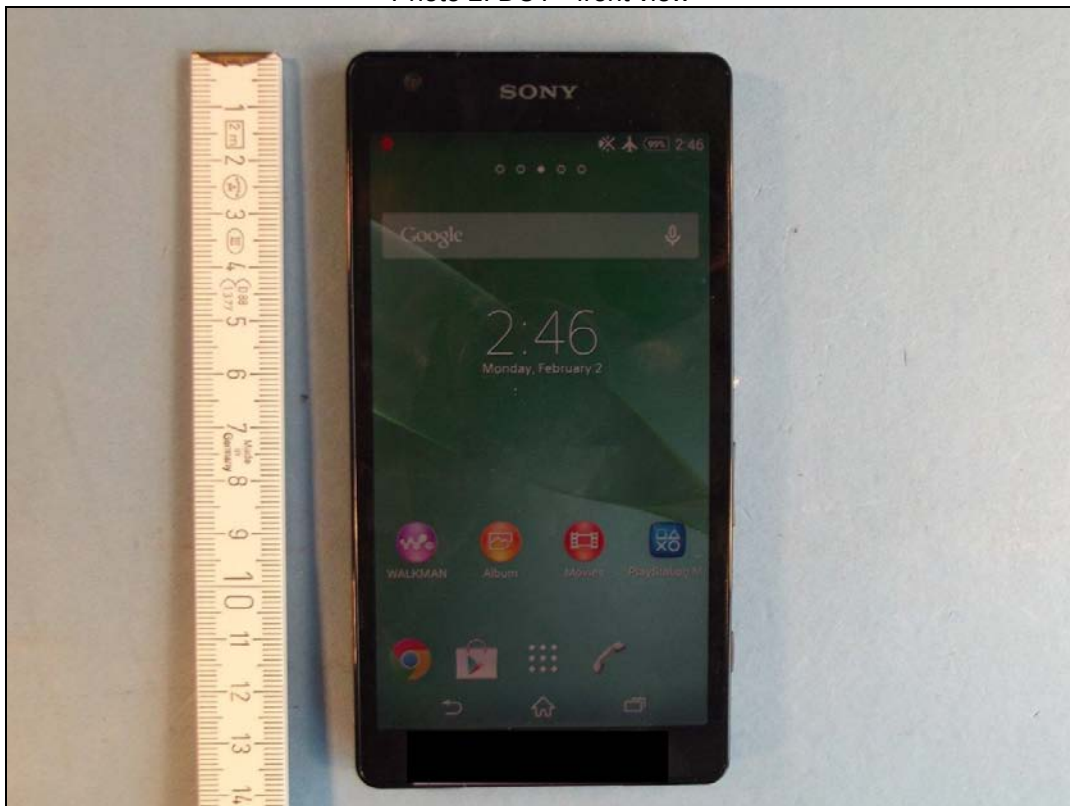
Photo 2: DUT - front view

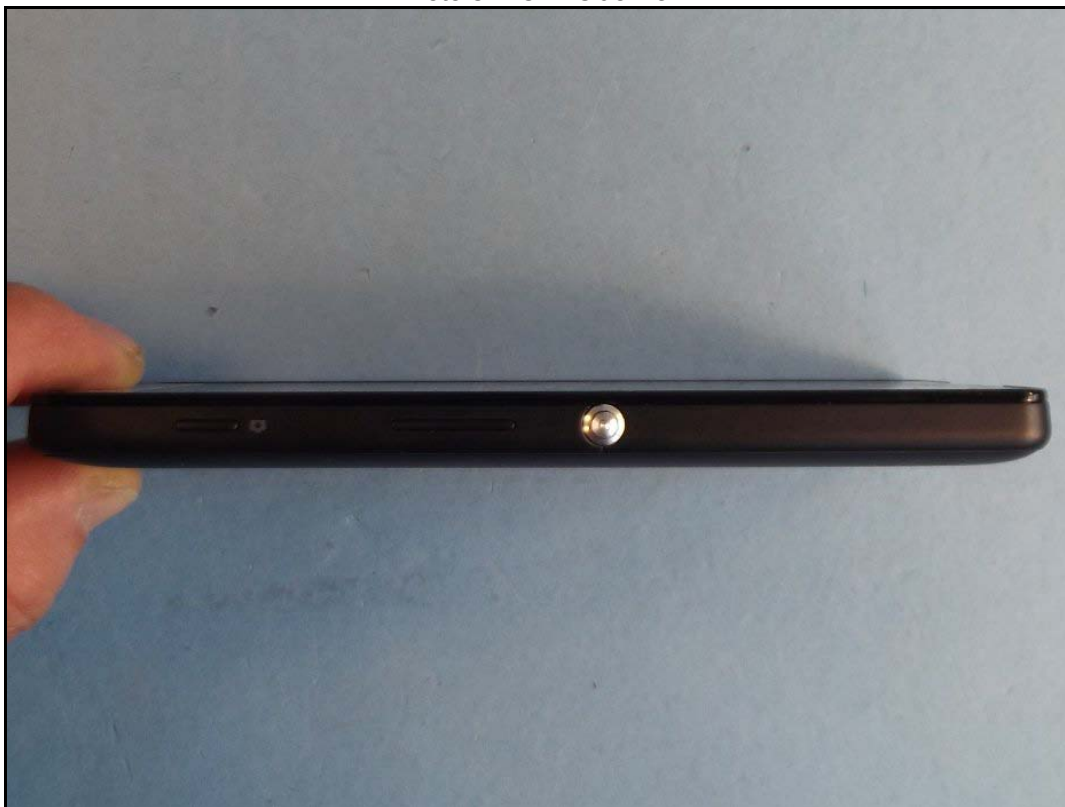
Photo 3: DUT - side view

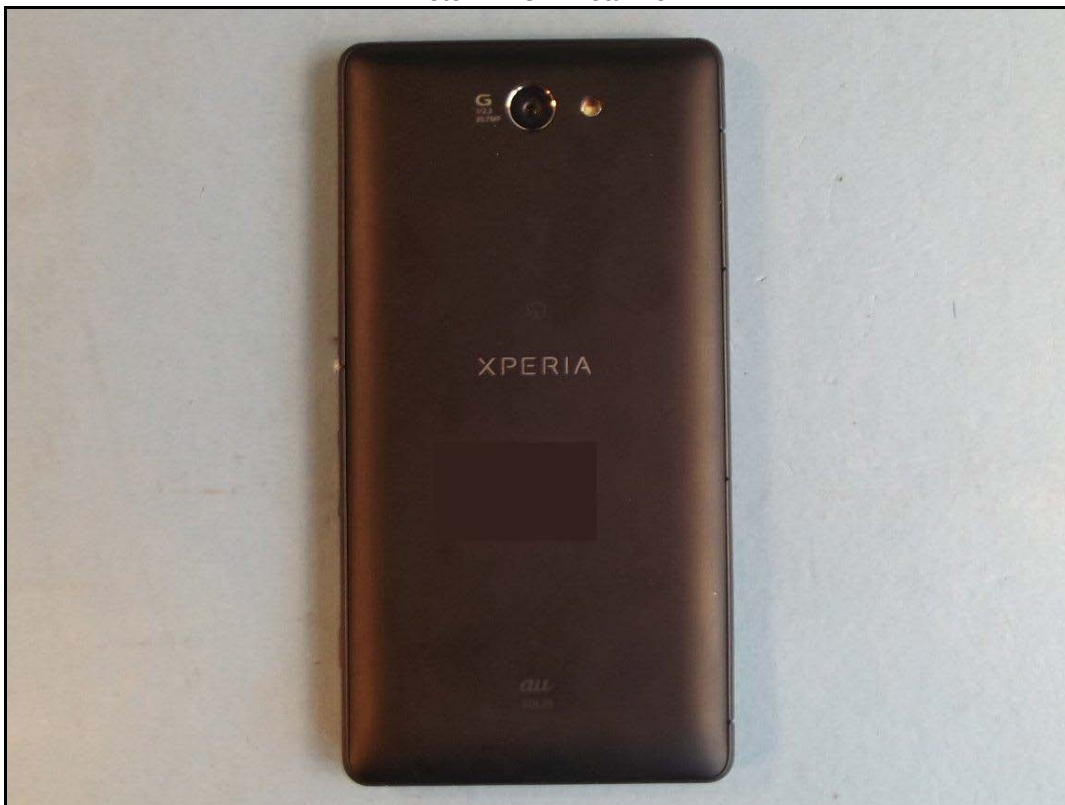
Photo 4: DUT - rear view

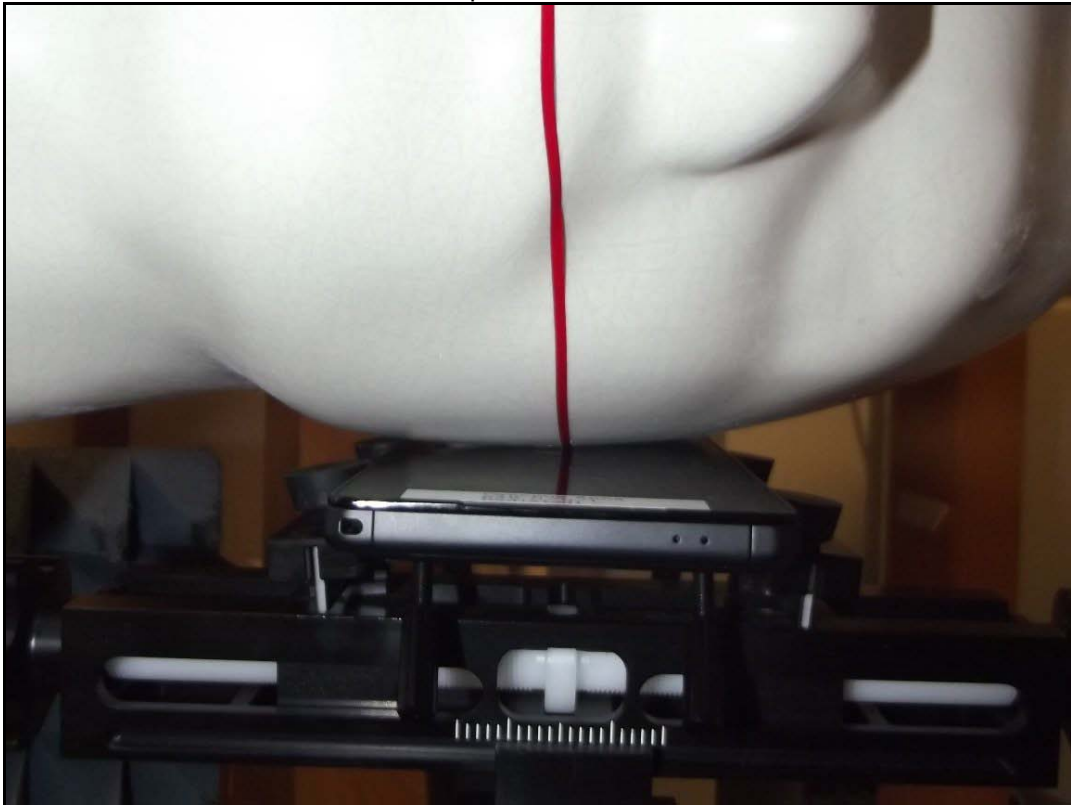
Photo 5: Test position left hand touched

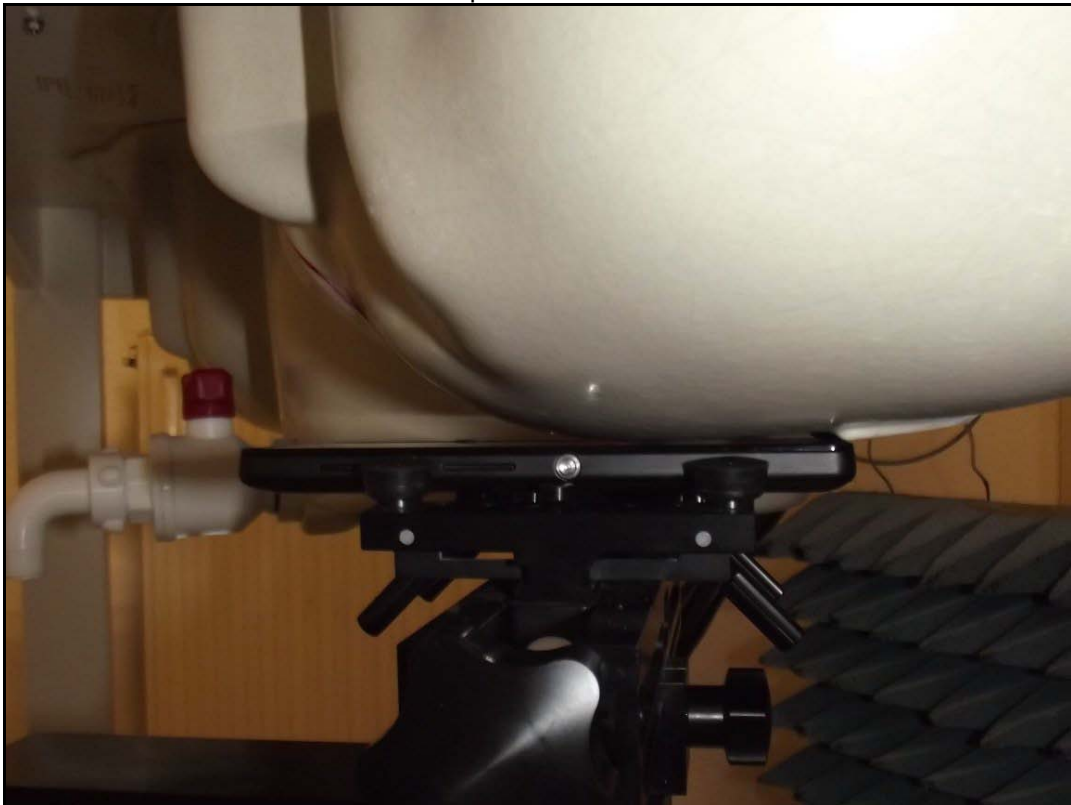
Photo 6: Test position left hand touched

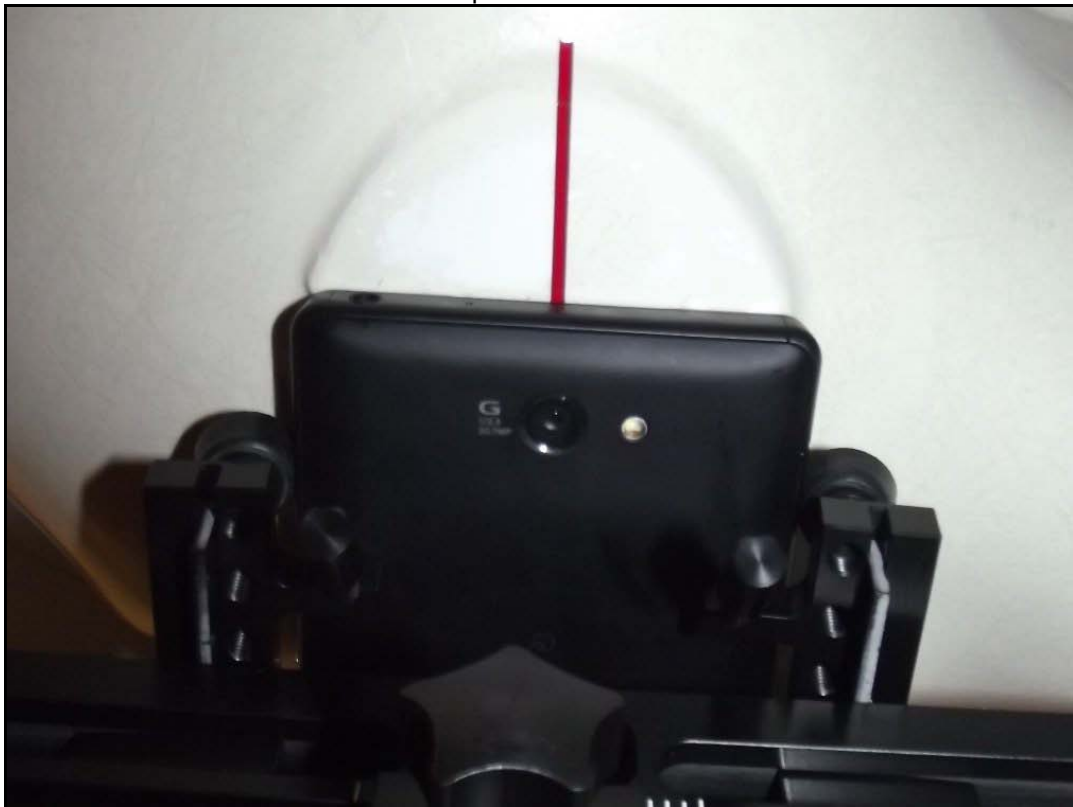
Photo 7: Test position left hand touched

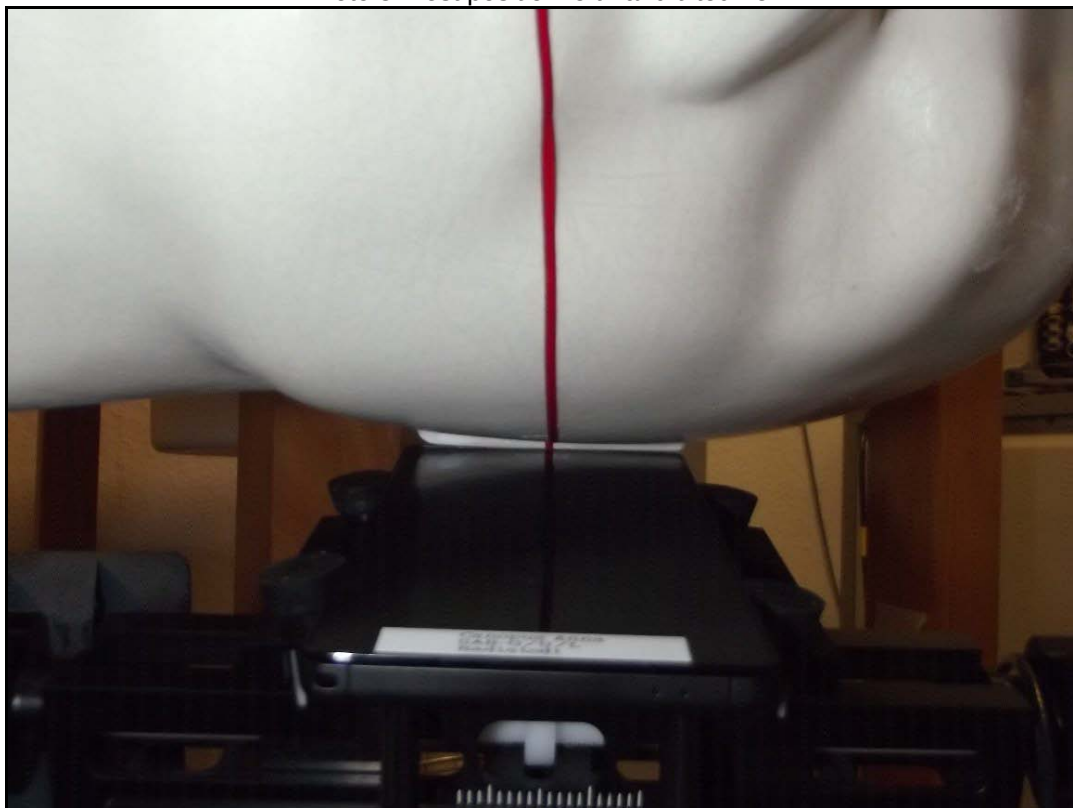
Photo 8: Test position left hand tilted 15°

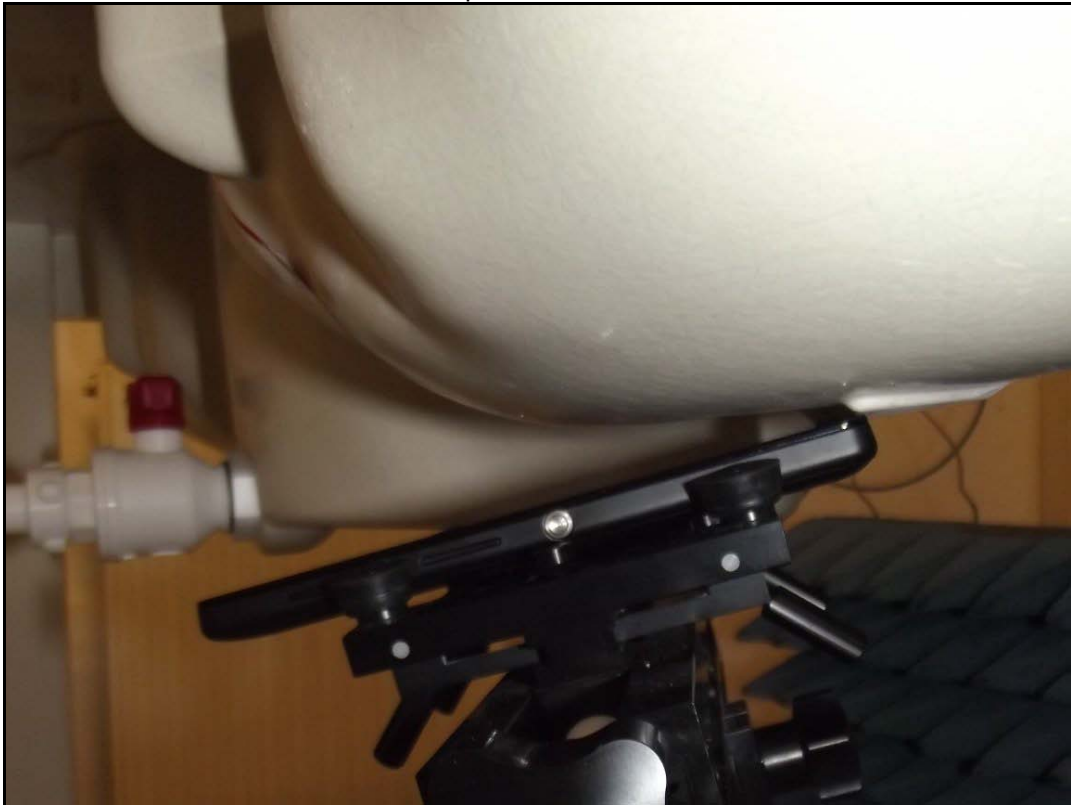
Photo 9: Test position left hand tilted 15°

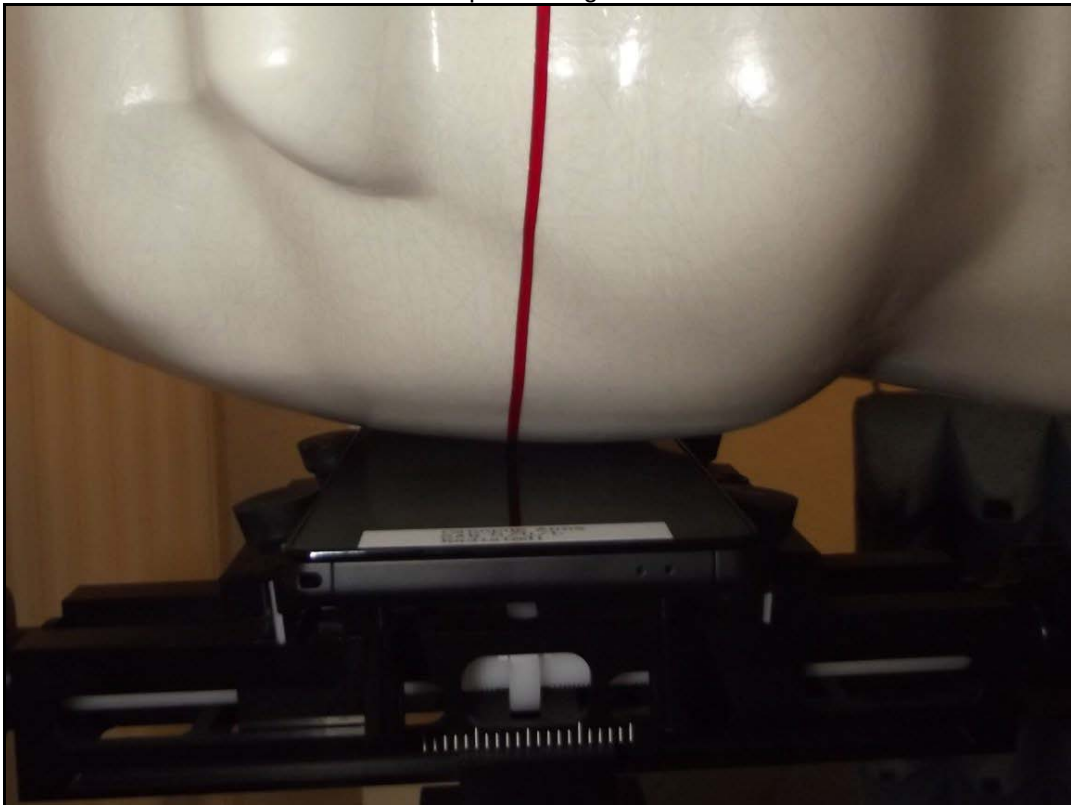
Photo 10: Test position right hand touched

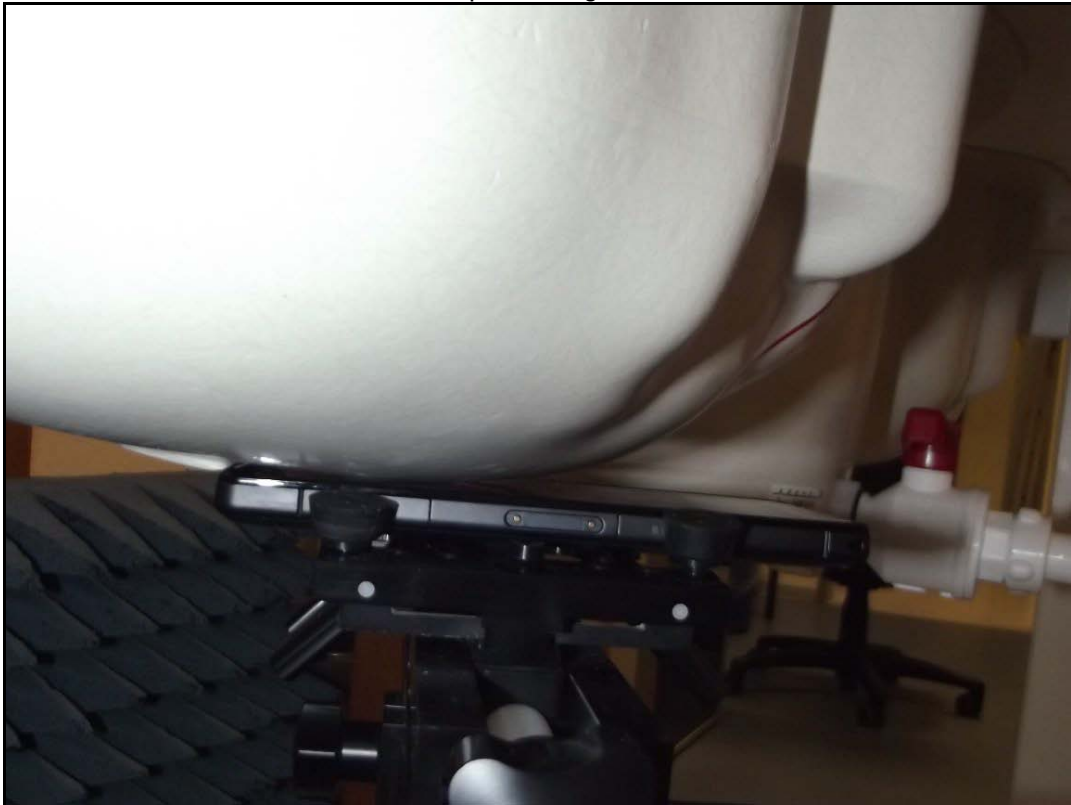
Photo 11: Test position right hand touched

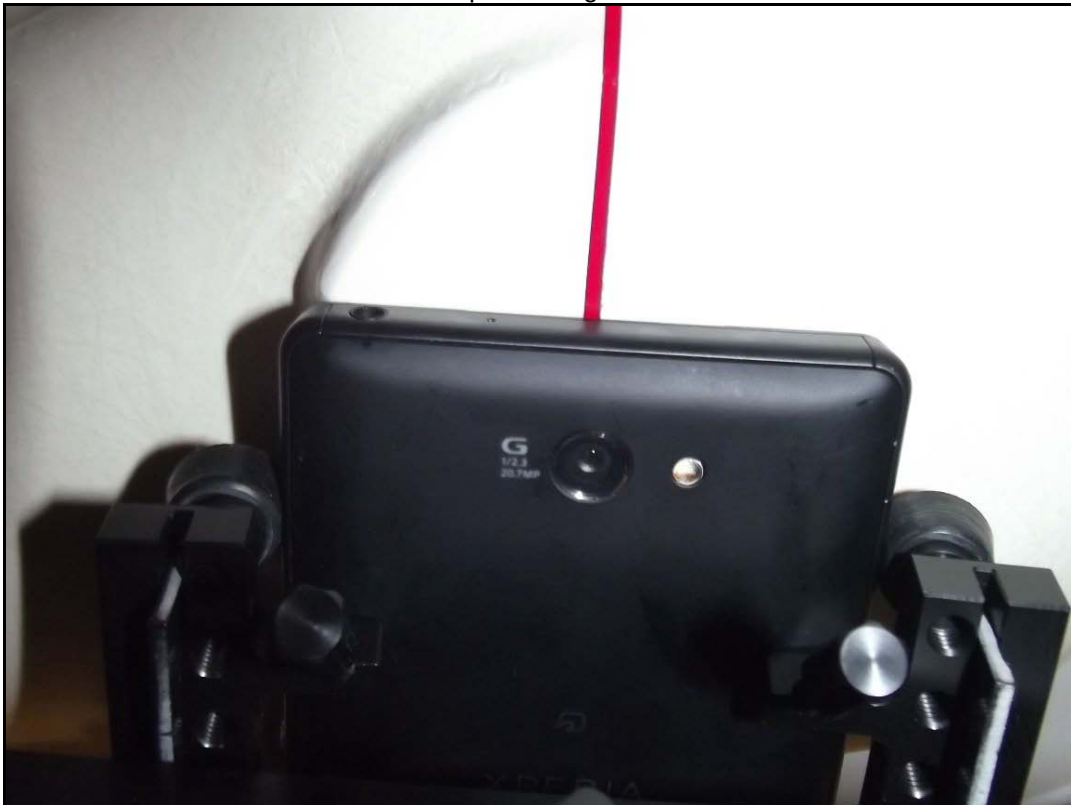
Photo 12: Test position right hand touched

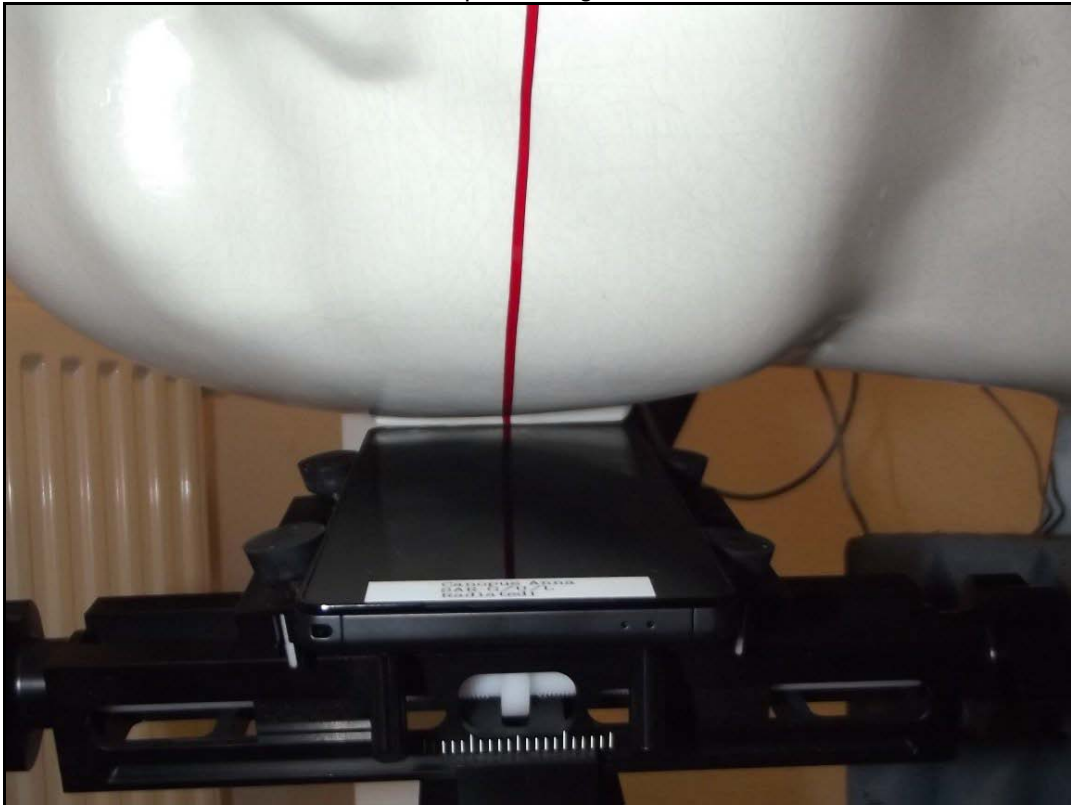
Photo 13: Test position right hand tilted 15°

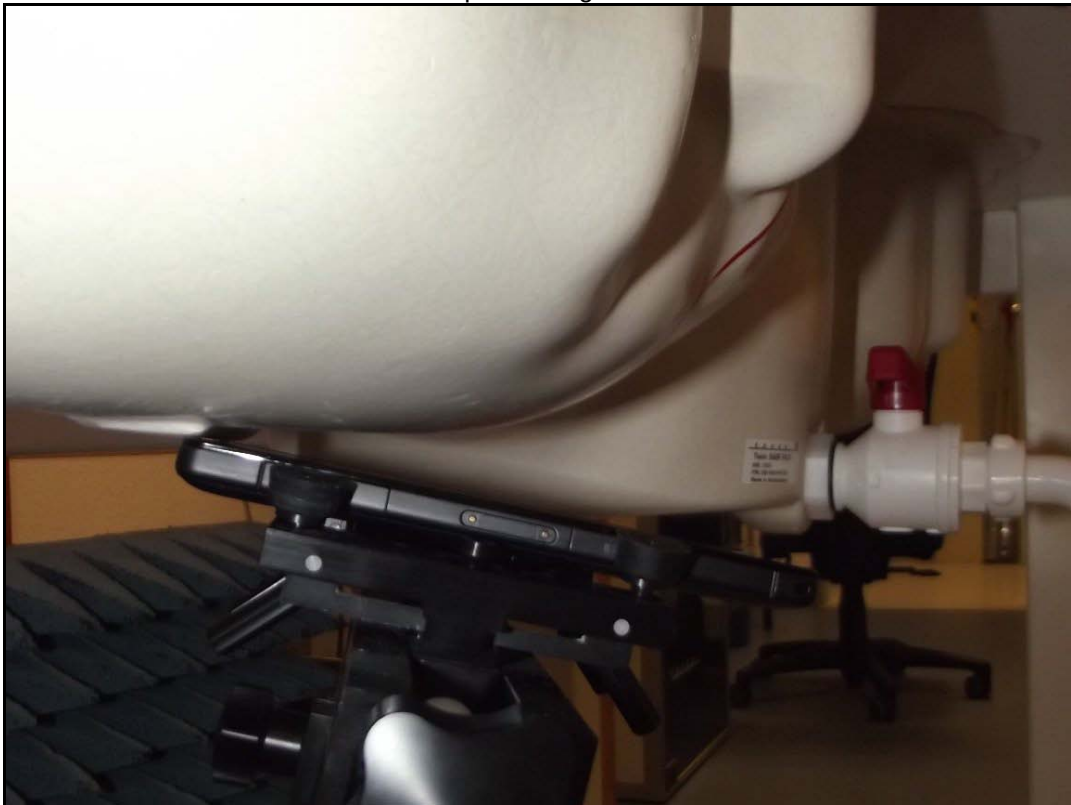
Photo 14: Test position right hand tilted 15°

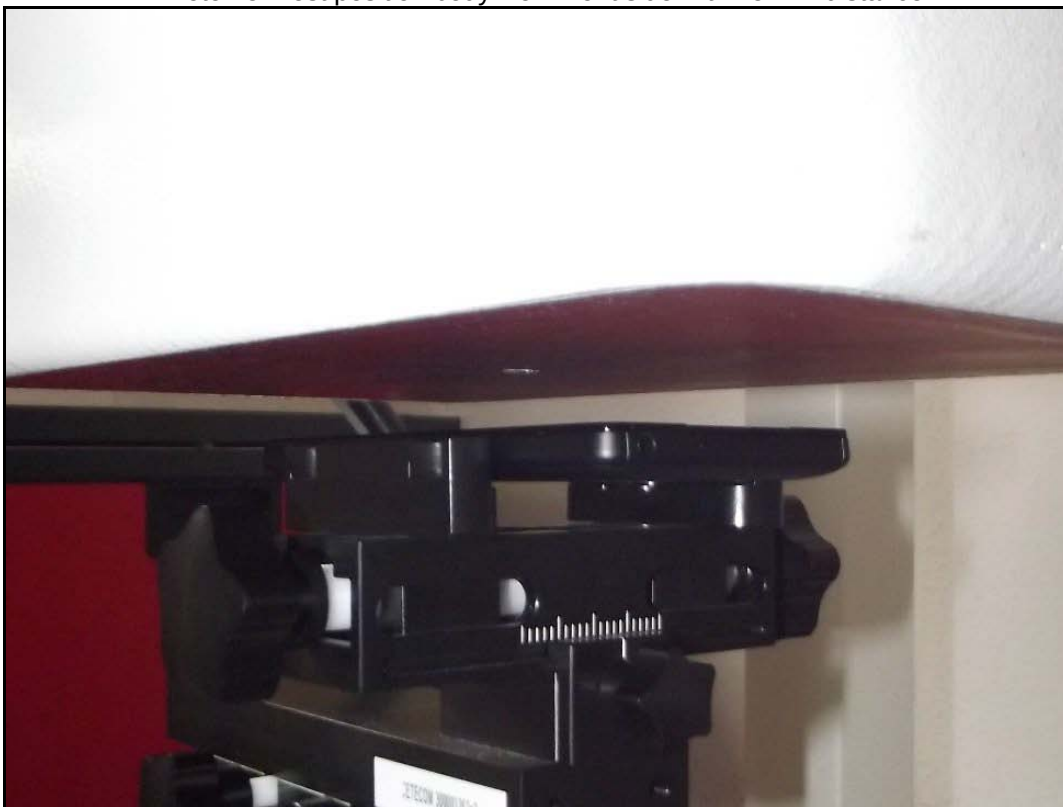
Photo 15: Test position body worn front side with 15 mm distance

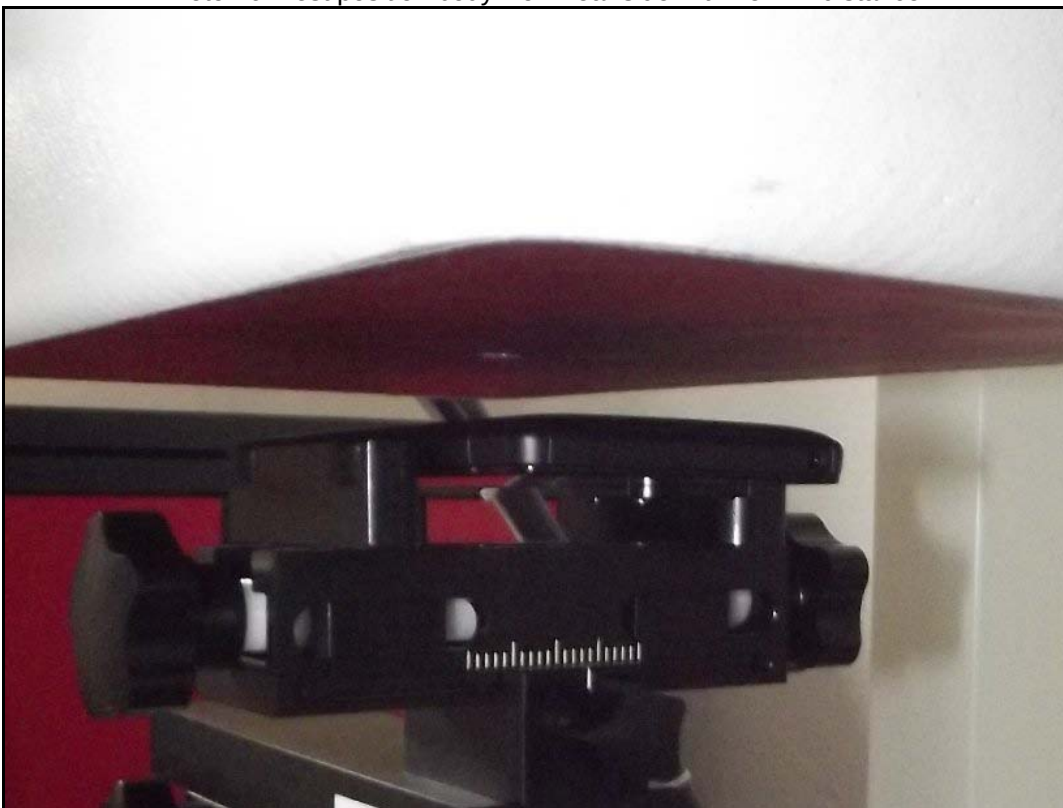
Photo 16: Test position body worn rear side with 15 mm distance

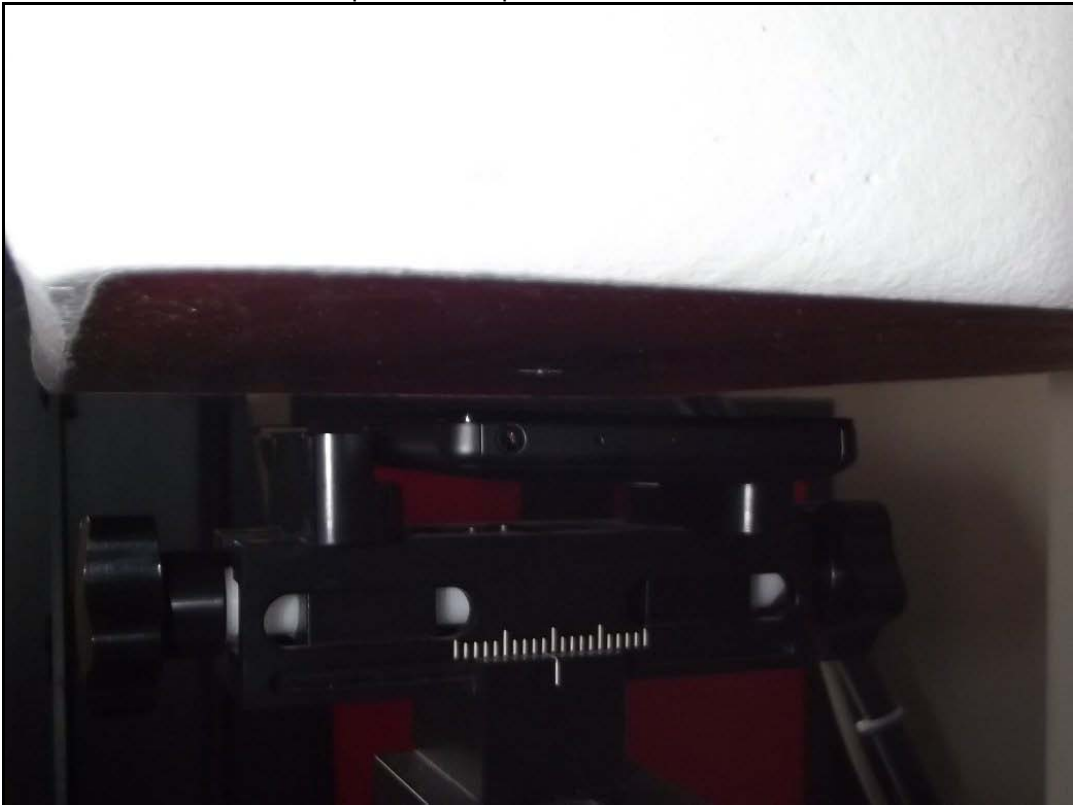
Photo 17: Test position hotspot front side with 10 mm distance

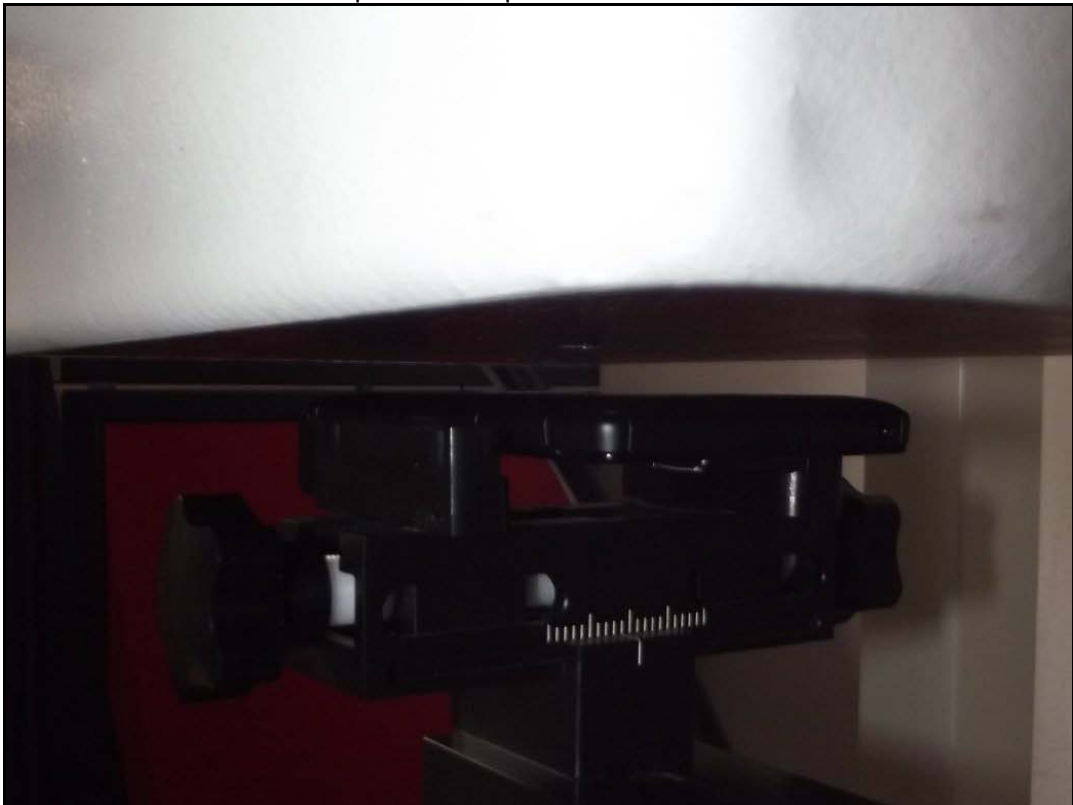
Photo 18: Test position hotspot rear side with 10 mm distance

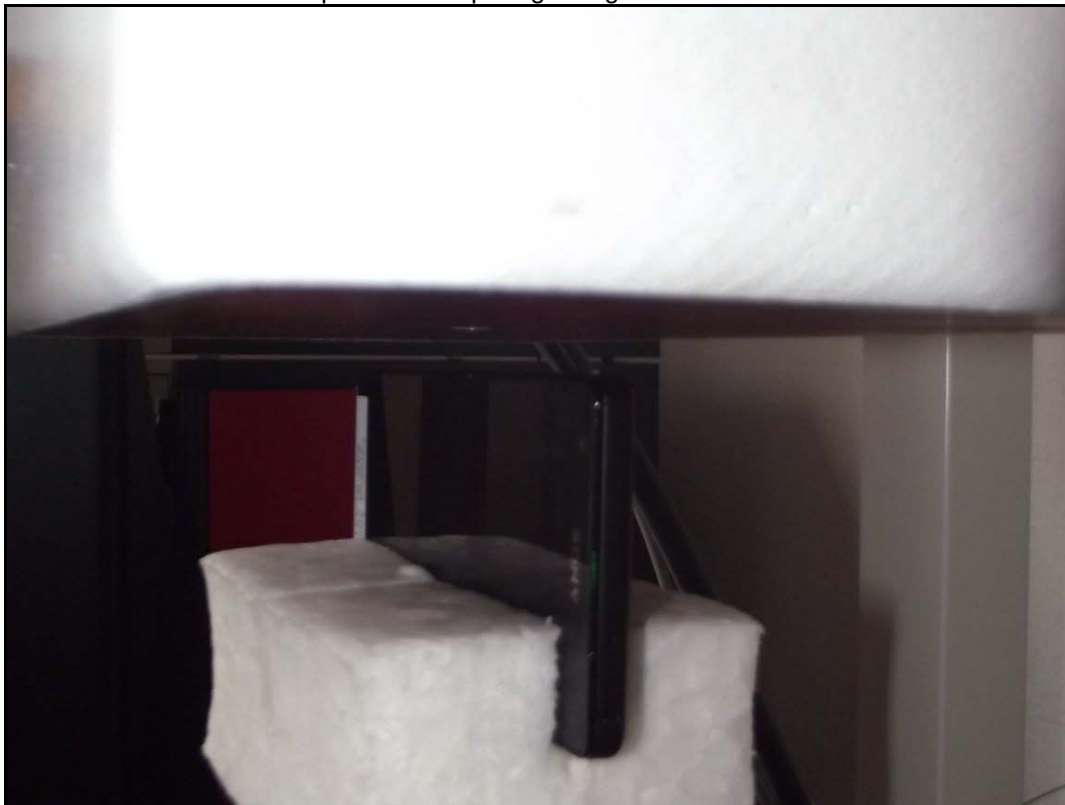
Photo 19: Test position hotspot right edge side with 10 mm distance

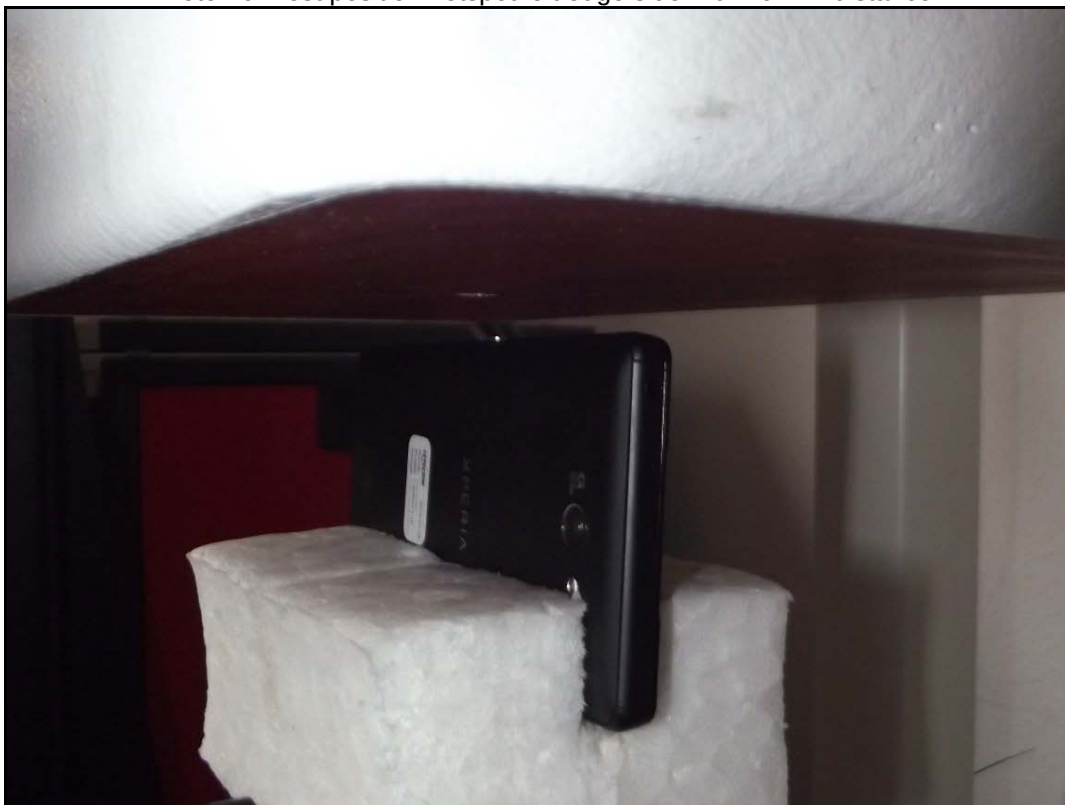
Photo 20: Test position hotspot left edge side with 10 mm distance

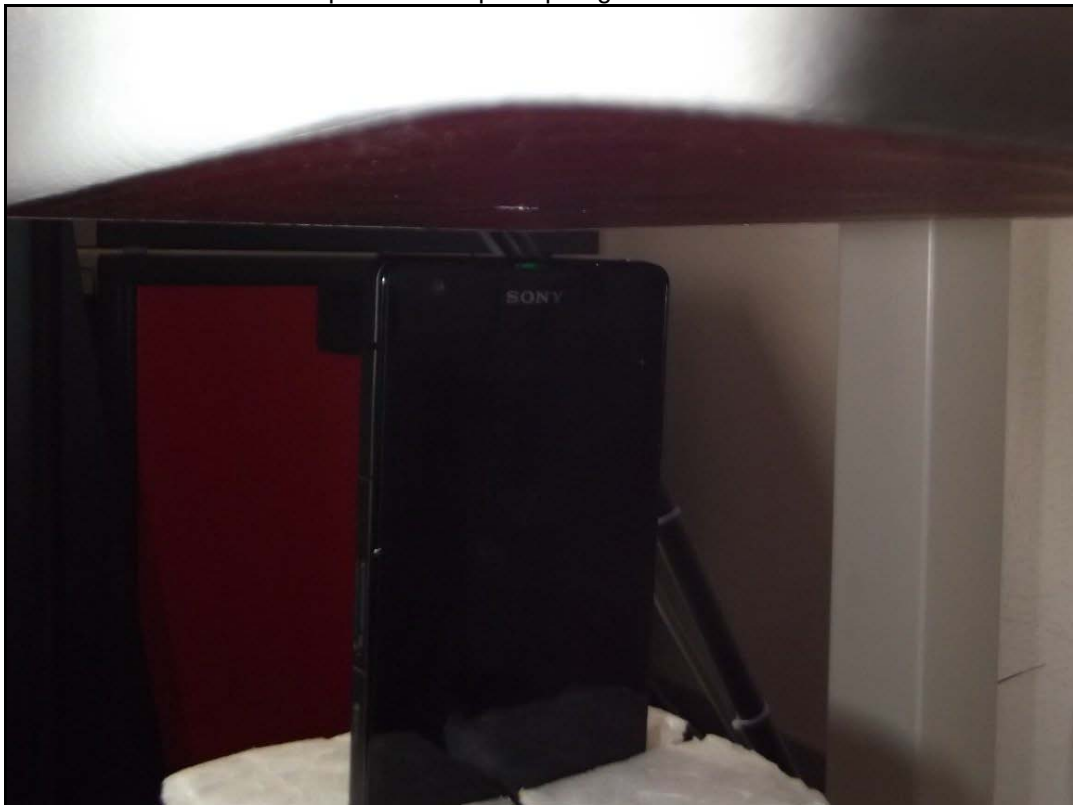
Photo 21: Test position hotspot top edge side with 10 mm distance

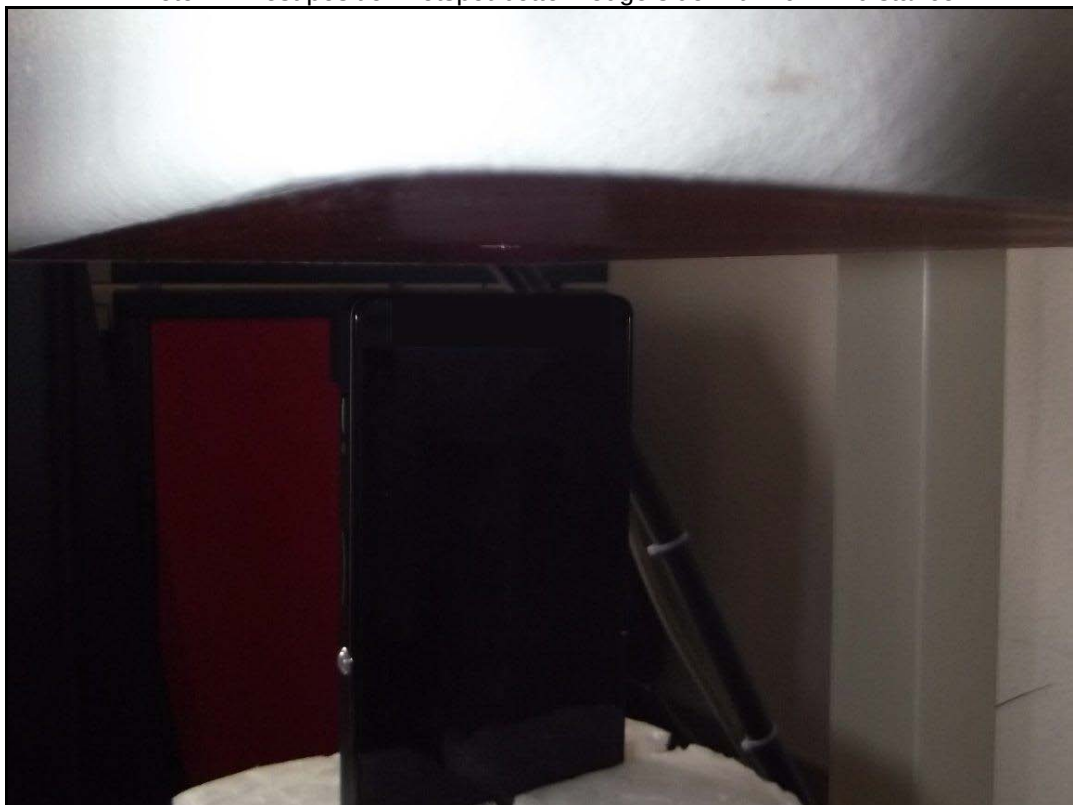
Photo 22: Test position hotspot bottom edge side with 10 mm distance

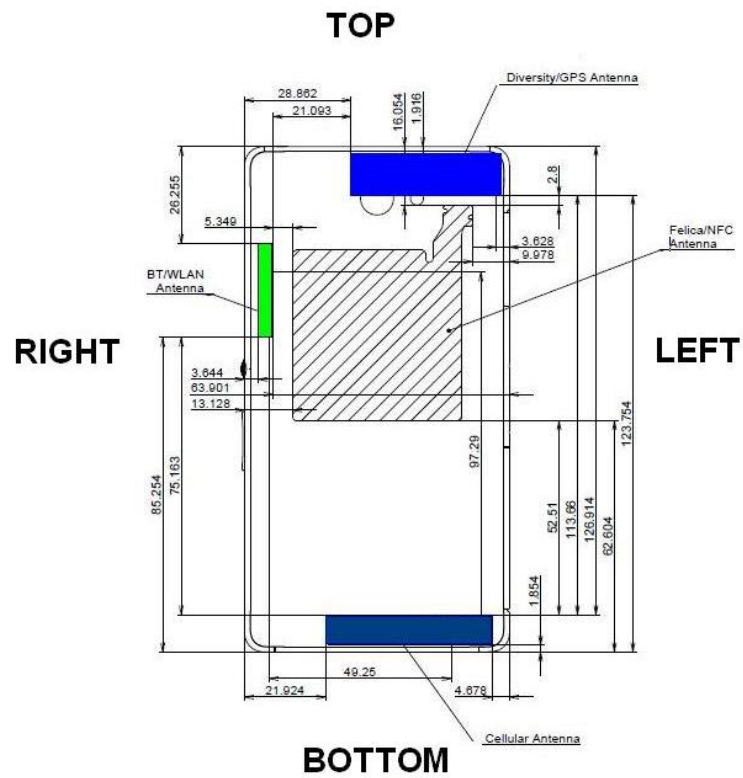
Photo 23: Antenna dimensions and separation distances
