# H3 V7A Antenna Return Loss & Radiation Pattern Test Report

MICROLINK

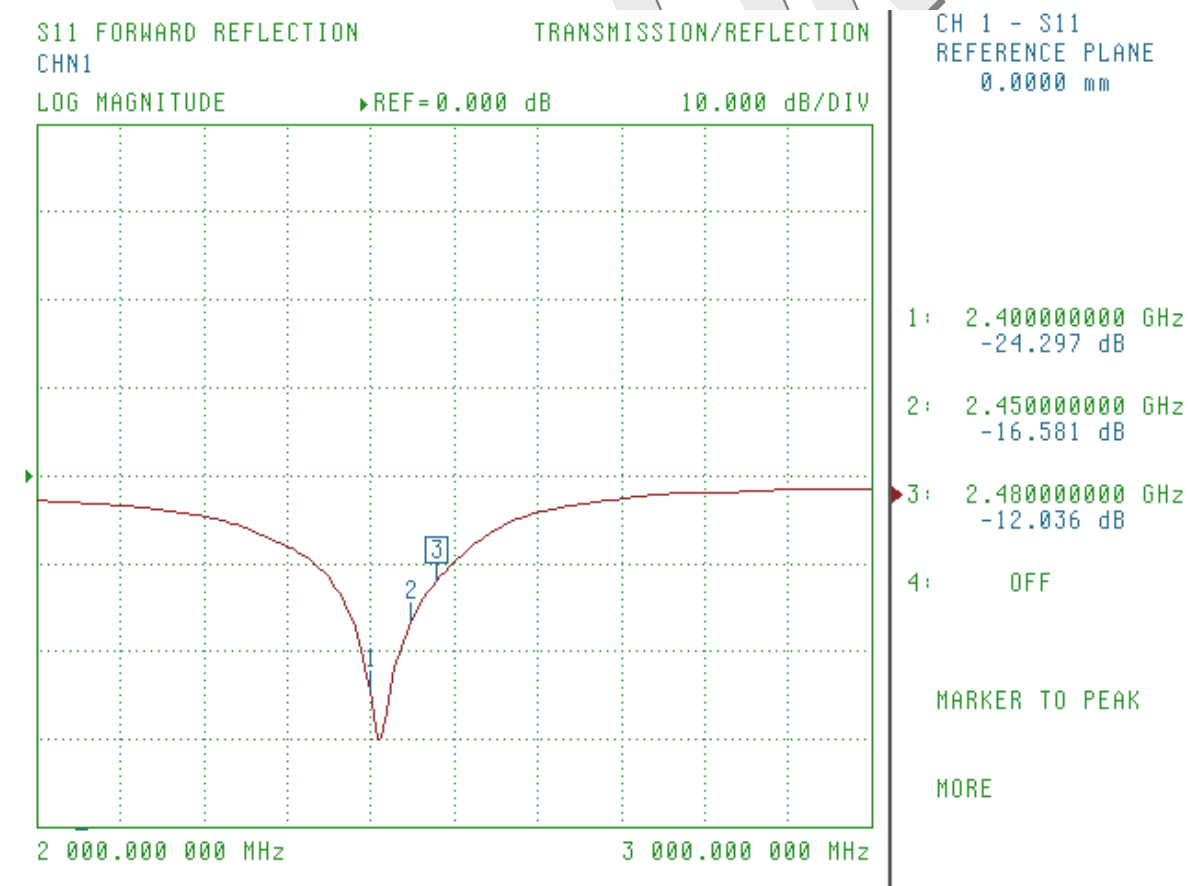
#### 1.2.1 Return Loss

### 1.2 Sample A Return Loss and Radiation Pattern

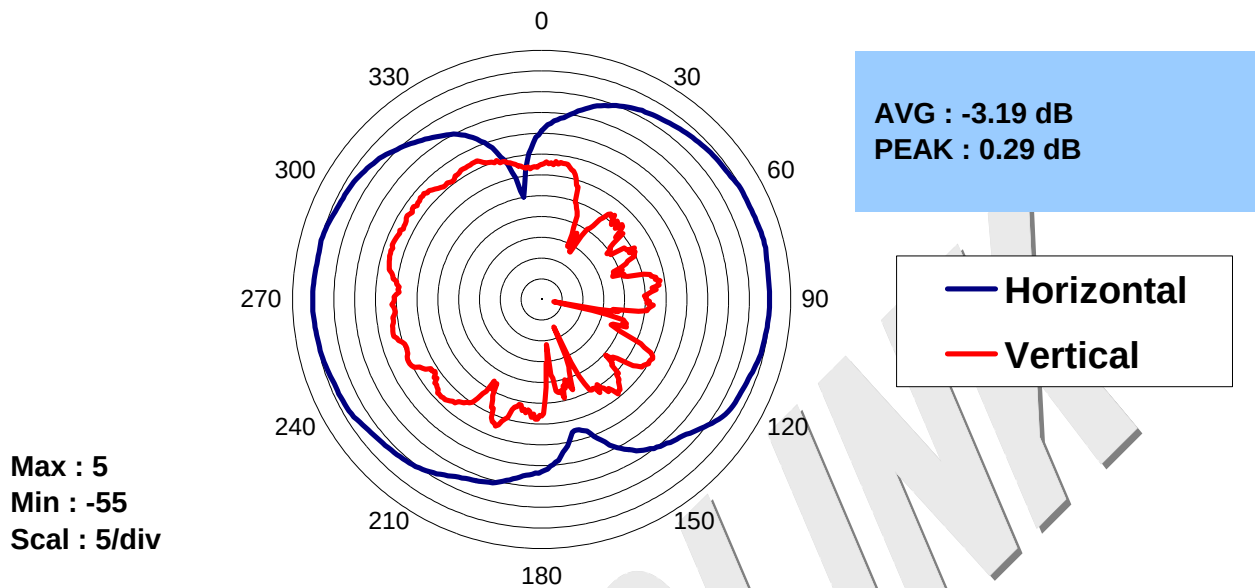
### Antenna Radiation Pattern - XY (Meander Line Type)

## 1.2.2 Free Space Radiation Pattern

| Plane | | |
|---|---|---|
| XY | 0.29 | -3.19 |
