Appendix D: Maximum power spectral density  
Test Result

## Appendix E: Reference level measurement Test Result

## Appendix F: Band edge measurements

## Appendix G: Conducted Spurious Emission Test Result

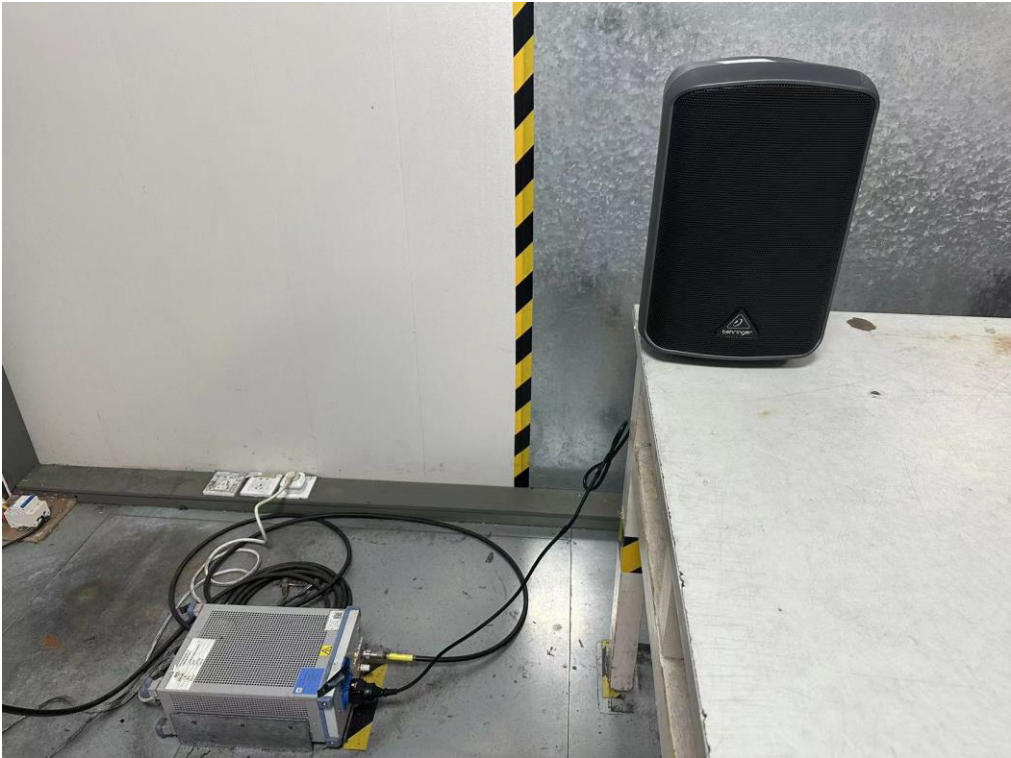
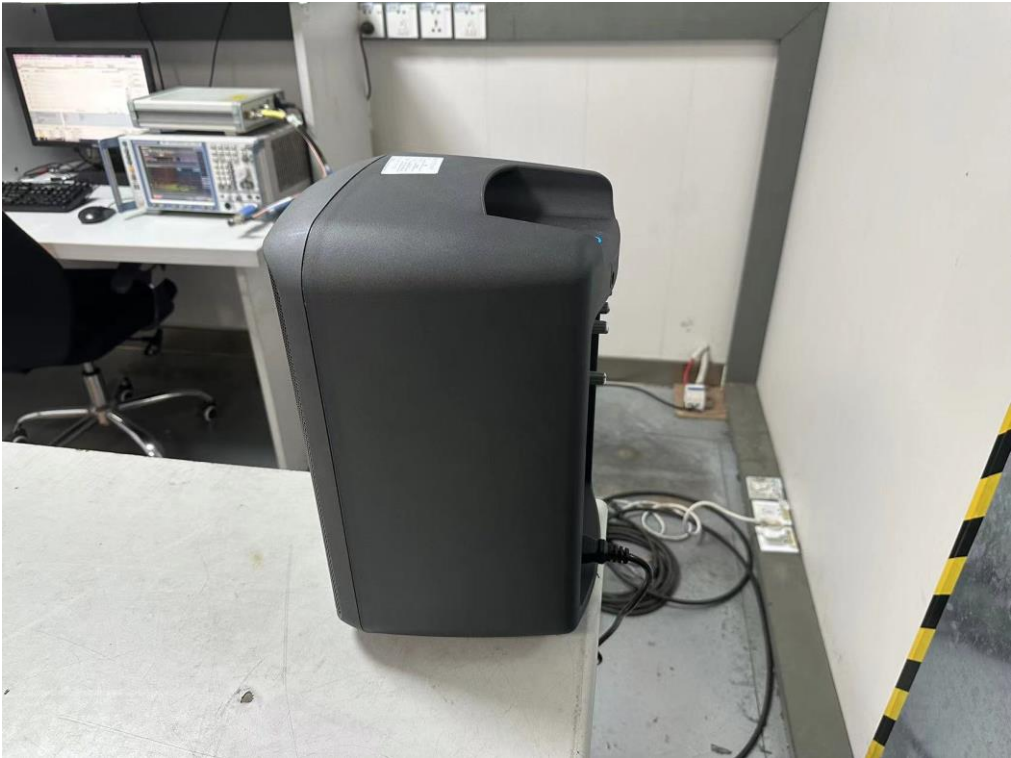
Conducted Test

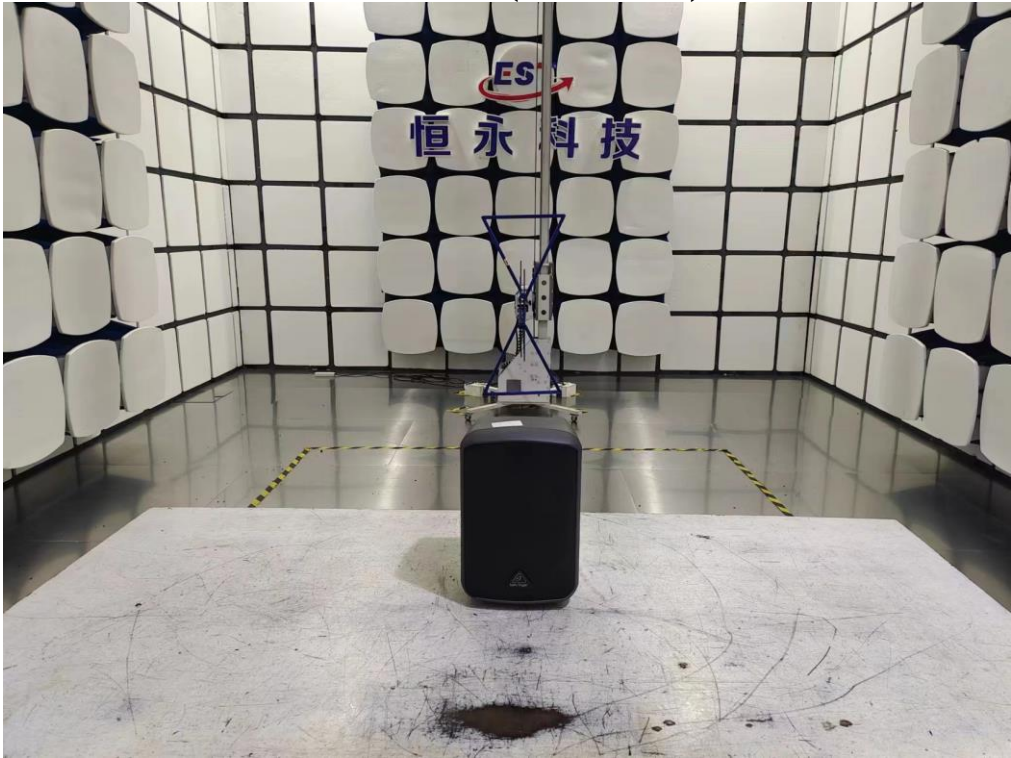
Radiated Test (Below 1GHz)

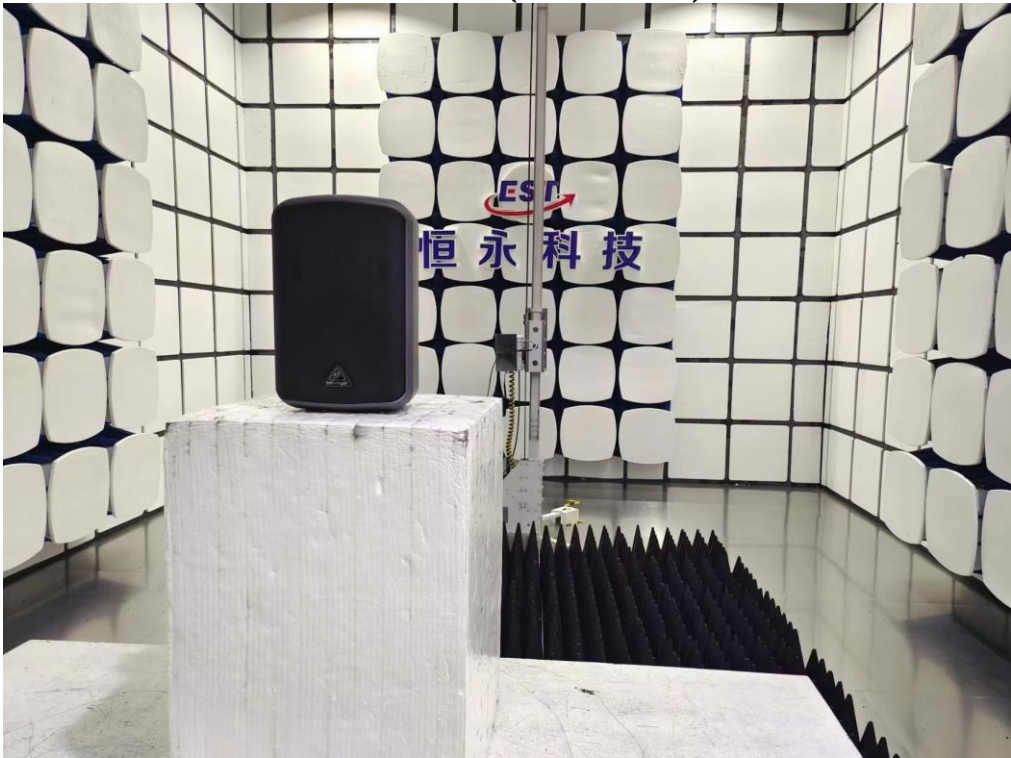
Radiated Test (Above 1GHz)
