**Prüfbericht - Nr.: 16005756 001**  
*Test Report No.:*

## 6 Photographs of the Test Set-Up

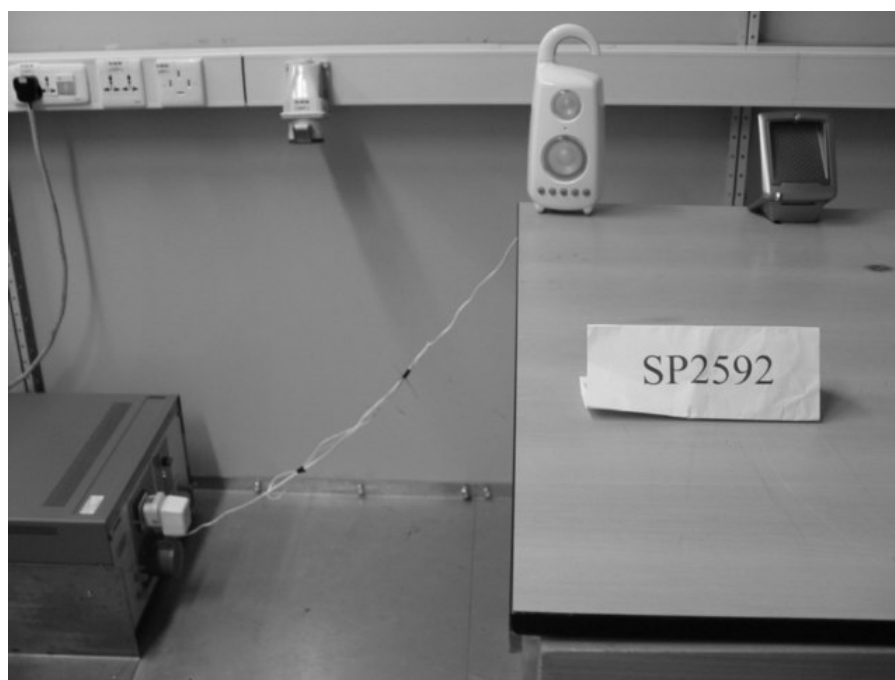
**Photograph 1: Set up for Conducted Emission on AC Mains**

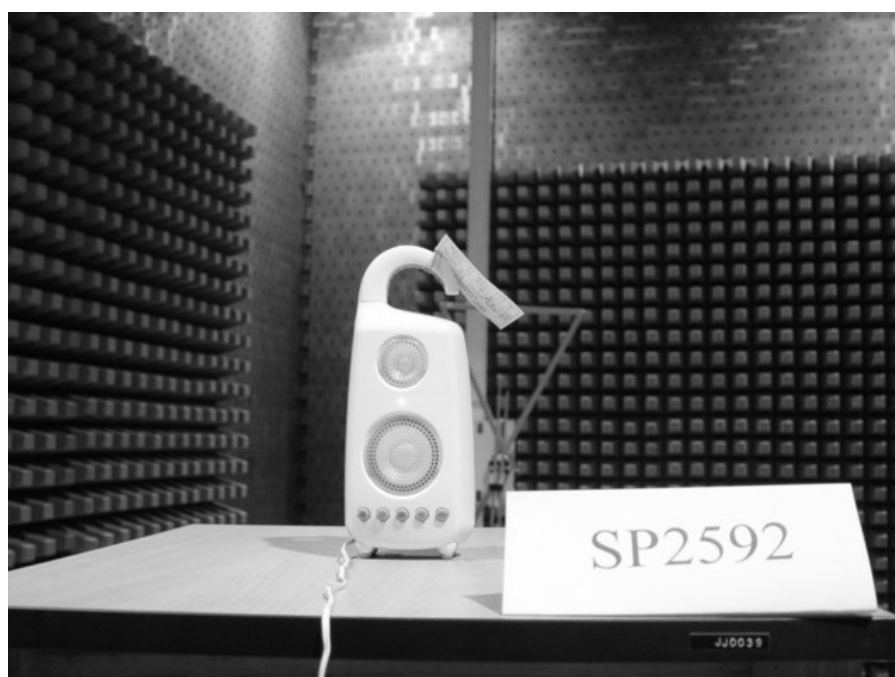
**Photograph 2: Set-up for Radiation Measurement Below 1GHz**

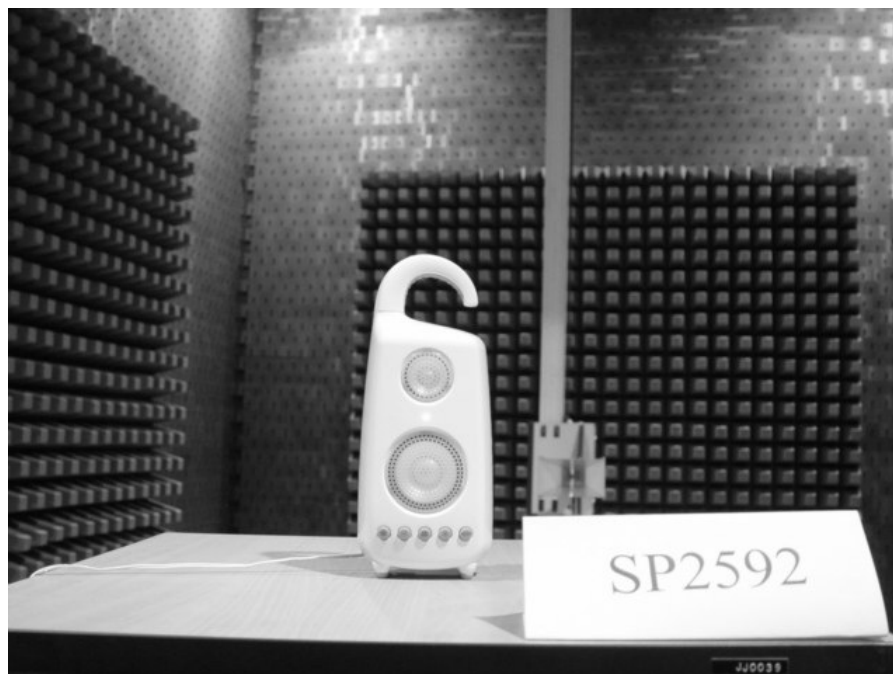
**Photograph 3: Set-up for Radiation Measurement Above 1GHz**
