# MPG2

KICKER MultiPro™ Tailgate  
Audio System

For 2019 & newer GMC Sierra 1500

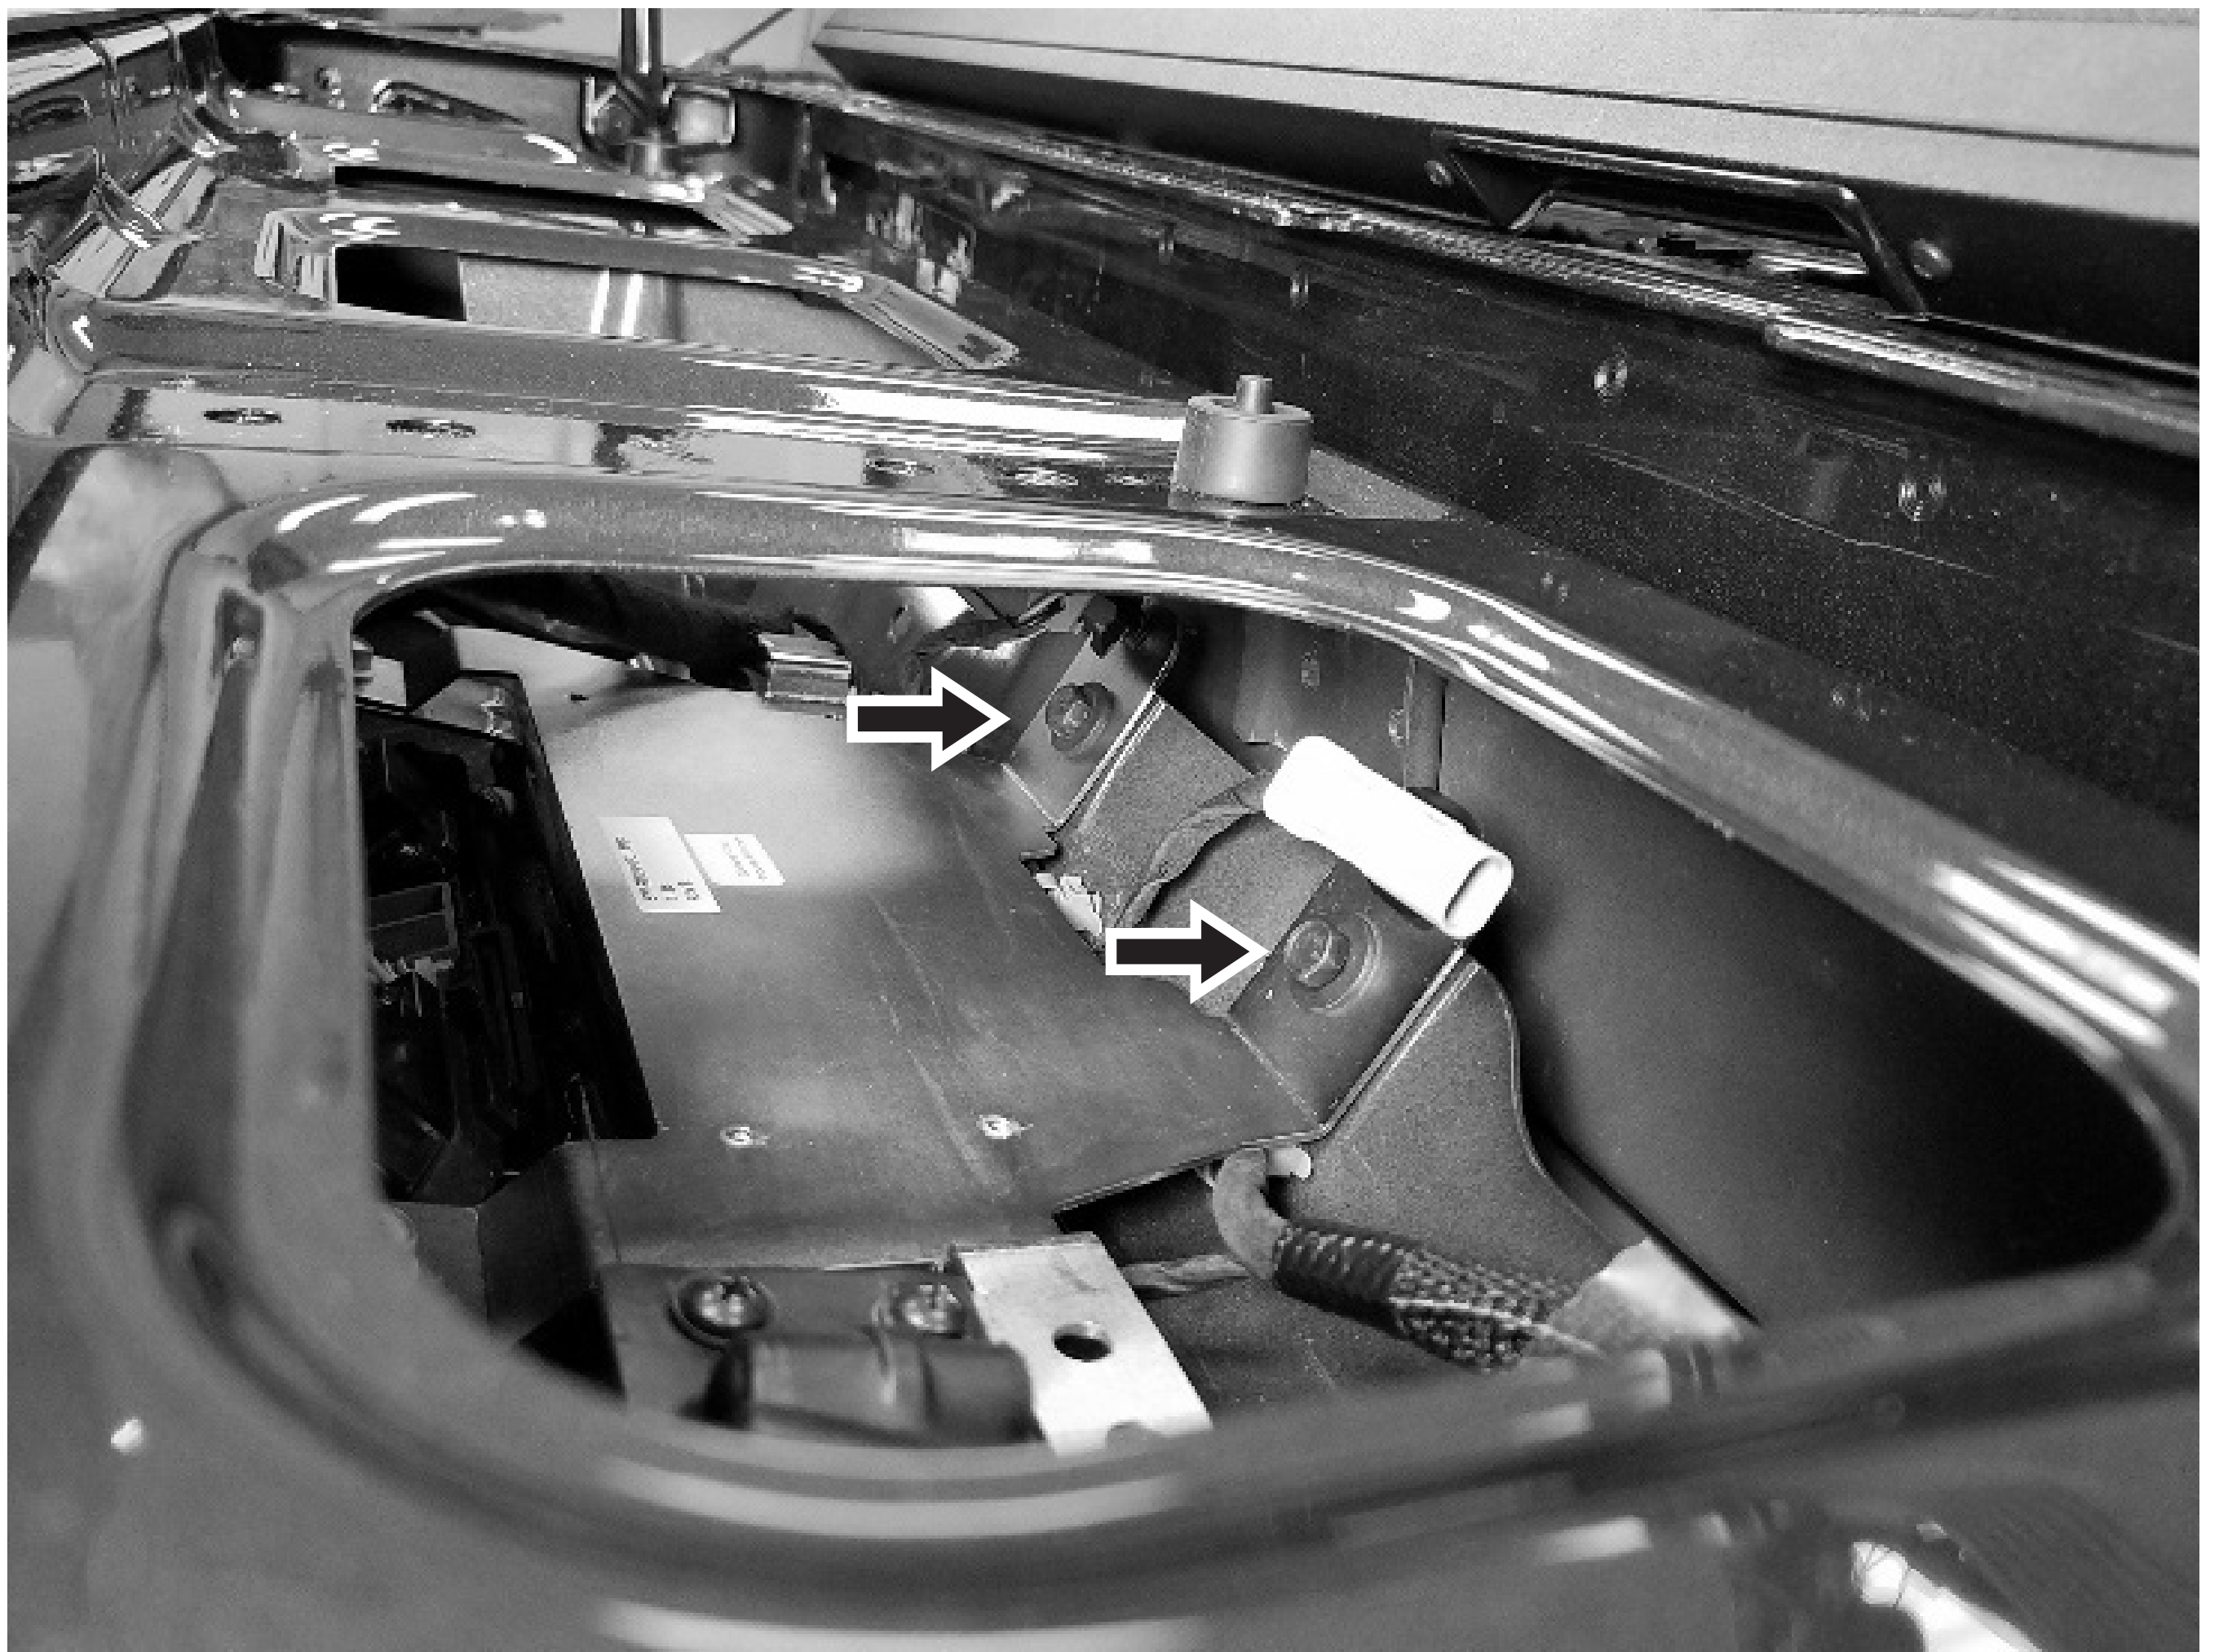
7. Install the amplifier mounting bracket through the right-of-center hole and secure with the tailgate handle bolts and the two supplied bolts.

8. Re-attach the wire retainers to the amplifier bracket.

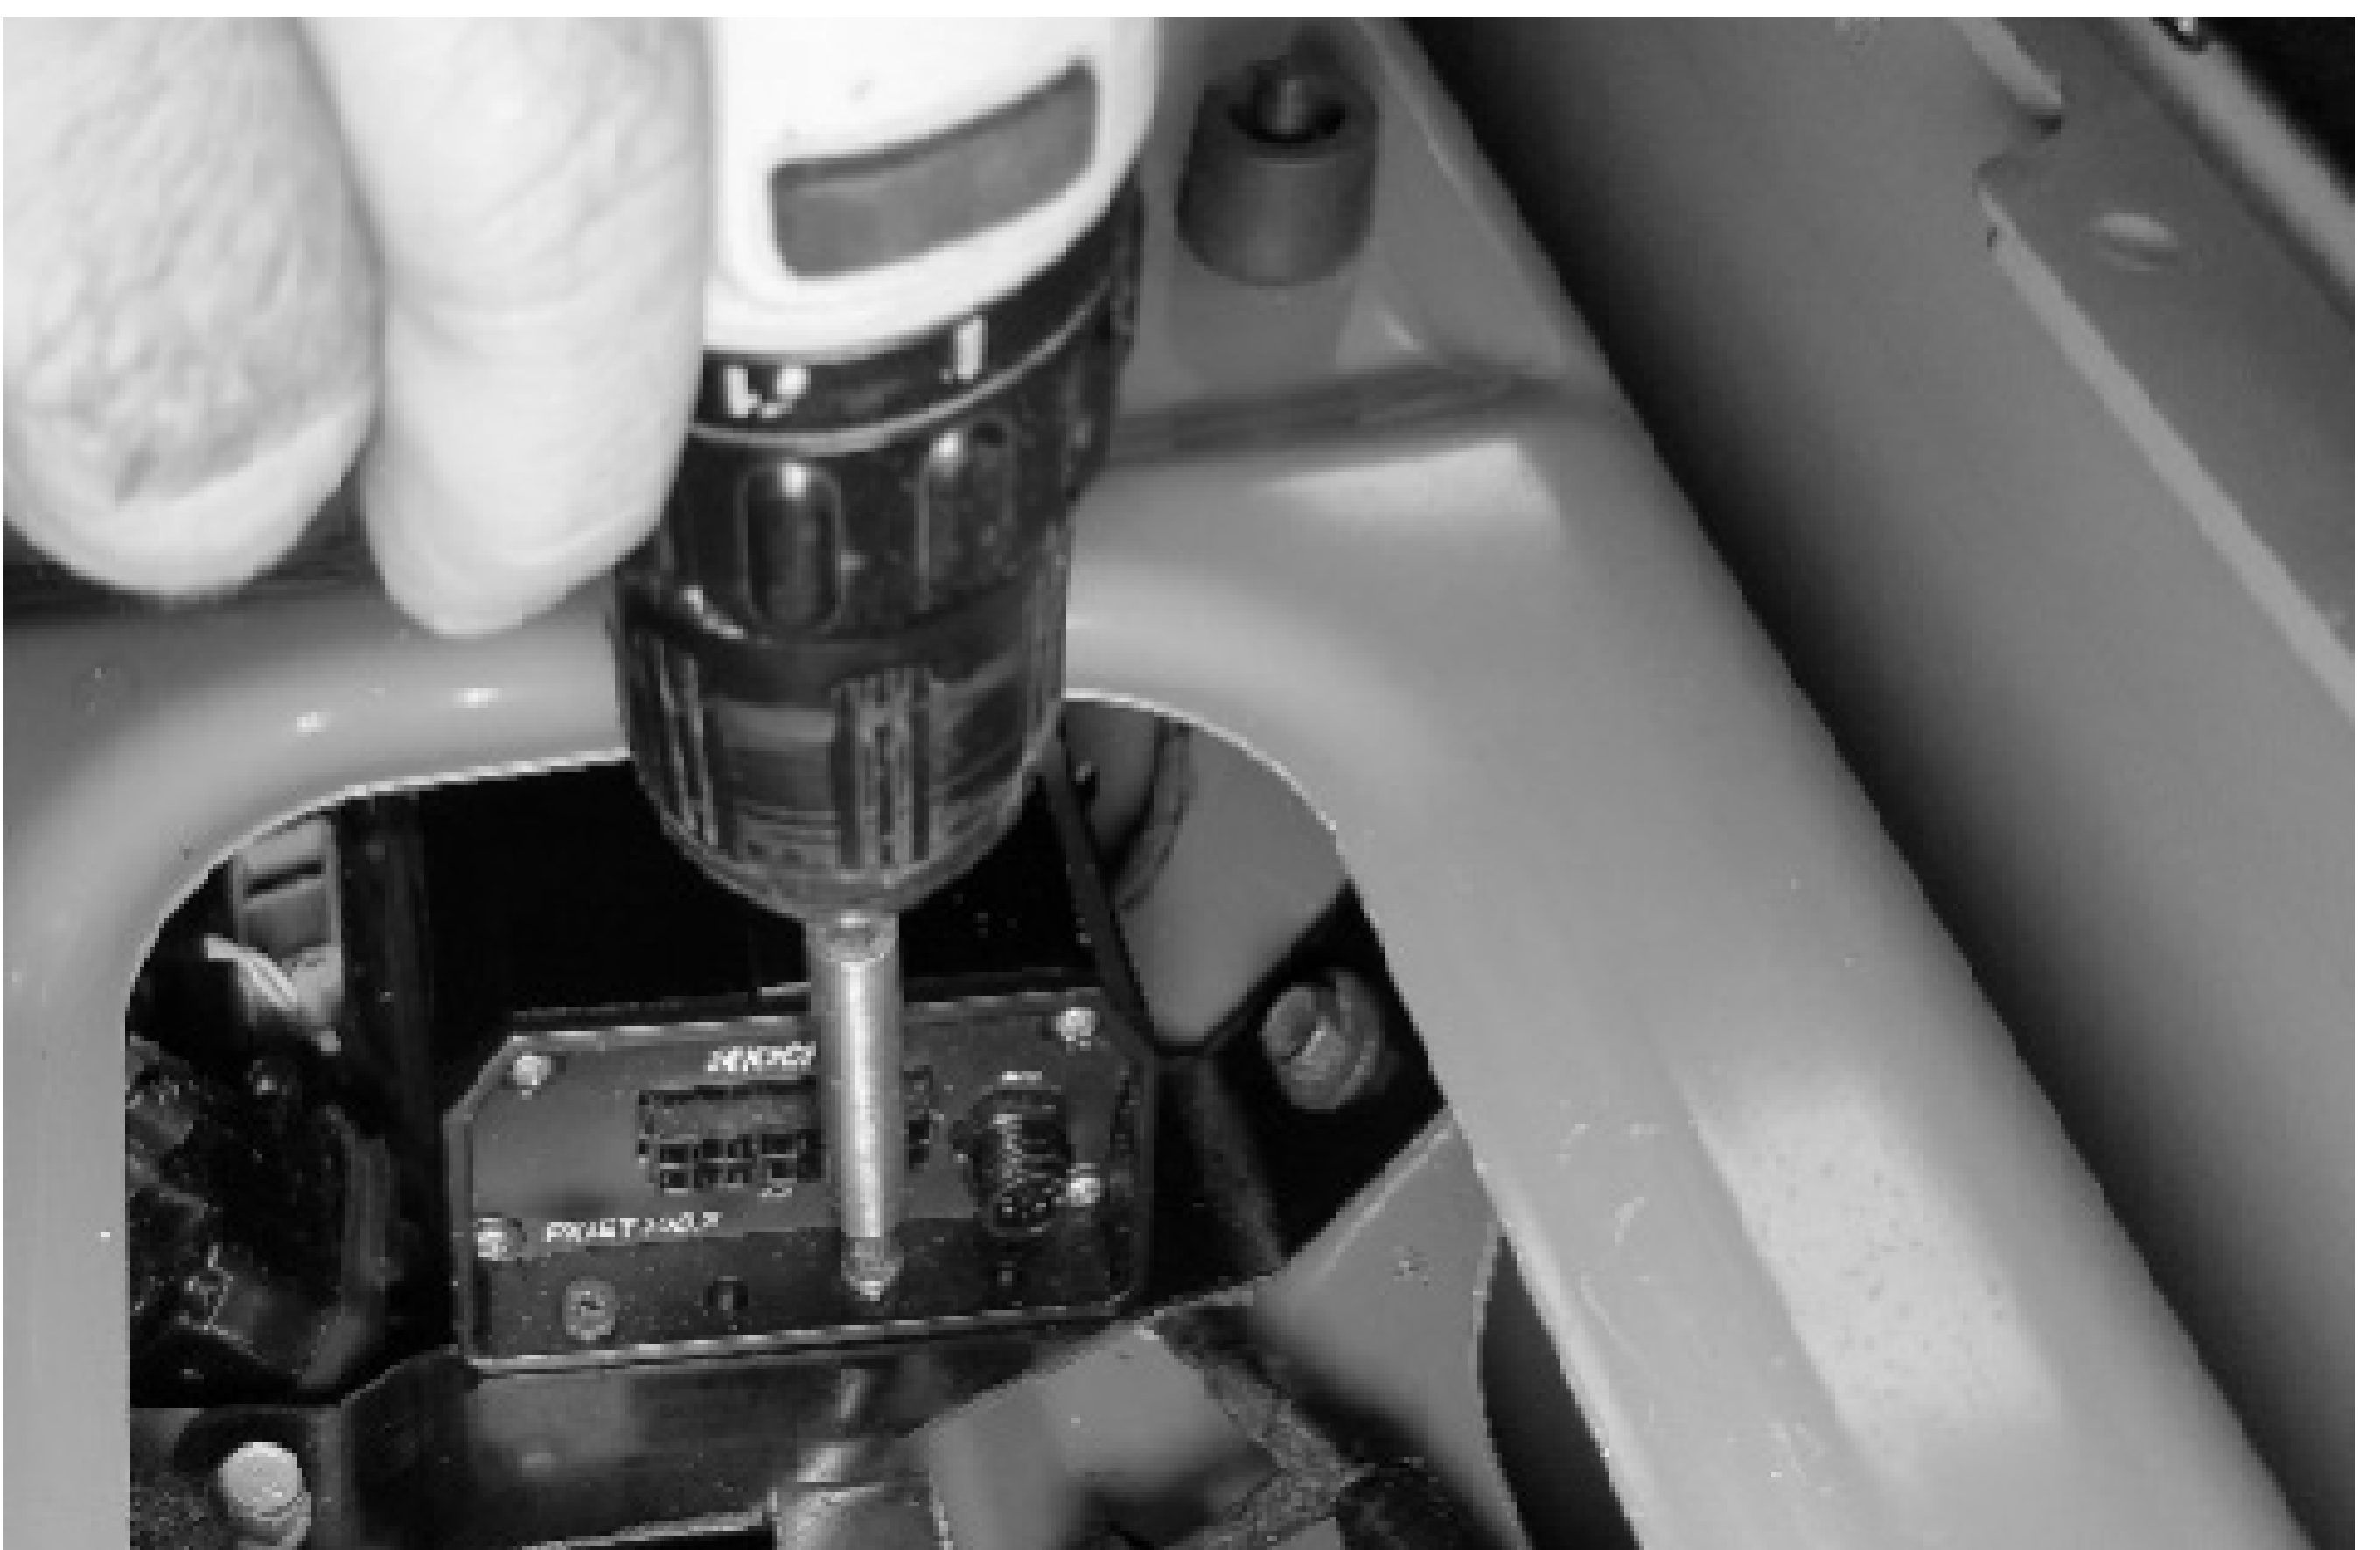
9. Install the amplifier onto the amplifier bracket with the supplied amplifier screws (short screws x 4).

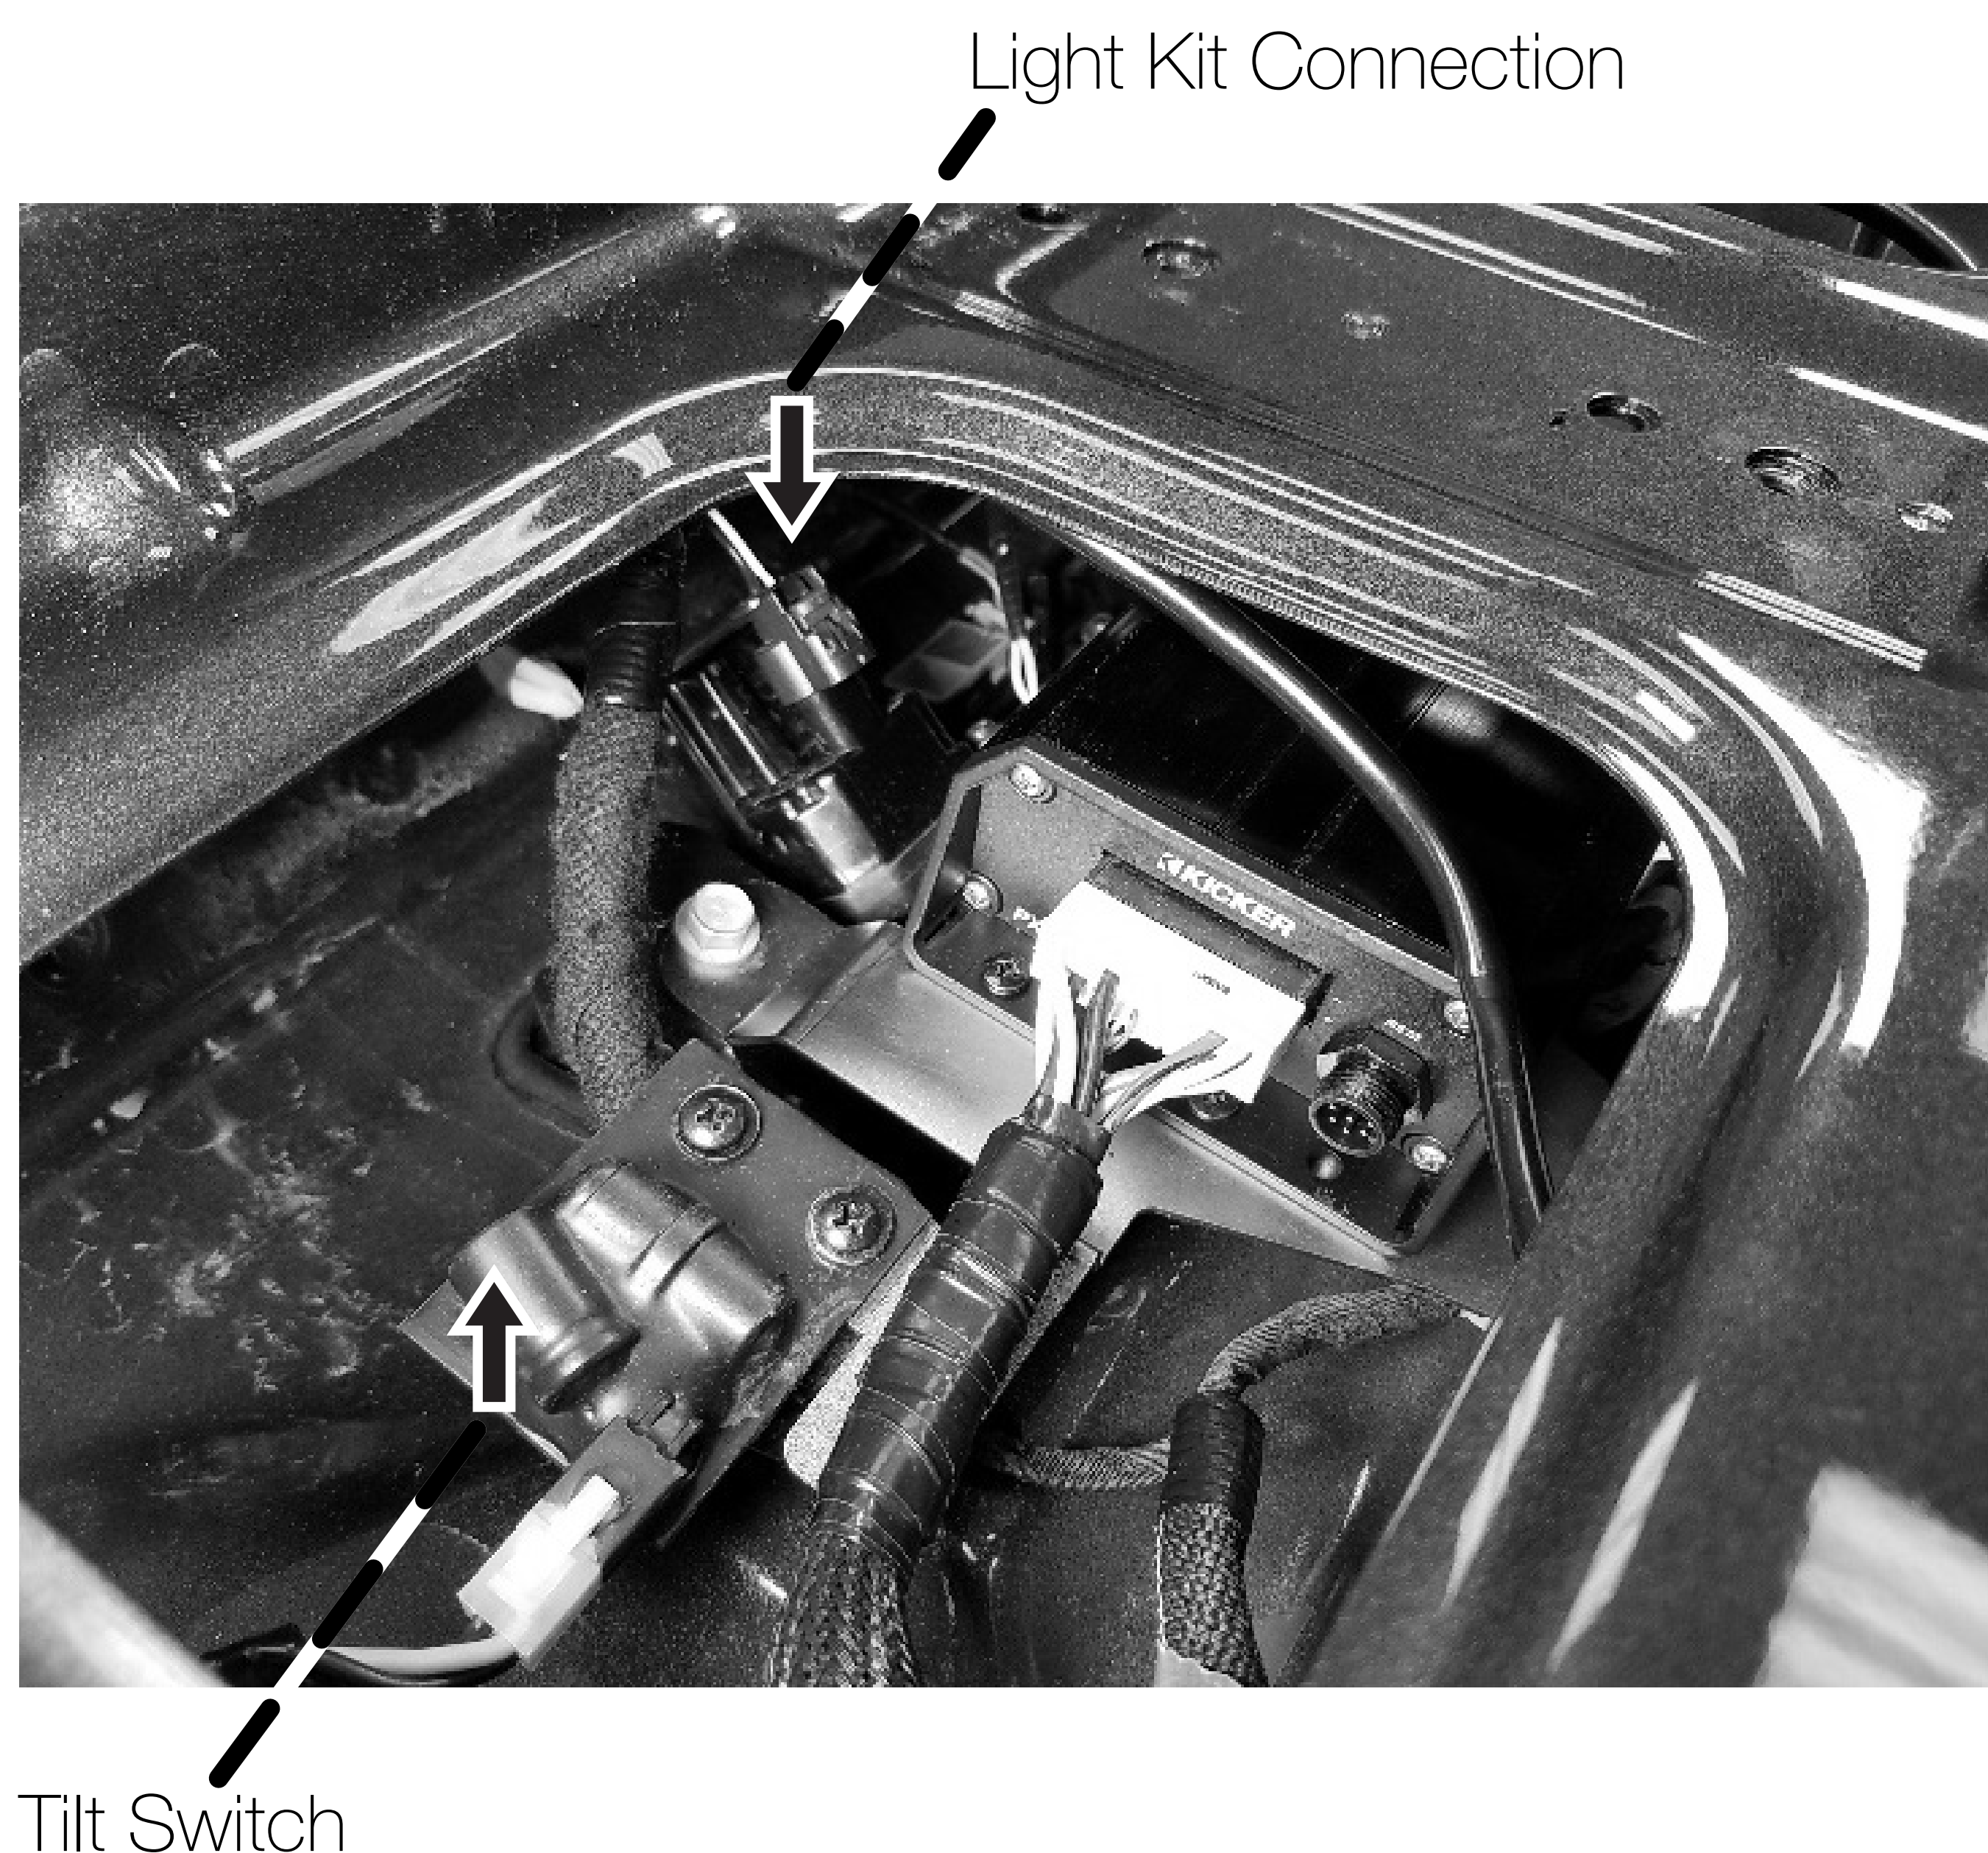
10. Connect the amplifier harness to the amplifier and the four-pin connector to the tilt switch attached to the amplifier bracket. Route the amplifier harness along the factory harness toward the passenger side.

*Note:* The tilt switch is designed to turn the speaker system off when the inner tailgate is not in the fully down position. Failure to make this connection or attempting to bypass this switch will result in a constant drain on the vehicle battery. Likewise, any cutting, splicing, or other modifications made to the amplifier harness will immediately void the warranty.

11. Disconnect the connector pictured and install the light kit T-harness (if equipped).

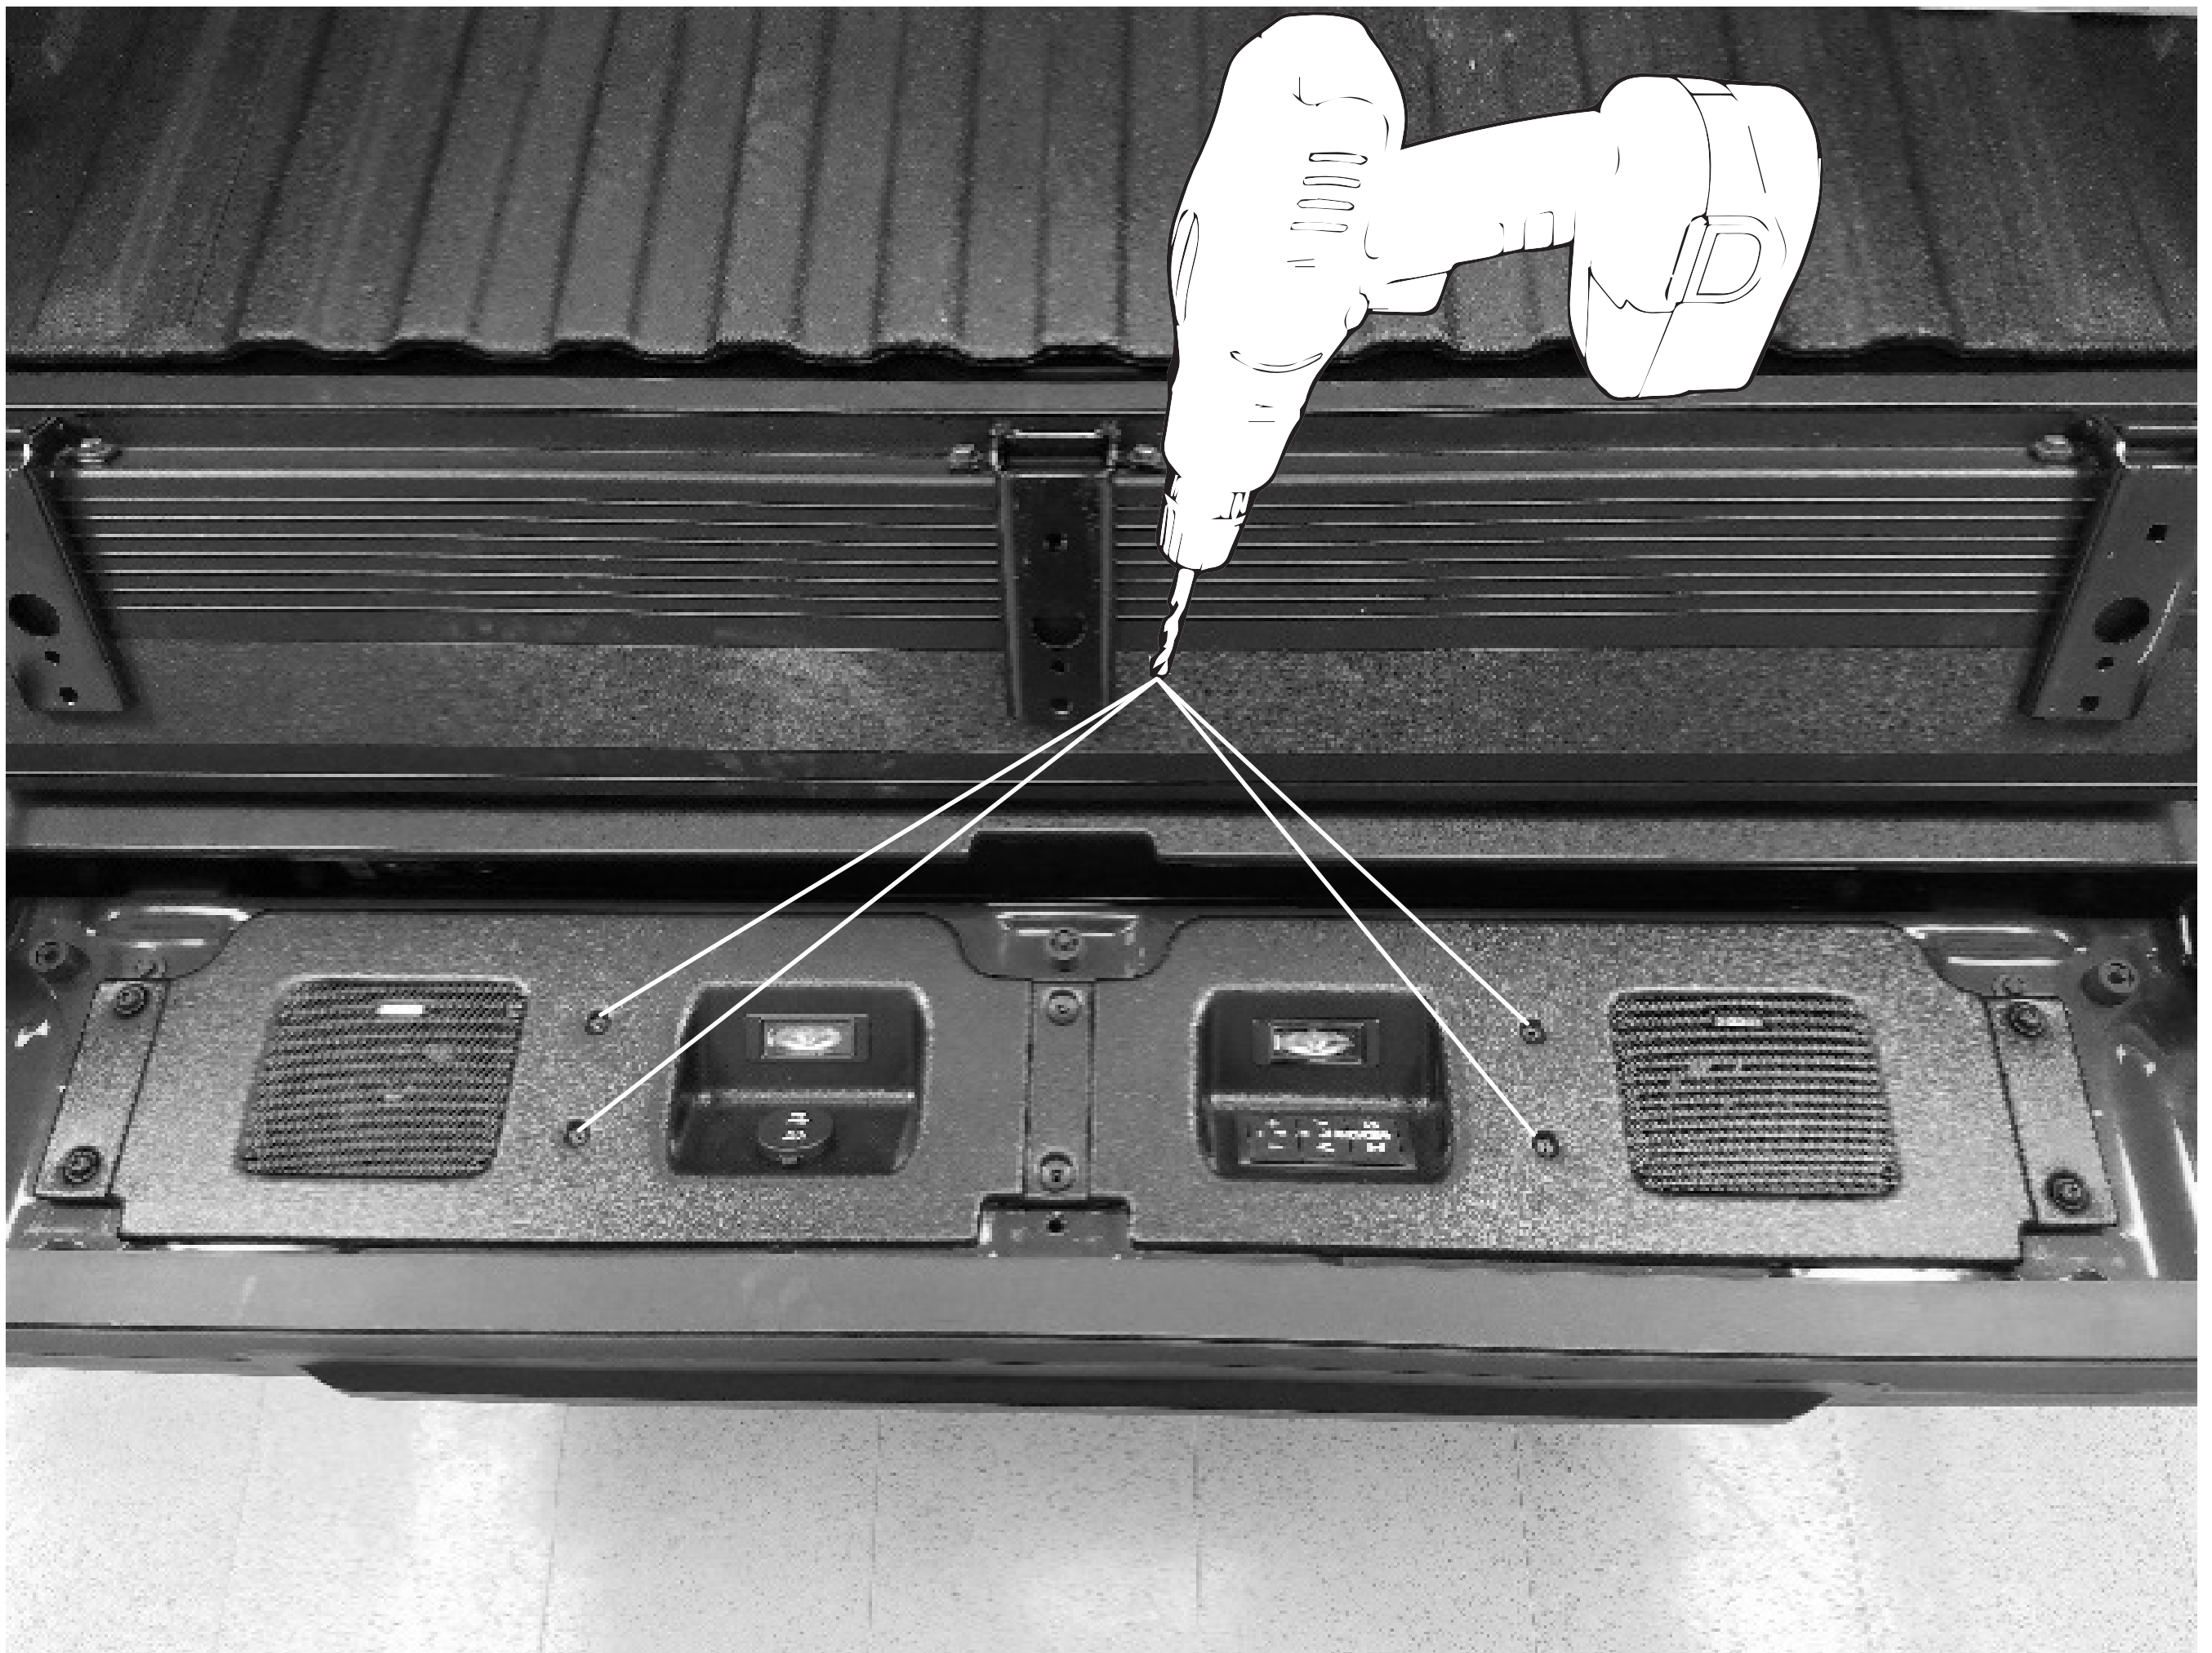
17. Temporarily install the speaker baffle and loosely install all six supplied replacement bolts.

18. Make sure the speaker baffle is perfectly mated to the tailgate and tighten the two center bolts.

19. Predrill the four pilot holes for the supplied fine-threaded screws using a 1/8 (.125) drill bit and then remove the bolts and speaker baffle.

*Note:* Take care to control drill as it penetrates metal to avoid hitting wires.

1/8"  
.125 inches
