Test data, continued

## EUT photos

### 9.1 External photos

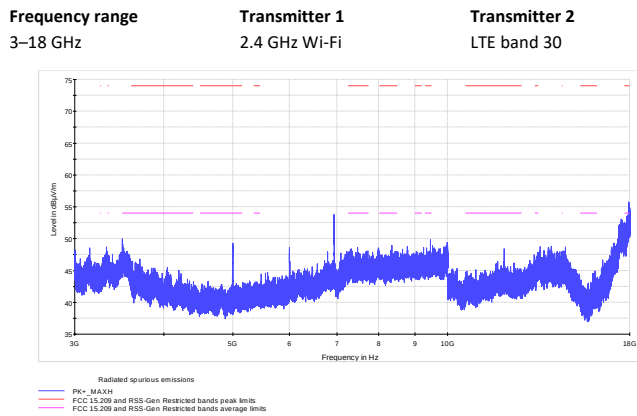
**Figure 8.1-25: Radiated spurious emissions**

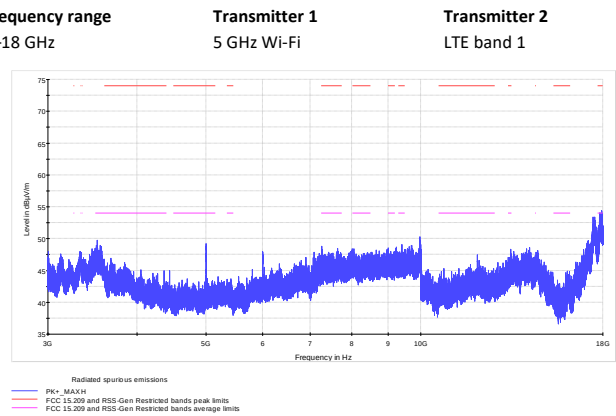
**Figure 8.1-26: Radiated spurious emissions**

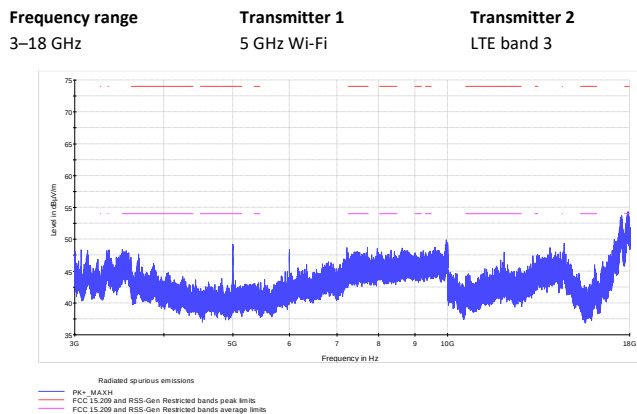
**Figure 8.1-27: Radiated spurious emissions**

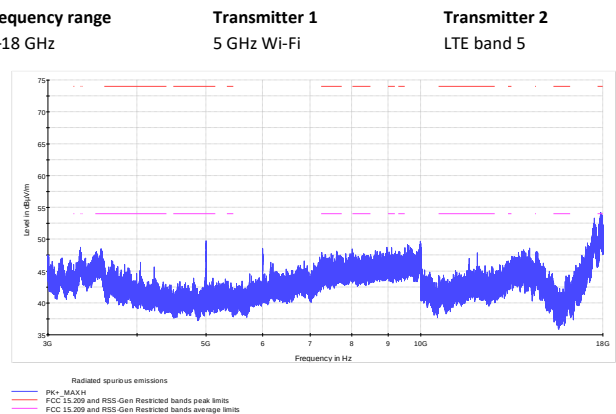
**Figure 8.1-28: Radiated spurious emissions**

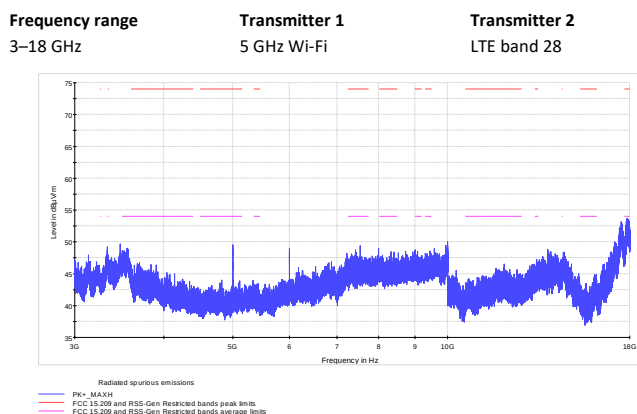
**Figure 8.1-29: Radiated spurious emissions**

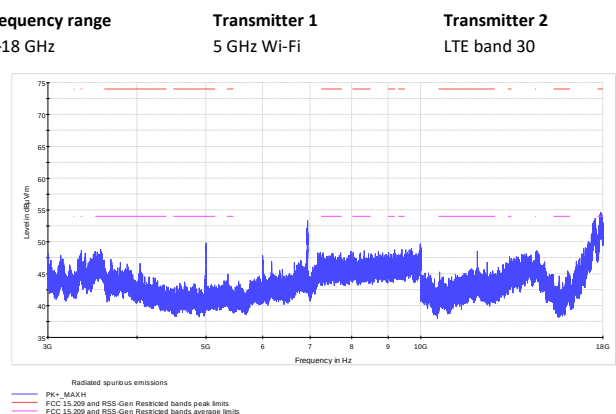
**Figure 8.1-30: Radiated spurious emissions**

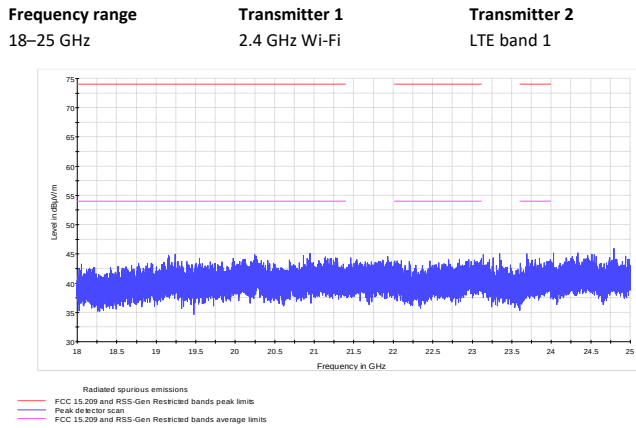
**Figure 8.1-31: Radiated spurious emissions**

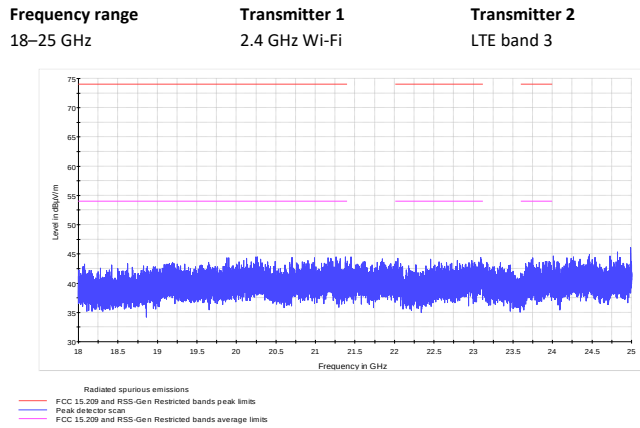
**Figure 8.1-32: Radiated spurious emissions**

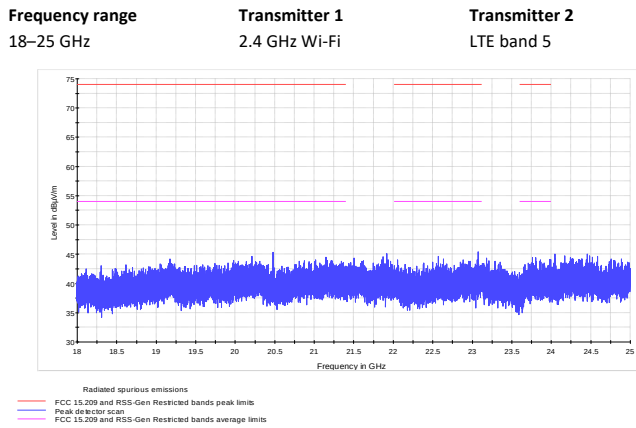
**Figure 8.1-33: Radiated spurious emissions**

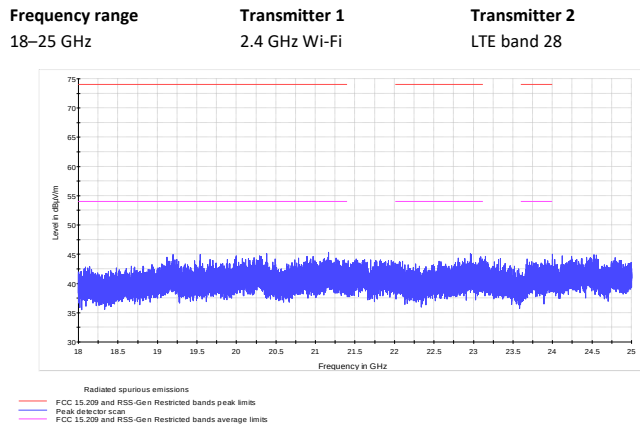
**Figure 8.1-34: Radiated spurious emissions**

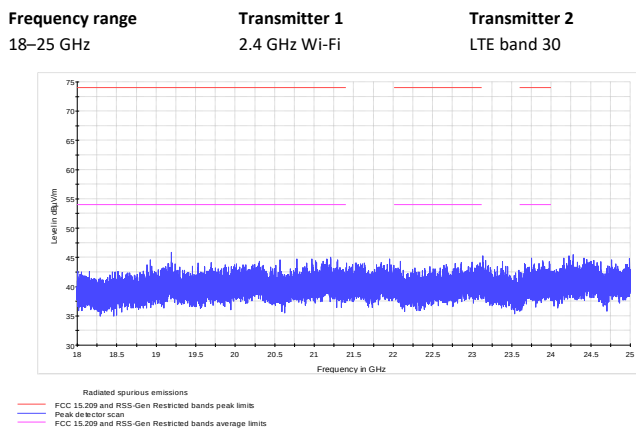
**Figure 8.1-35: Radiated spurious emissions**

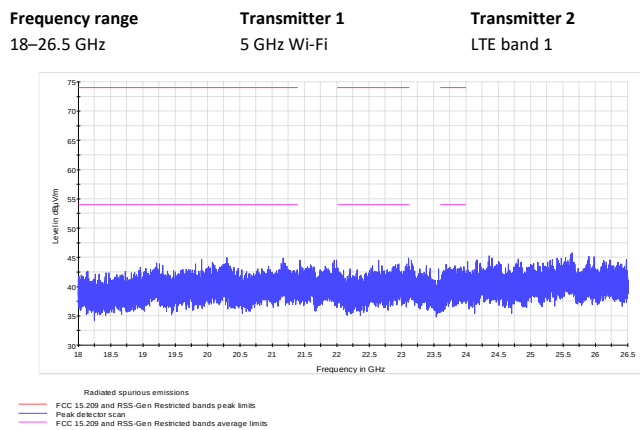
**Figure 8.1-36: Radiated spurious emissions**

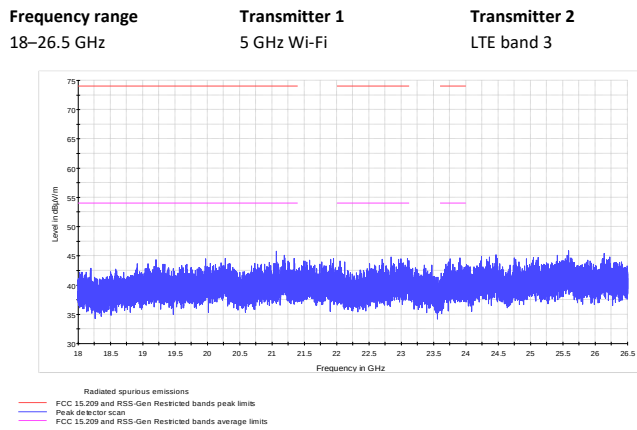
**Figure 8.1-37: Radiated spurious emissions**

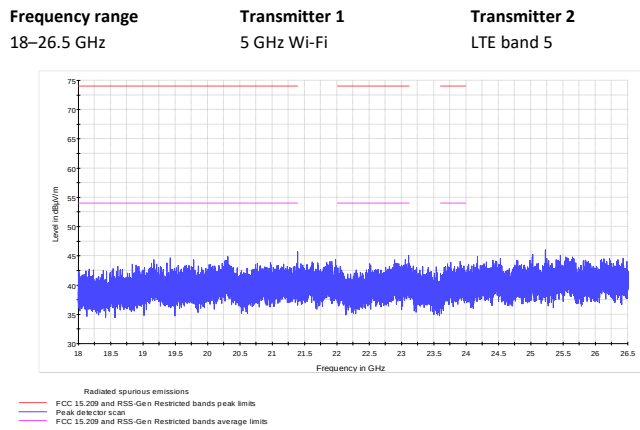
**Figure 8.1-38: Radiated spurious emissions**

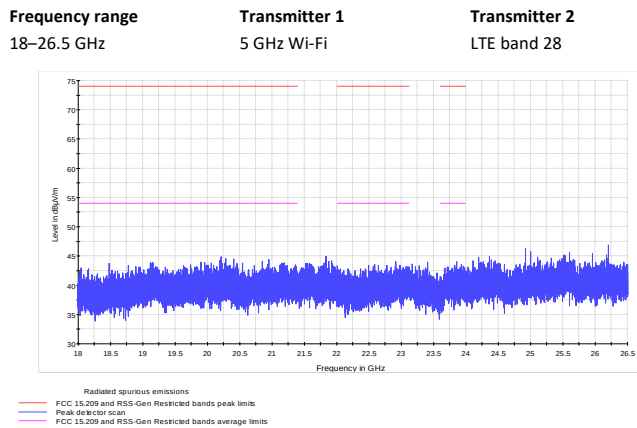
**Figure 8.1-39: Radiated spurious emissions**

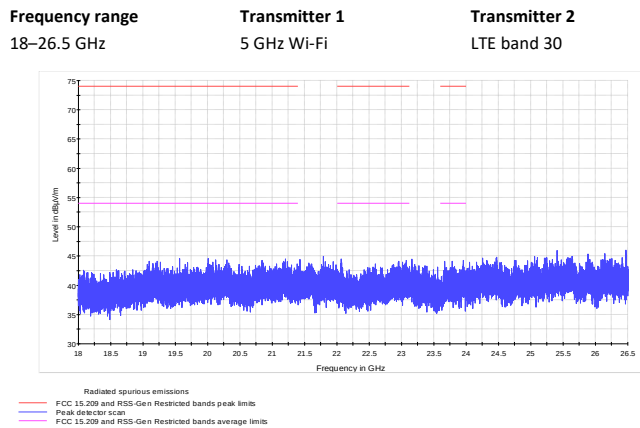
**Figure 8.1-40: Radiated spurious emissions**

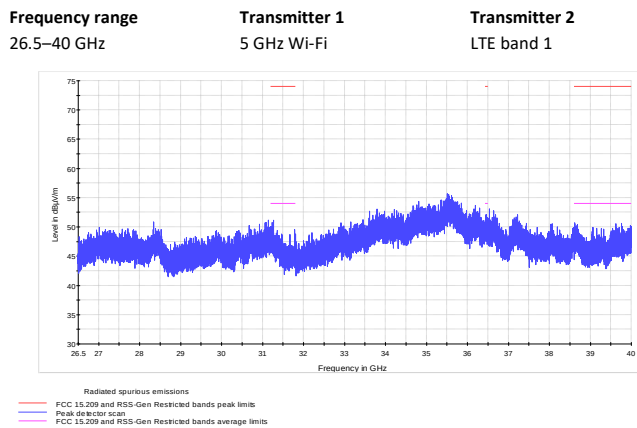
**Figure 8.1-41: Radiated spurious emissions**

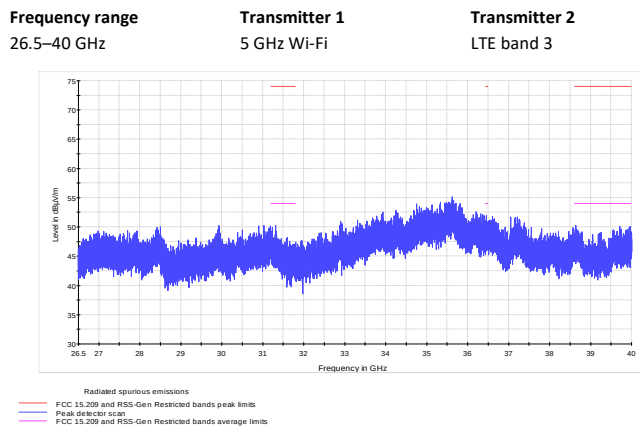
**Figure 8.1-42: Radiated spurious emissions**

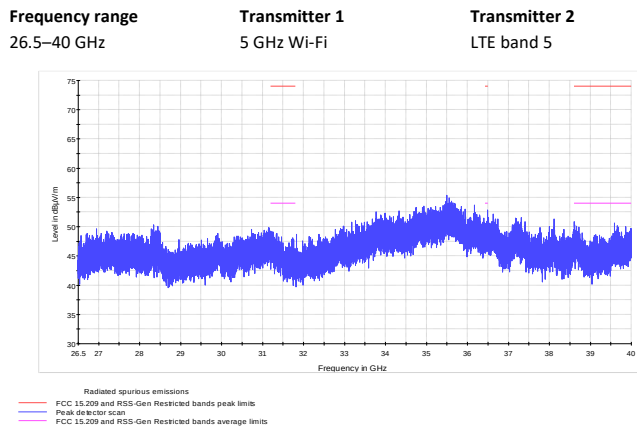
**Figure 8.1-43:** Radiated spurious emissions

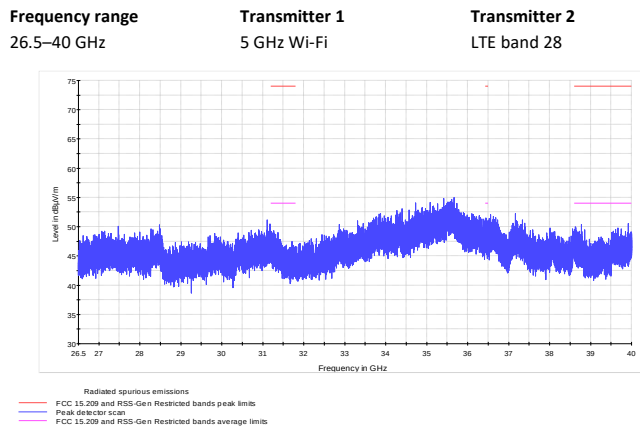
**Figure 8.1-44:** Radiated spurious emissions

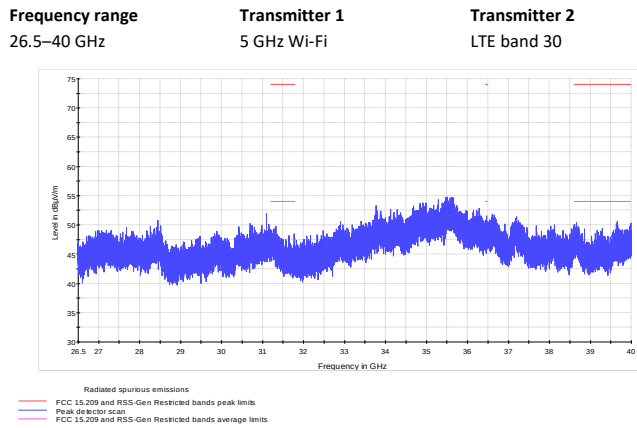
**Figure 8.1-45:** Radiated spurious emissions

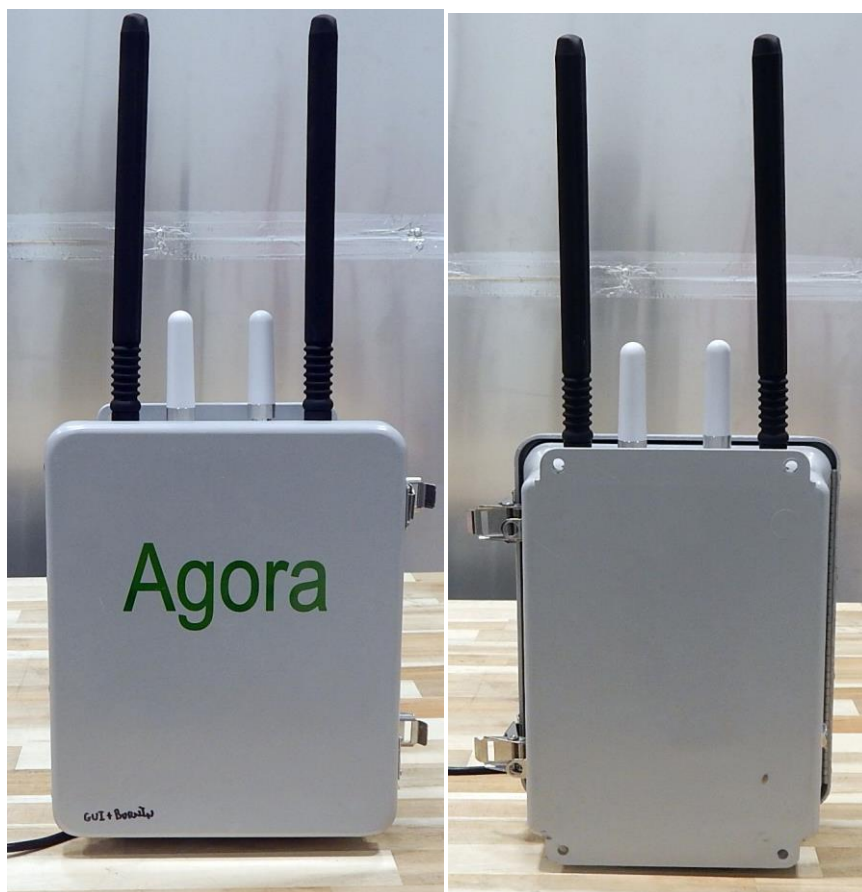
**Figure 9.1-2:** Front and rear view photos (001-0156-03)

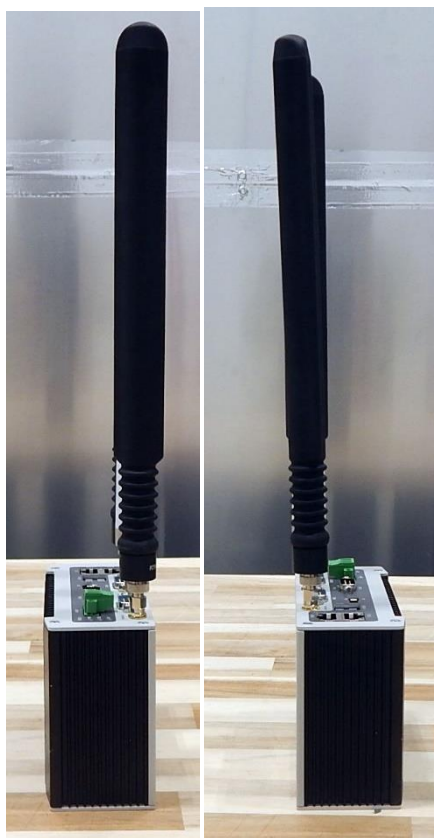
**Figure 9.1-5:** Side view photos (2-AOCW-20SLB-M2)
