# Worldwide Testing Services(Taiwan) Co., Ltd.

Registration number: W6M22111-21376-C-1  
FCC ID: TKZAP7632EC1

## **3.9 Radiated Emission from Digital Part**

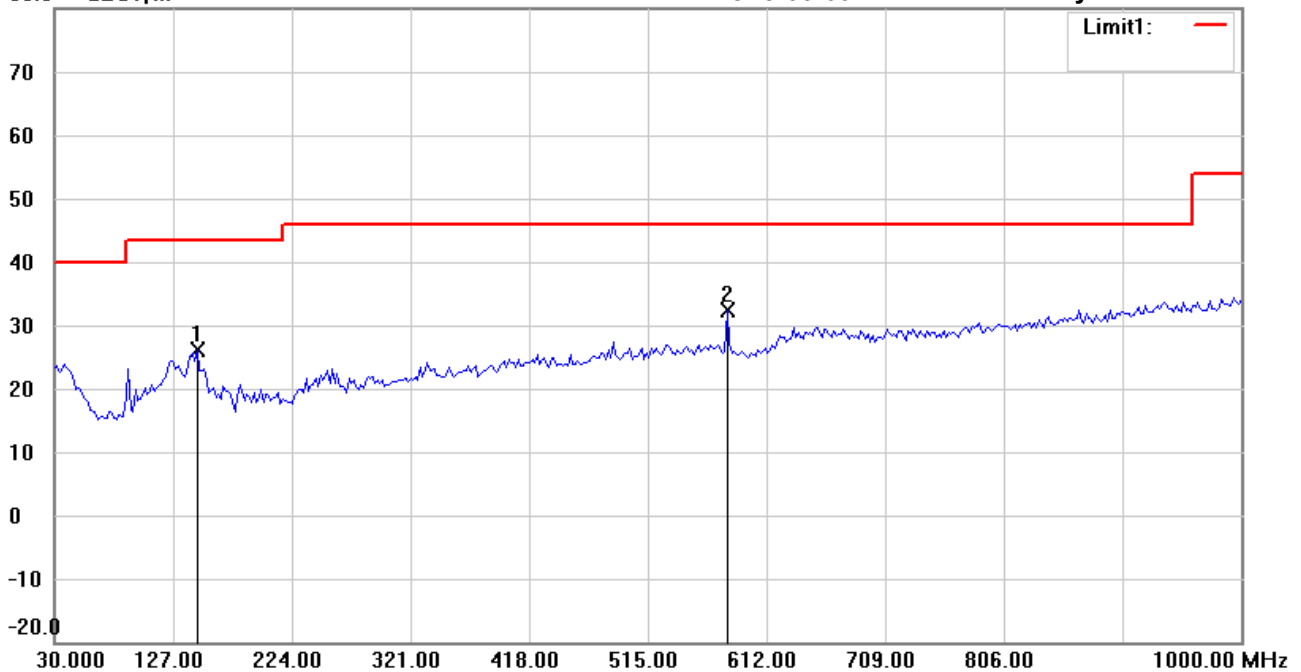
Condition : FCC\_part 15 RE-Class C\_30-1000MHz

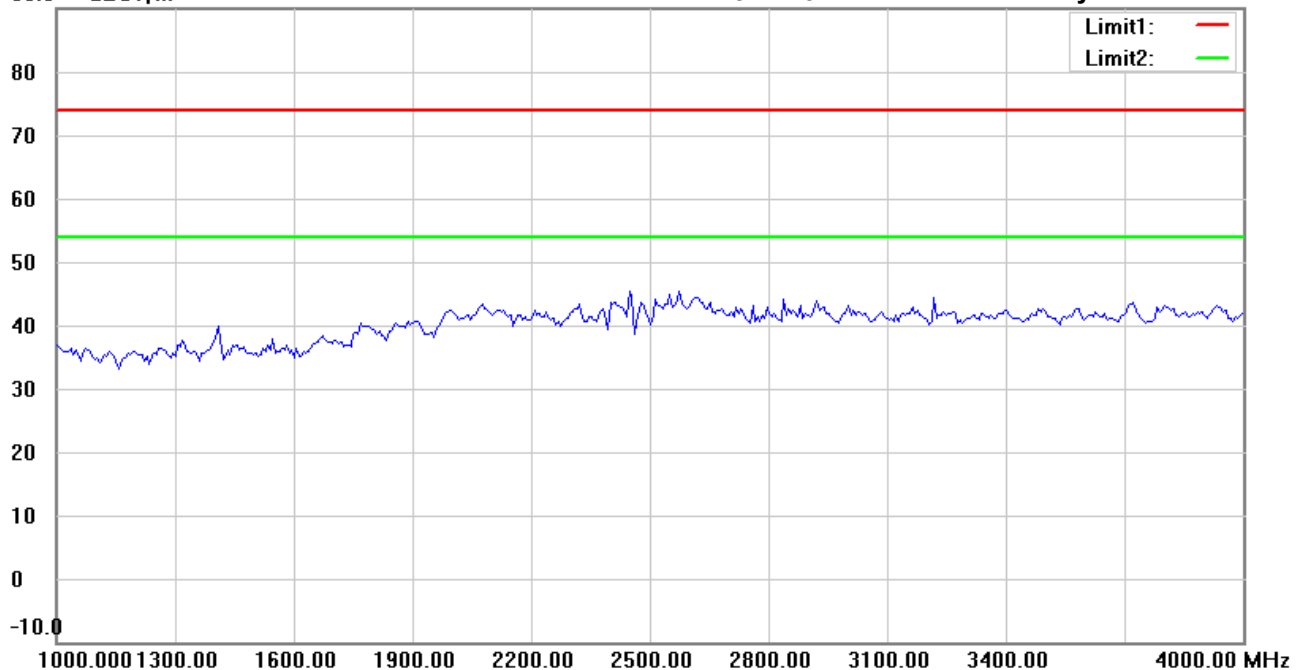
Condition : FCC\_part 15 RE-Class C\_Above 1GHz\_PK

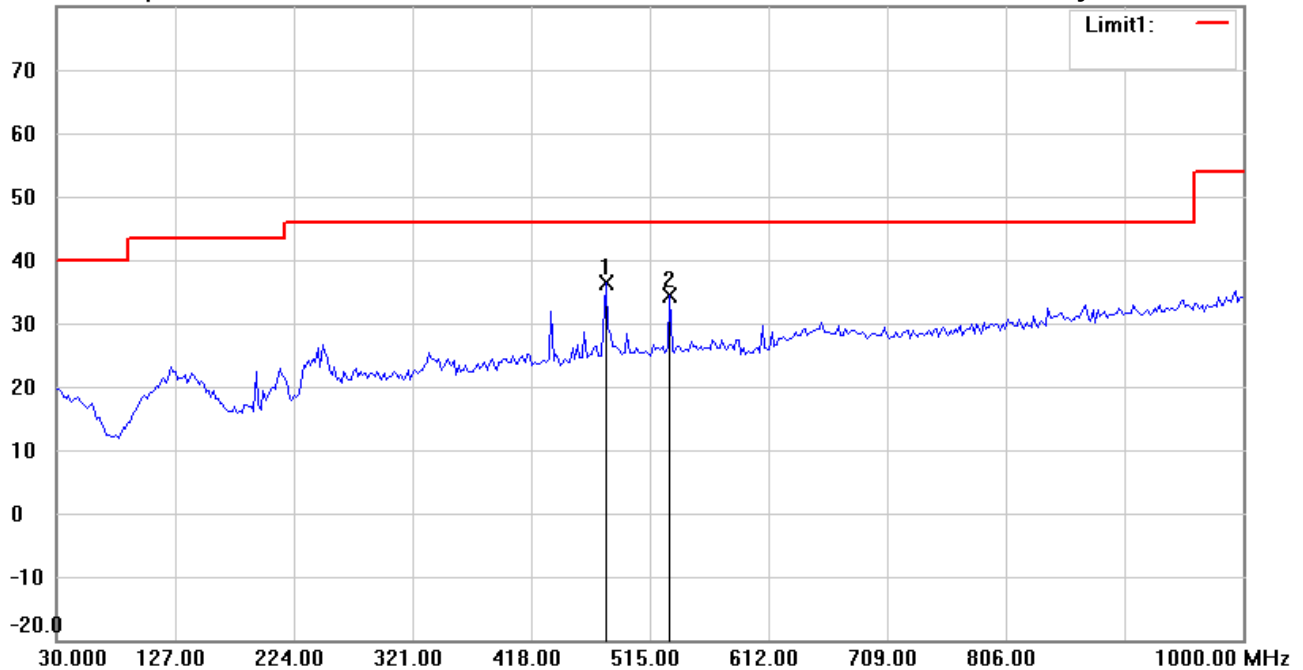
Condition : FCC\_part 15 RE-Class C\_30-1000MHz

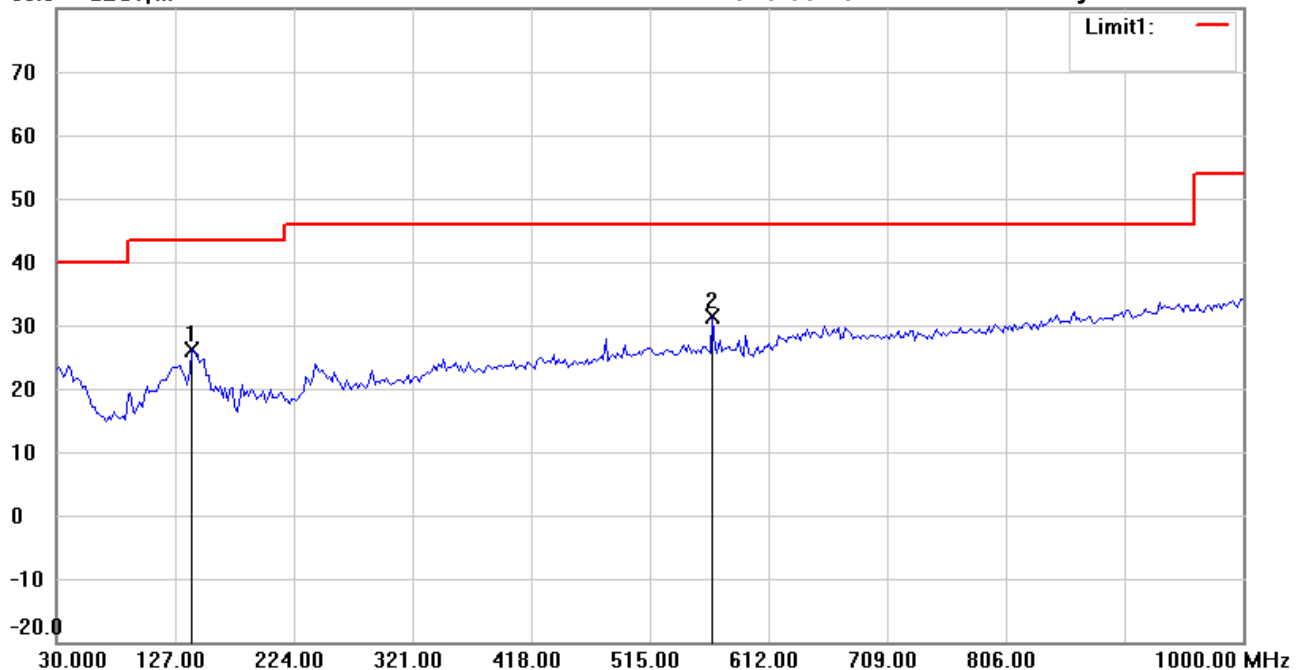
Condition : FCC\_part 15 RE-Class C\_30-1000MHz
