# Changes in the Aprisa SR+ 896 MHz

Revision 1

Changes in the Aprisa SR+ 896 MHz associated with the change to the transmitter and receiver synthesizers under C2PCPX. Changes required due to the obsolescence of the original synthesizer component. No additional functionality has been added with this change.

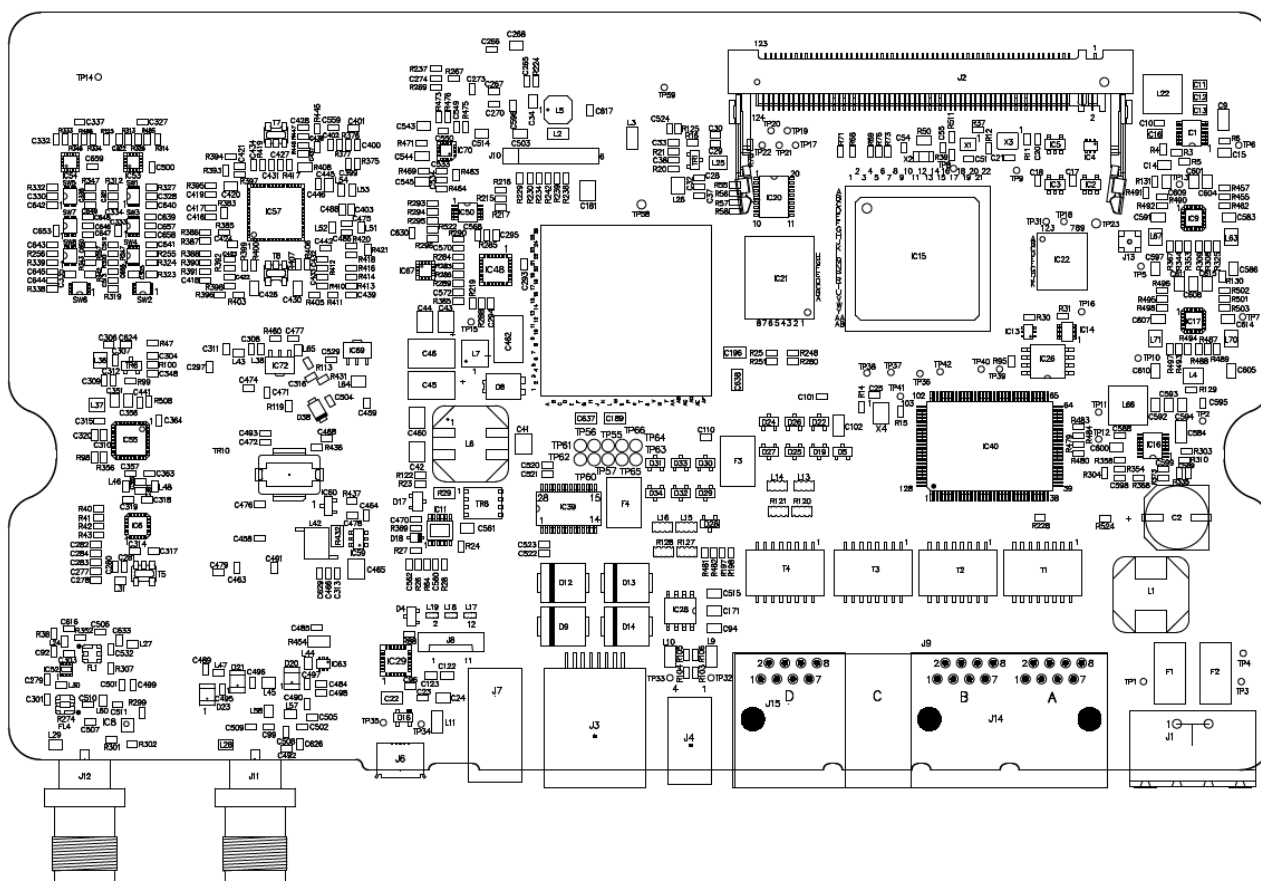
| Figure 1: Old PCA layout top view ..... | 2 |

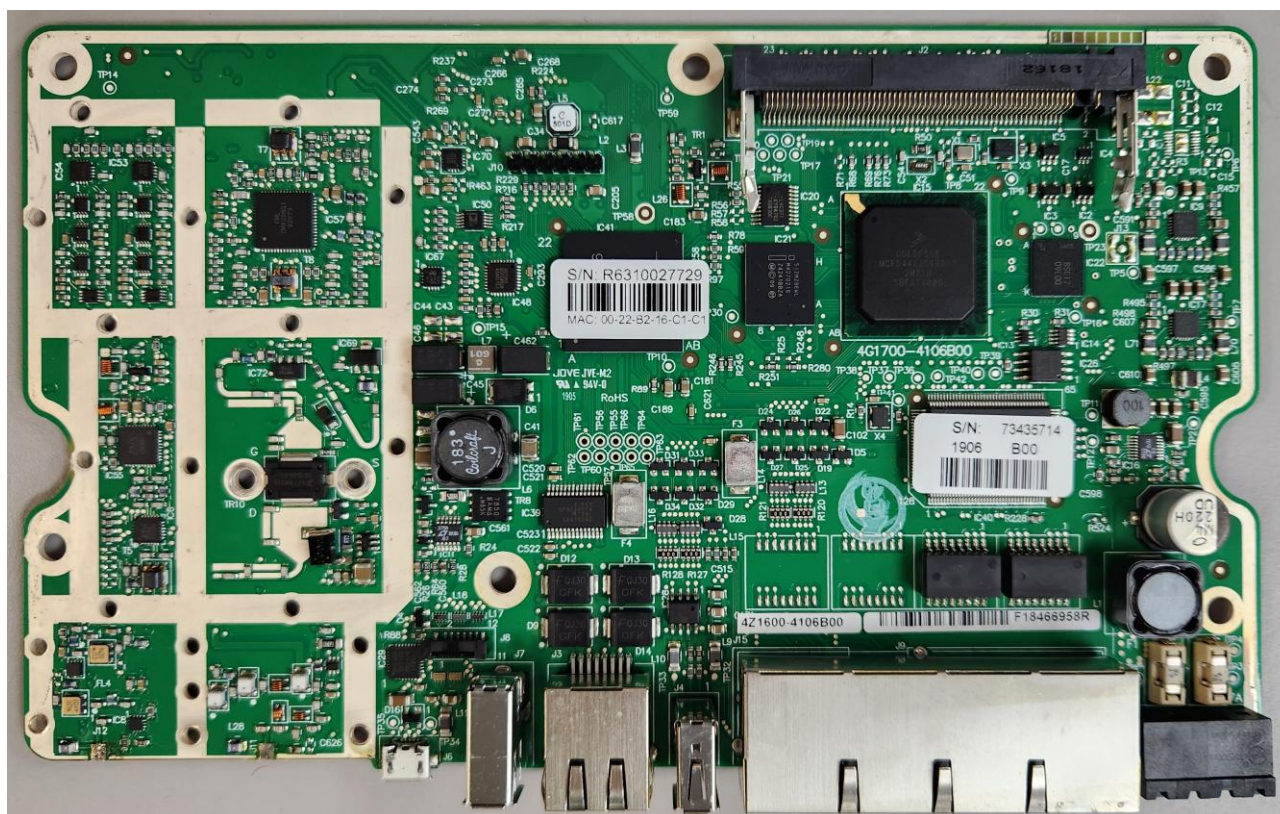
**Figure 2: Old PCA photo top view**

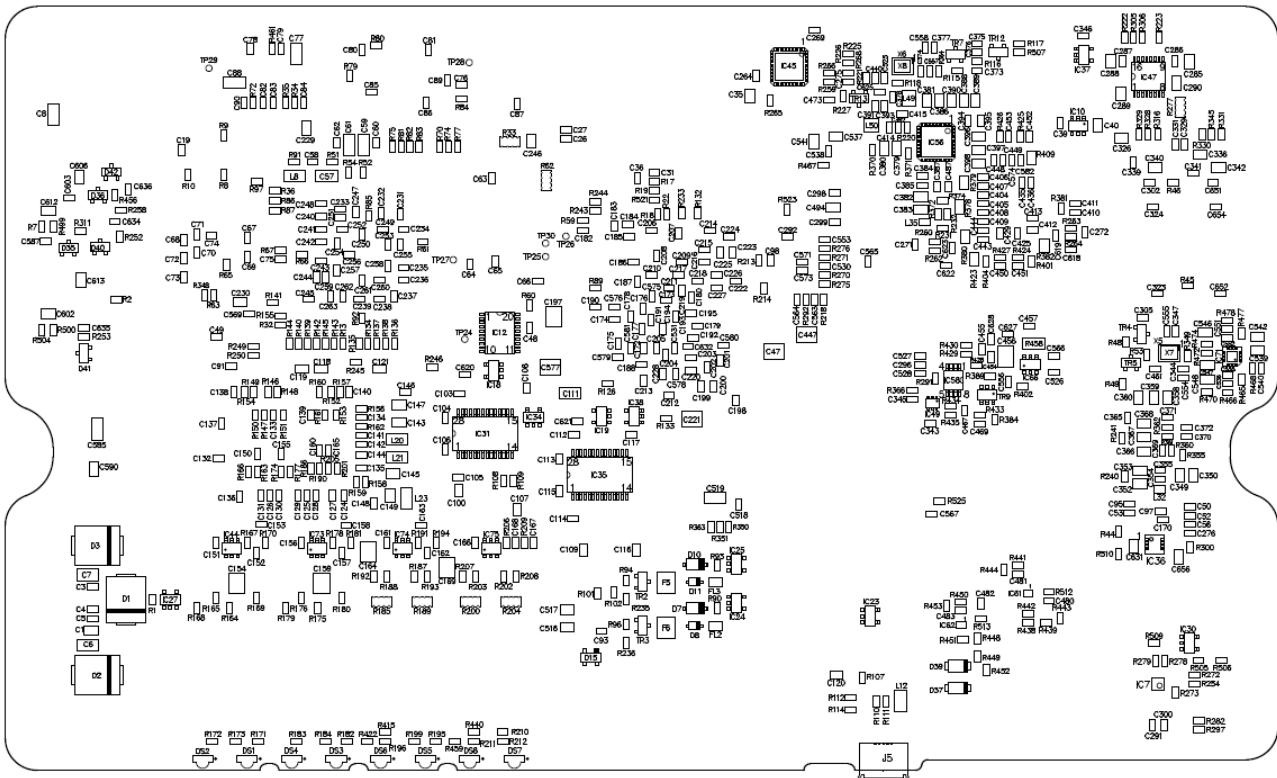
**Figure 3: Old PCA layout bottom view**

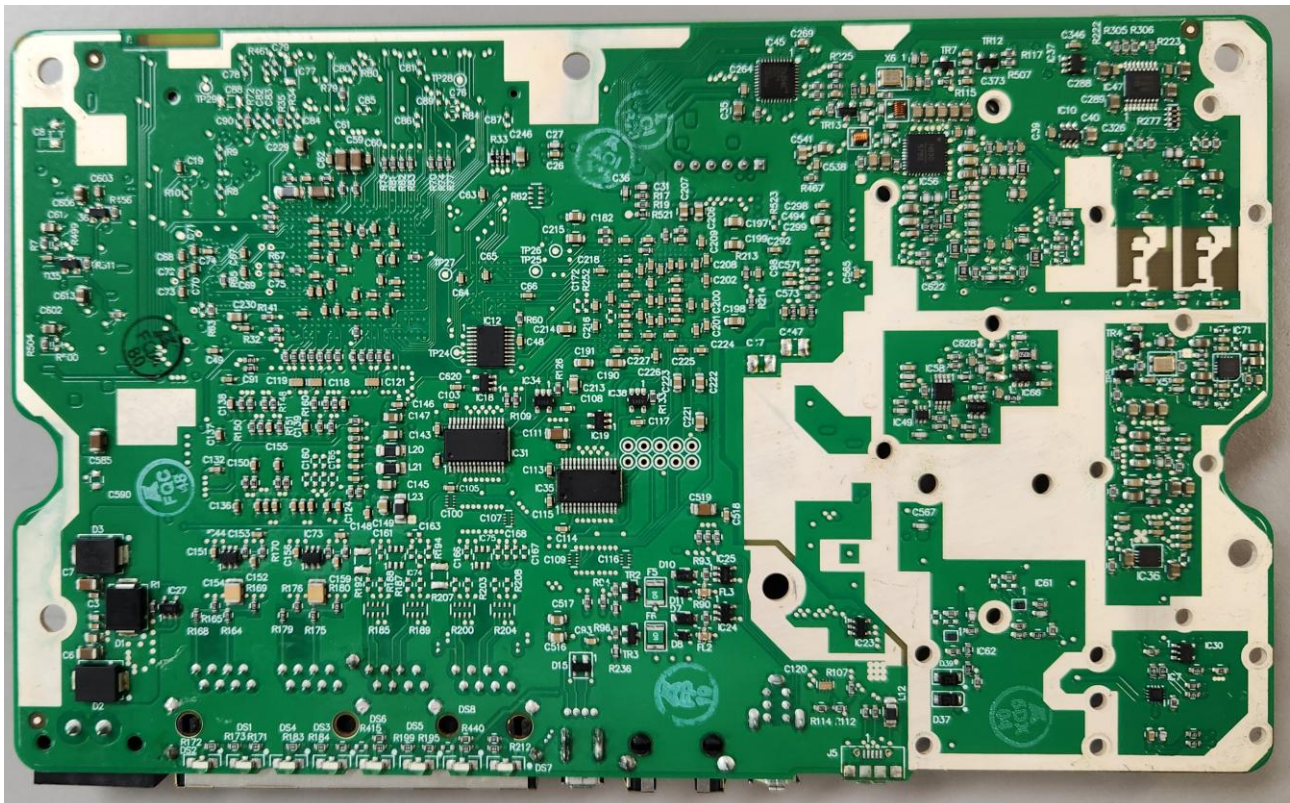
**Figure 4: Old PCA Photo bottom view**

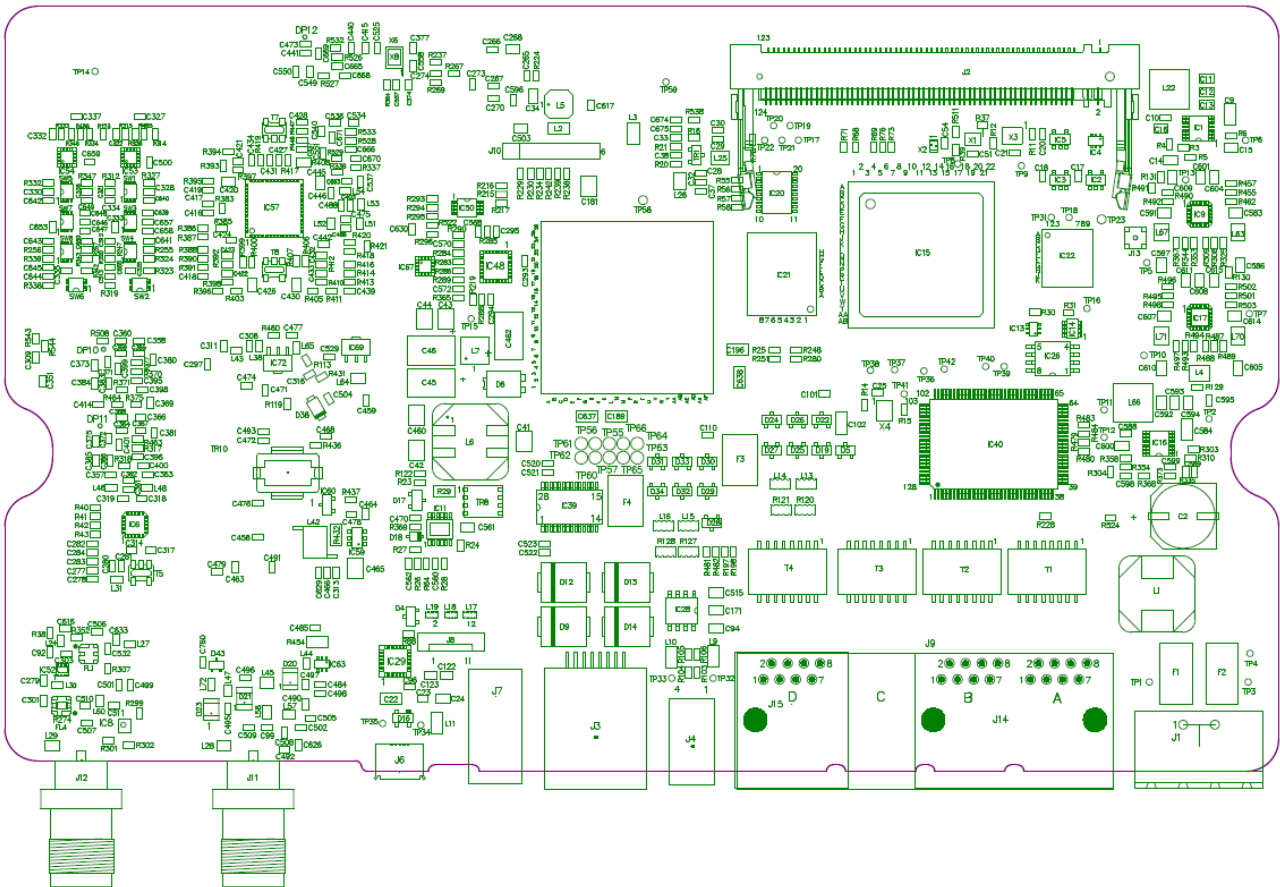
Figure 5: New PCA layout top view

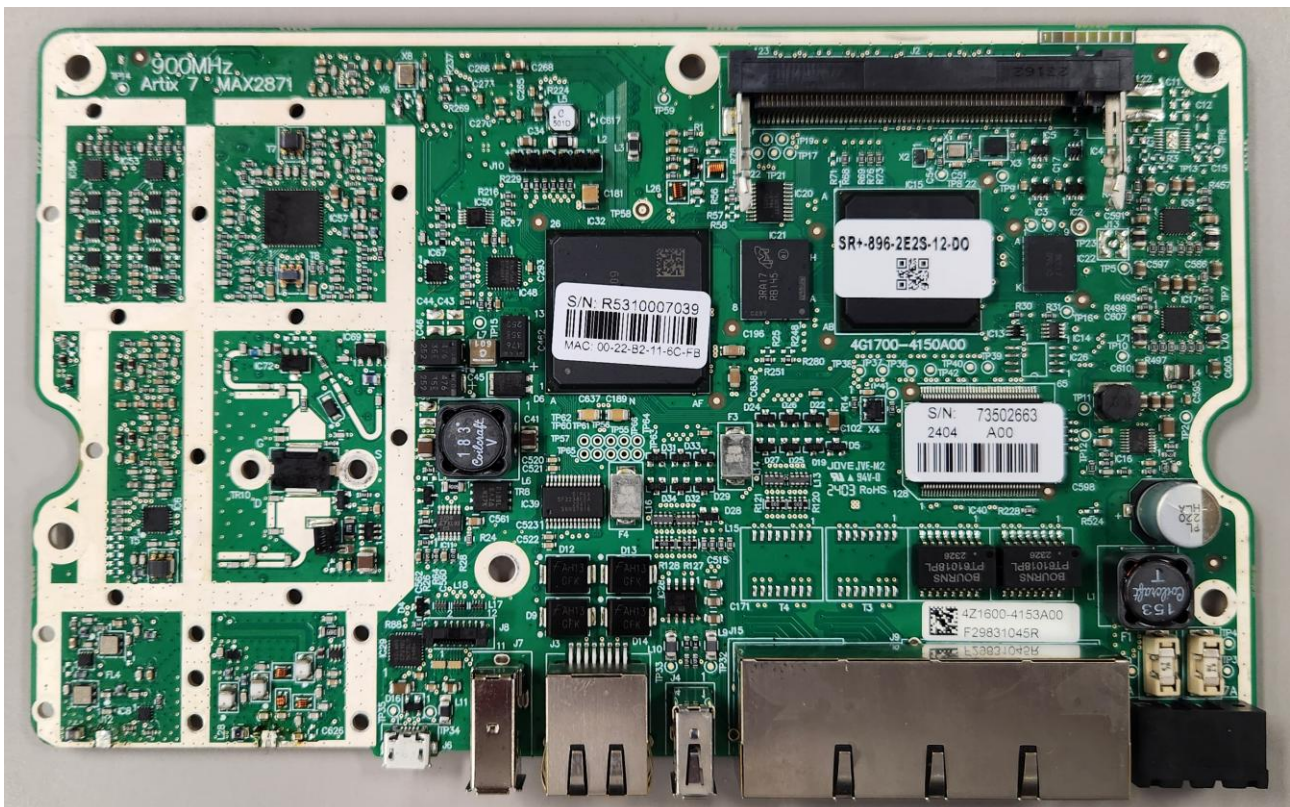
Figure 6: New PCA photo top view

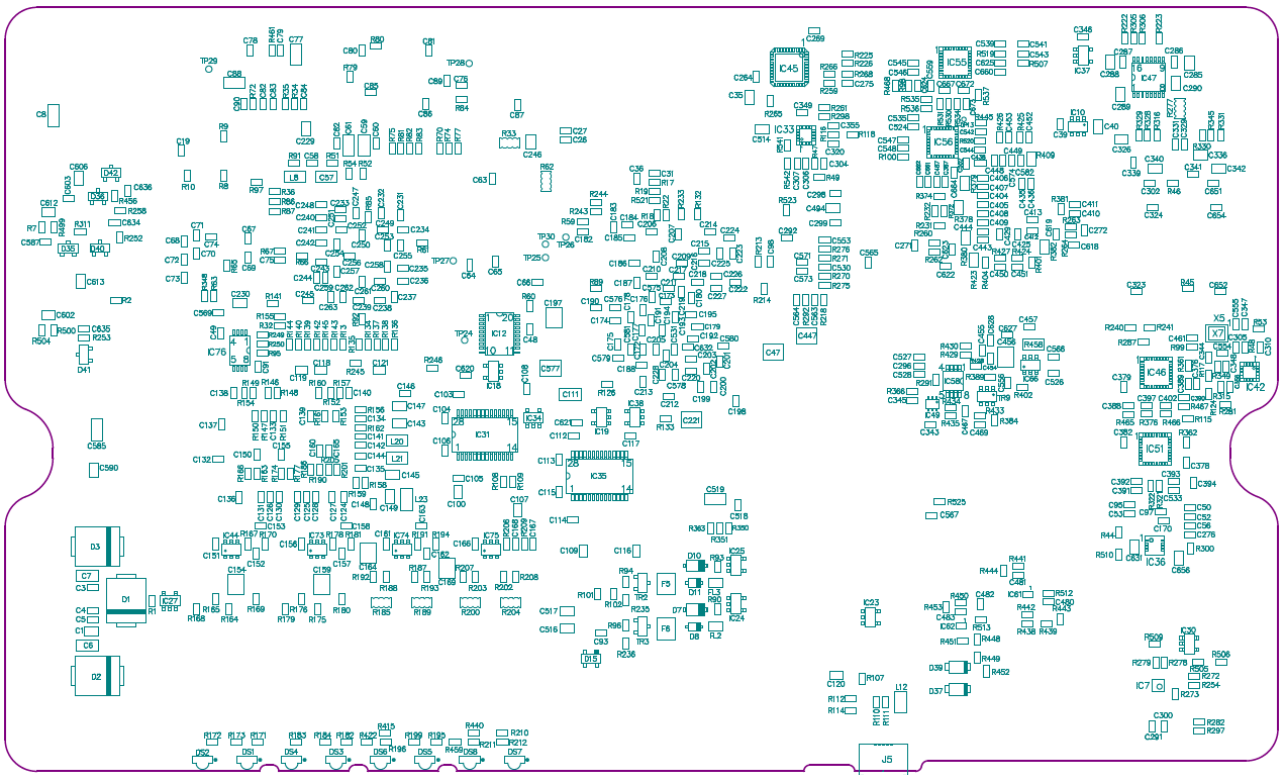
**Figure 7: New PCA layout bottom view**

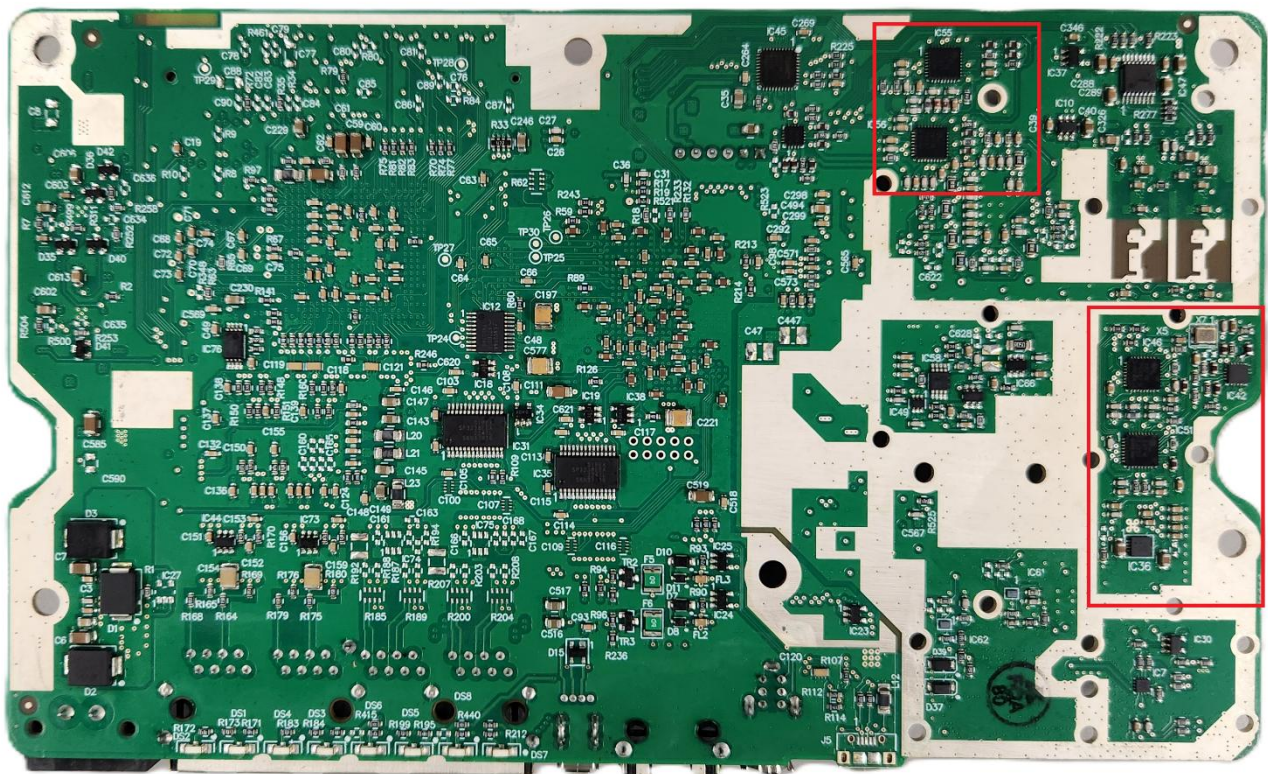
**Figure 8: New PCA photo bottom view (changed areas highlighted)**

Both transmitter and receiver synthesizers are located on the bottom of the Printed Circuit Assembly (PCA), however top layouts and photographs have been included for completeness.
