Registration number: W6R22002-19655-C-54

FCC ID: W23-WMXWAVE2AS

### **3.13 Channel Move Time, Channel Closing Transmission Time**

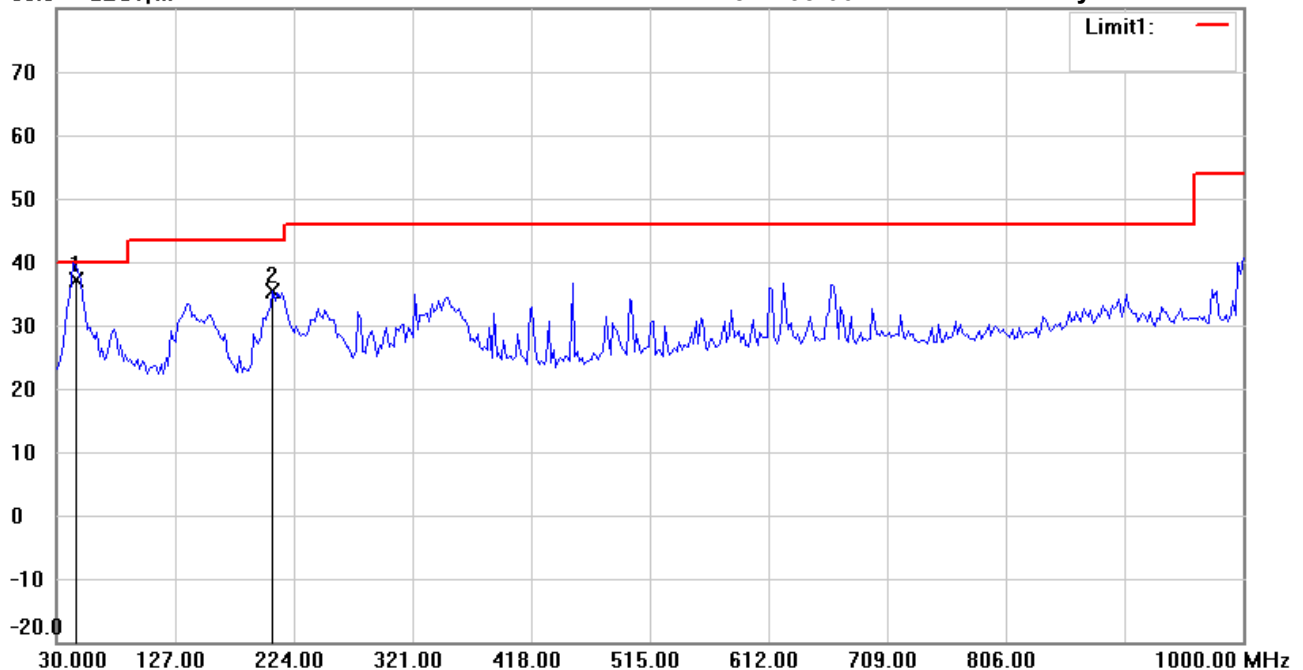
Condition : FCC\_part 15 RE-Class E\_30-1000MHz

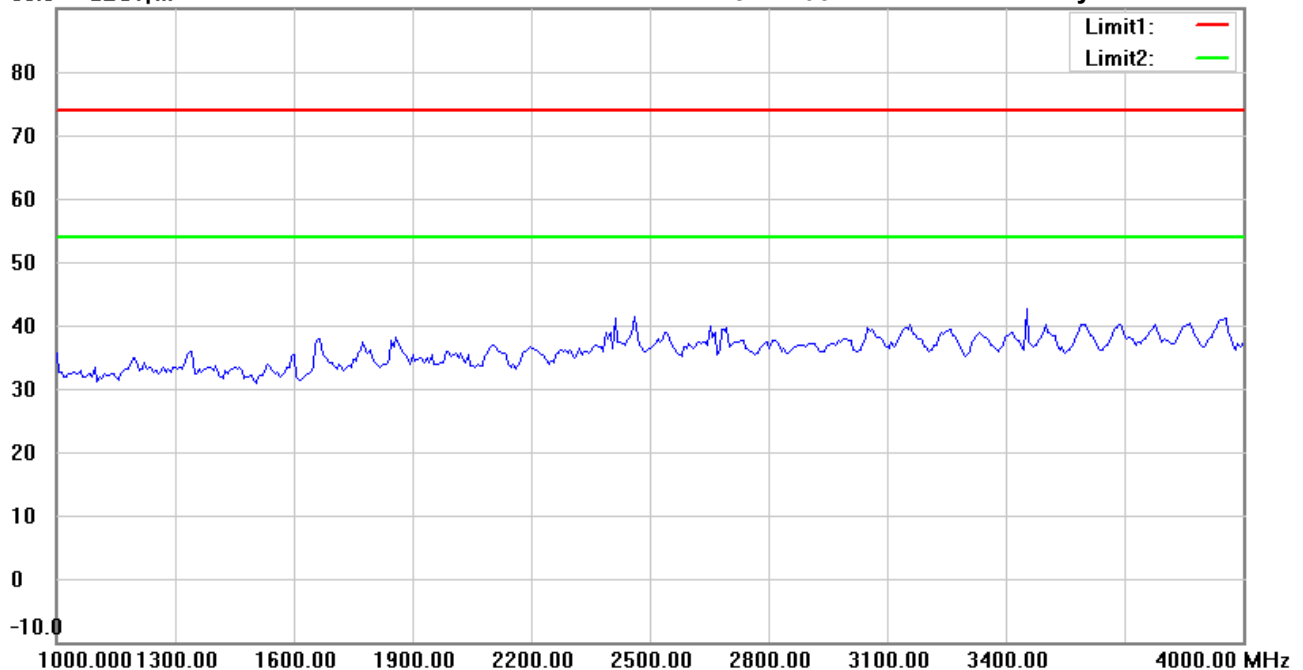
Condition : FCC\_part 15E RE\_Above 1GHz\_PK

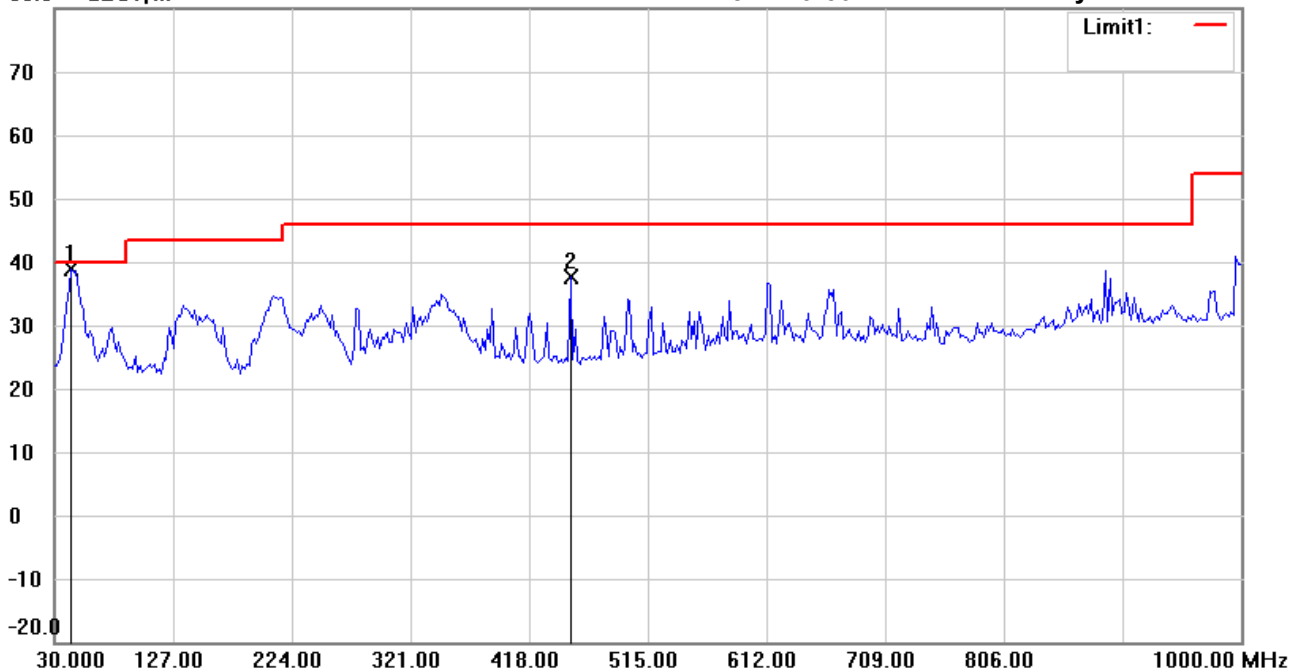
Condition : FCC\_part 15 RE-Class E\_30-1000MHz
