Radiated Emission Measurement

Condition : FCC\_part 15E RE\_Above 1GHz\_PK

EUT : W6R22002-19655

Test Mode : TX 802.11a CH100

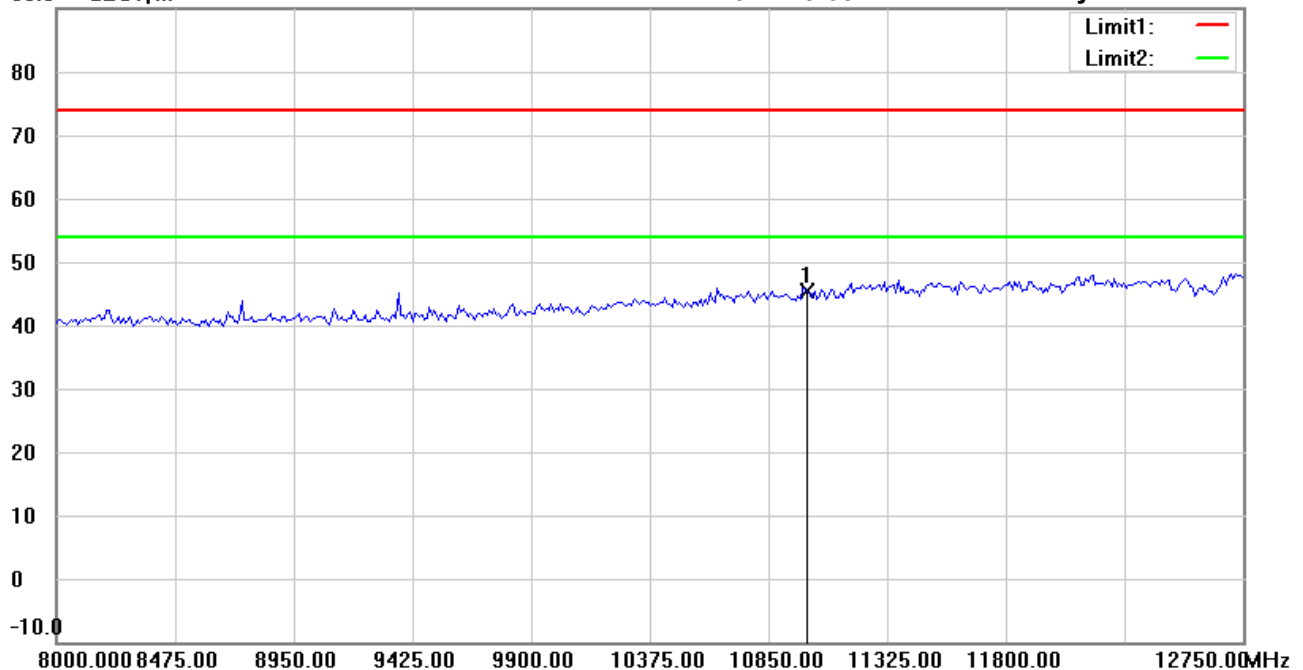
Site : Chamber

Condition : FCC\_part 15E RE\_Above 1GHz\_PK

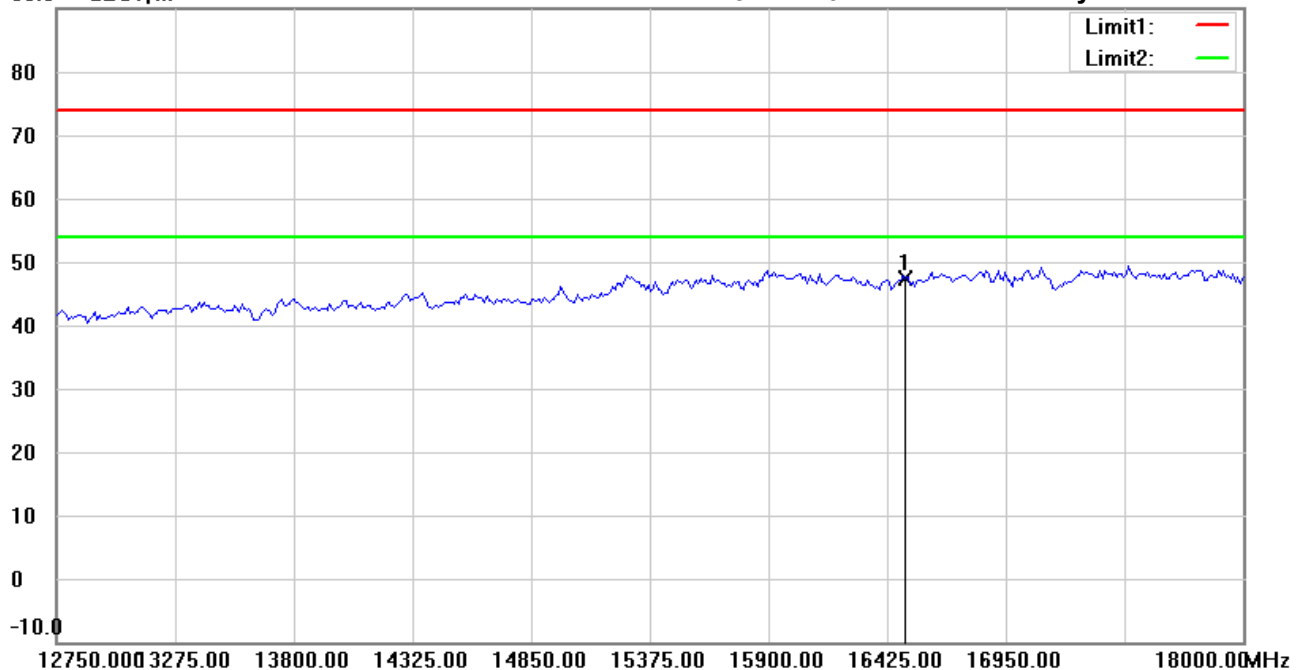
Site : Chamber

Condition : FCC\_part 15E RE\_Above 1GHz\_PK

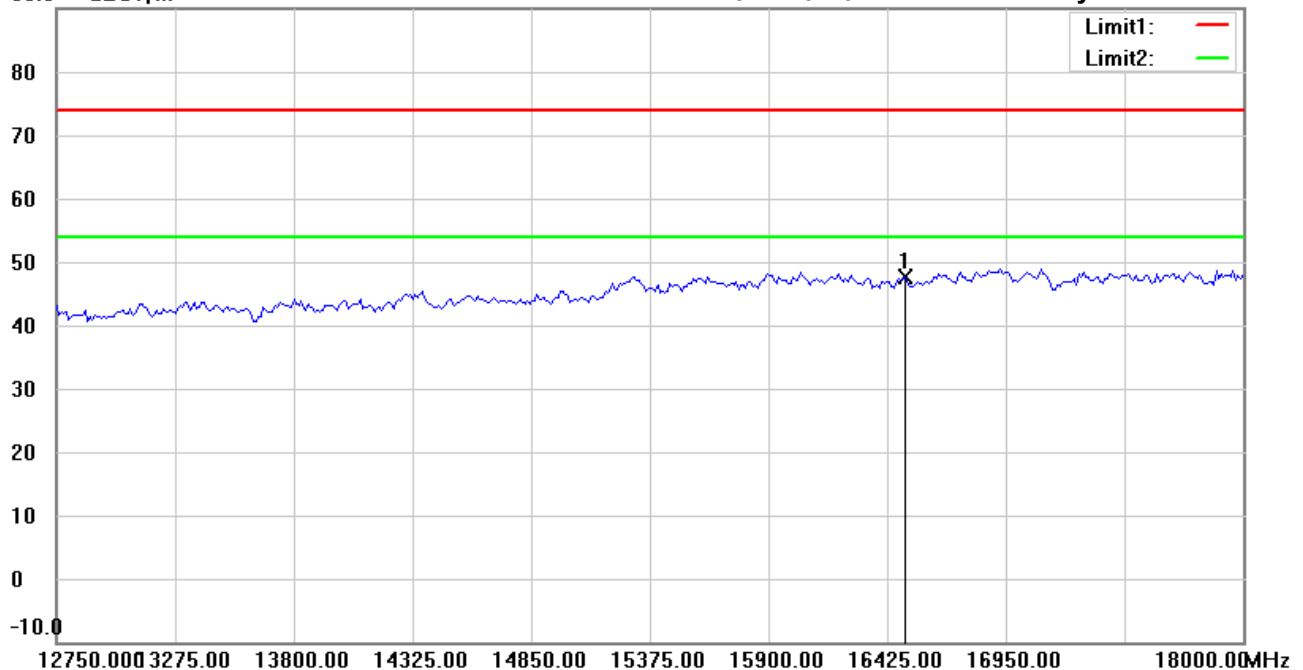
Site : Chamber

Condition : FCC\_part 15E RE\_Above 1GHz\_PK

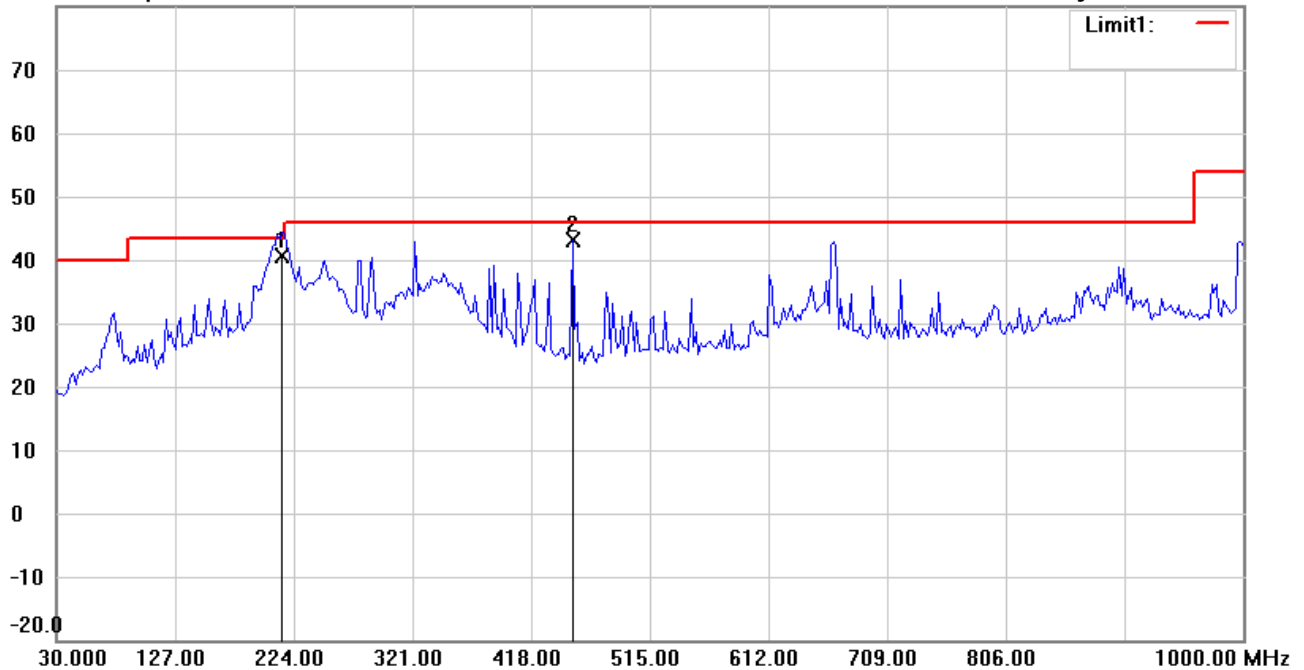
Site : Chamber

Condition : FCC\_part 15 RE-Class E\_30-1000MHz
