# Radiated Emission Measurement

EUT : W6R22002-19655

Test Mode : TX 802.11a CH52

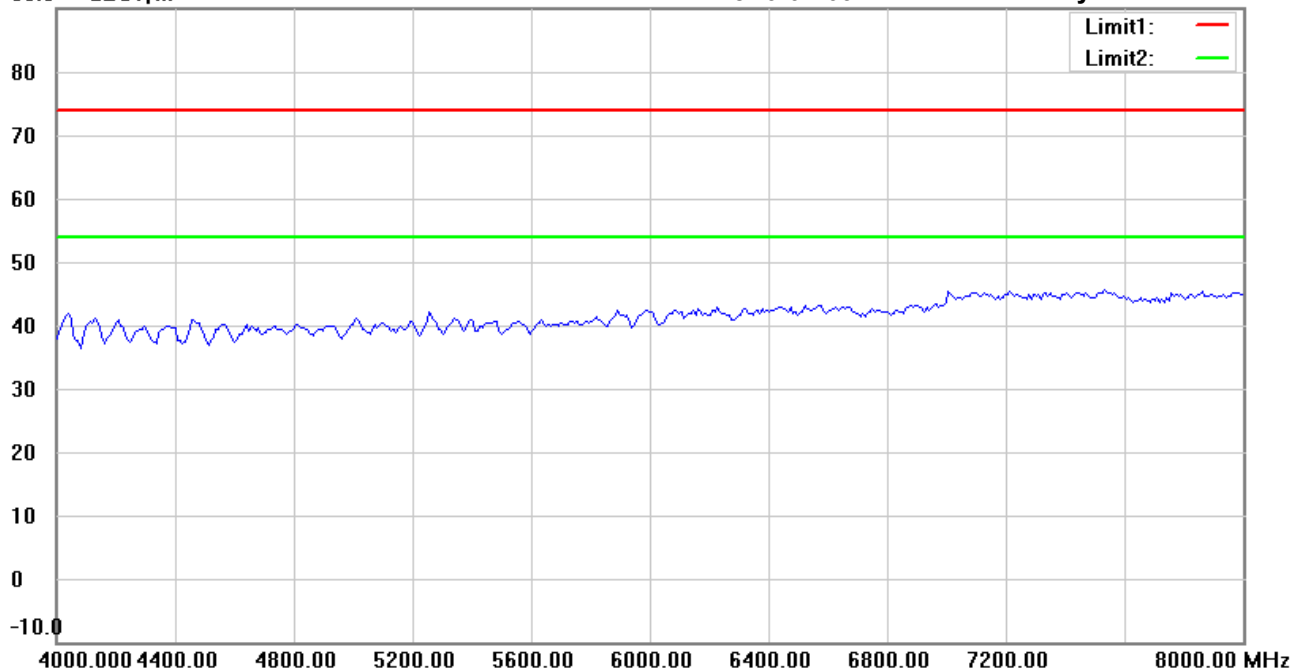
Condition : FCC\_part 15E RE\_Above 1GHz\_PK

Polarization: *Horizontal*

| Mk. | Frequency (MHz) | Reading (dBuV) | Detector | Corr. factor (dB/m) | Result (dBuV/m) | Limit (dBuV/m) | Ant.Pos (cm) | Tab.Pos (deg.) | Margin (dB) | Comment |

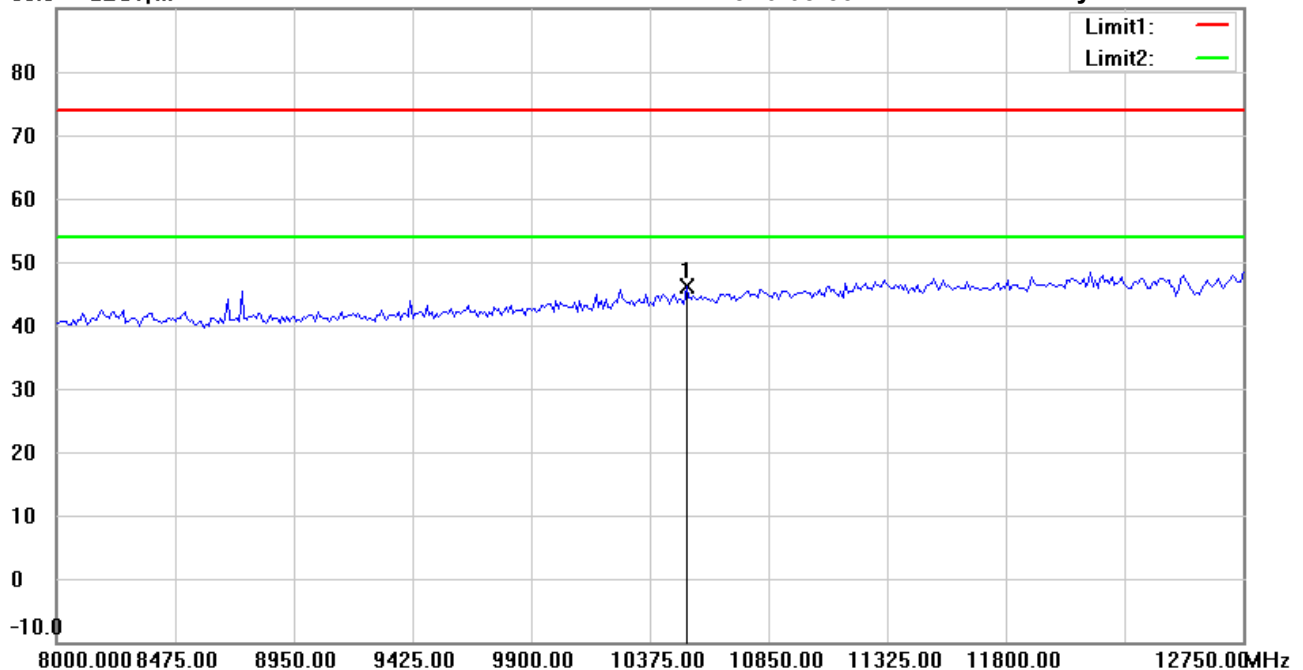
Condition : FCC\_part 15E RE\_Above 1GHz\_PK

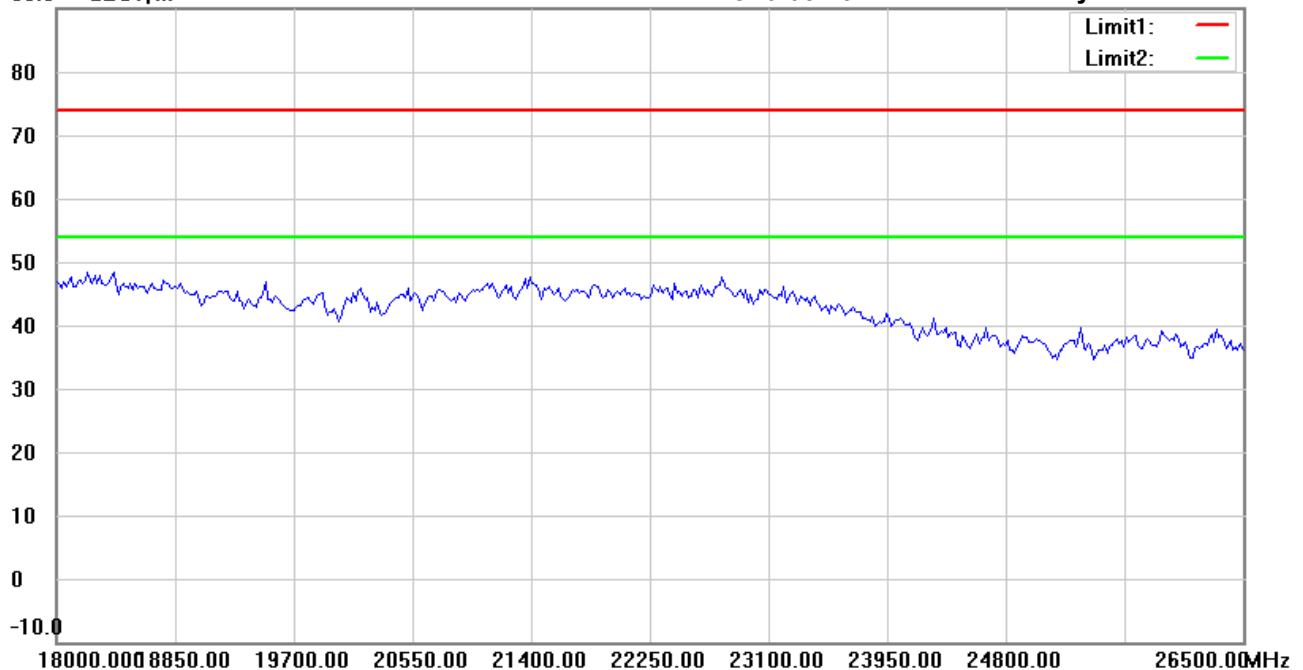
Condition : FCC\_part 15E RE\_Above 1GHz\_PK

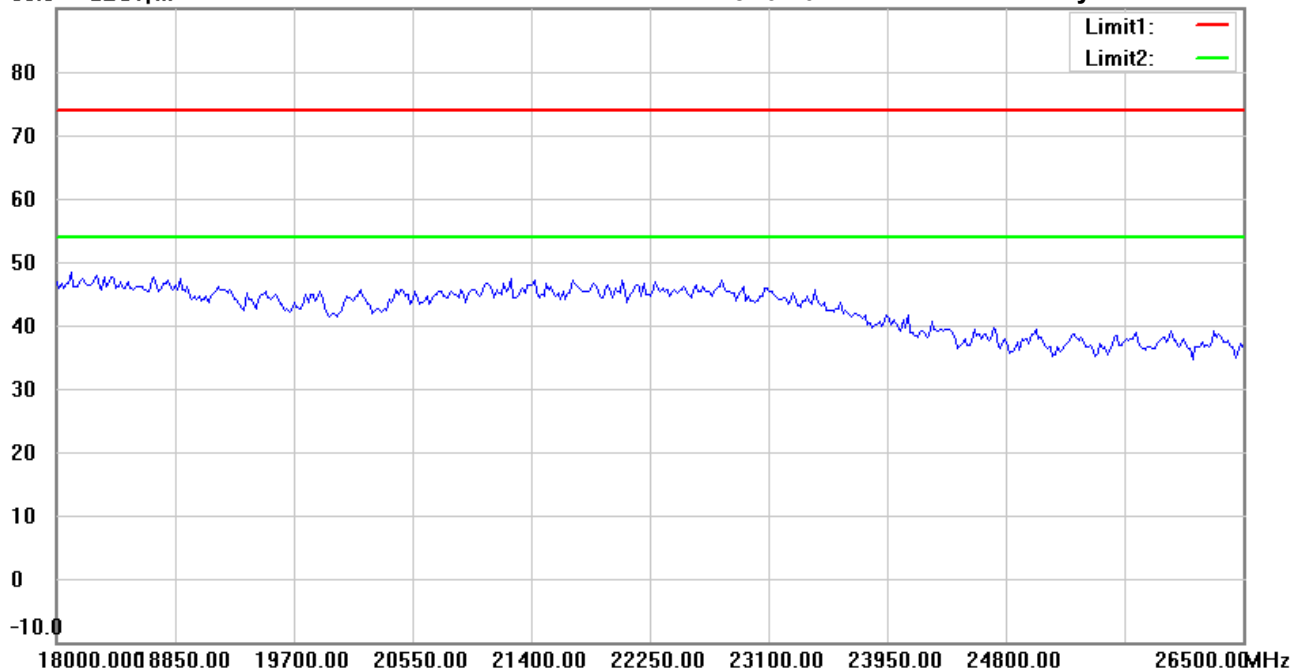
Condition : FCC\_part 15E RE\_Above 1GHz\_PK

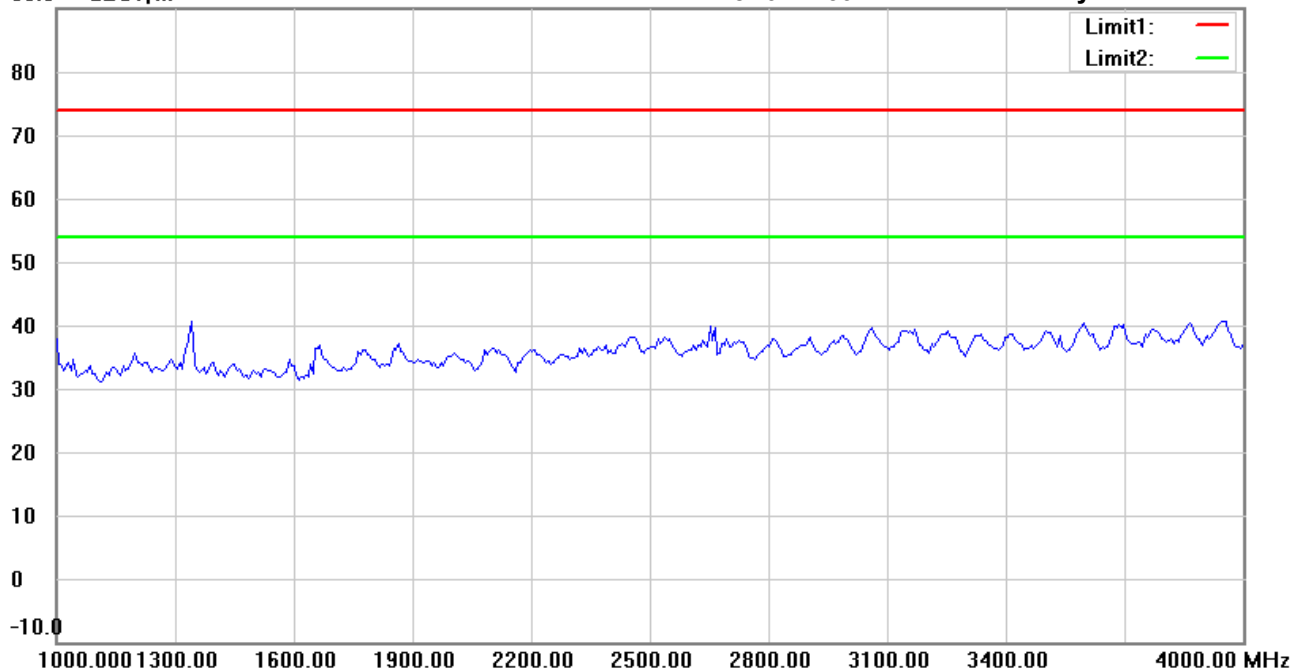
Condition : FCC\_part 15E RE\_Above 1GHz\_PK

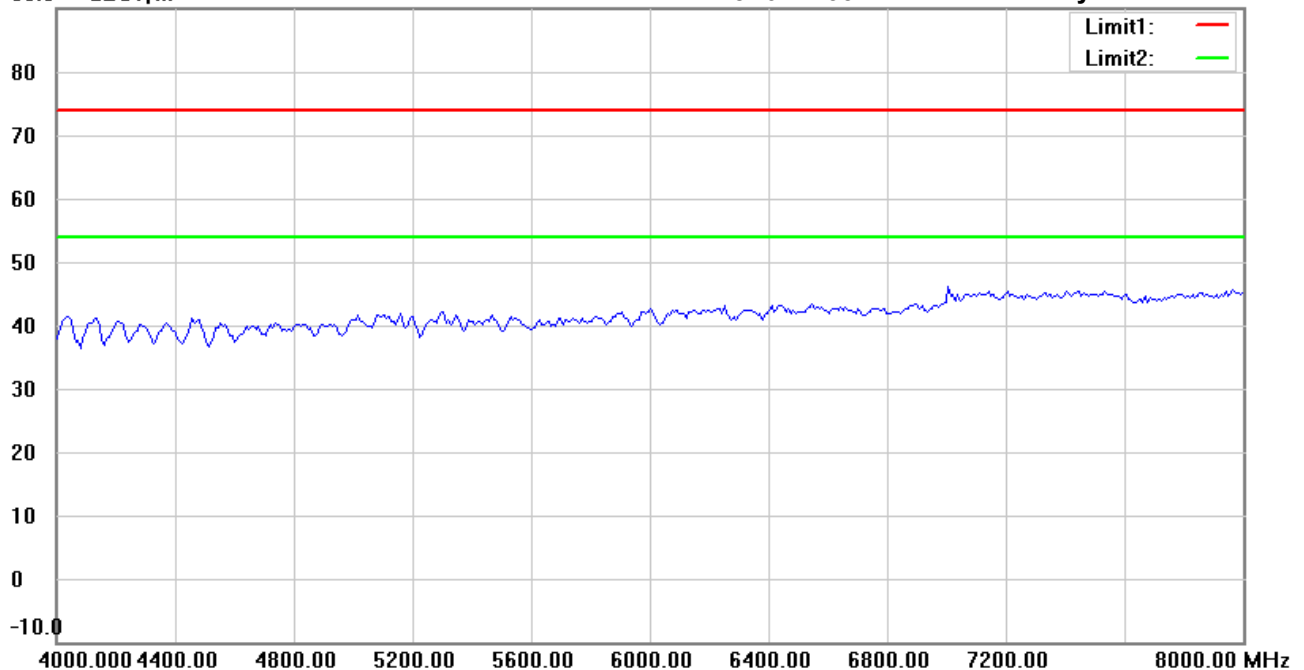
Condition : FCC\_part 15E RE\_Above 1GHz\_PK

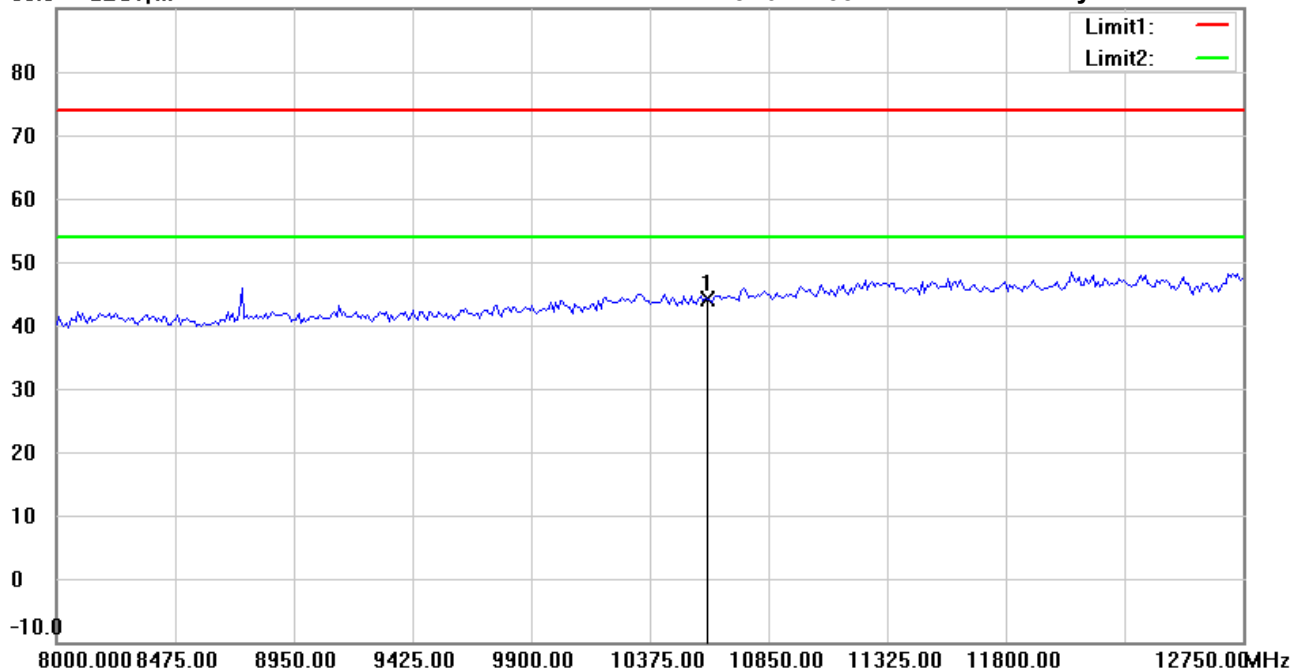
Condition : FCC\_part 15E RE\_Above 1GHz\_PK

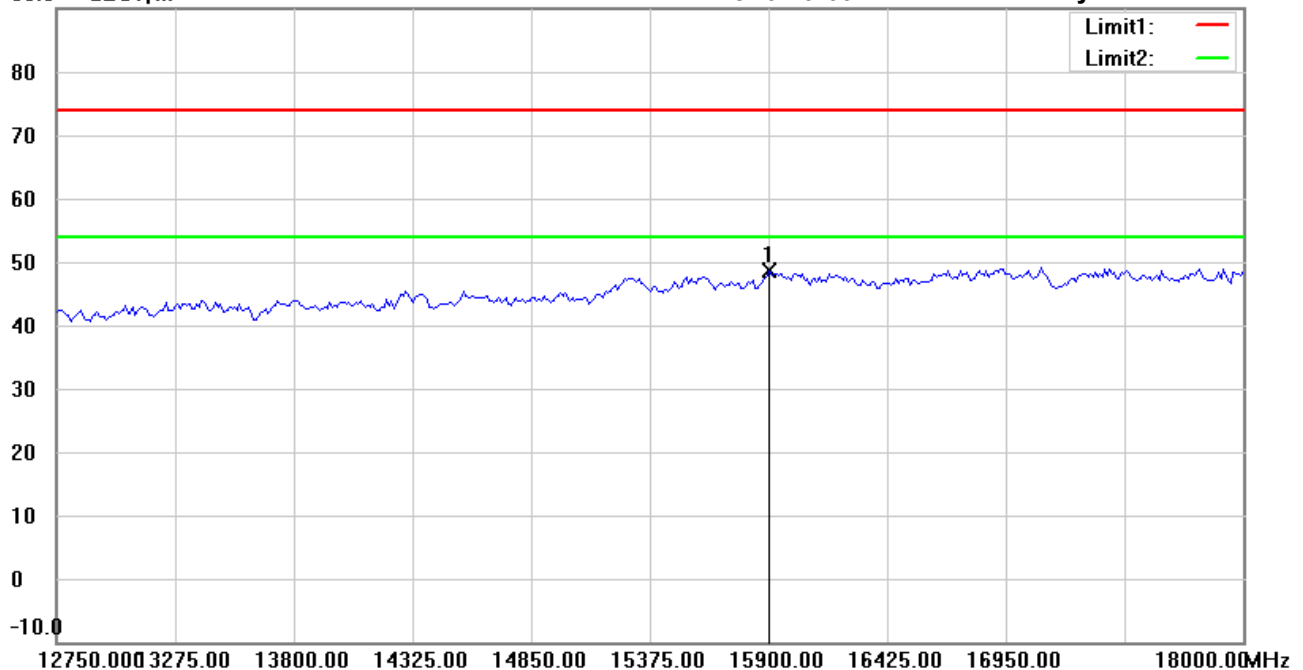
Condition : FCC\_part 15E RE\_Above 1GHz\_PK

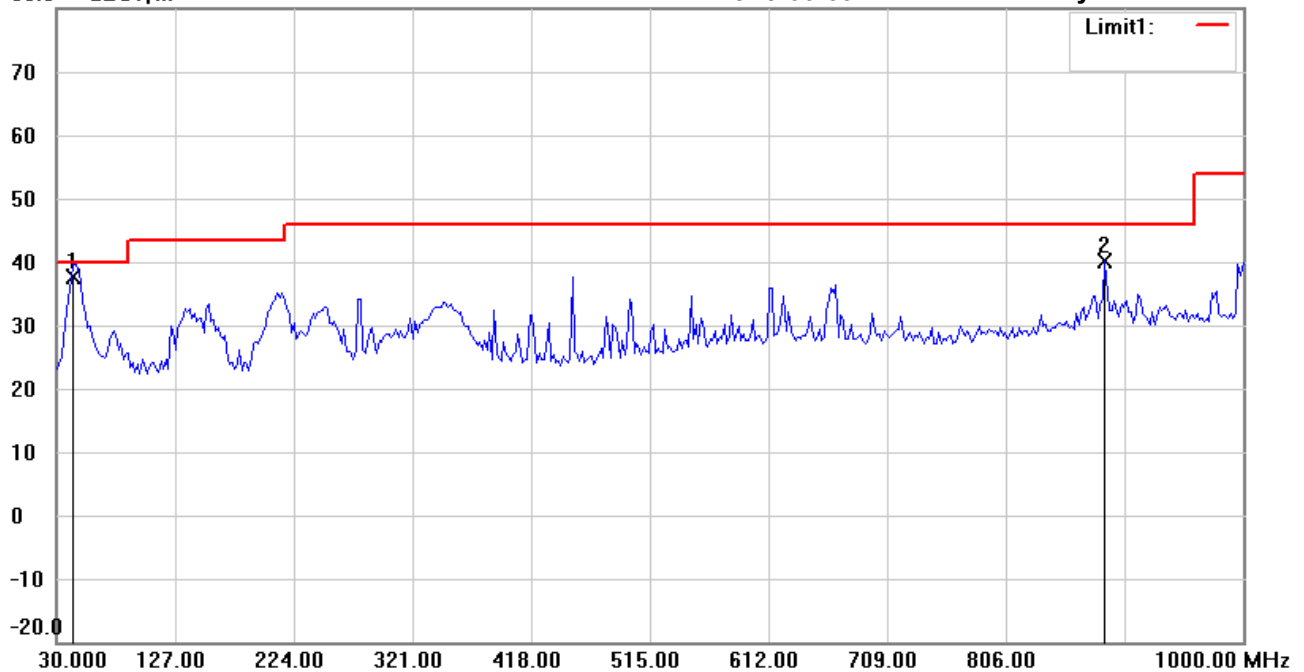
Condition : FCC\_part 15 RE-Class E\_30-1000MHz
