## Band Edge

## APPENDIX: PHOTOGRAPHS OF TEST CONFIGURATION

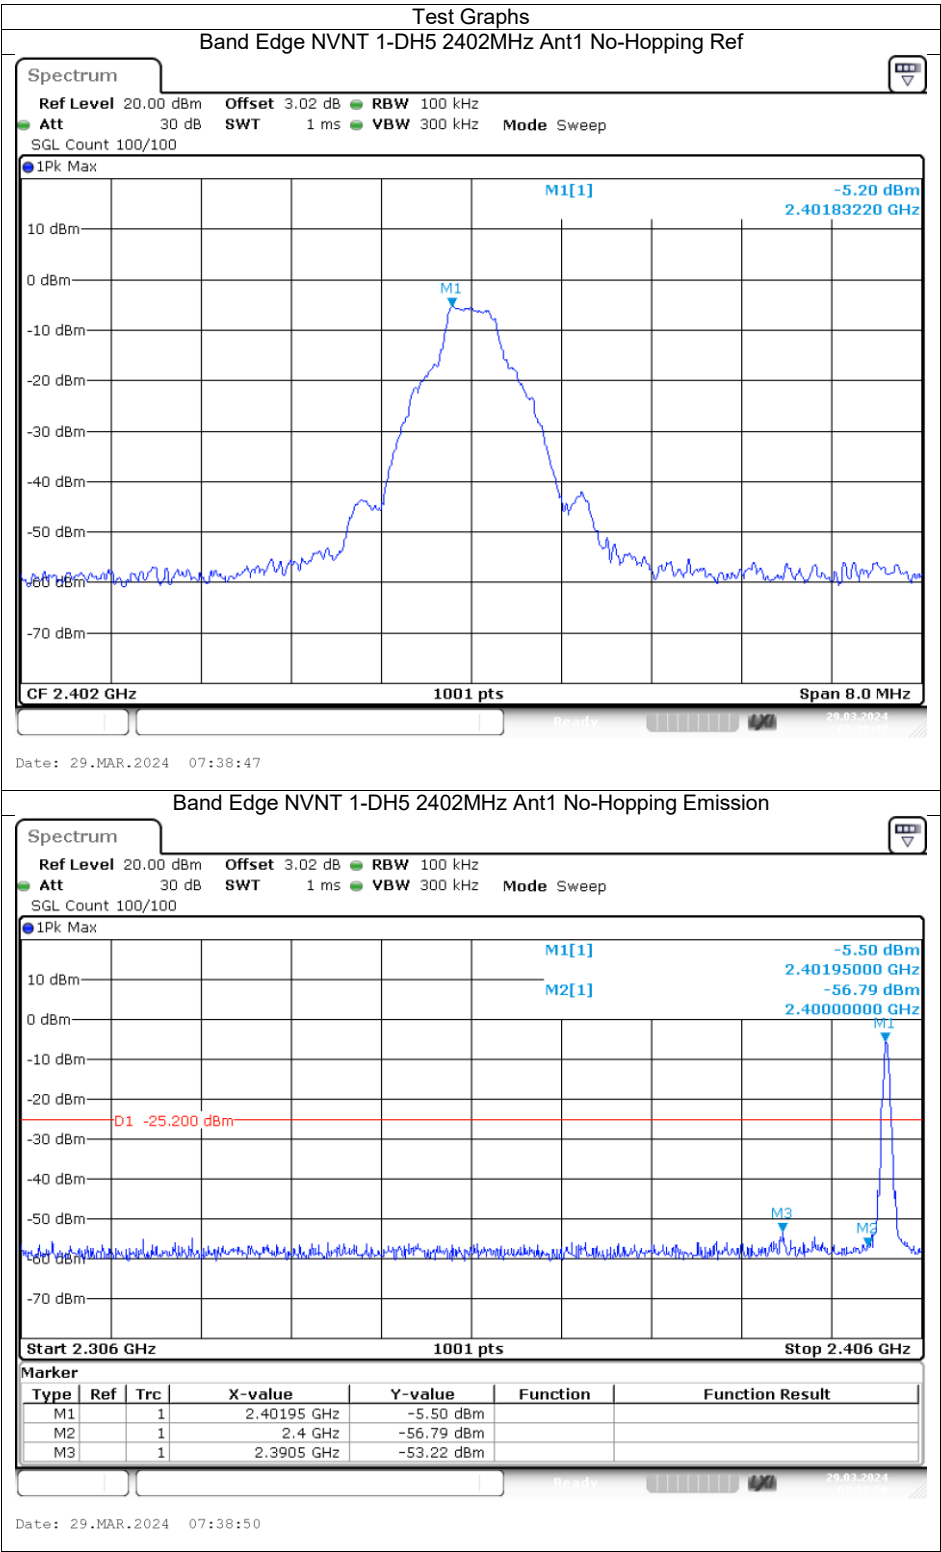
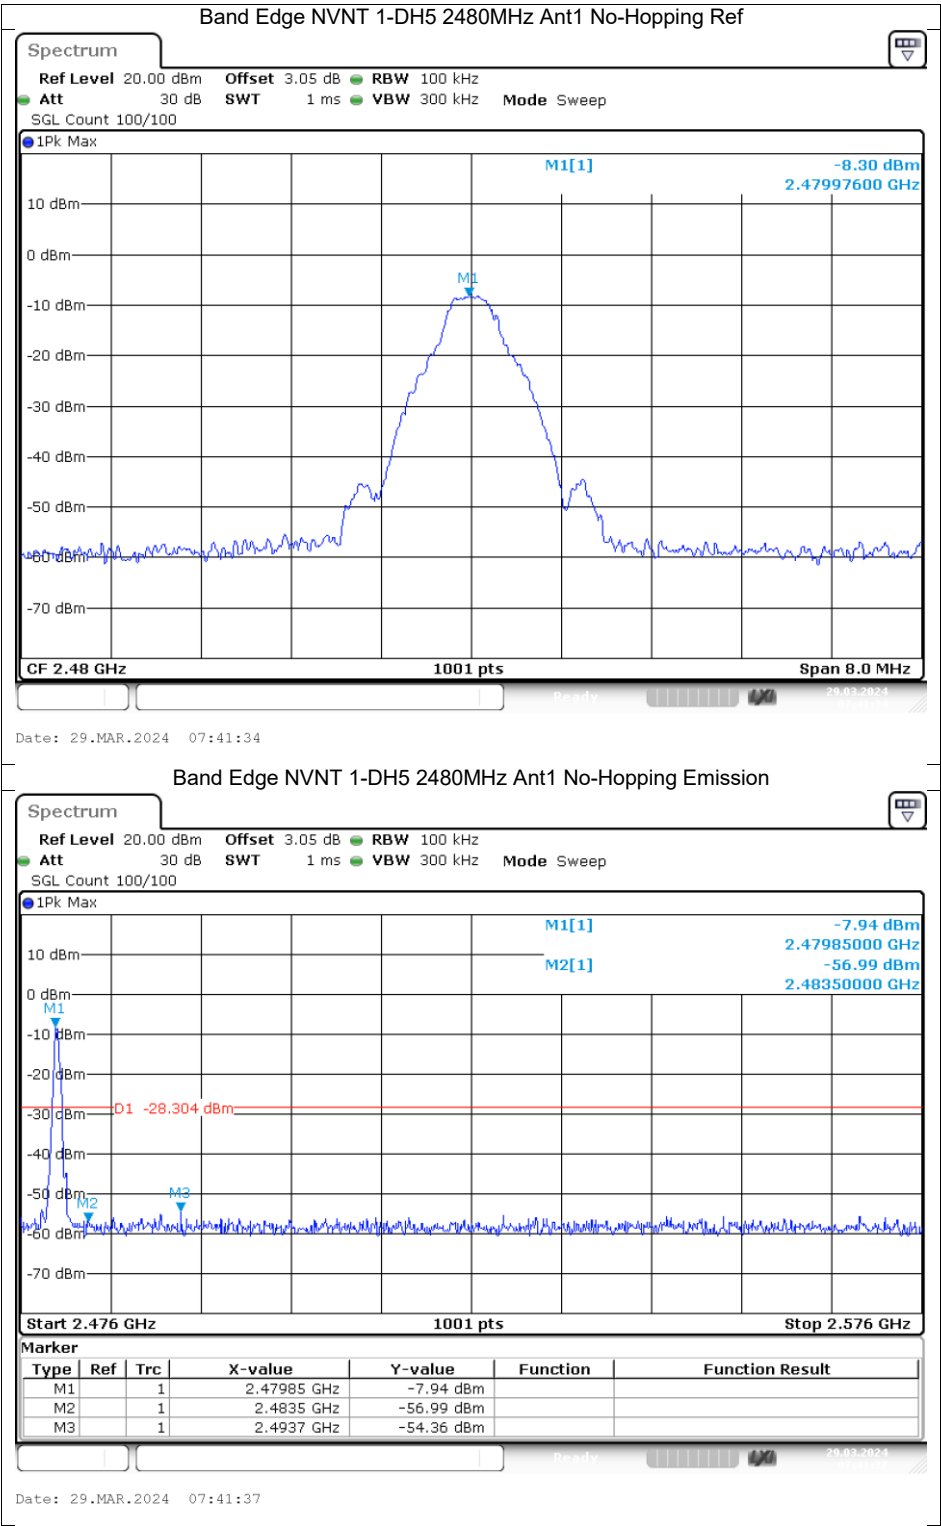
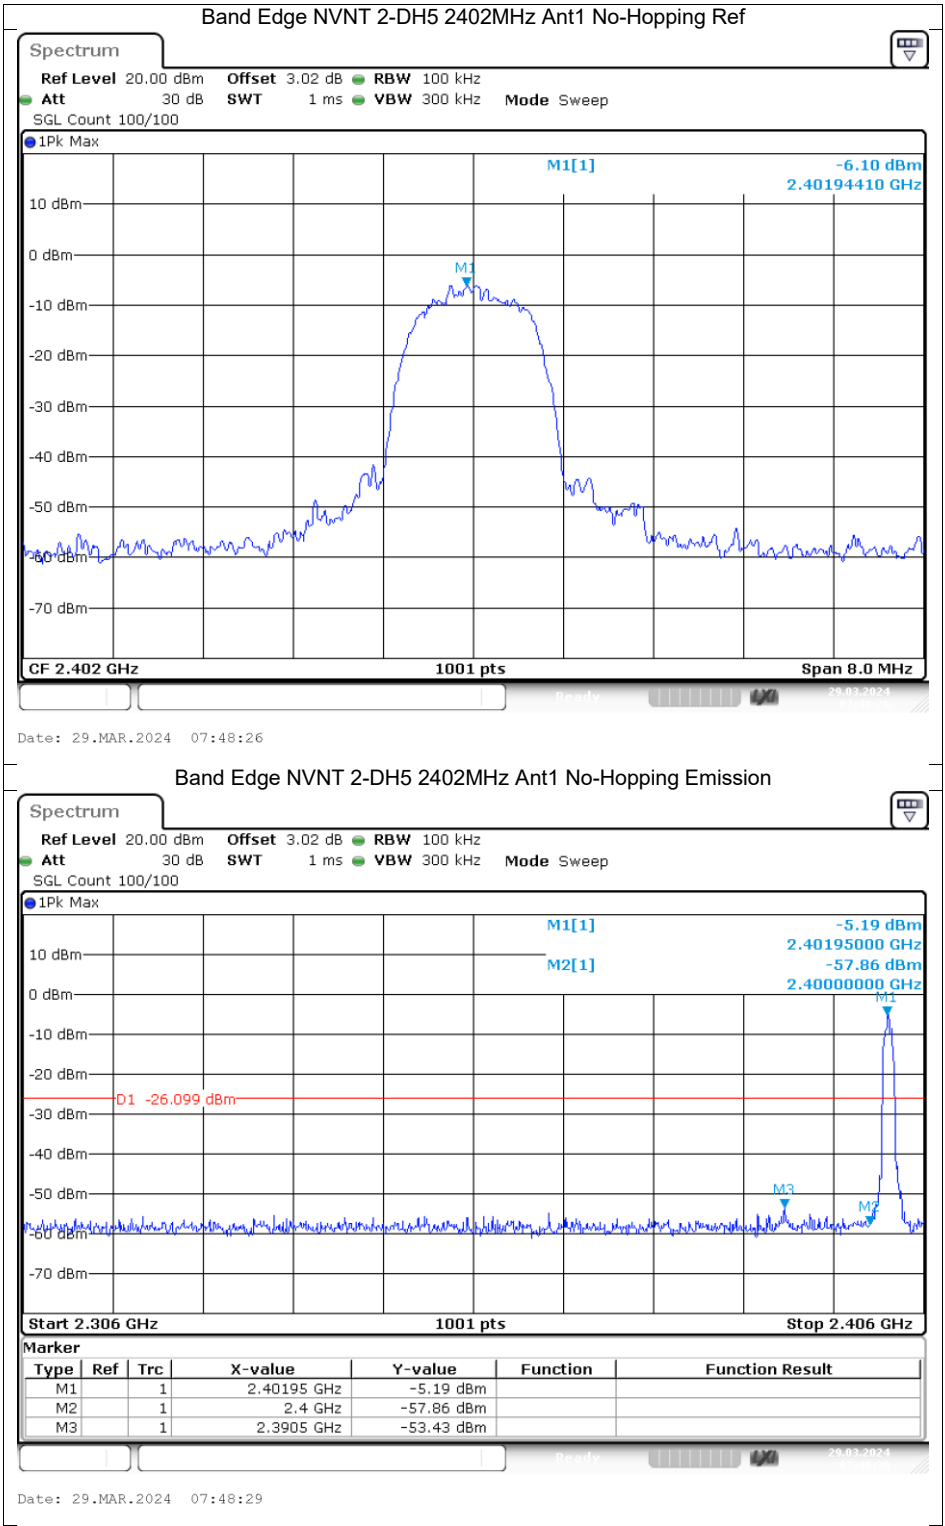
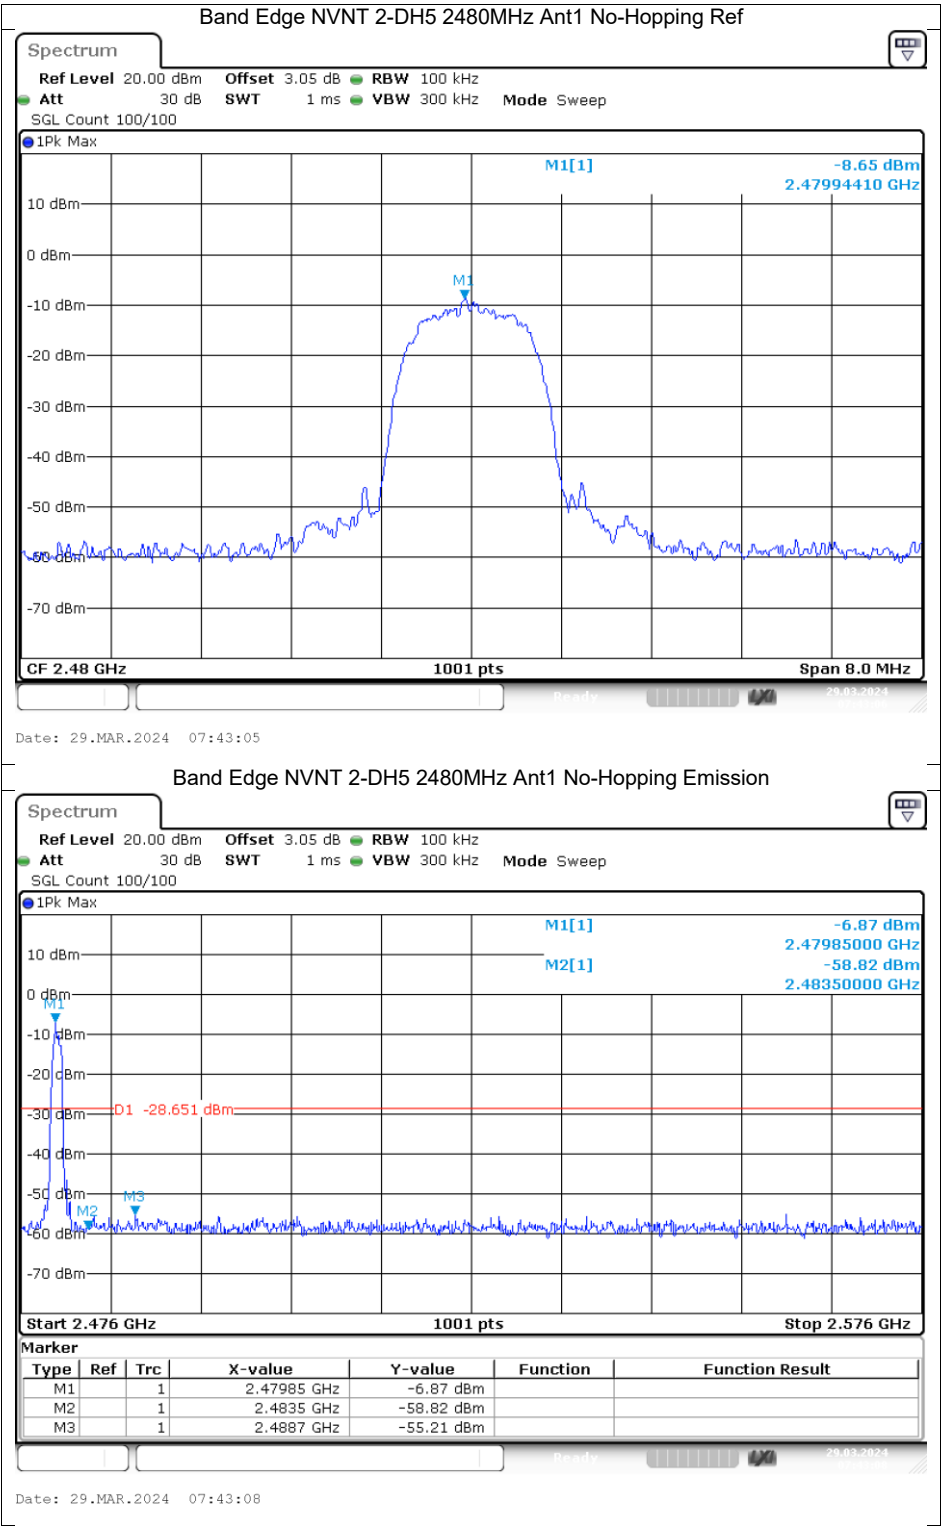
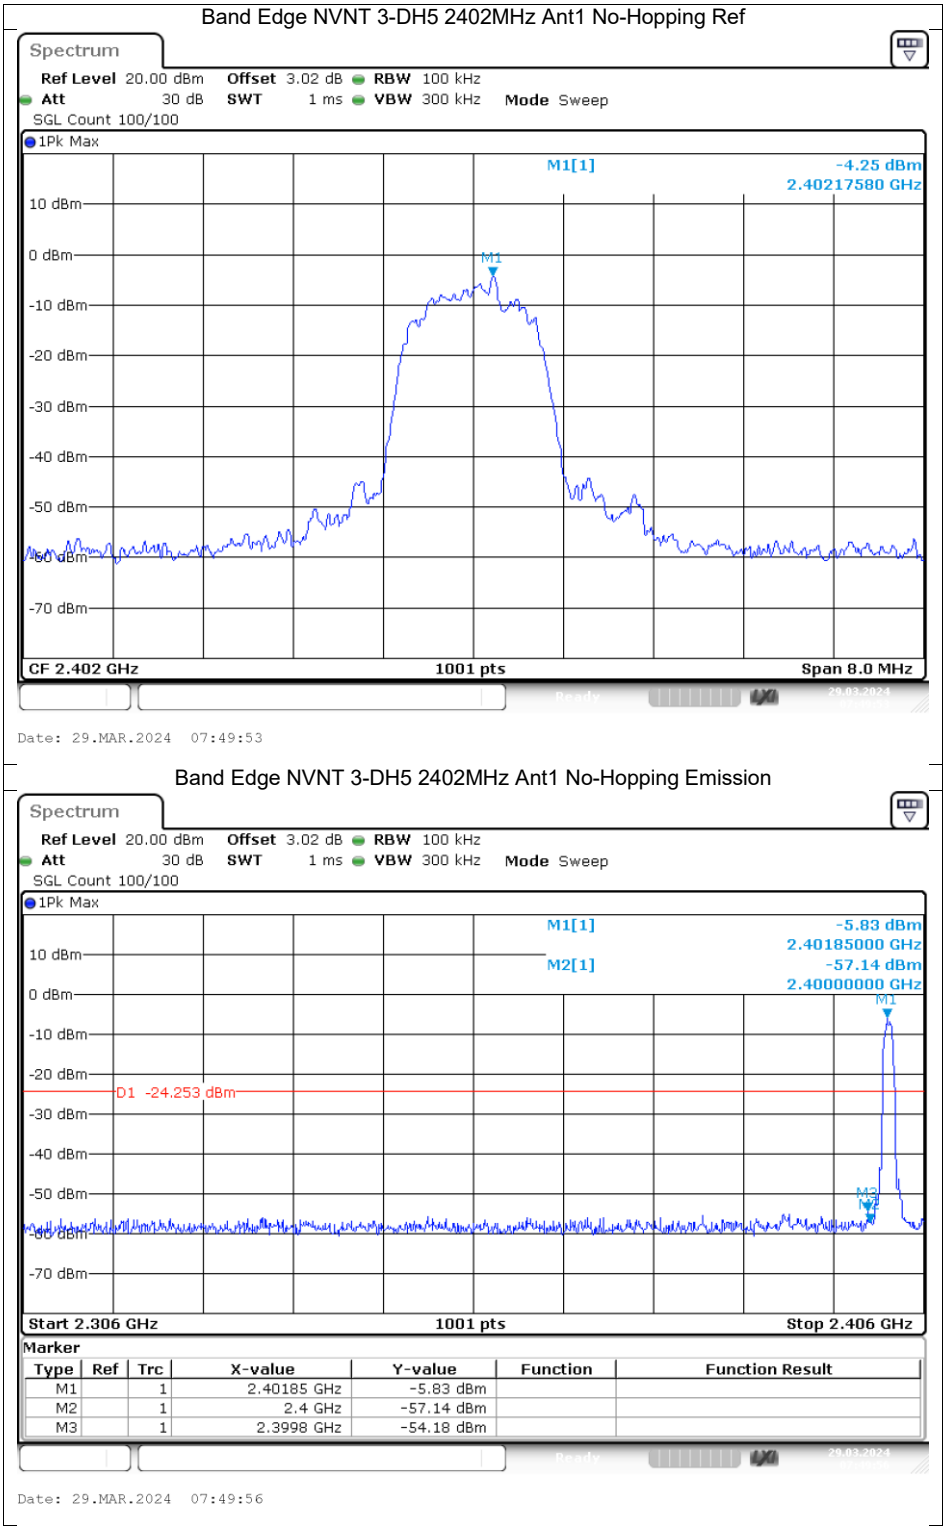
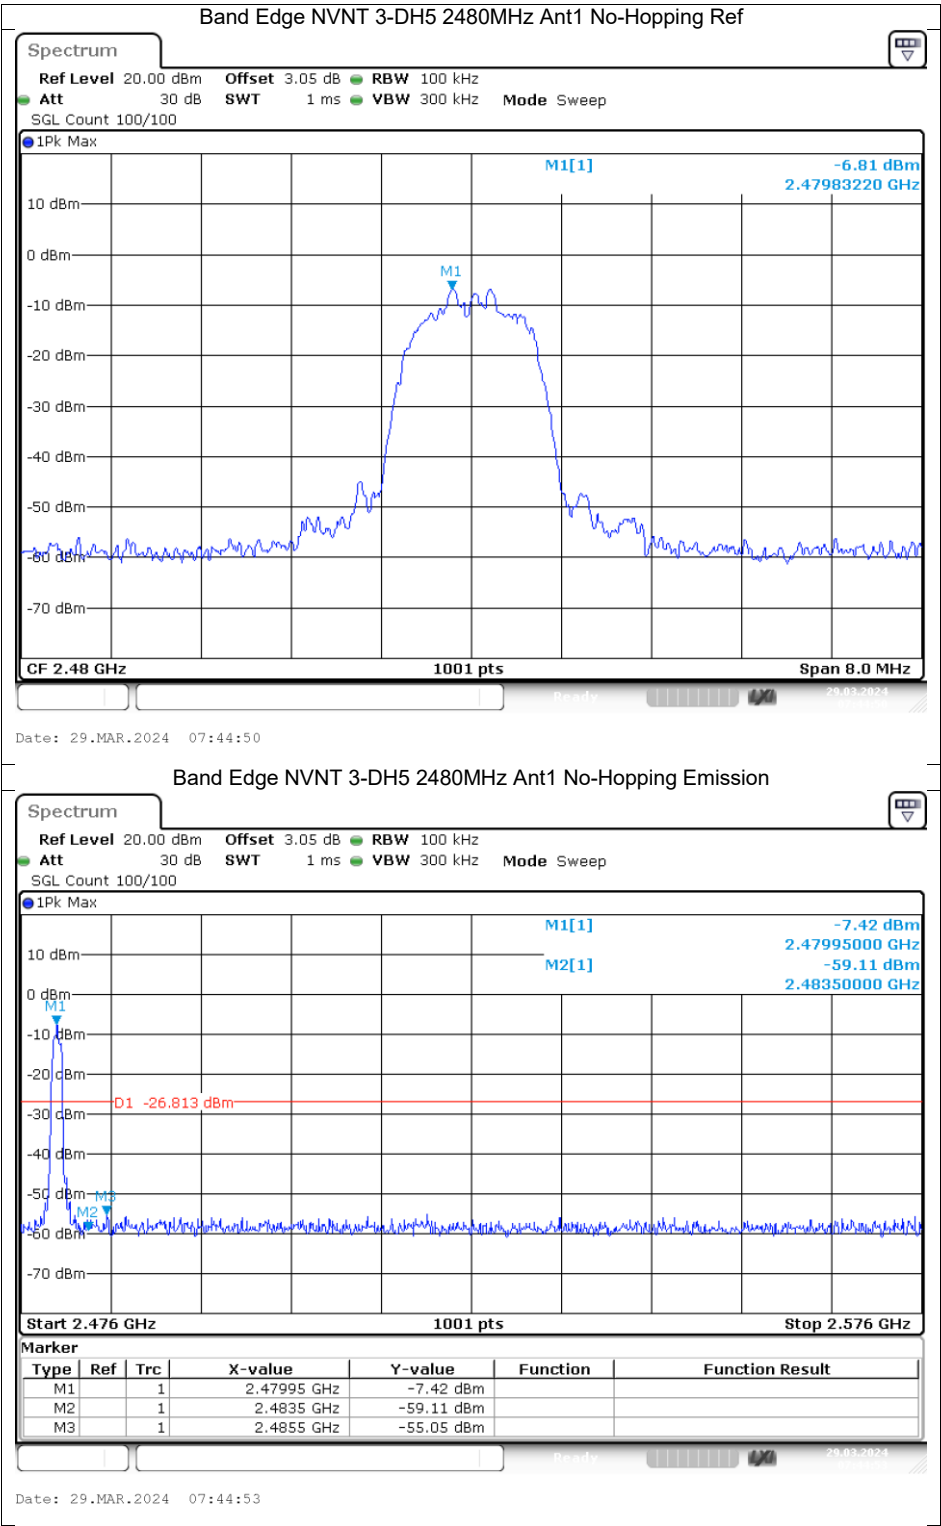
| Condition | Mode | Frequency (MHz) | Antenna | Hopping Mode | Max Value (dBc) | Limit (dBc) | Verdict |

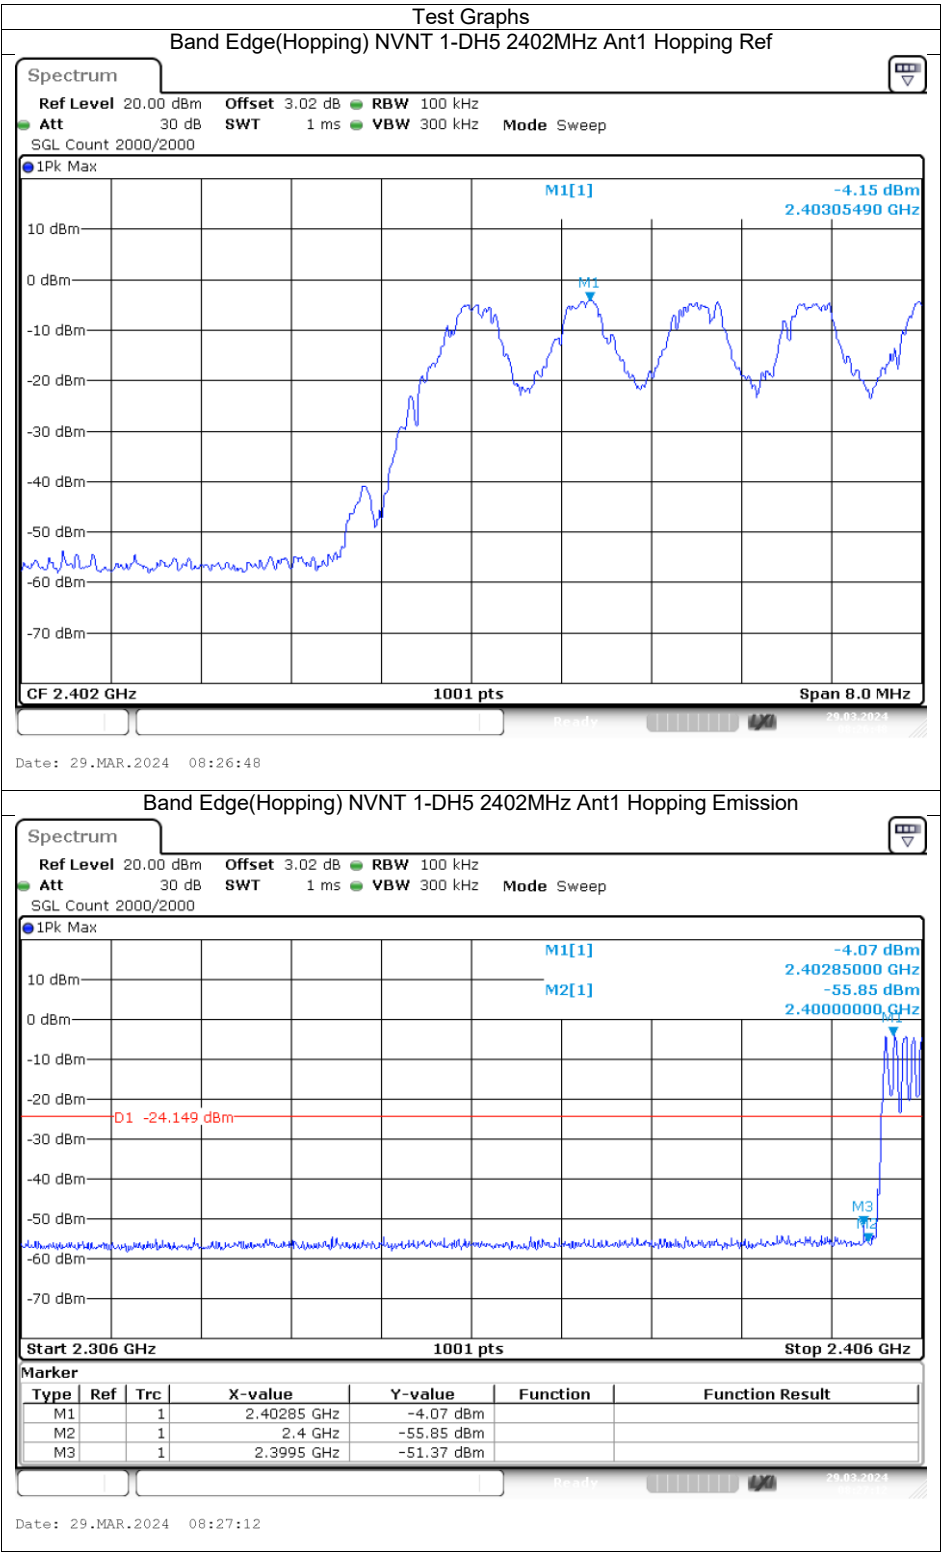
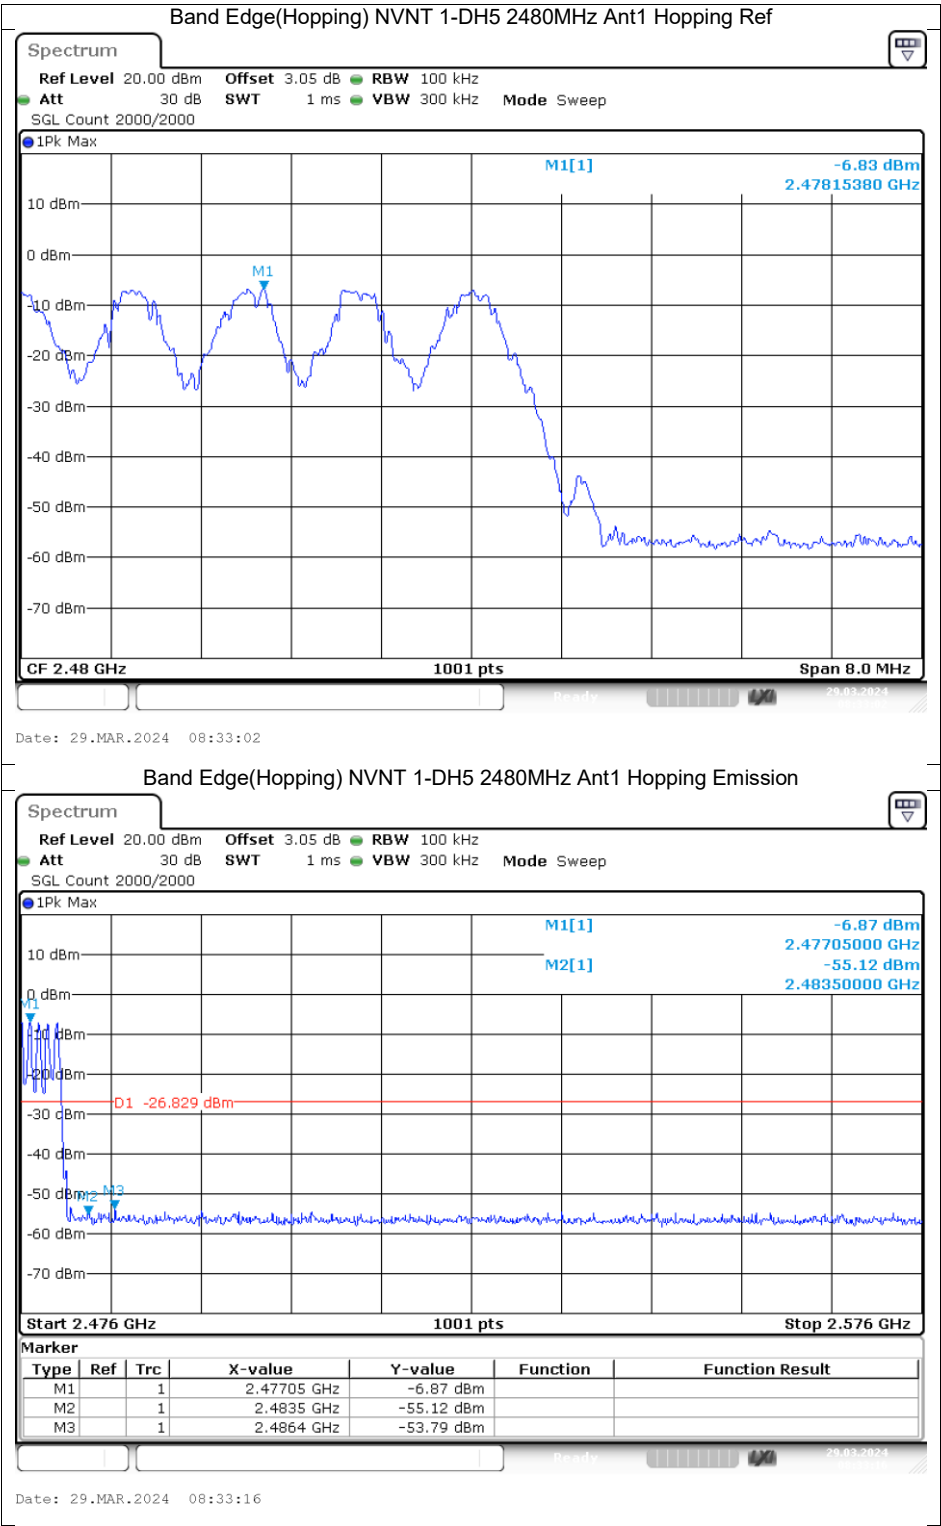
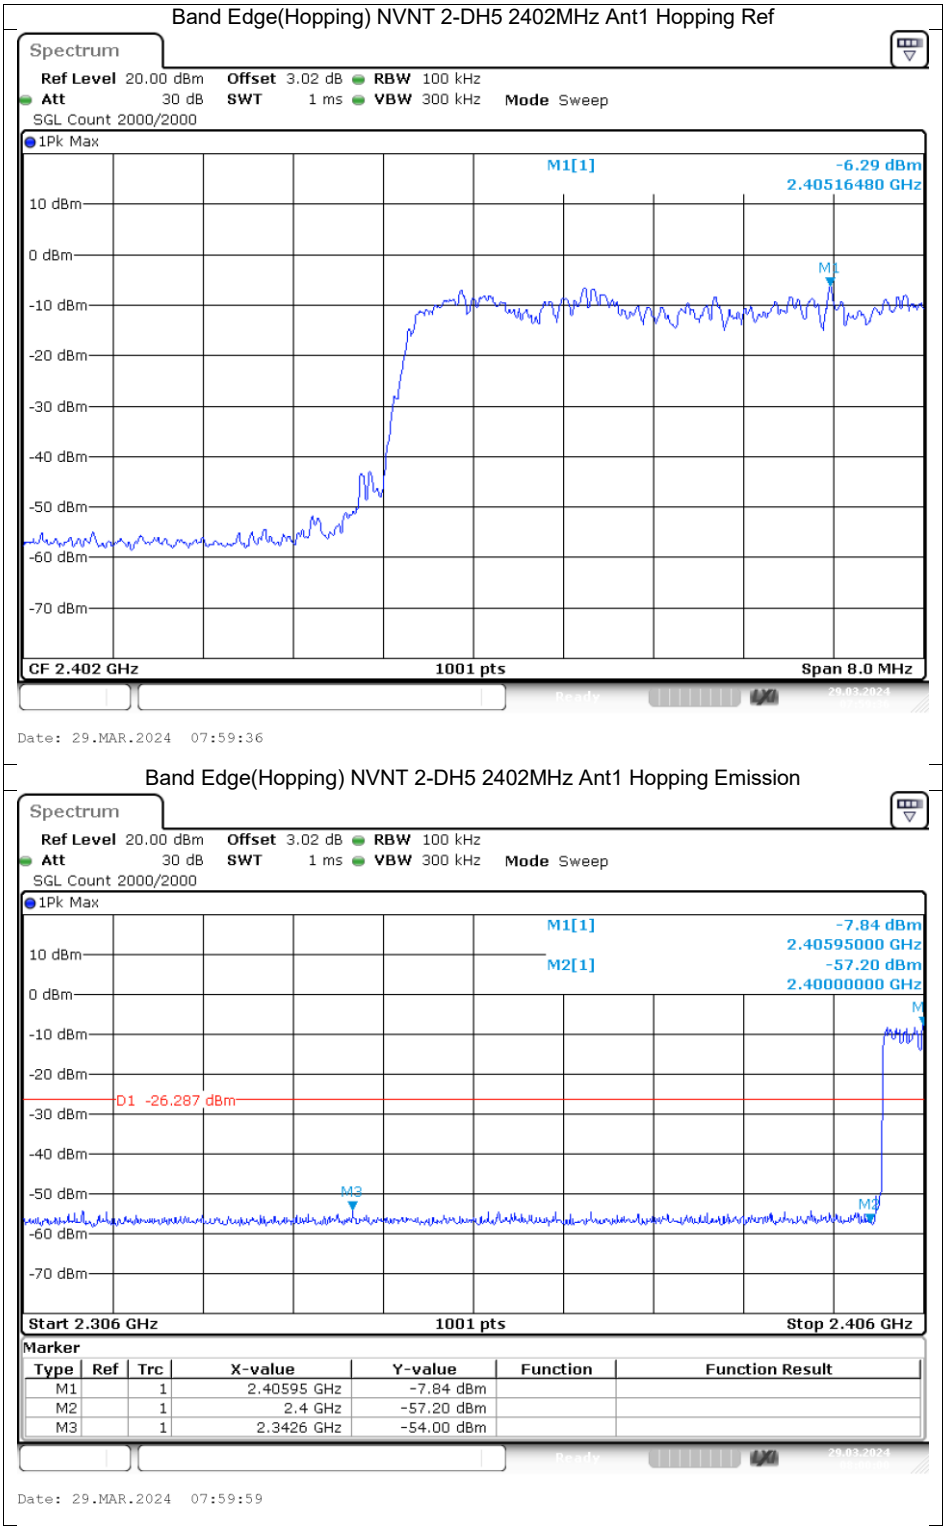
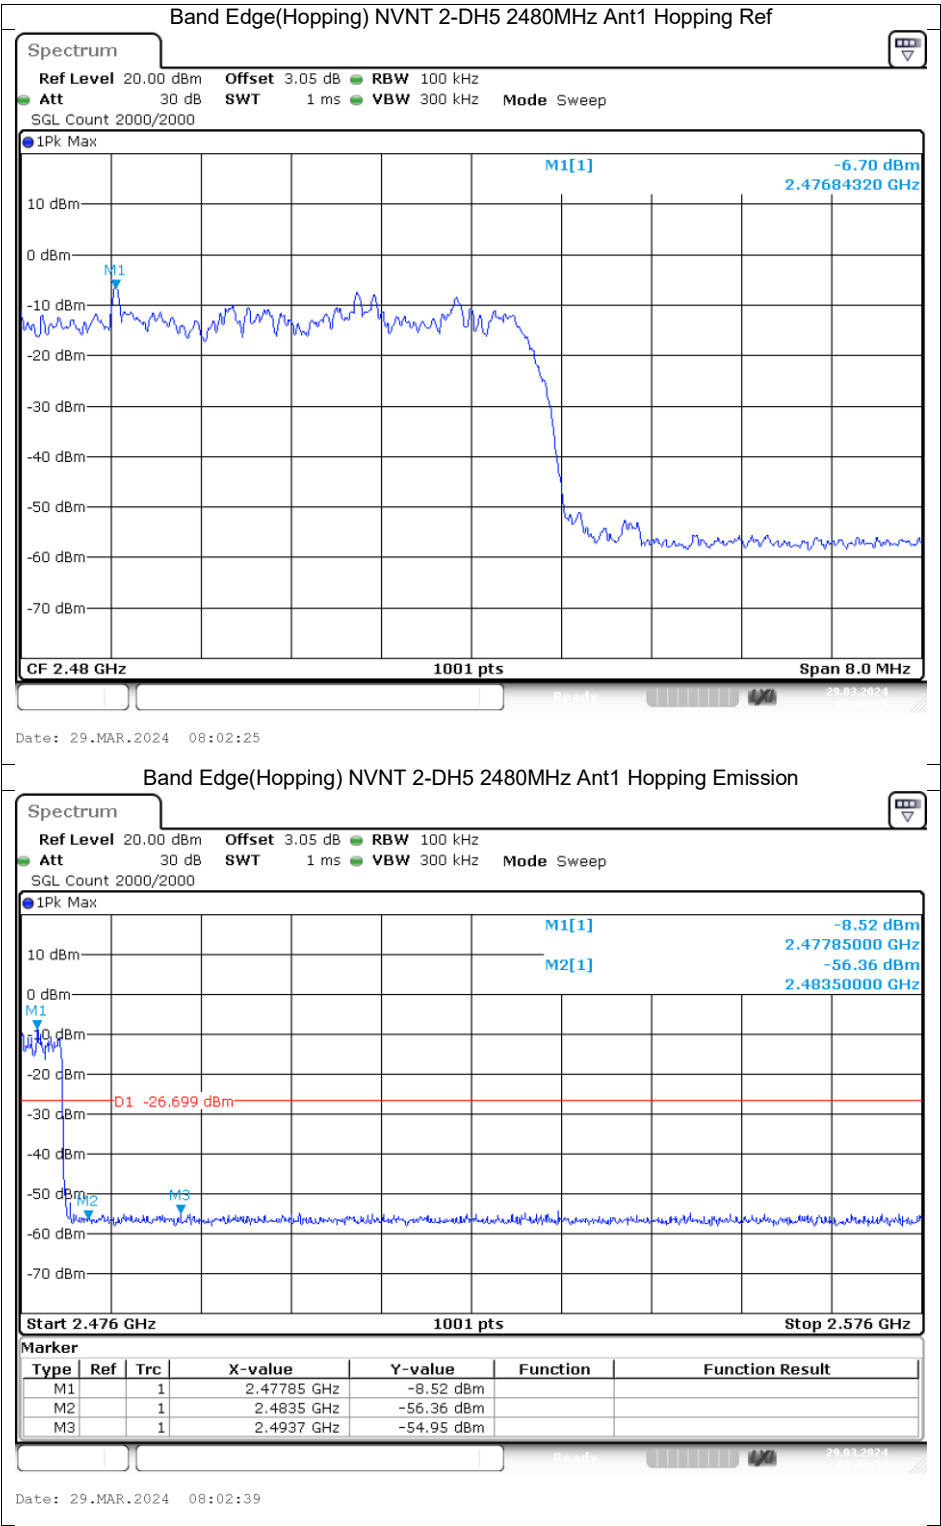
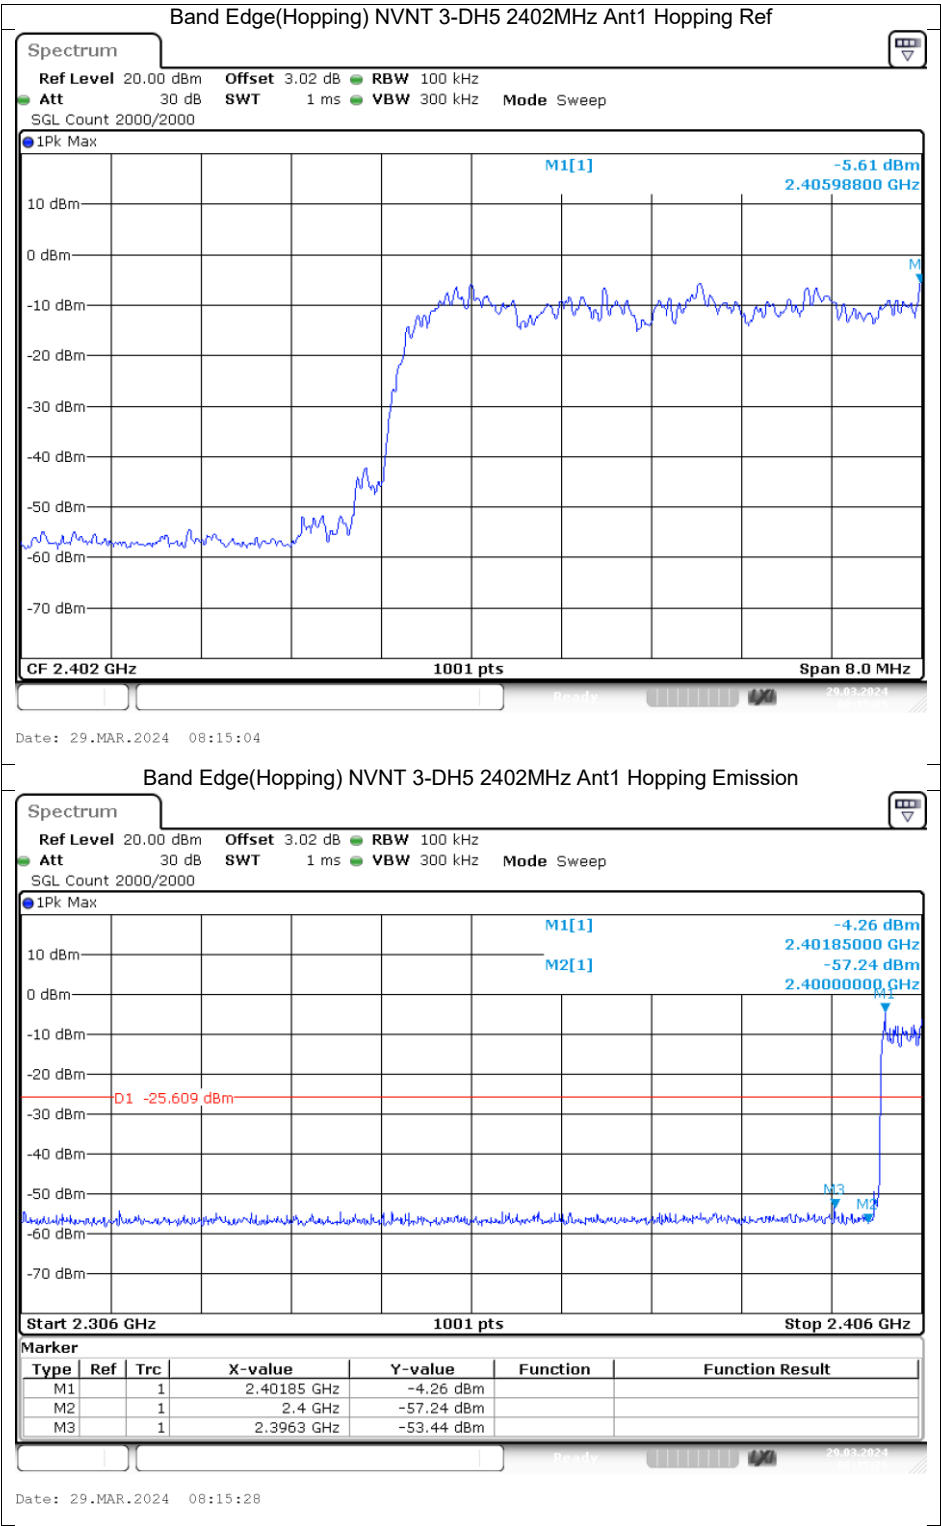
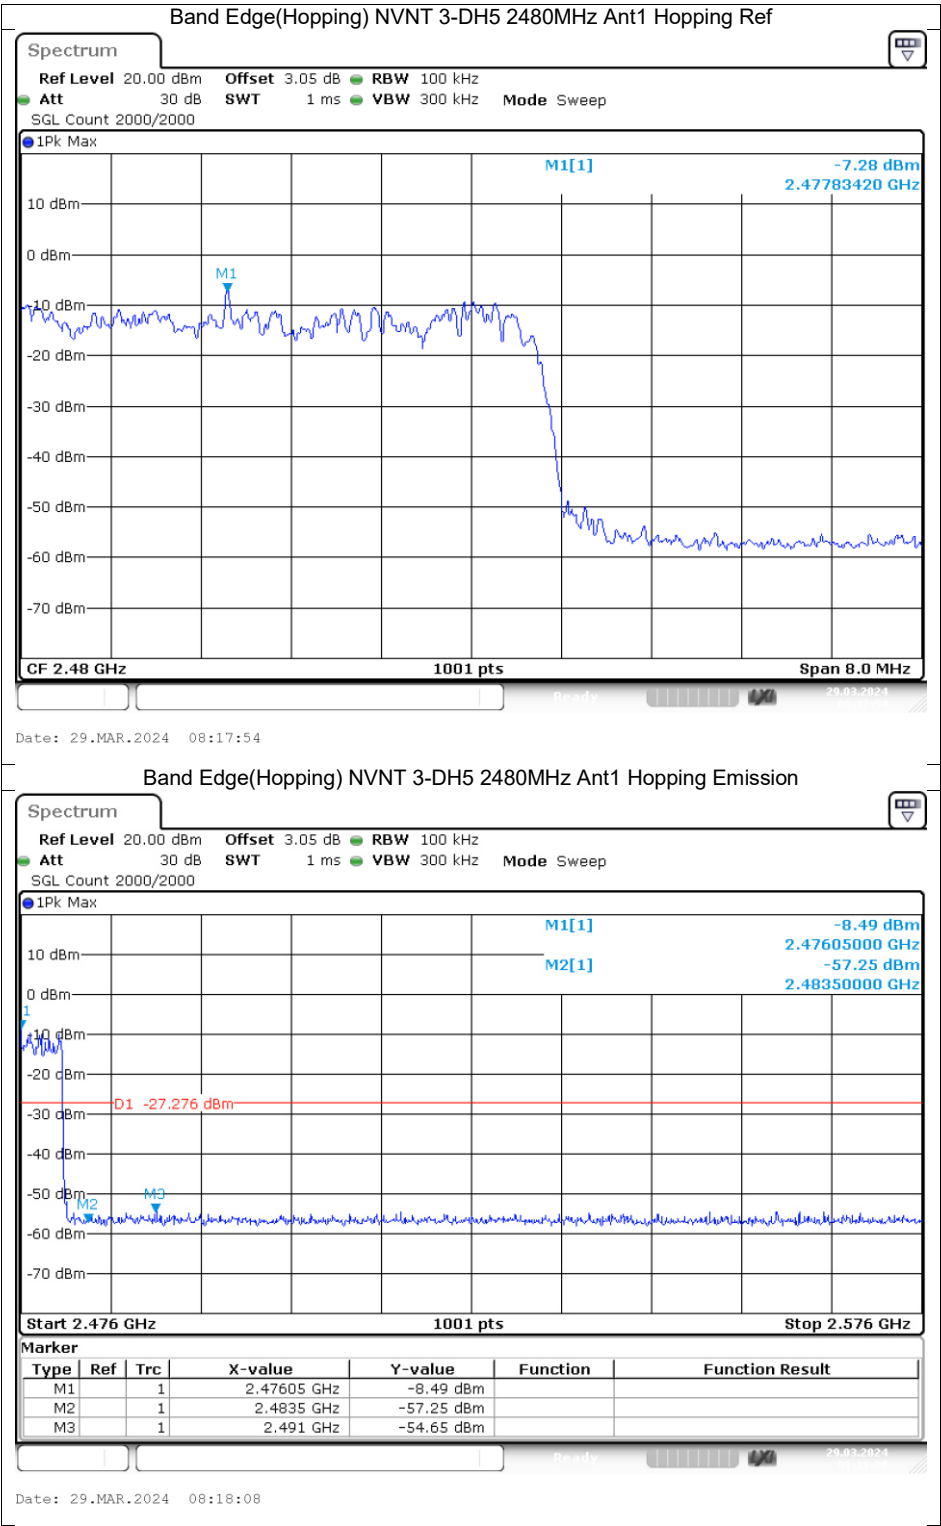
## Band Edge(Hopping)

| Condition | Mode | Frequency (MHz) | Antenna | Hopping Mode | Max Value (dBc) | Limit (dBc) | Verdict |
