## Band Edge

## APPENDIX: PHOTOGRAPHS OF TEST CONFIGURATION

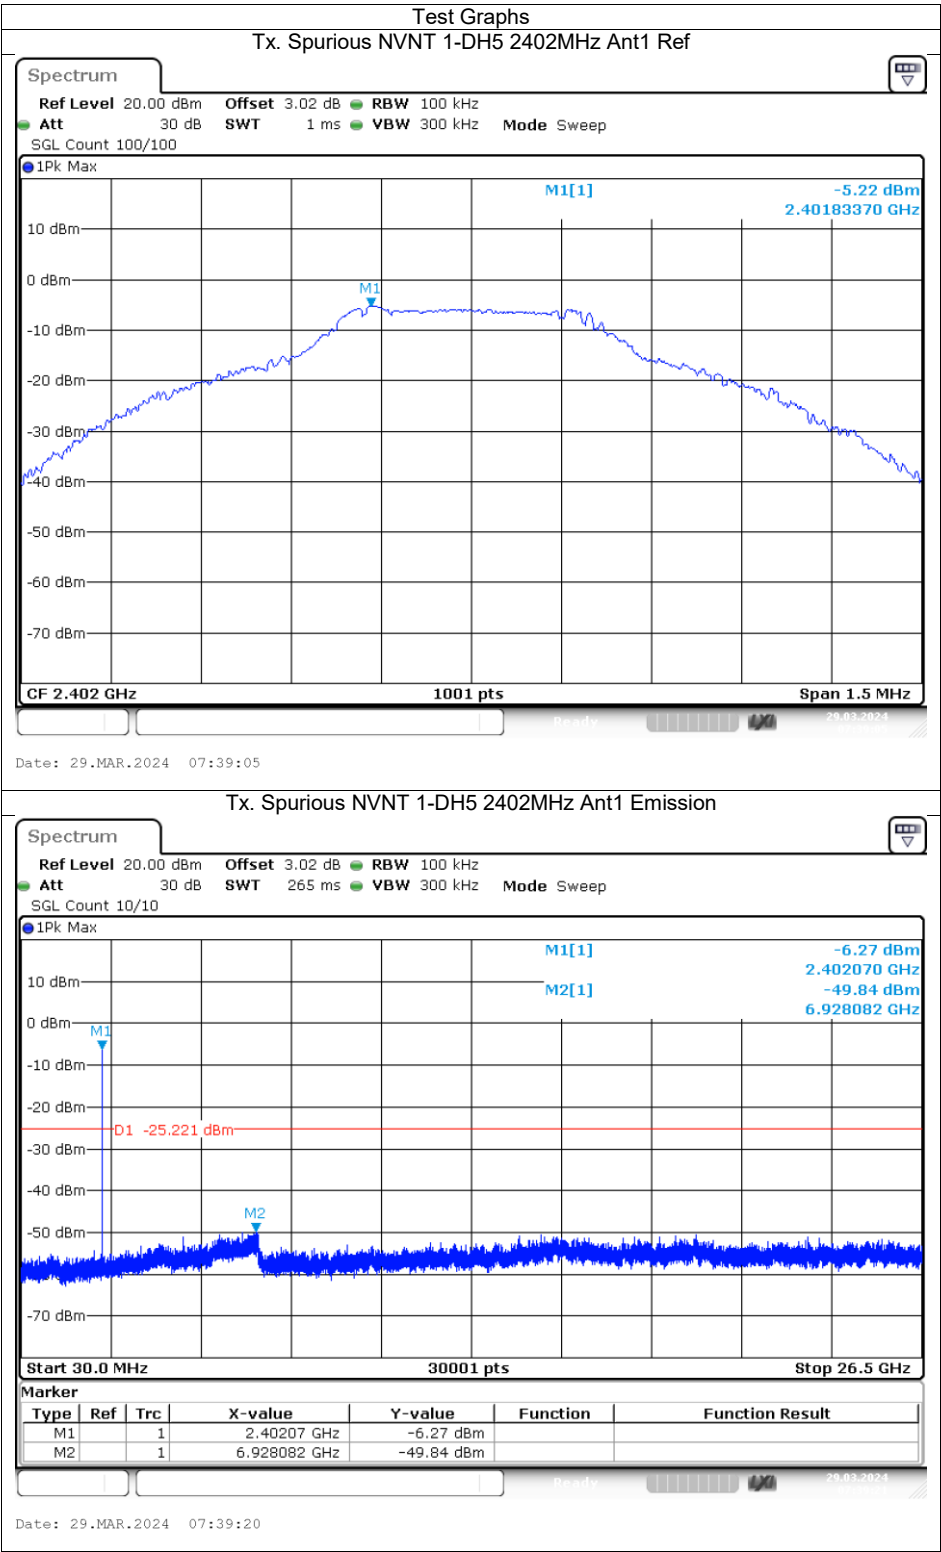
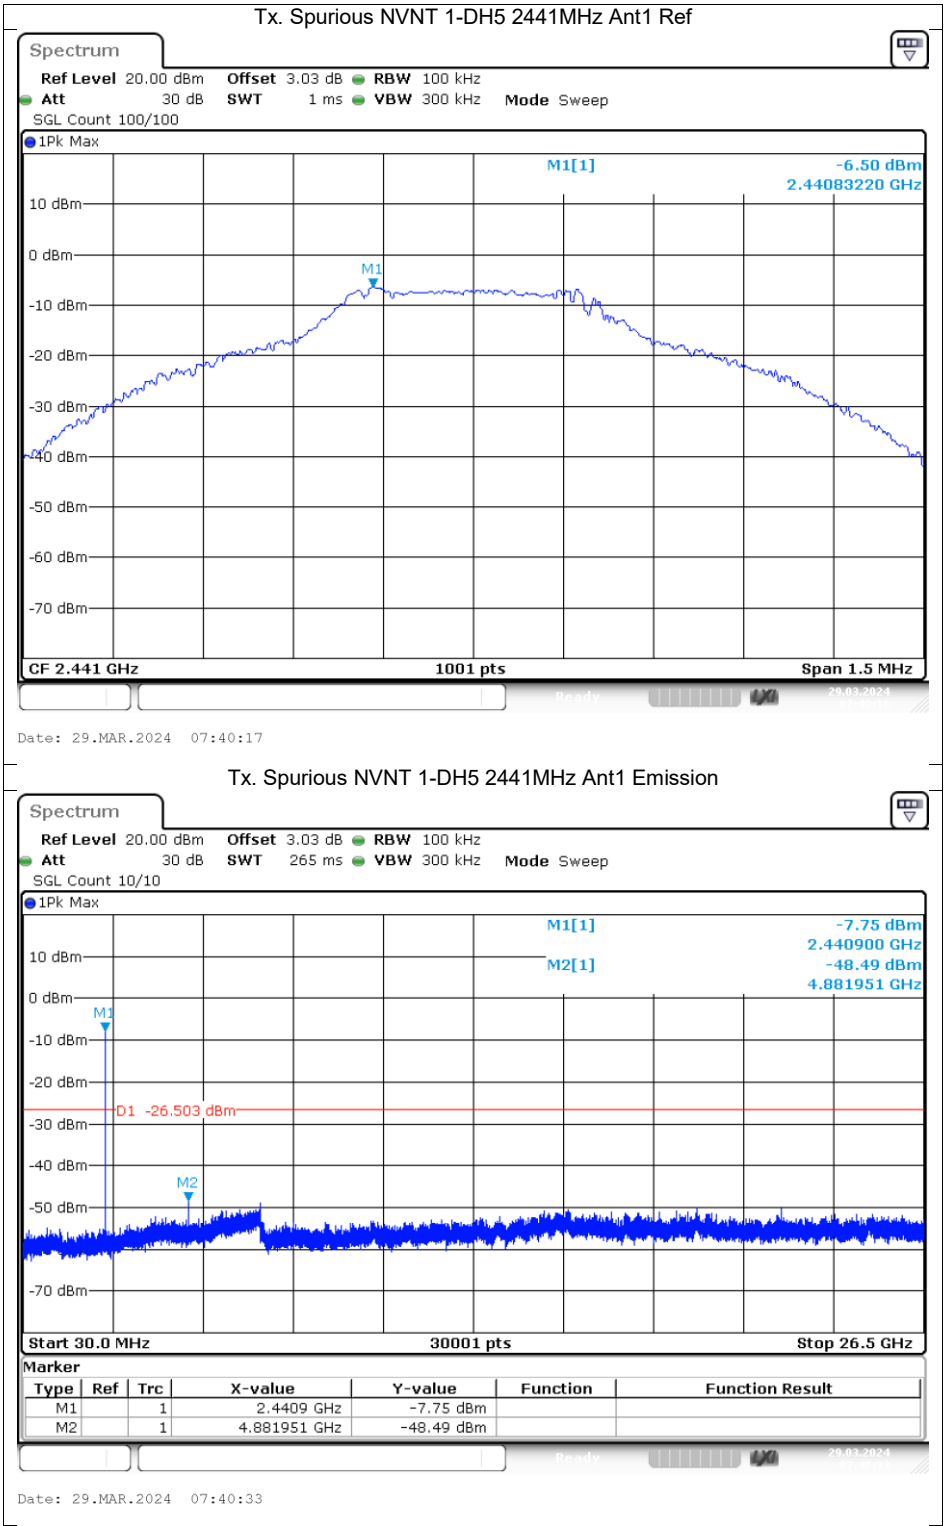
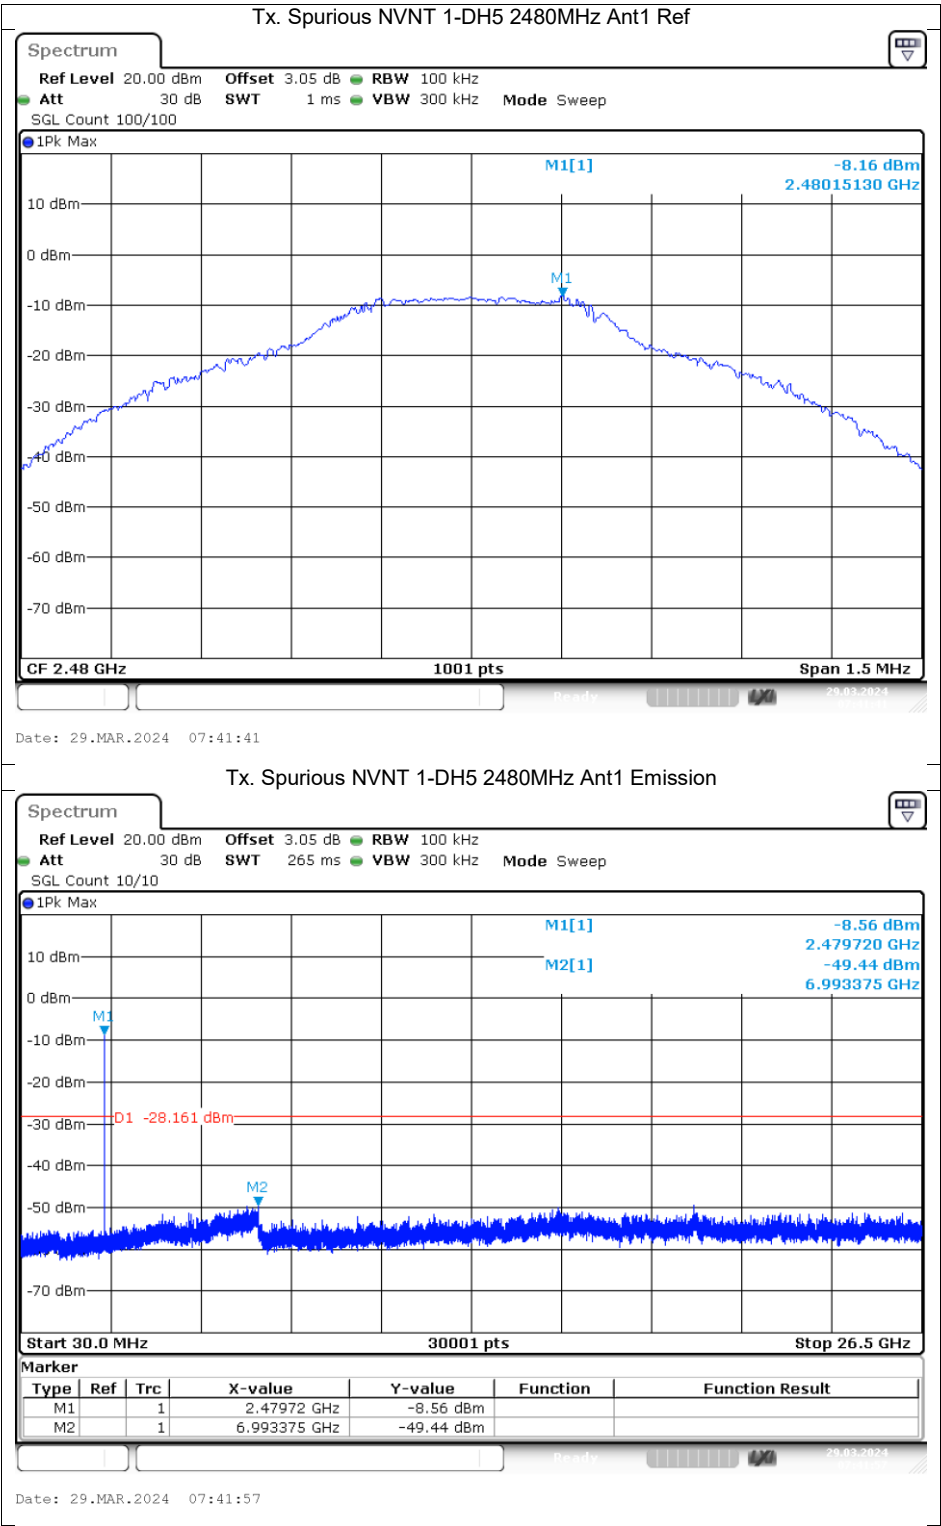
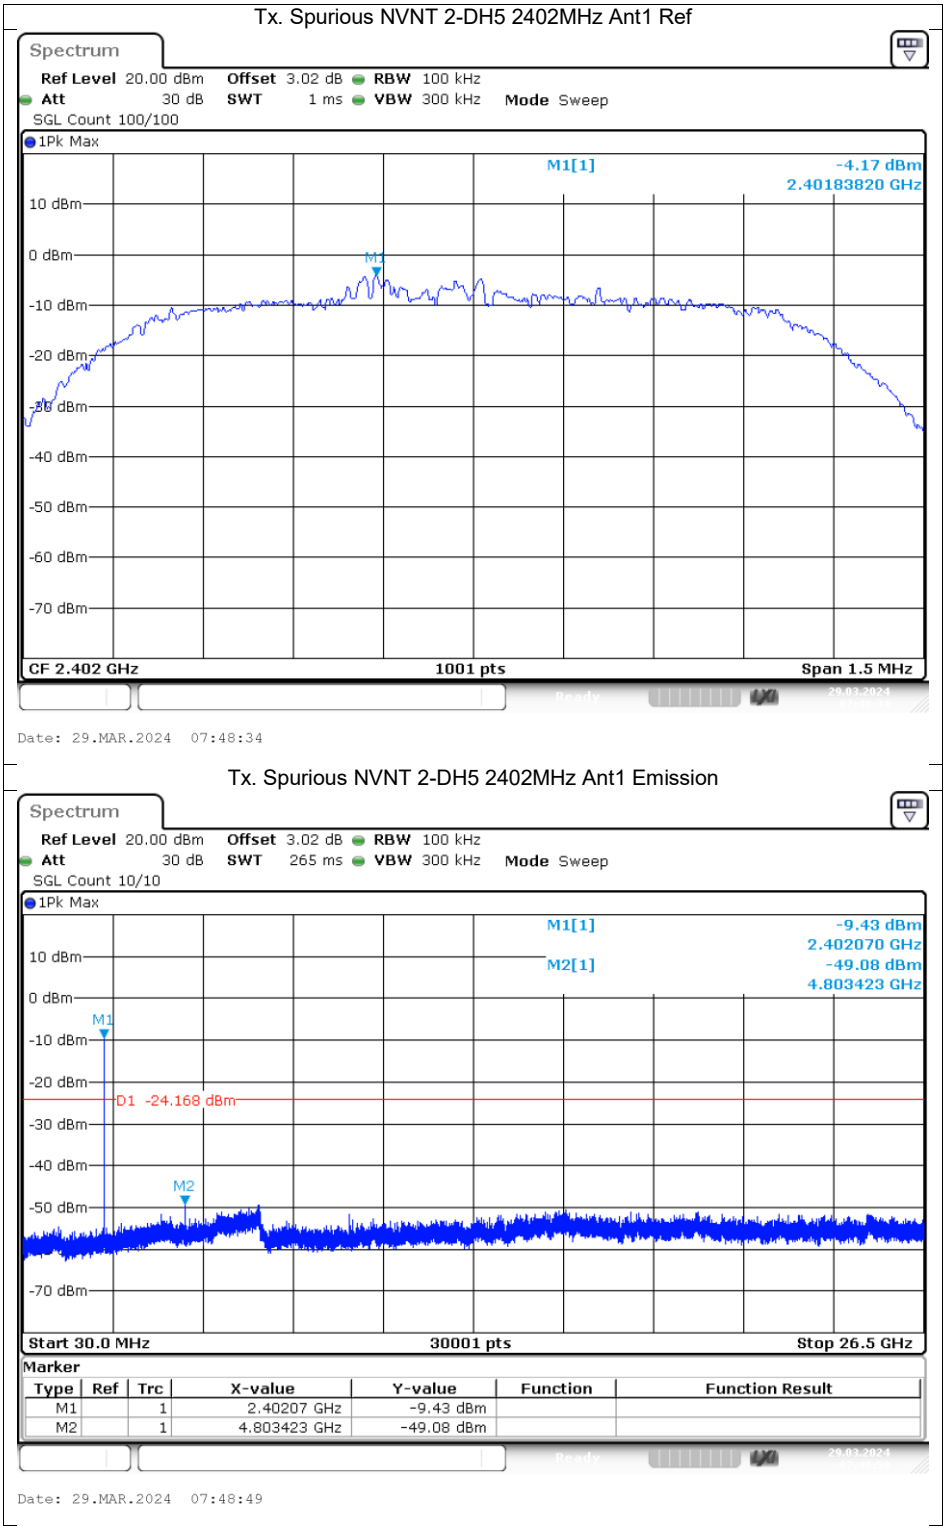
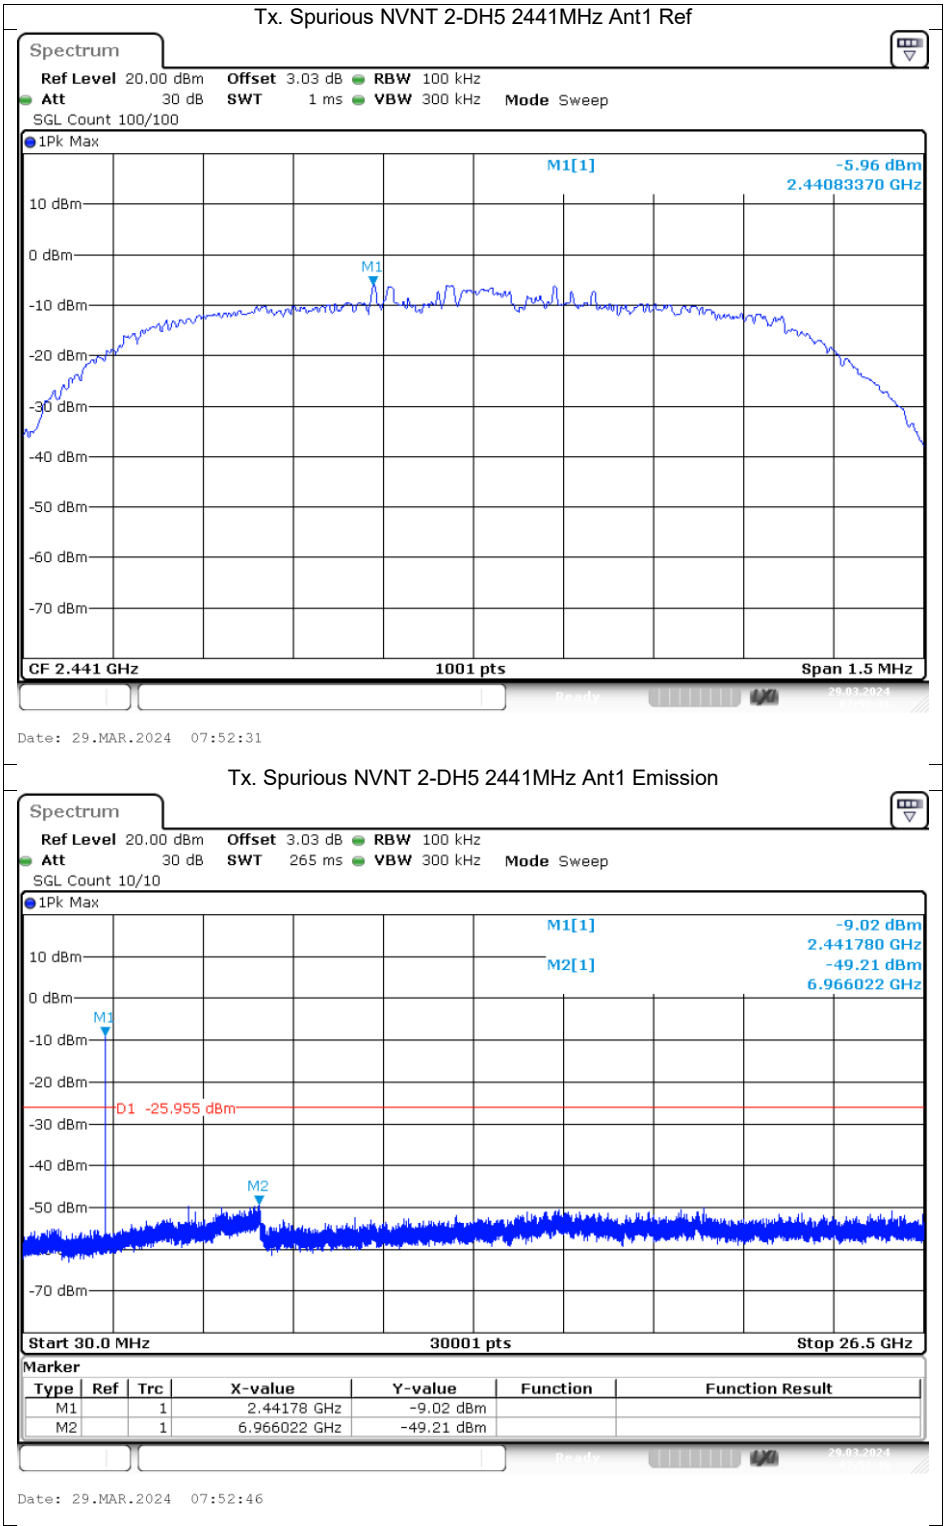
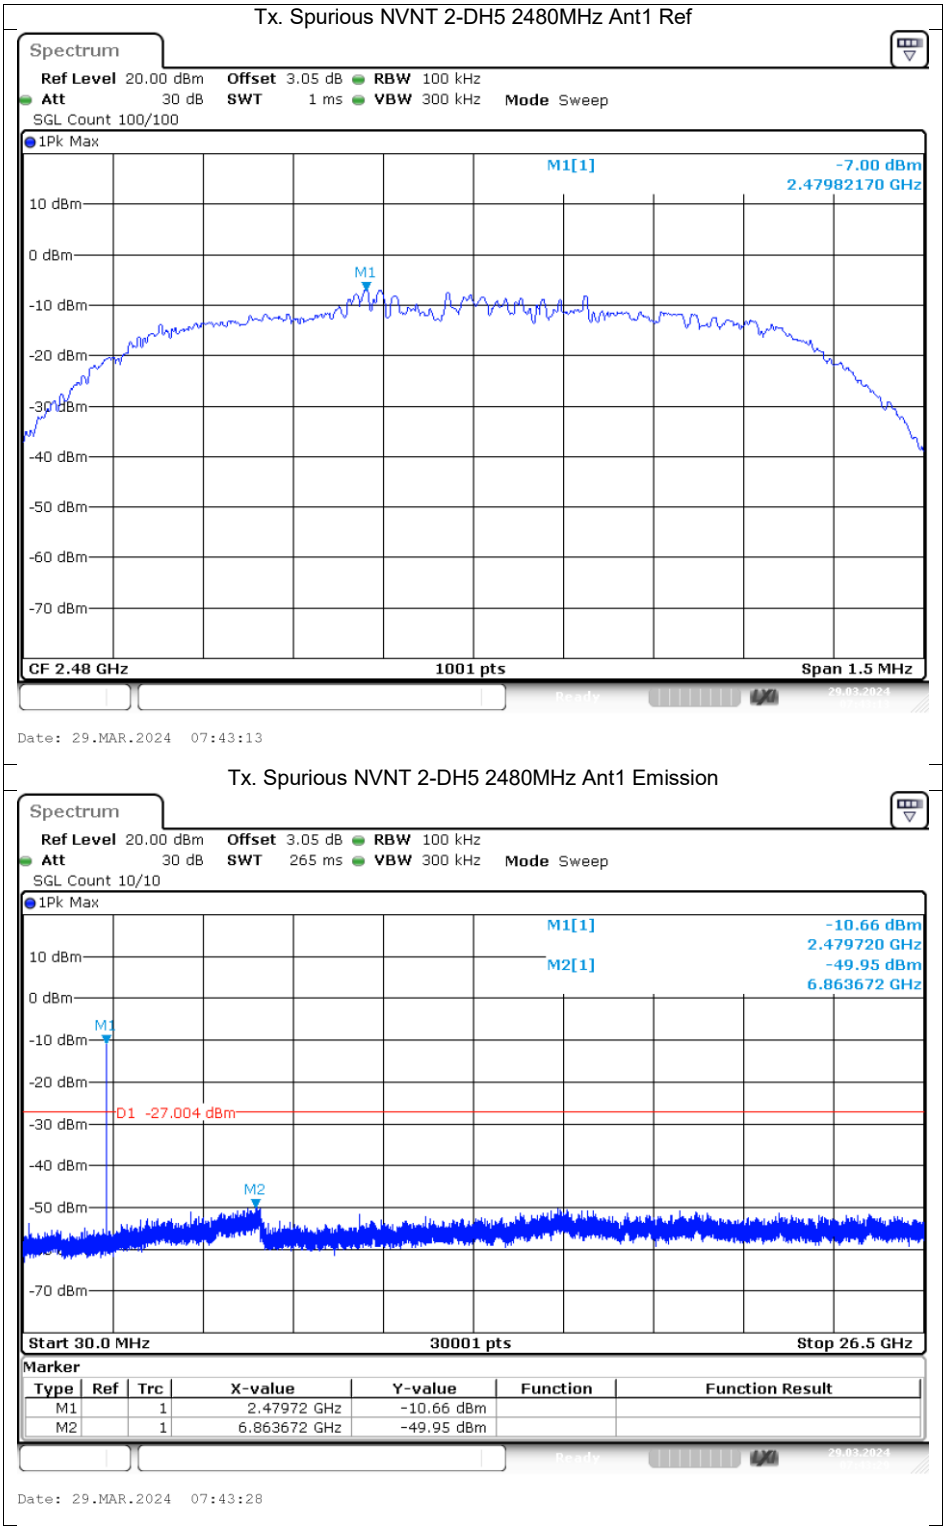
## Conducted RF Spurious Emission

| Condition | Mode | Frequency (MHz) | Antenna | Max Value (dBc) | Limit (dBc) | Verdict |

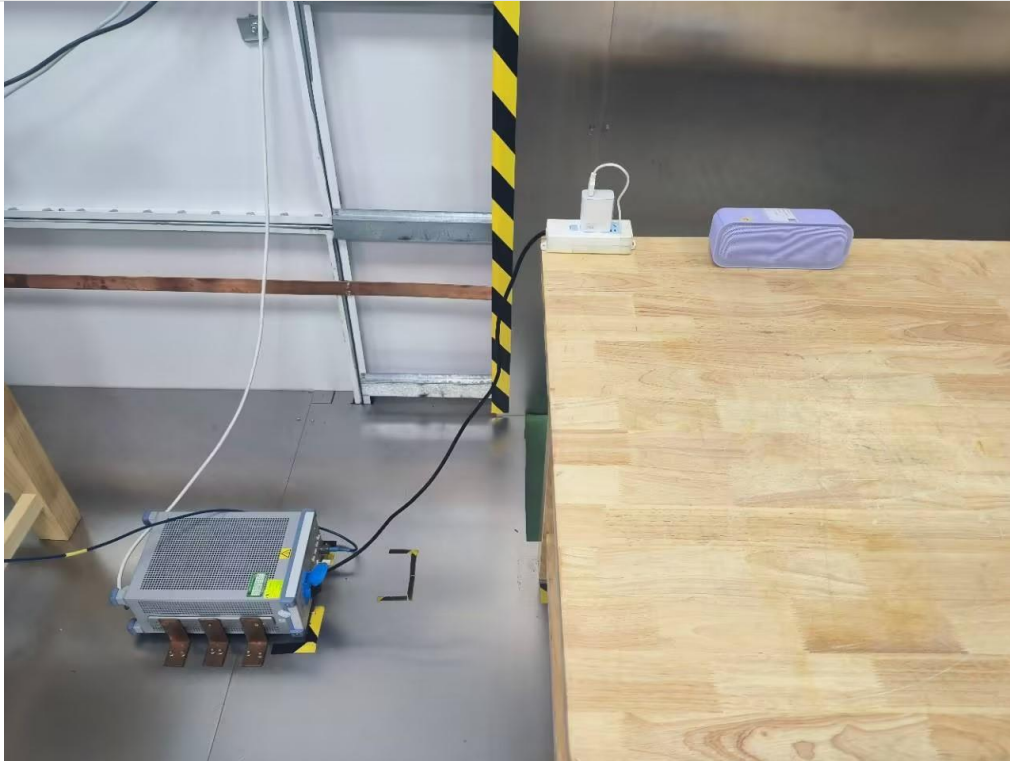
AC Power Line Conducted Emission

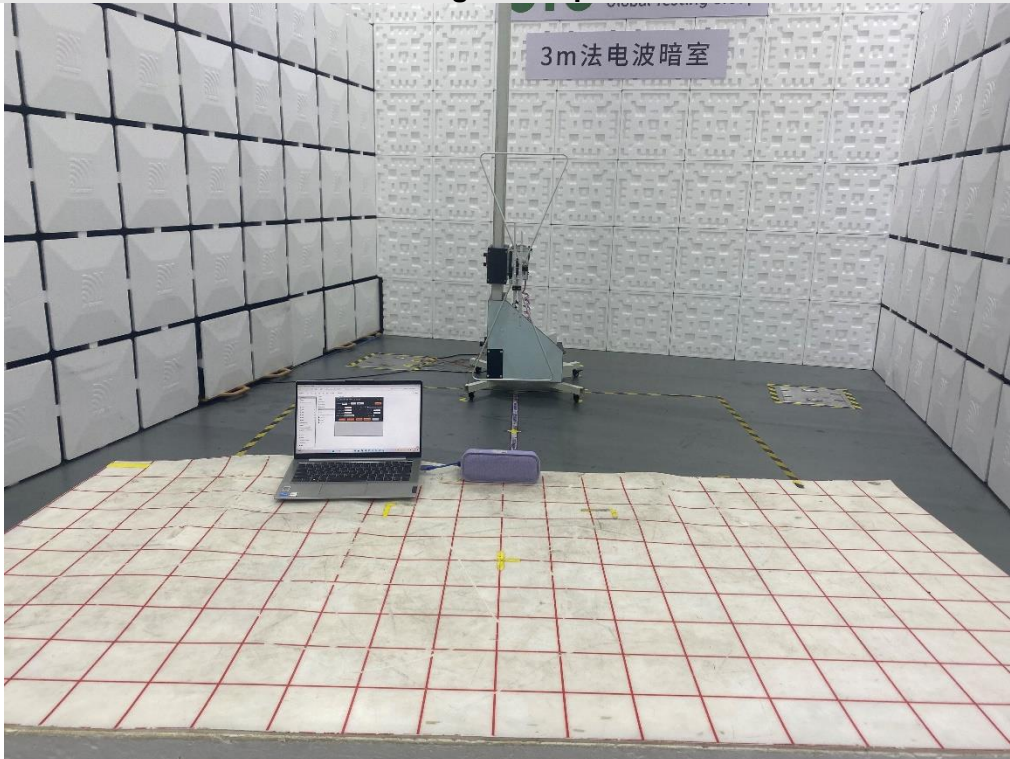
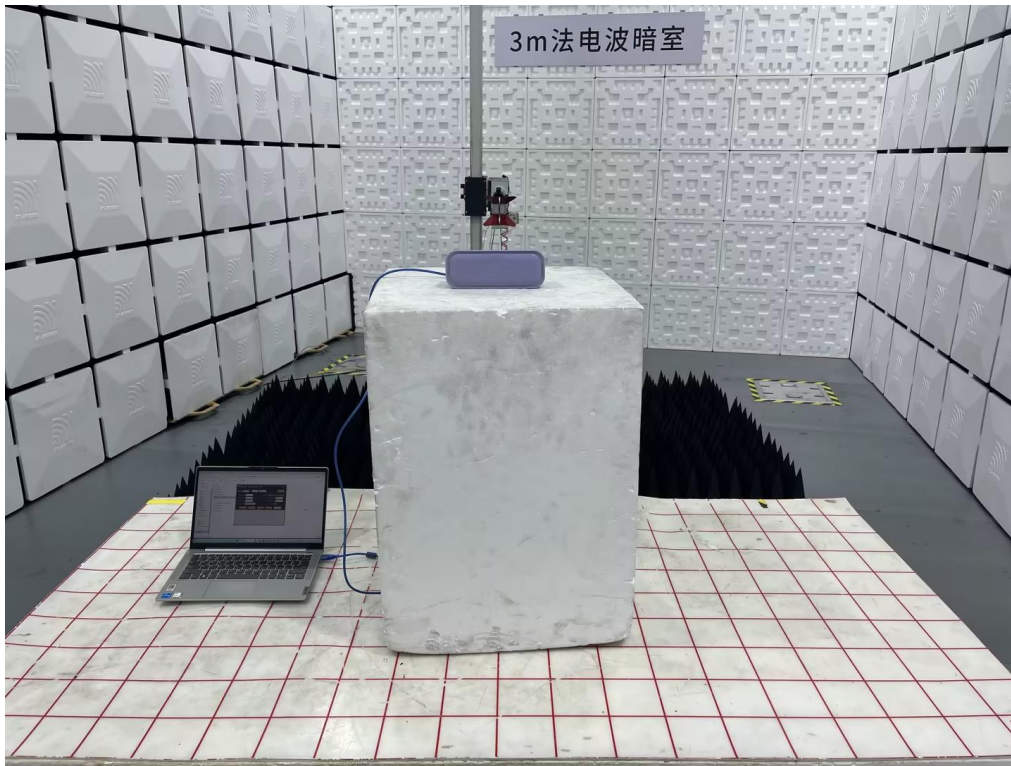
Radiated Band edge and Spurious Emission
