### **APPENDIX 3: Photographs of test setup**

#### **Radiated Emission** **Below 1GHz**

**Radiated Emission**  
**Above 1GHz**

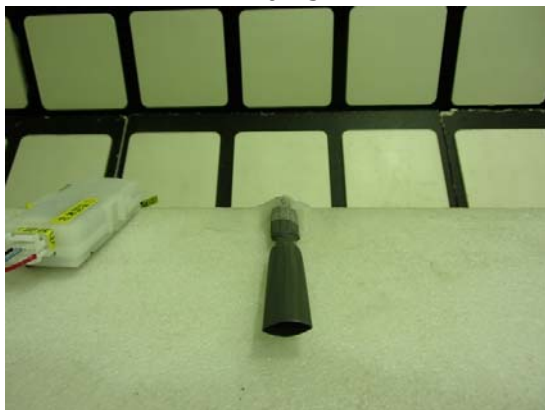
X-axis

#### ANT

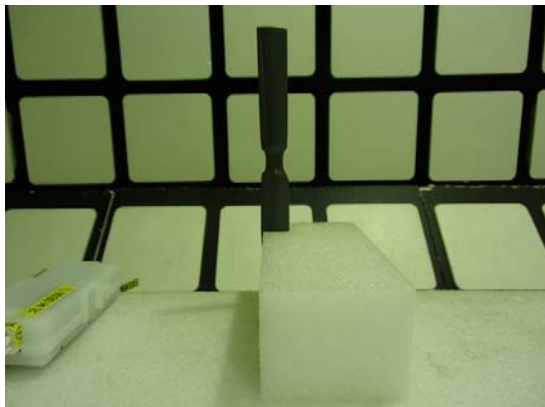
Horizontal: Y-axis / Vertical: Y-axis

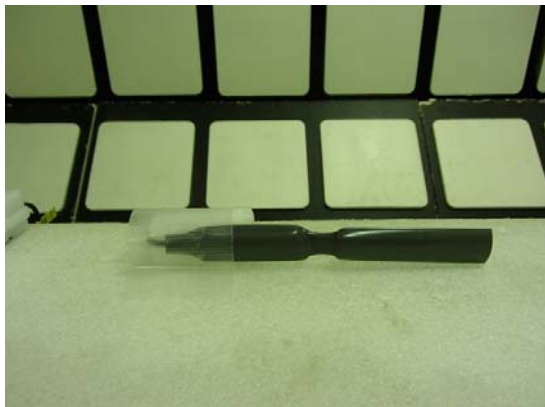
Horizontal: Z-axis / Vertical: Y-axis

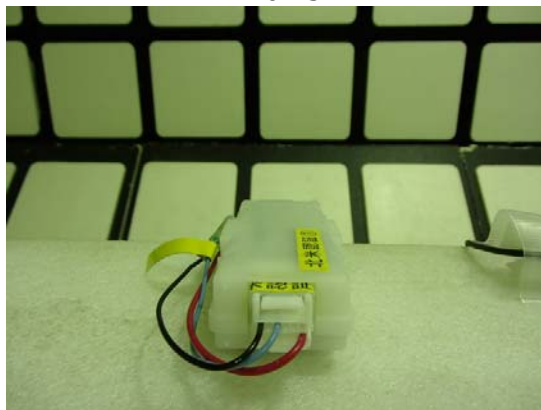
#### Starter Unit

Horizontal: X-axis / Vertical: Z-axis

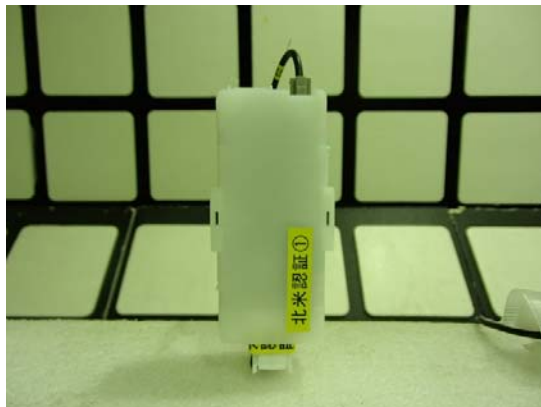
Horizontal: Y-axis / Vertical: Z-axis
