### **APPENDIX 3: Photographs of Test Setup**

#### **Radiated Spurious Emission**

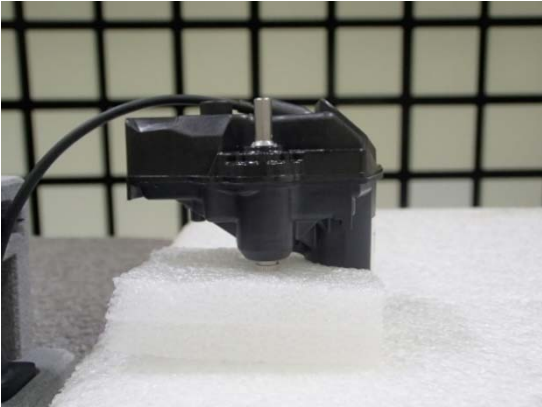
**X-axis**

**Worst Case Position**

| Test Range | BT LE | ANT+ | SHIMANO ORIGINAL |
| Below 1 GHz | Horizontal: X-axis<br>Vertical: X-axis | Horizontal: X-axis<br>Vertical: X-axis | Horizontal: X-axis<br>Vertical: X-axis |
| Above 1 GHz | Horizontal: Y-axis<br>Vertical: Z-axis | Horizontal: X-axis<br>Vertical: Z-axis | Horizontal: X-axis<br>Vertical: Z-axis |

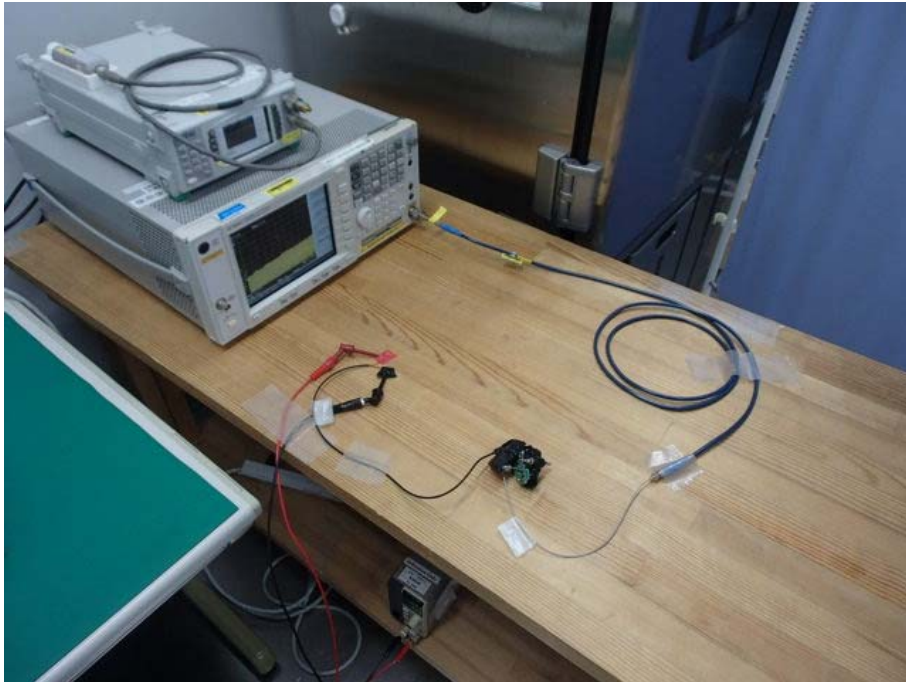
**Photo 1**

### Antenna Terminal Conducted Tests
