## Tx. Spurious NVNT n40 2452MHz Ant1 Ref

## APPENDIX 2-PHOTOS OF TEST SETUP

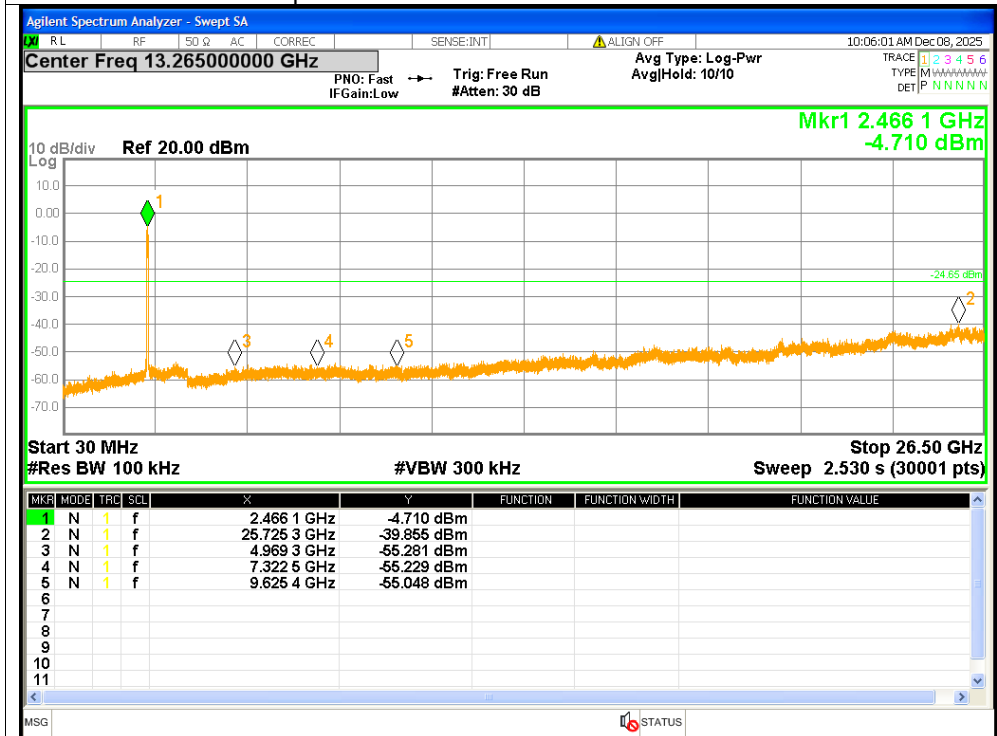
## Tx. Spurious NVNT n40 2452MHz Ant1 Emission

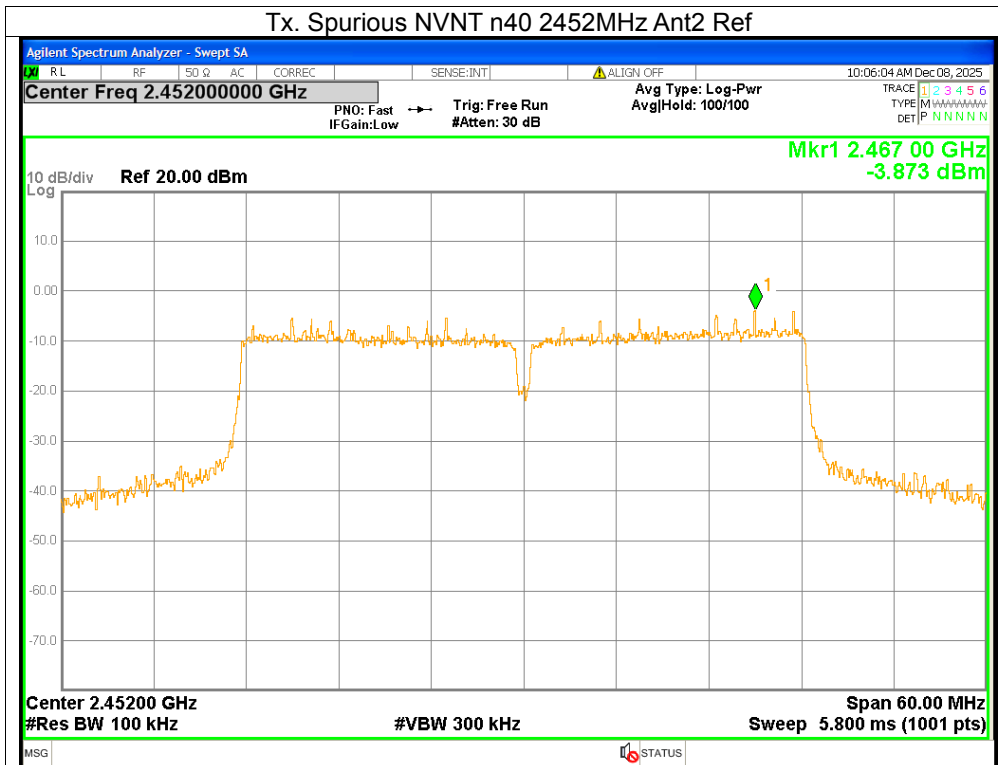
## Tx. Spurious NVNT n40 2452MHz Ant2 Ref

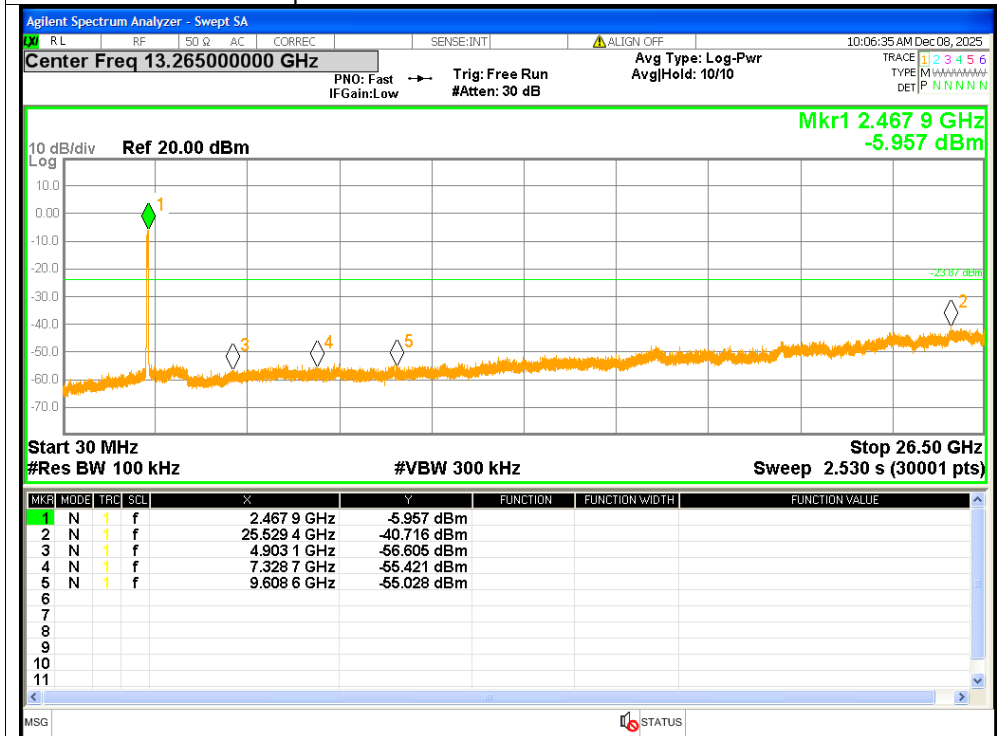
## Tx. Spurious NVNT n40 2452MHz Ant2 Emission
