# Photo Report on Test Setups

**Report Reference:** MDE\_3M\_1601\_FCC\_Photo\_Setups

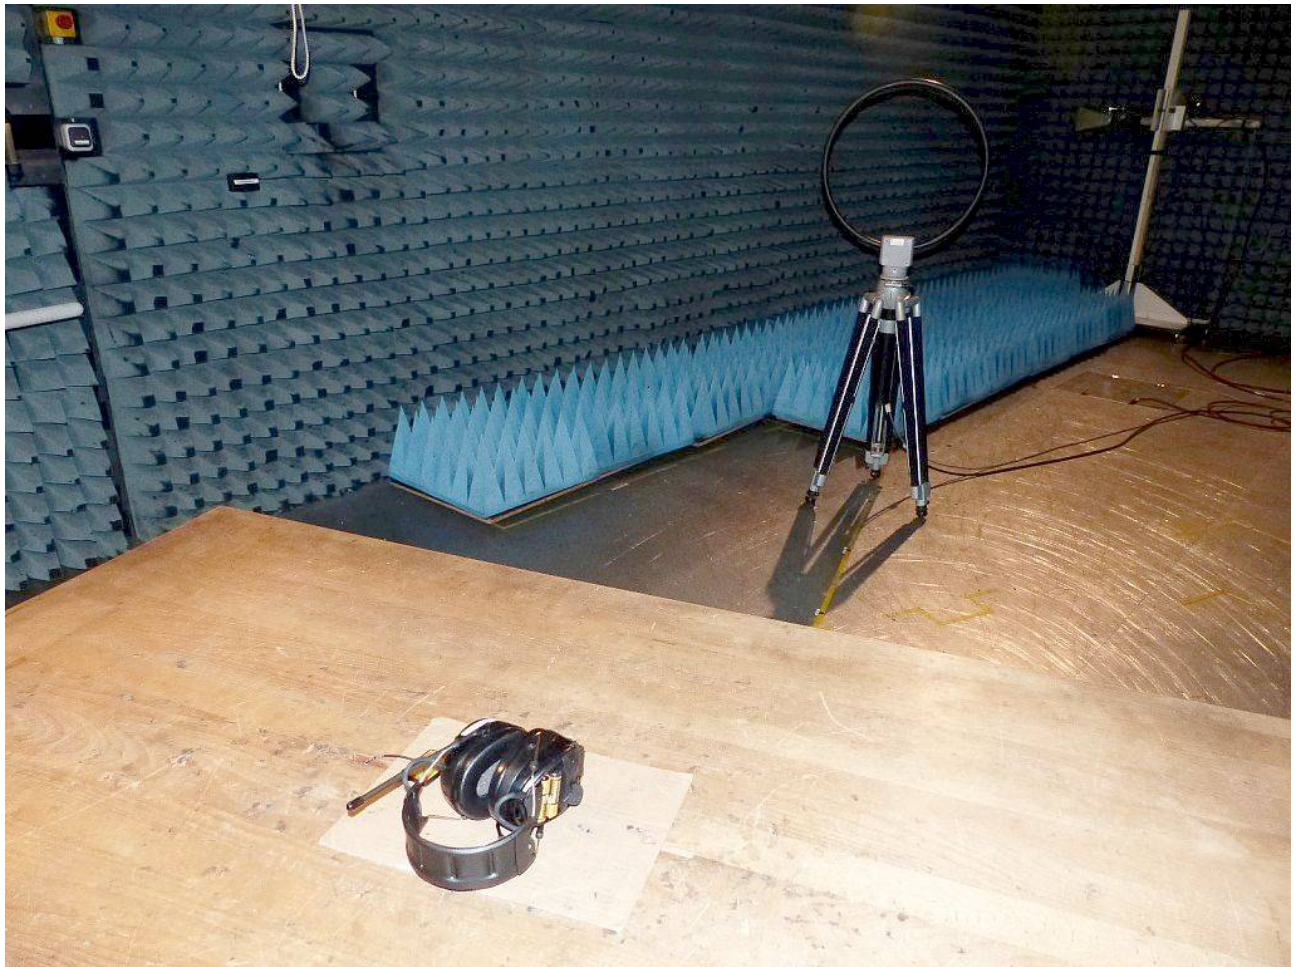
**Photo 1:** Test setup for radiated measurements (Enclosure, below 30 MHz, intentional radiator §15.209, ANSI C63.10)

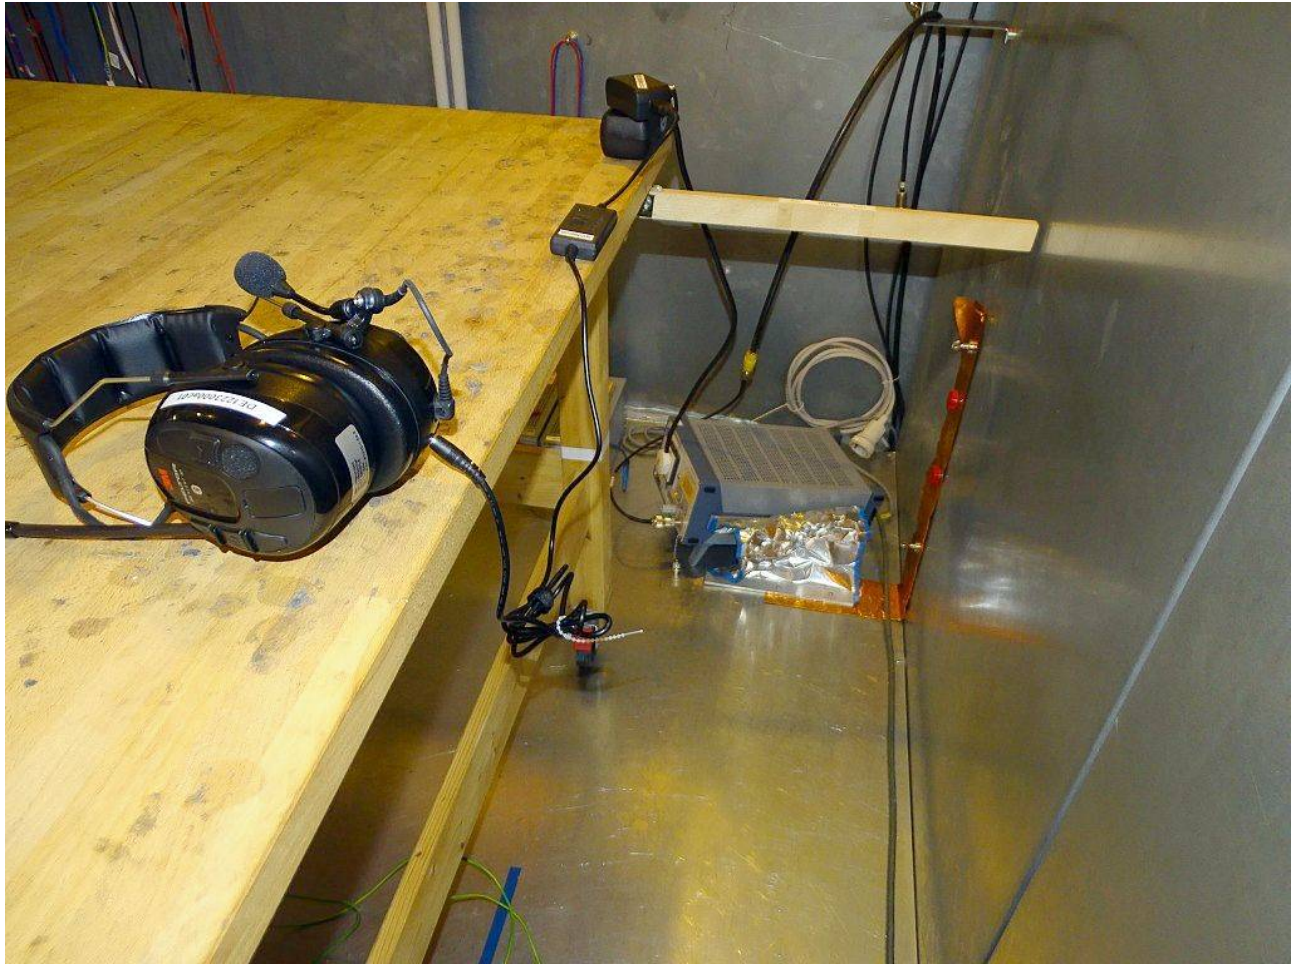
**Photo 4:** Test setup for conducted measurements (AC Port (power line), EUT supplied by AC/DC adapter, intentional / unintentional radiator §15, ANSI C63.10/4)
