Environmental Testing of the Vesper Marine Ltd  
VHF DSC Radio Transceiver, Model: Cortex M1 and Handset, Model: Cortex H1  
In accordance with IEC 60945

**Document 75943855 Report 10 Issue 2**

Environmental Testing of the  
Vesper Marine Ltd, Cortex M1, Model: Cortex M1  
In accordance with IEC 60945

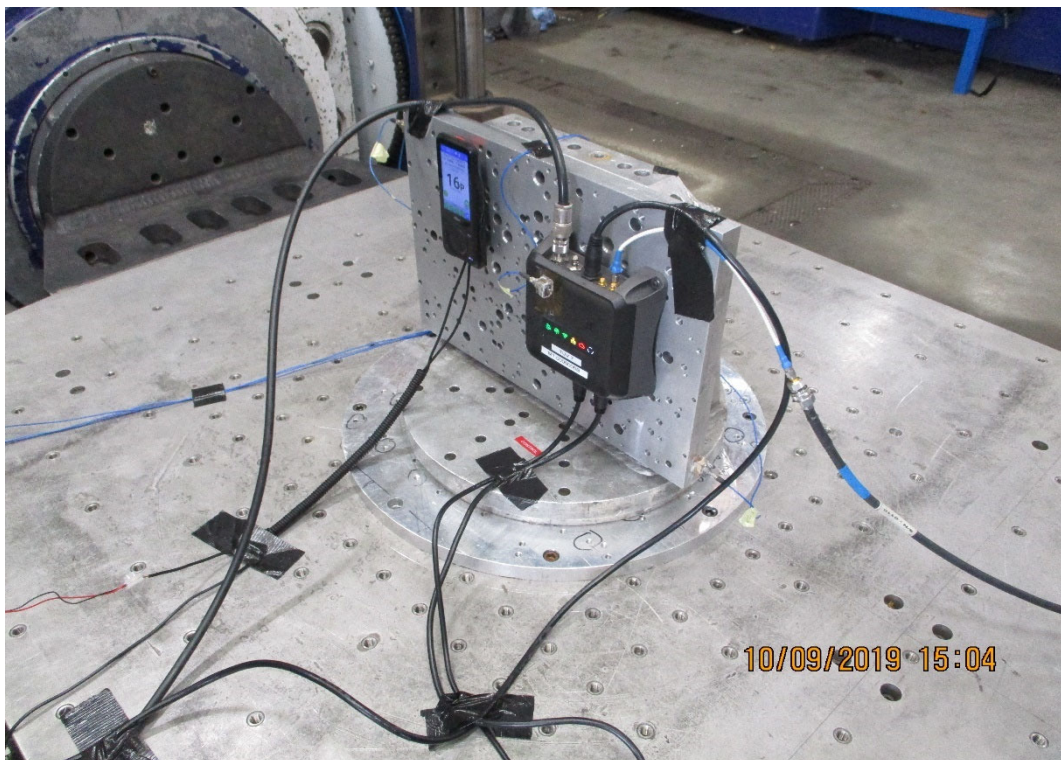
2.4.6.2 EUT Y Axis test set-up
