## 1. SETUP PHOTOS

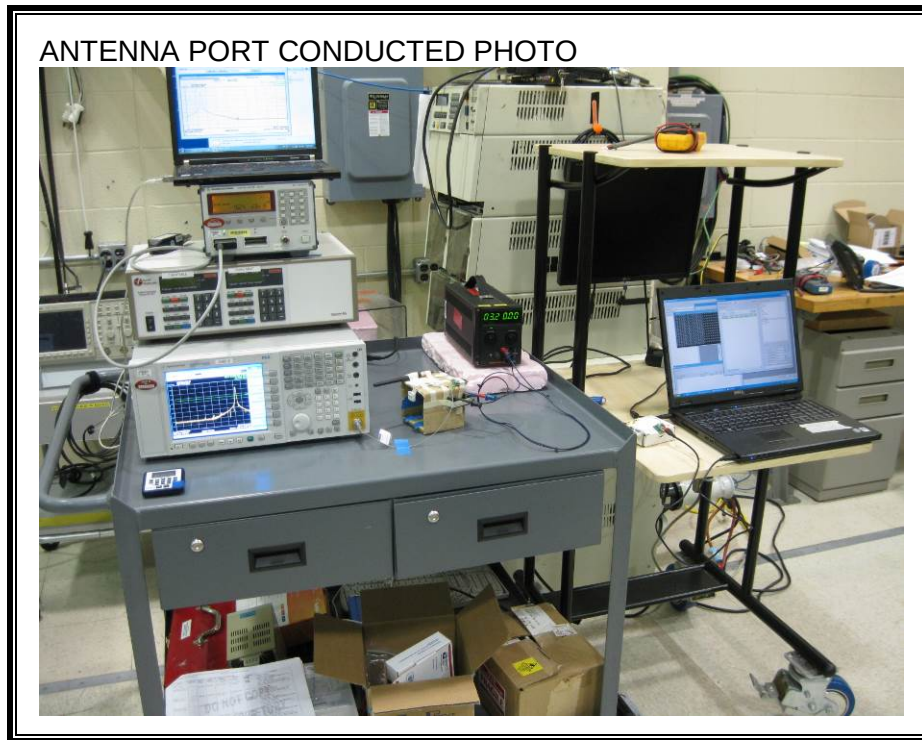
### ANTENNA PORT CONDUCTED RF MEASUREMENT SETUP

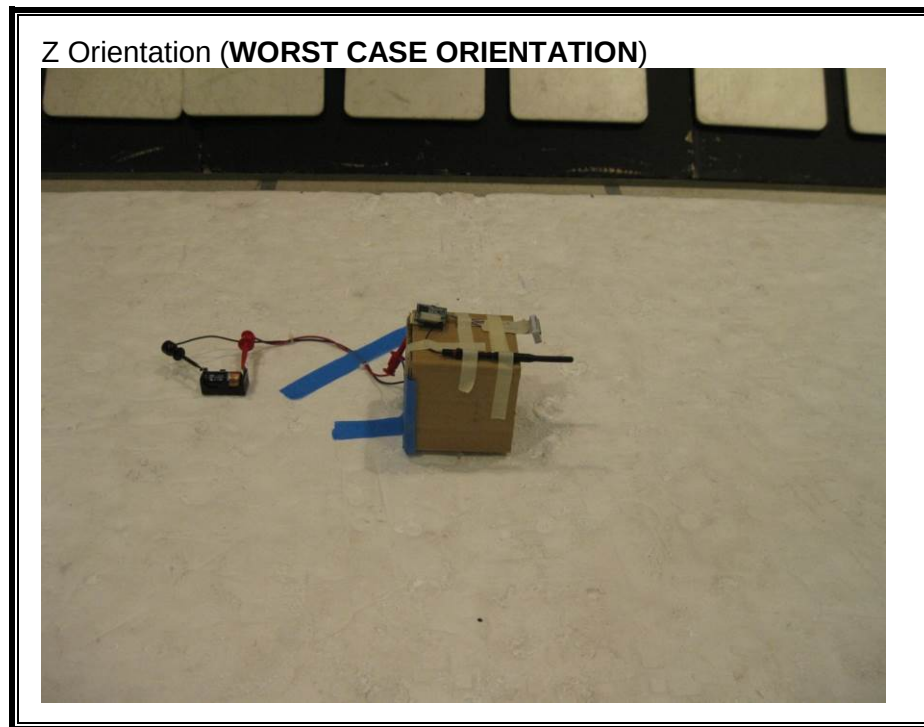
This orientation proved to be the worst-case. Therefore, it was used throughout testing. Testing in this orientation with the battery replaced by a power supply showed no appreciable difference in emissions at the fundamental. Therefore, a power supply was used during the remaining test program.
