## Appendix E: Band edge measurements

## Appendix F: Conducted Spurious Emission

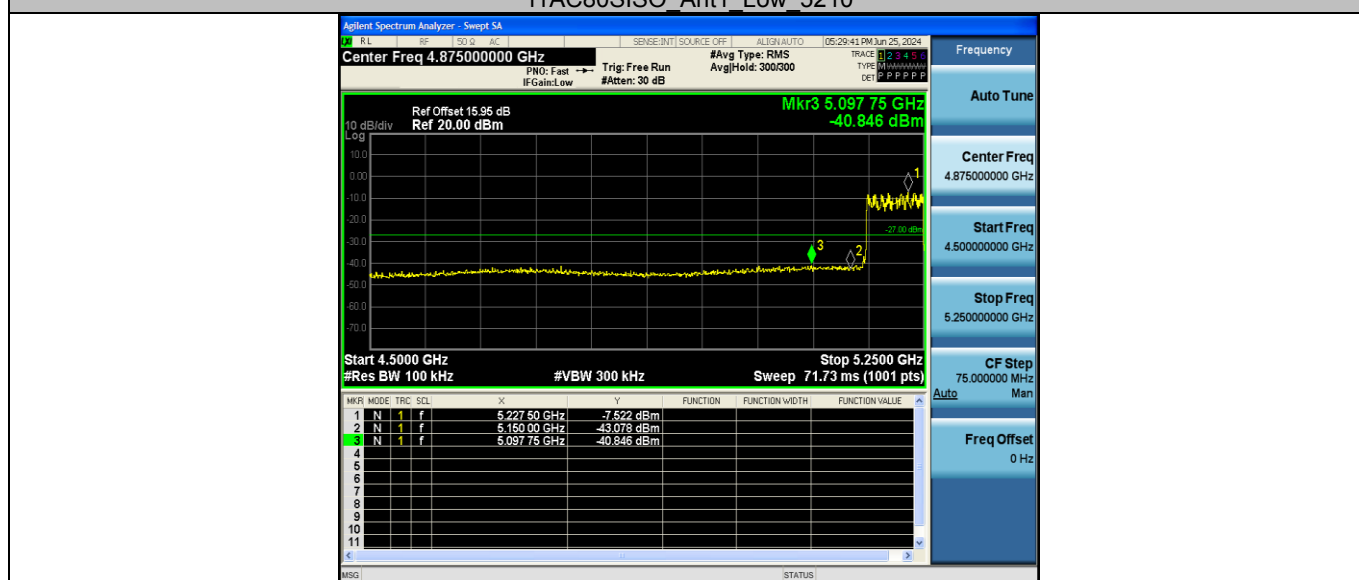
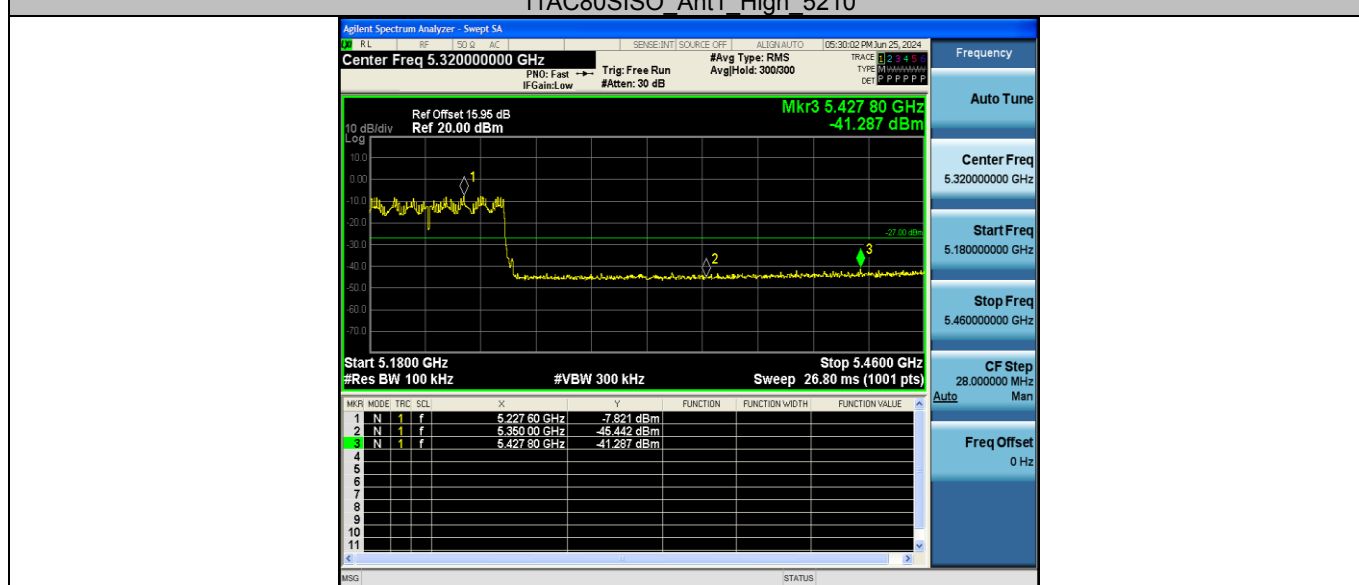
11AC40SISO Ant1 High 5230

**Note:** The antenna gain and cable loss is compensated in the test plot.

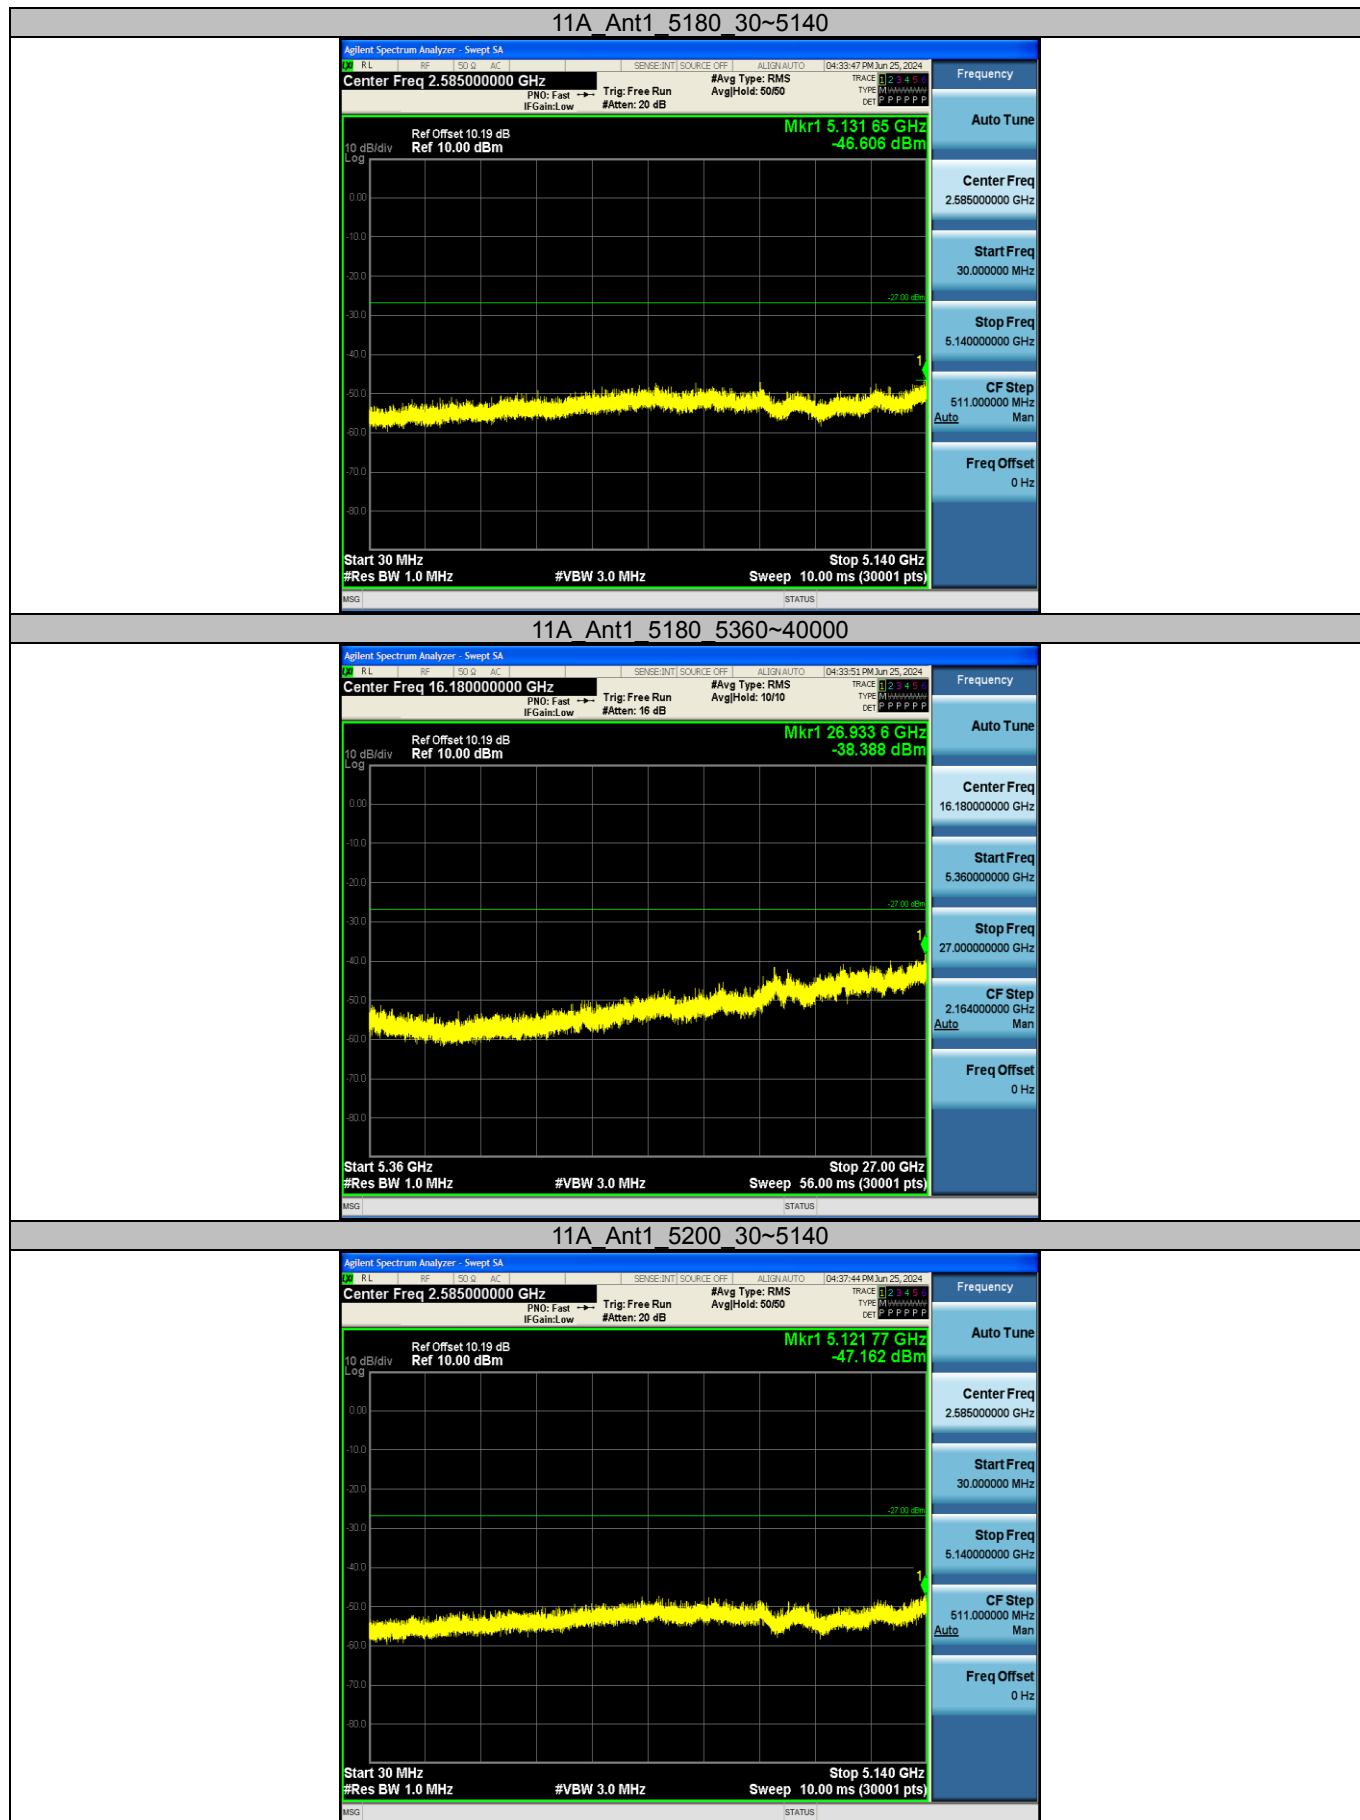
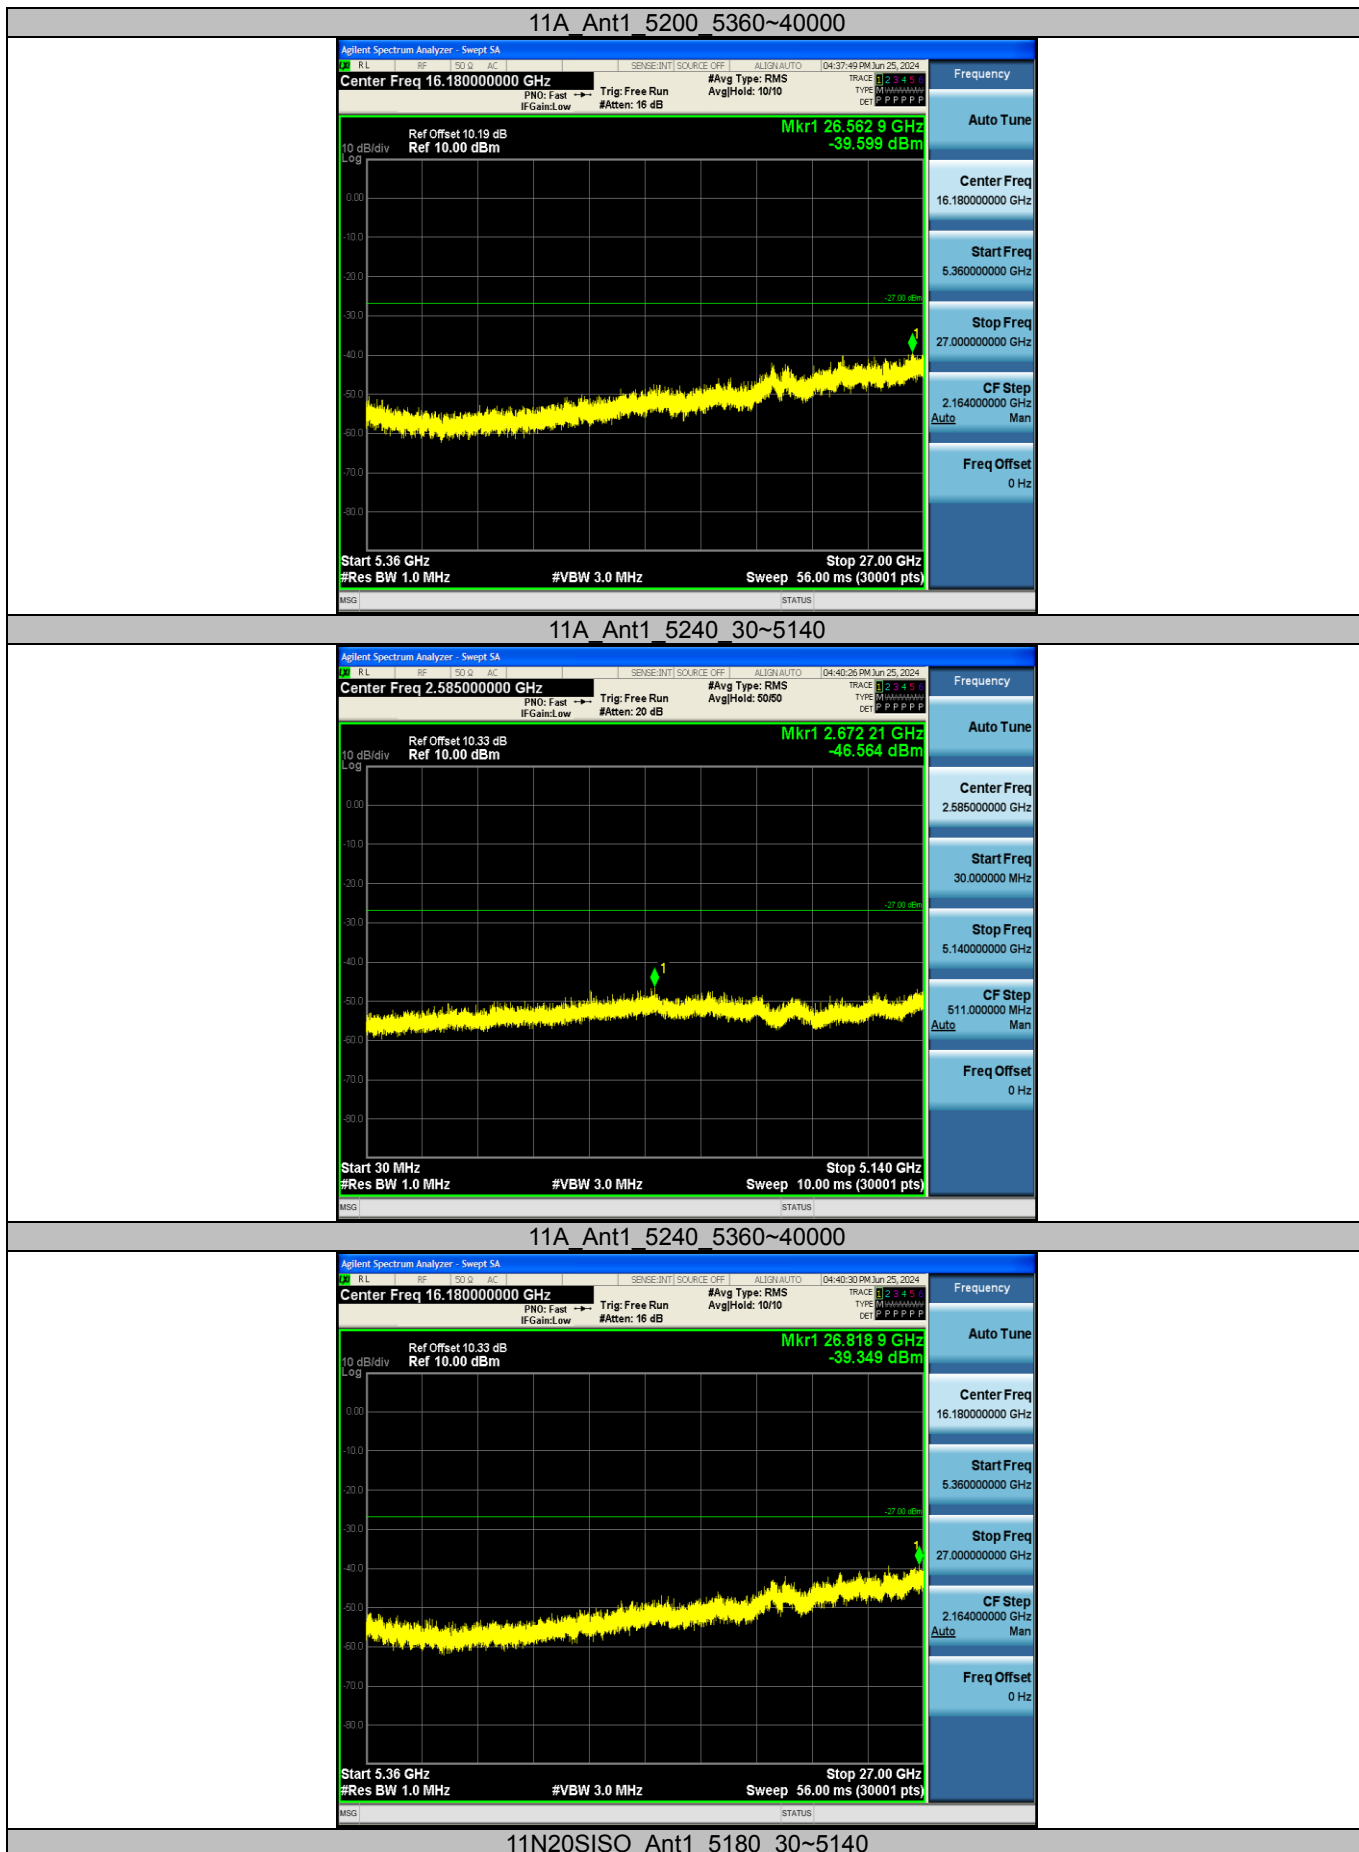
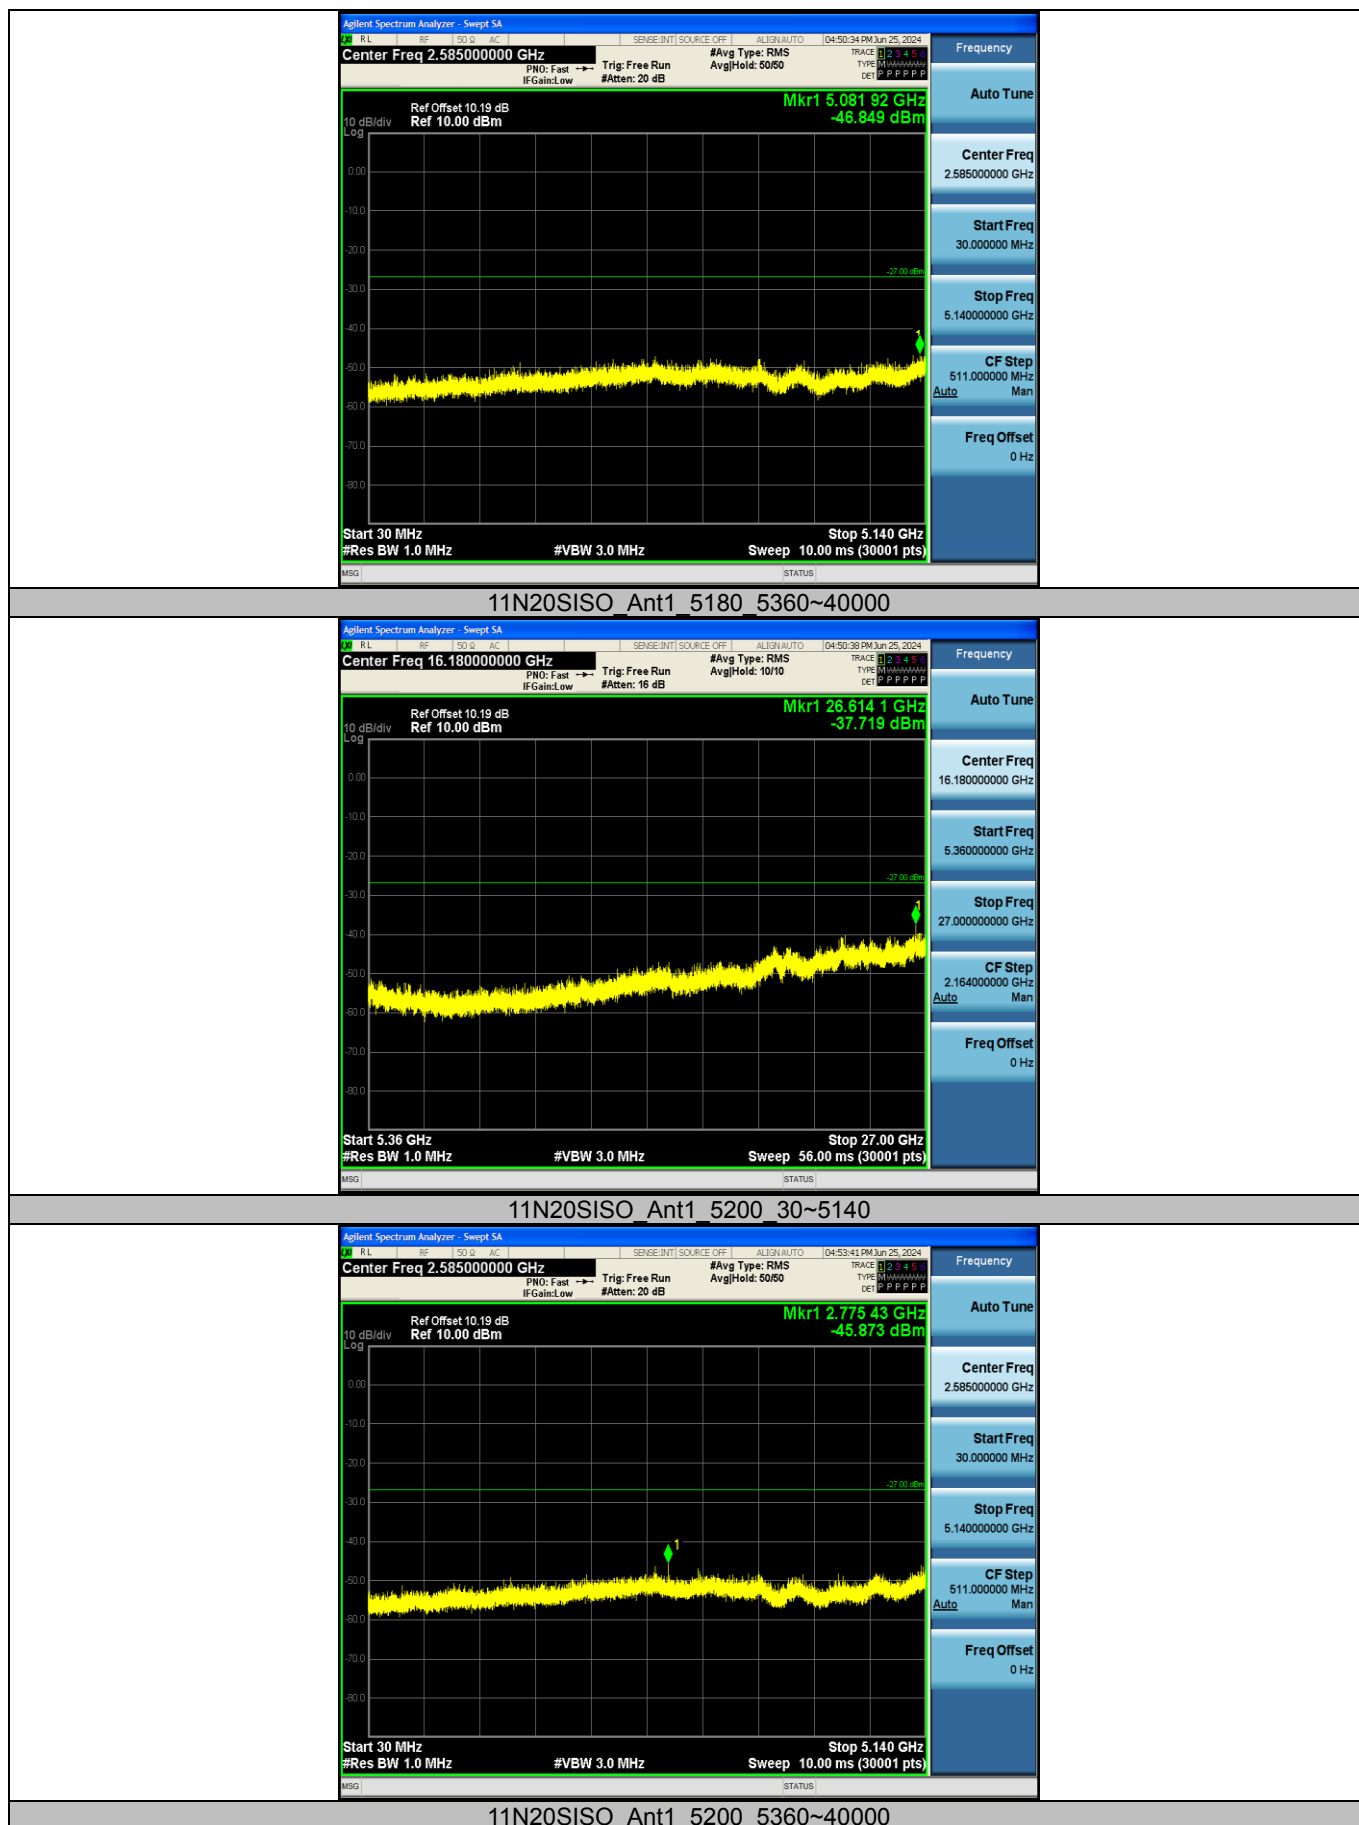
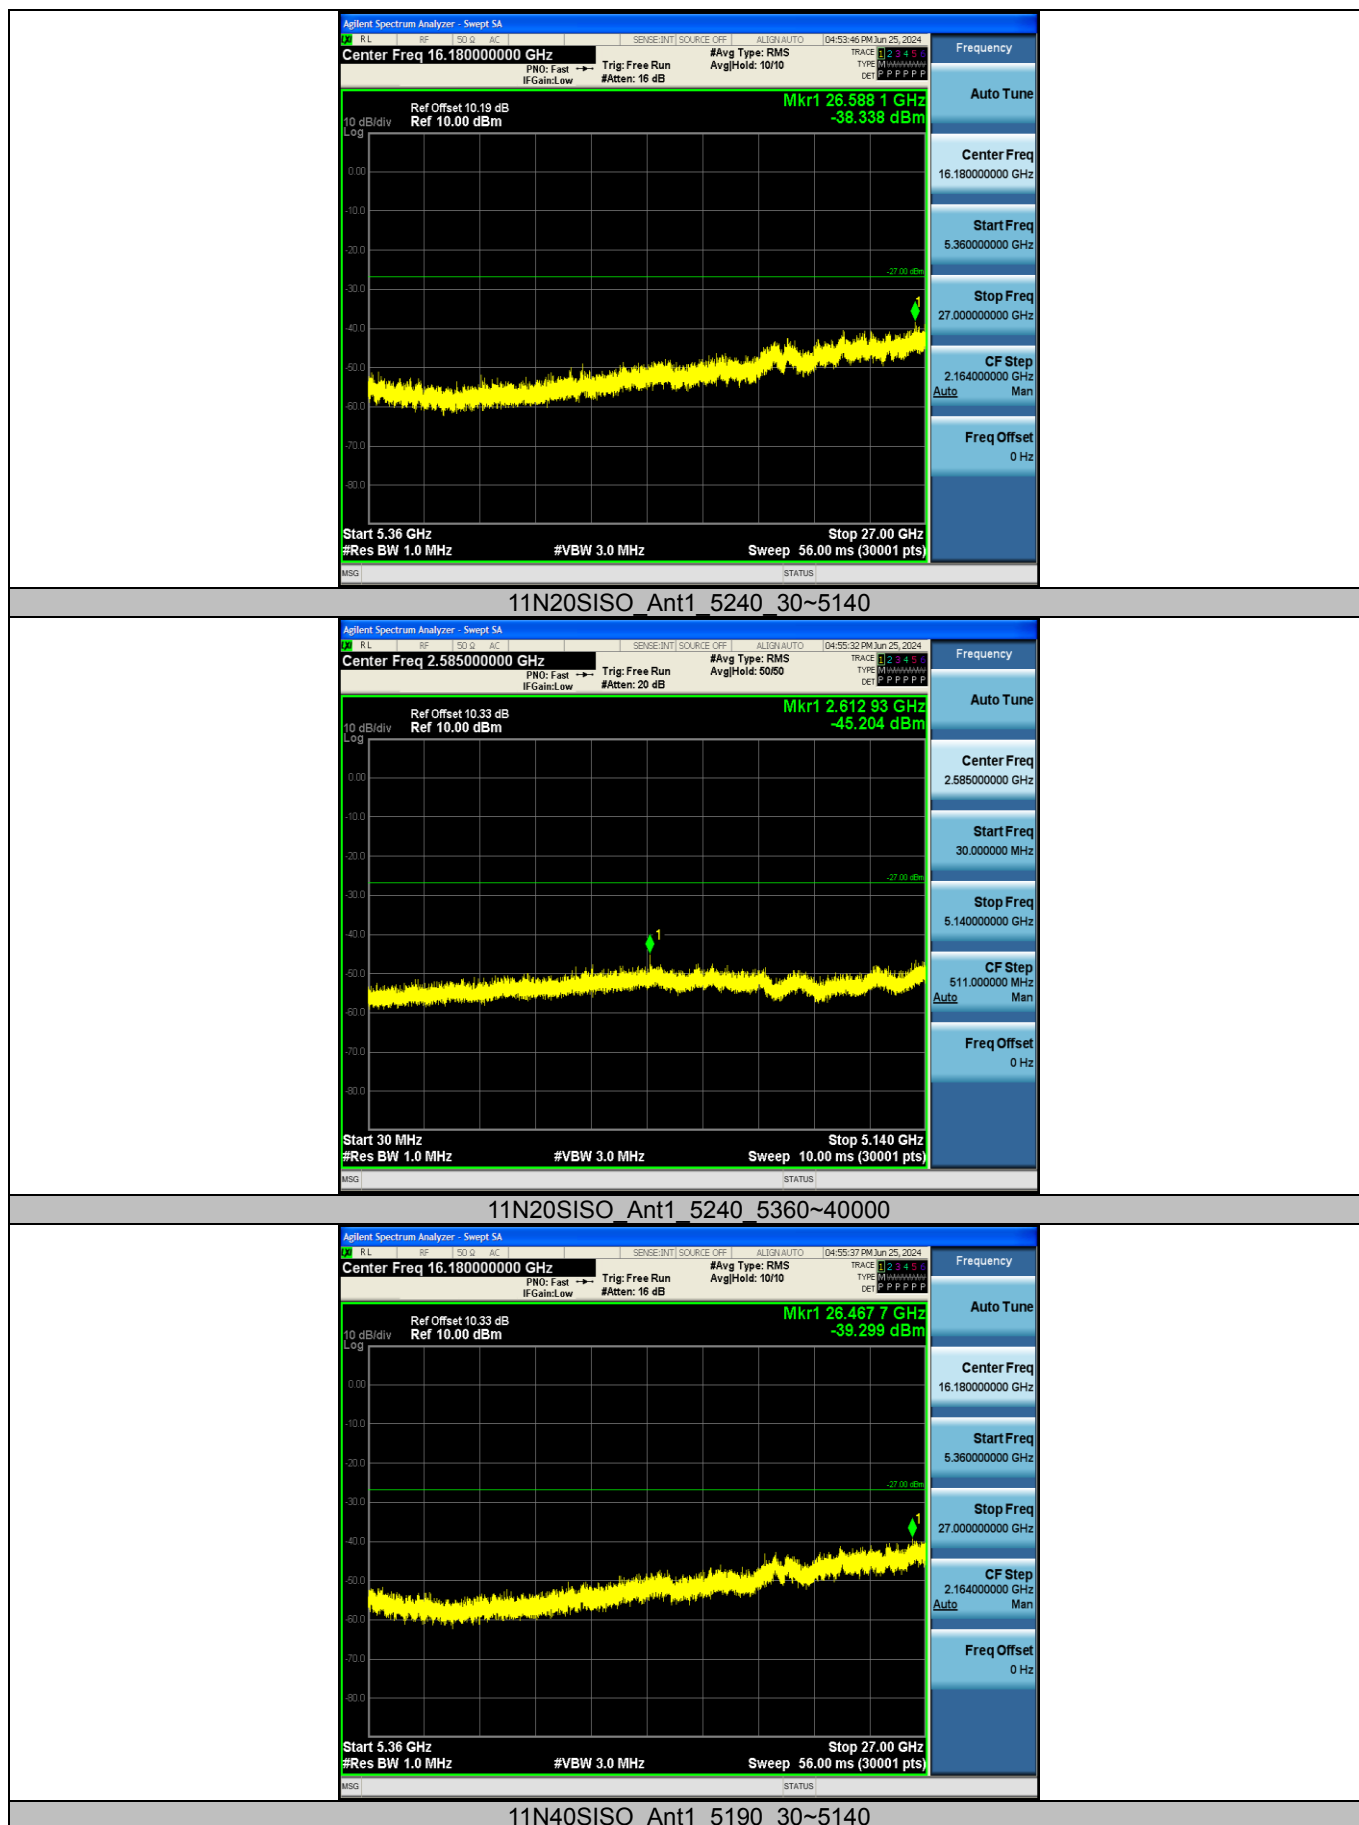
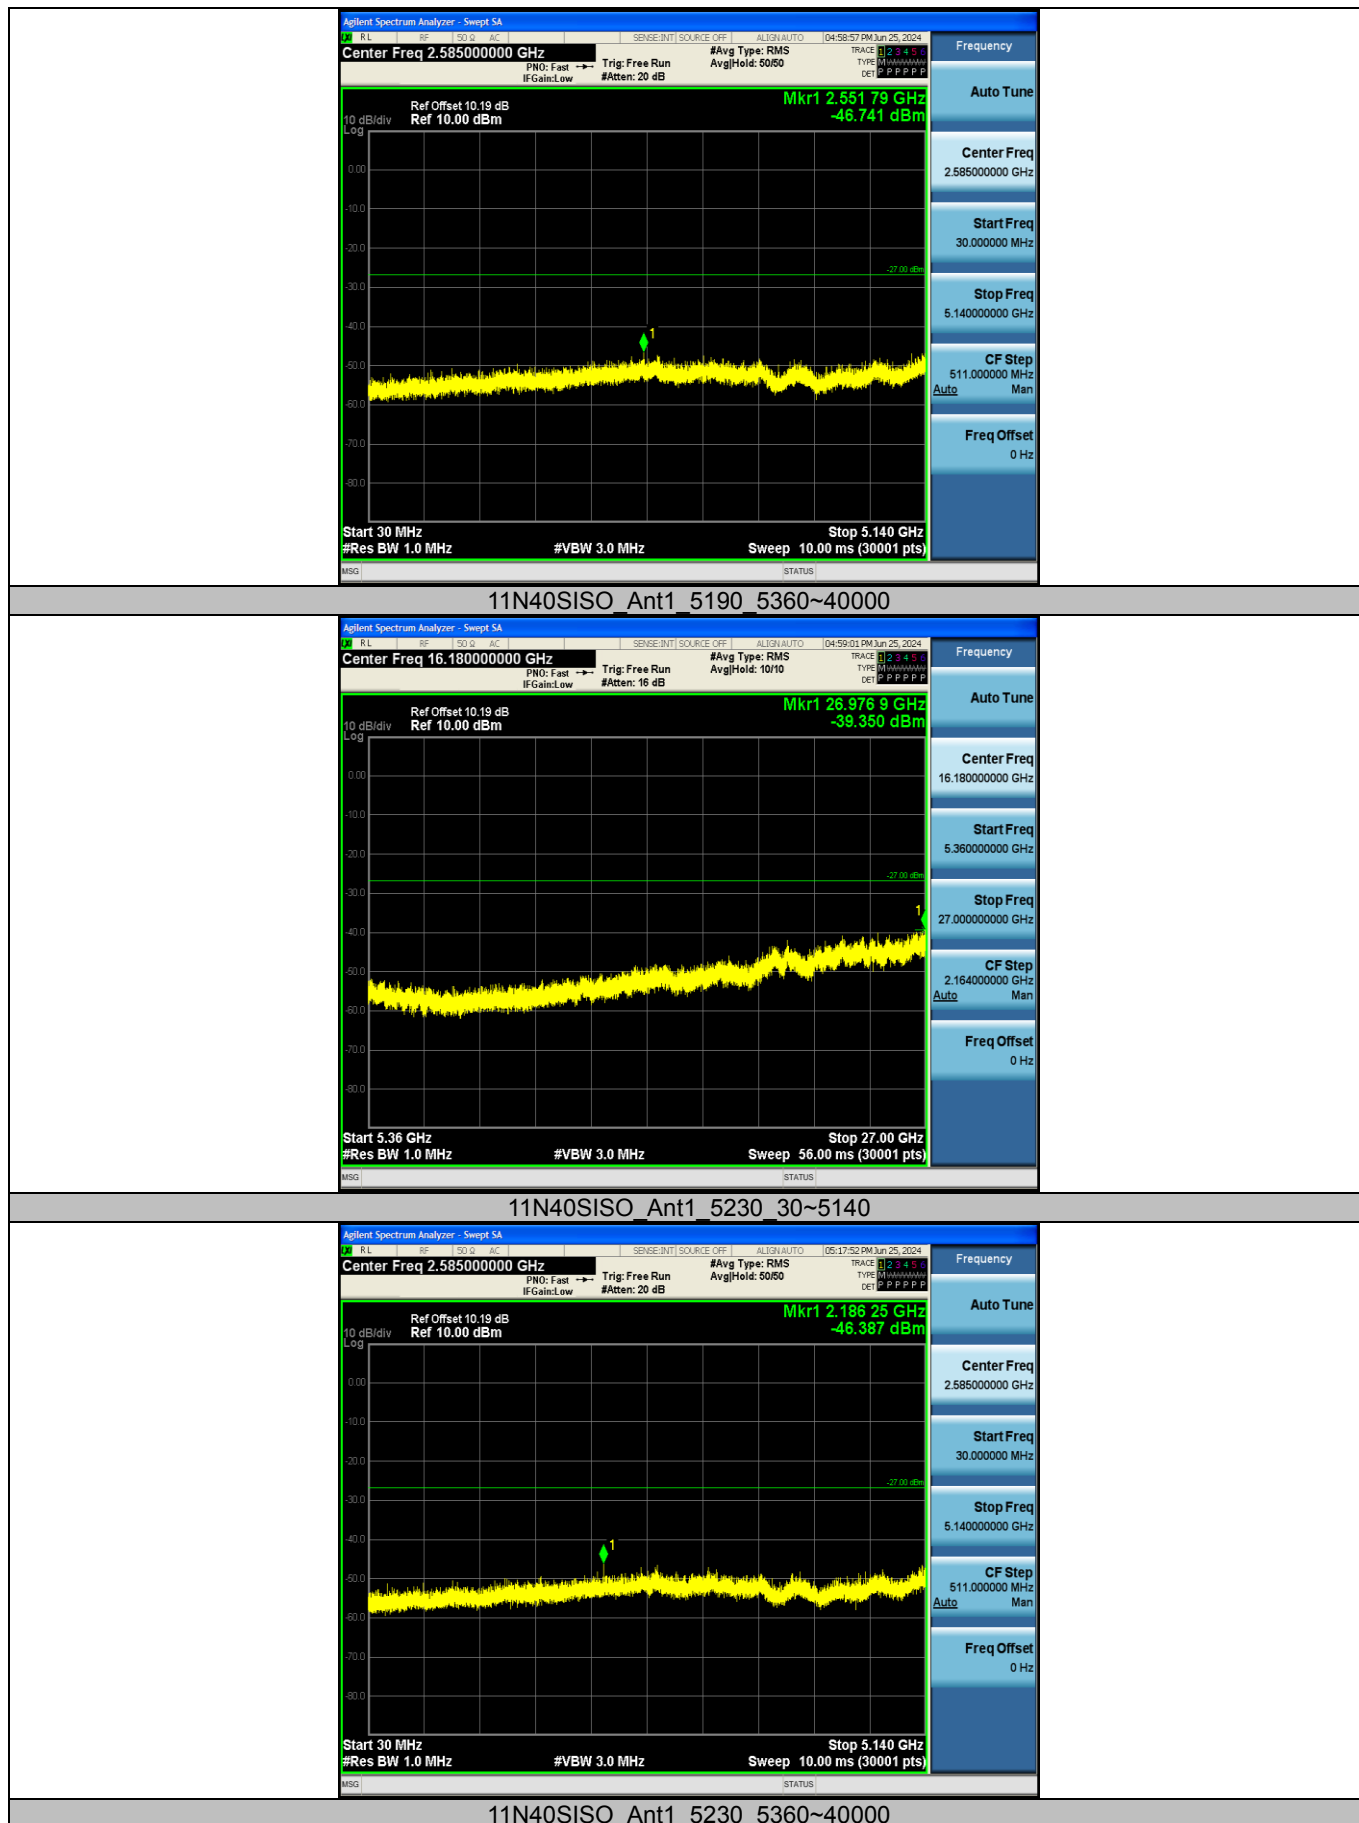
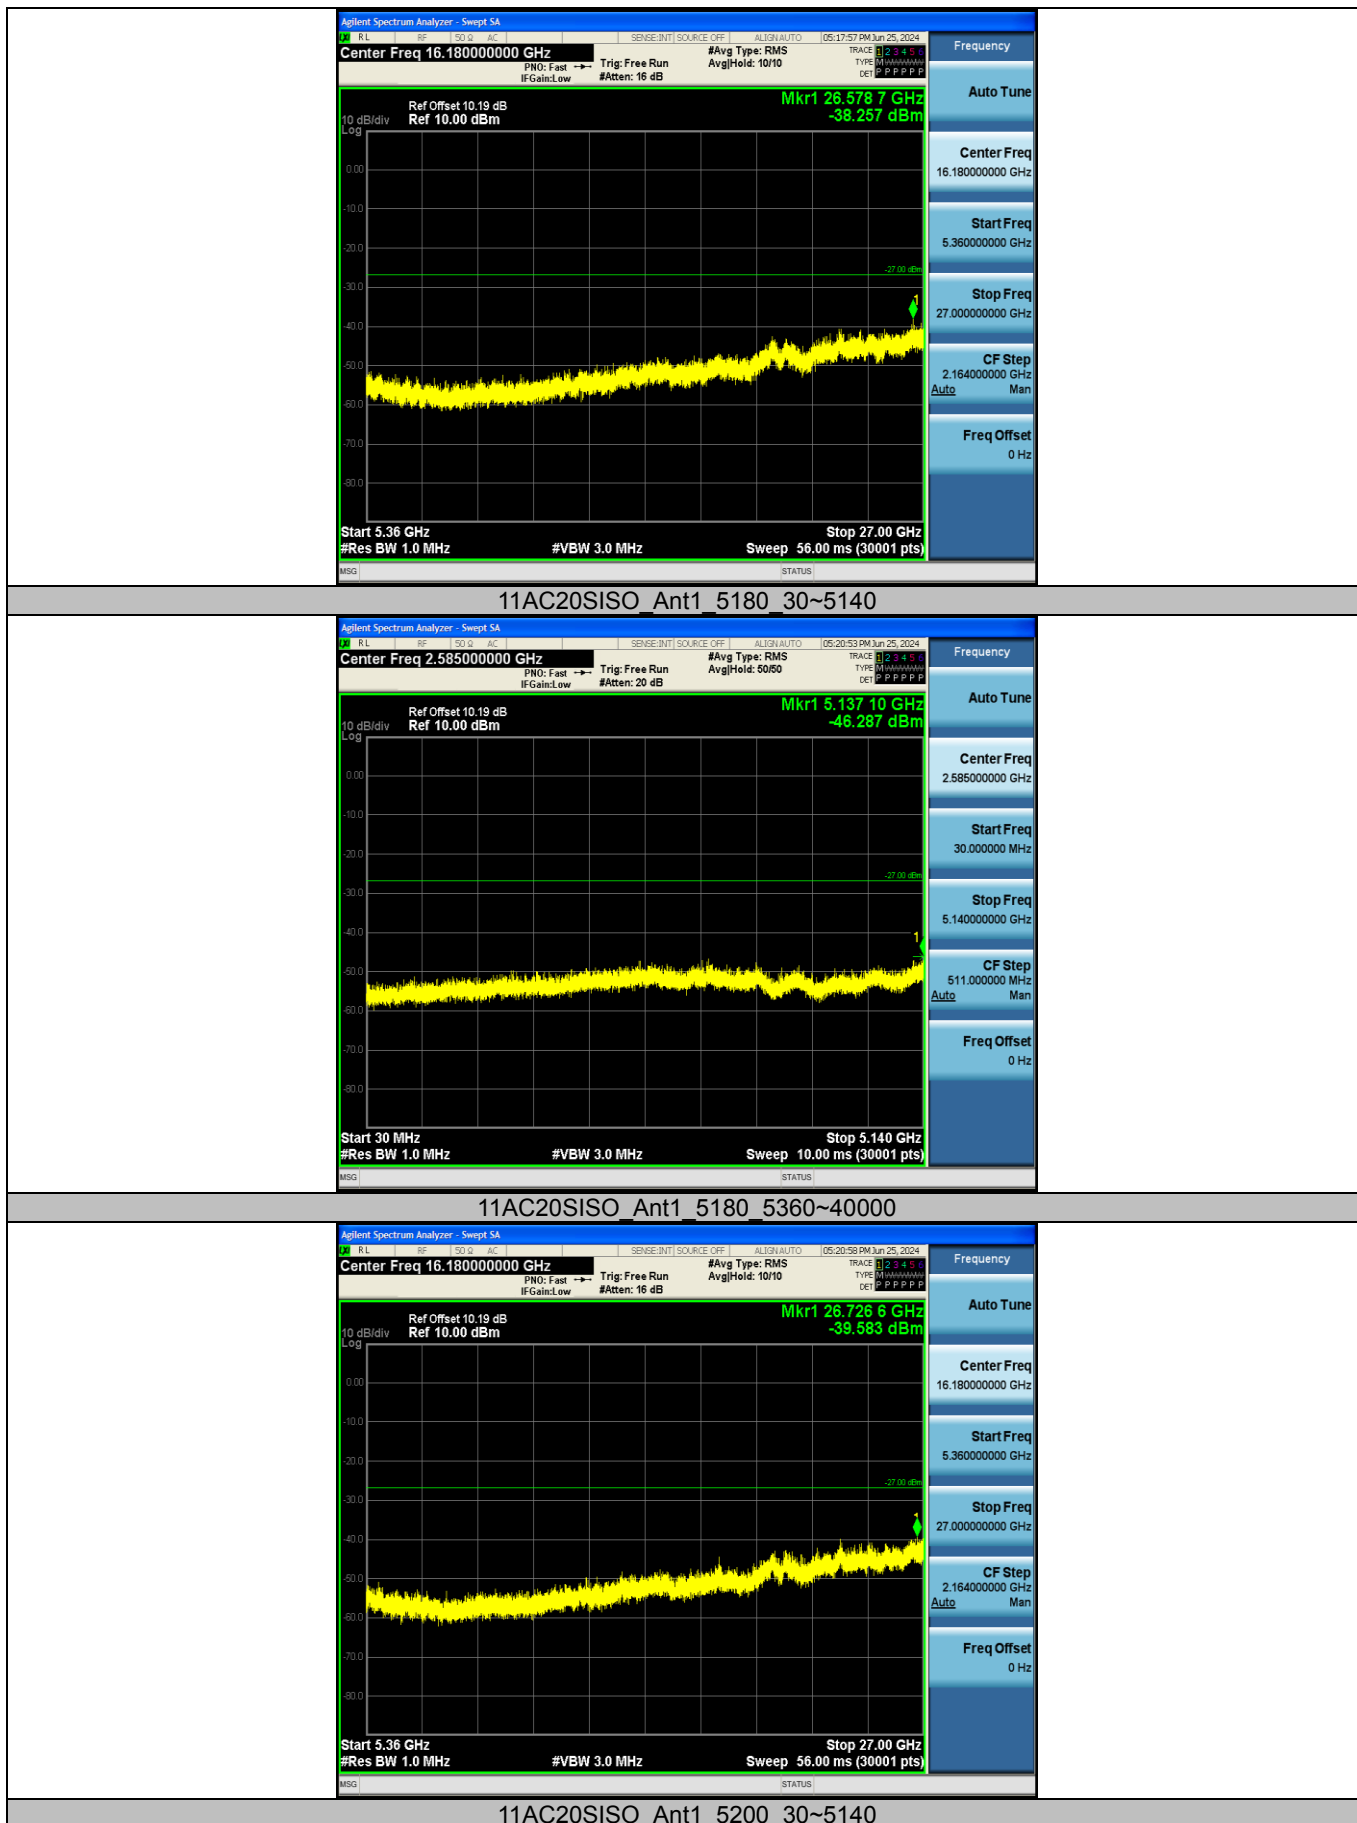
### Test Graphs

1. The antenna gain and cable loss is compensated in the test plot.
2. Test frequency are from 1GHz to 40GHz, the amplitude of spurious emissions which are attenuated more than 20 dB below the limits are not reported.
