## Appendix E: Band edge measurements

## Appendix F: Conducted Spurious Emission

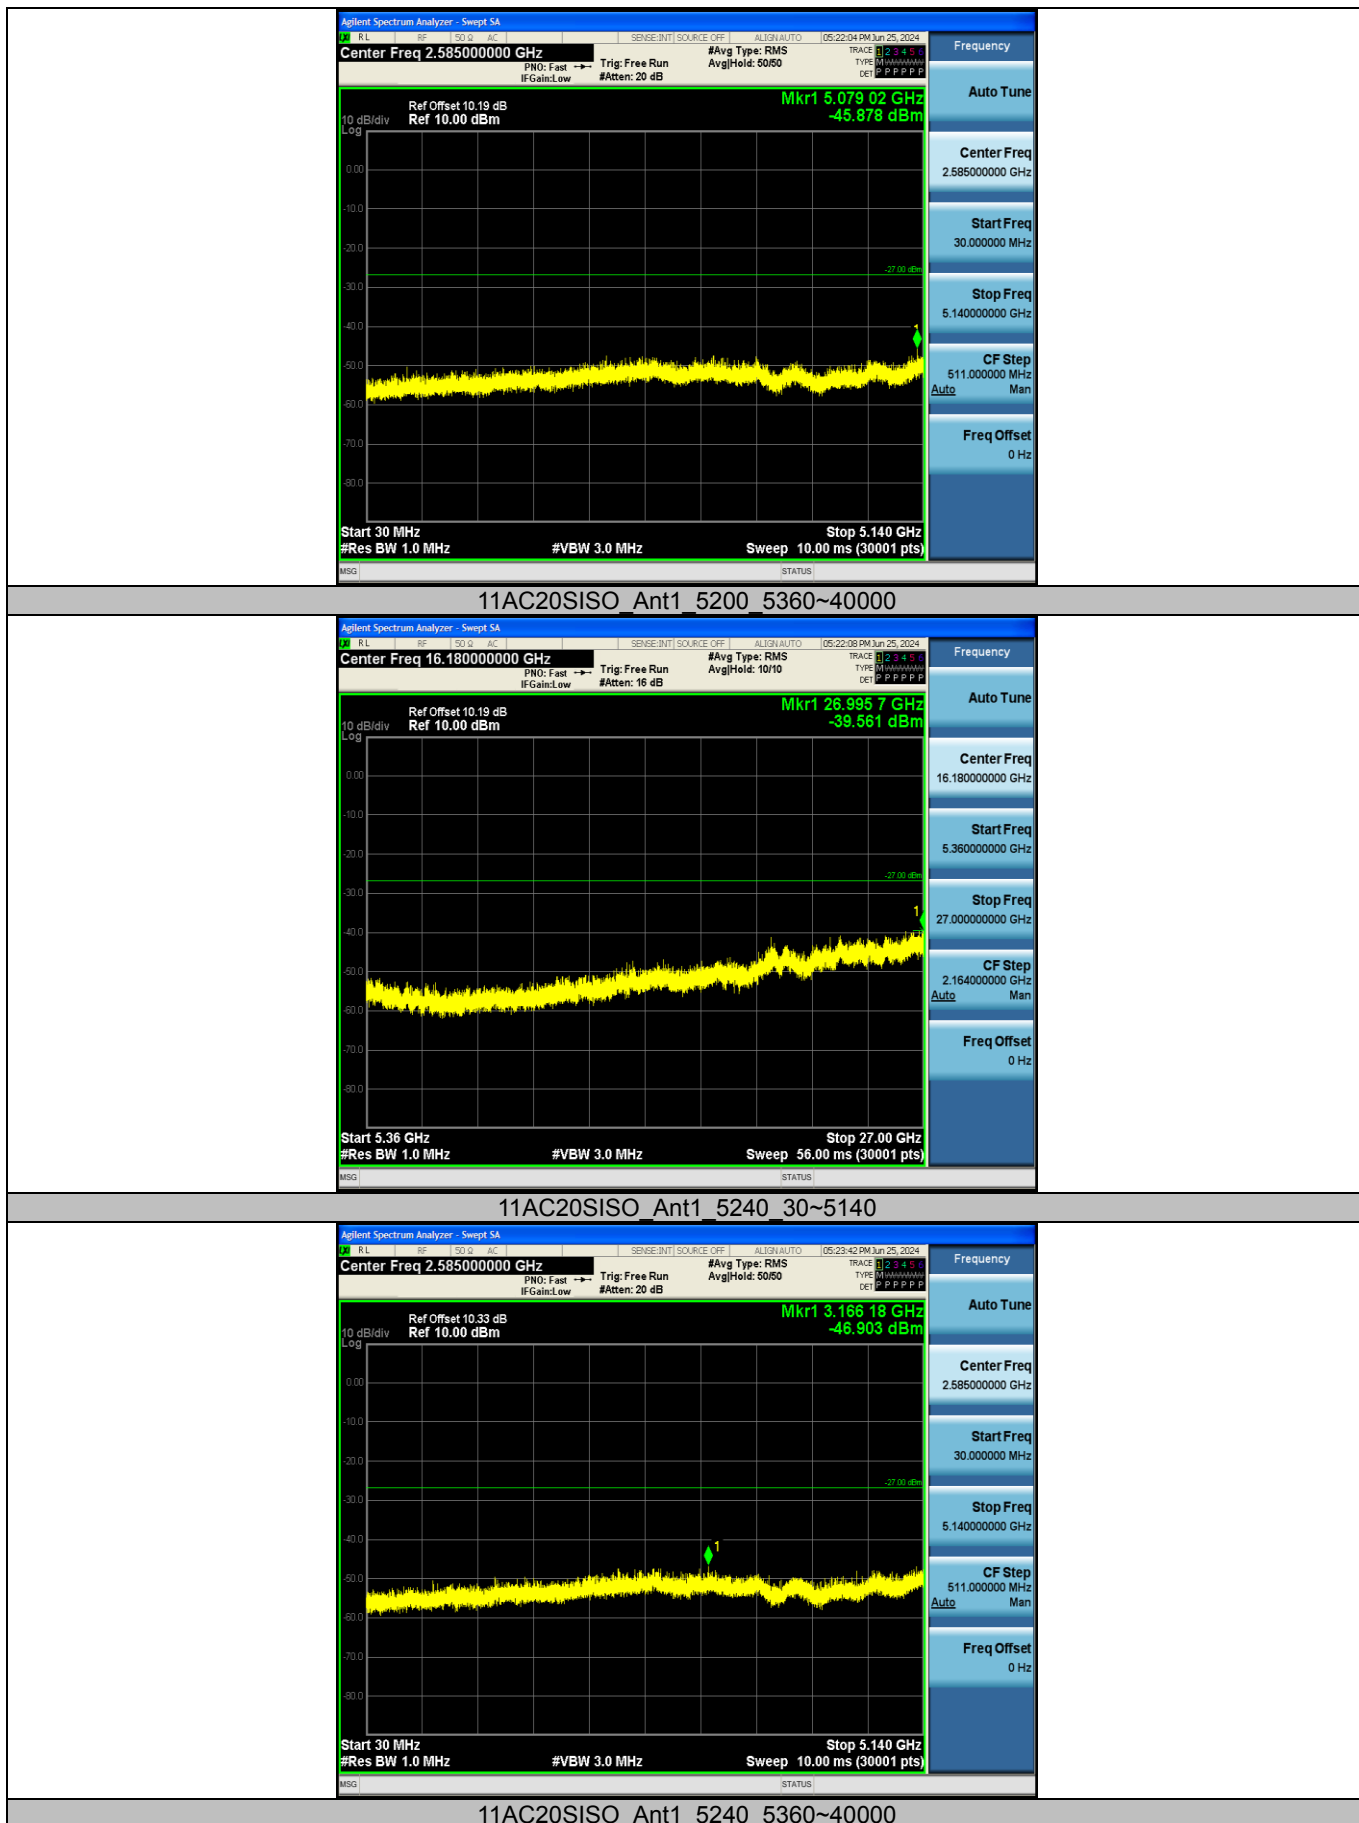
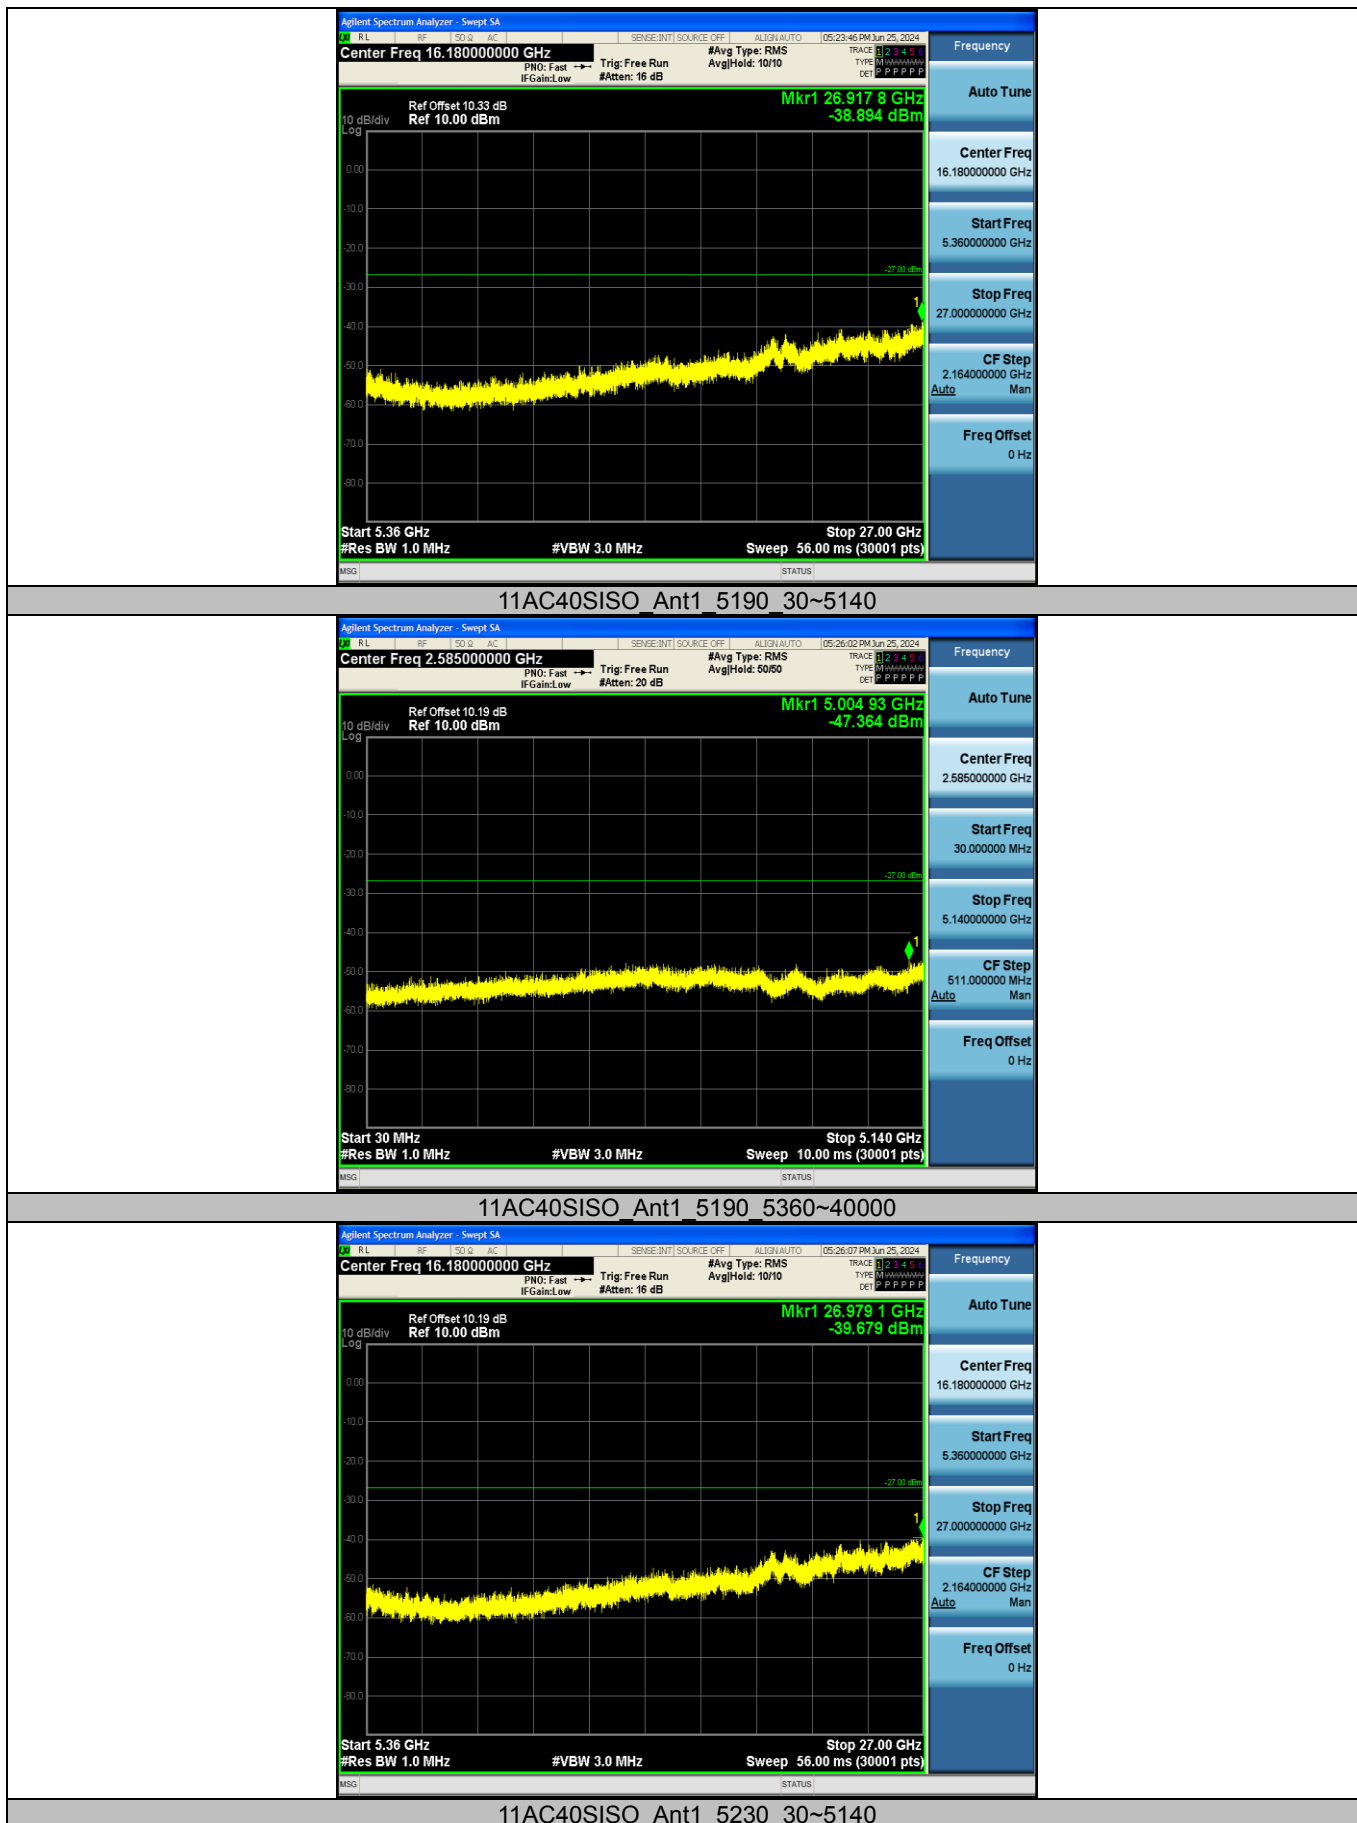
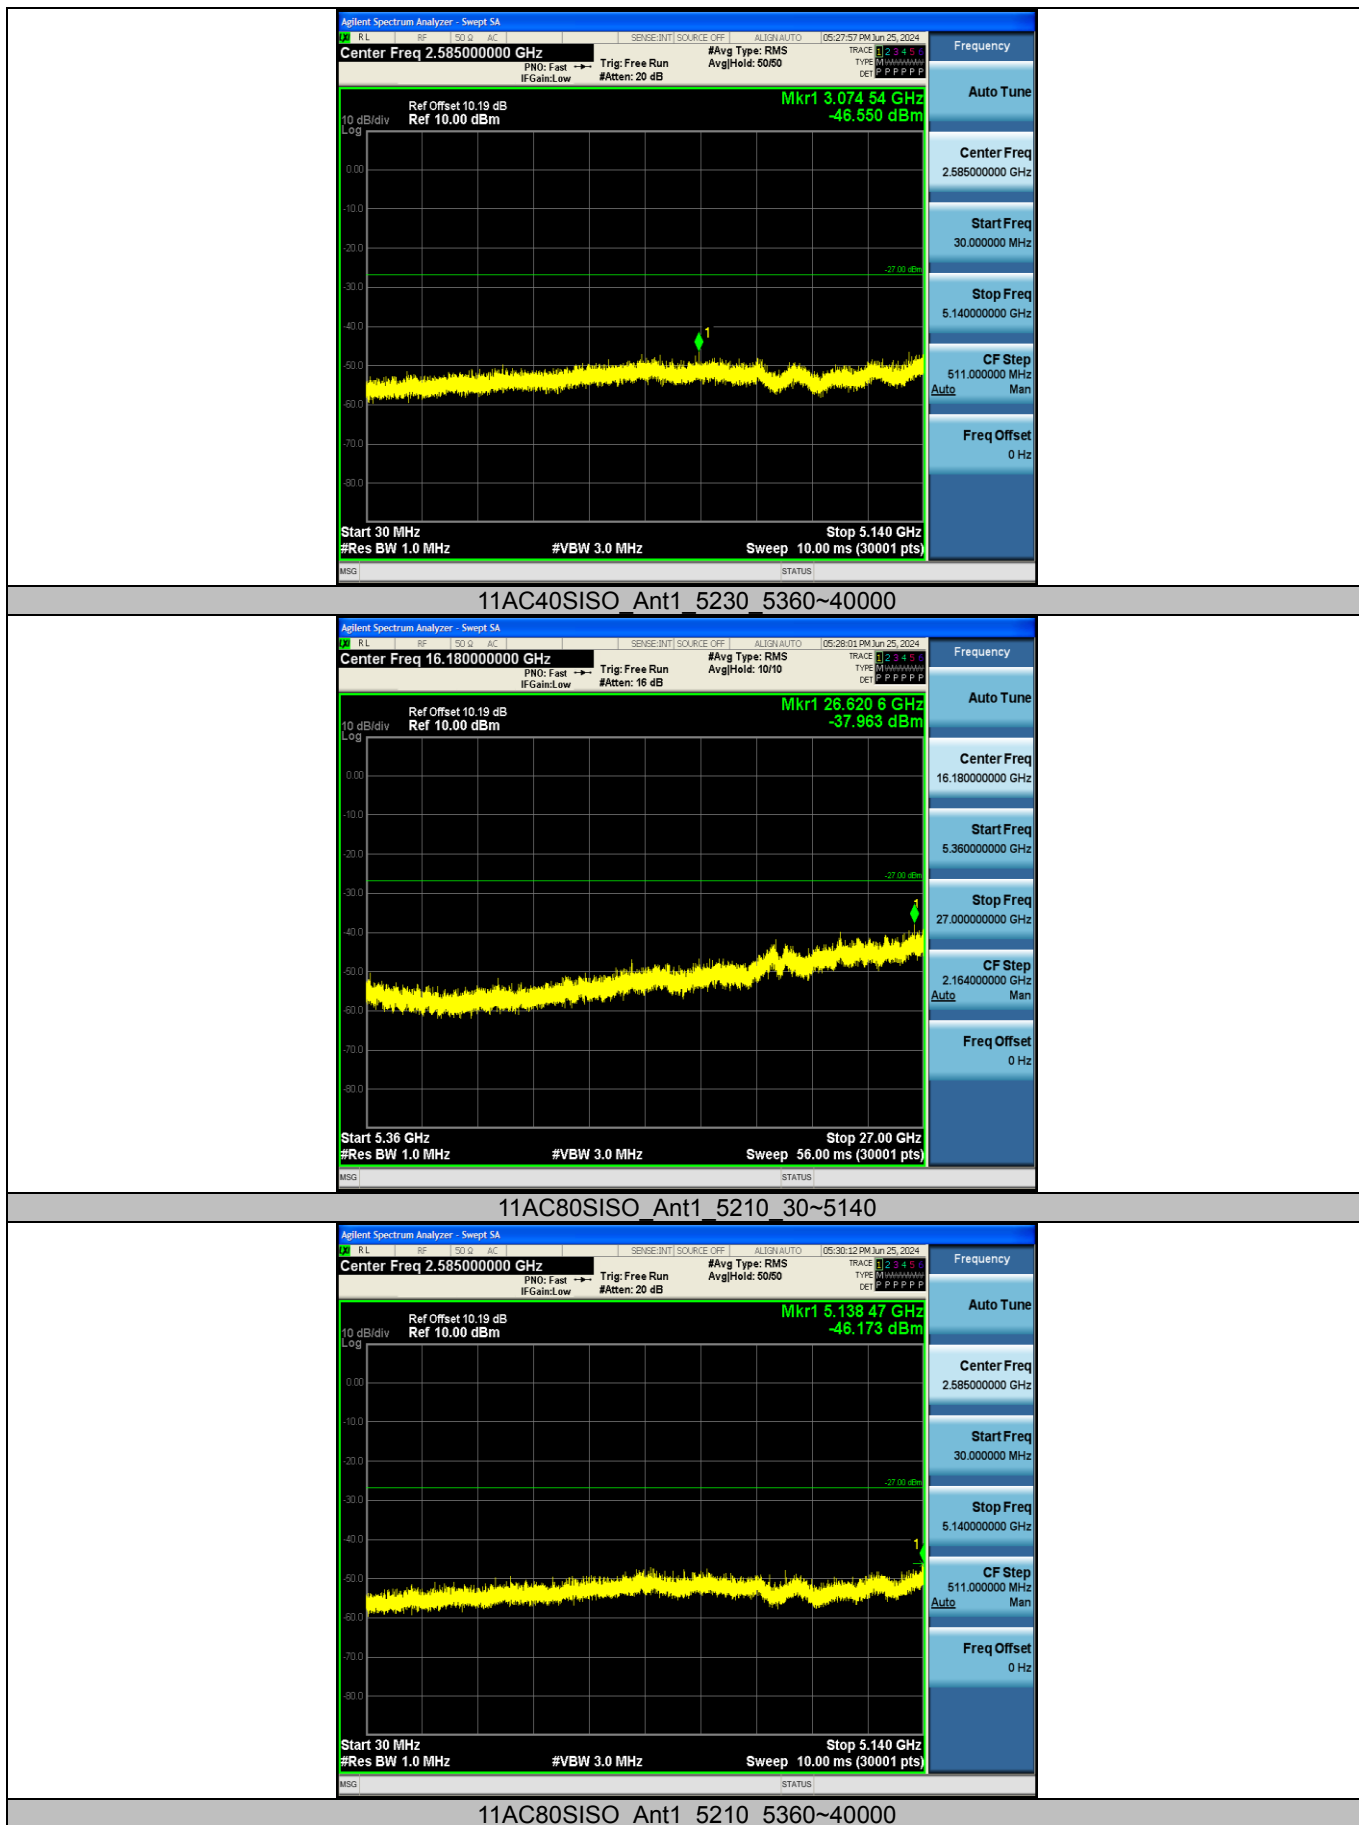
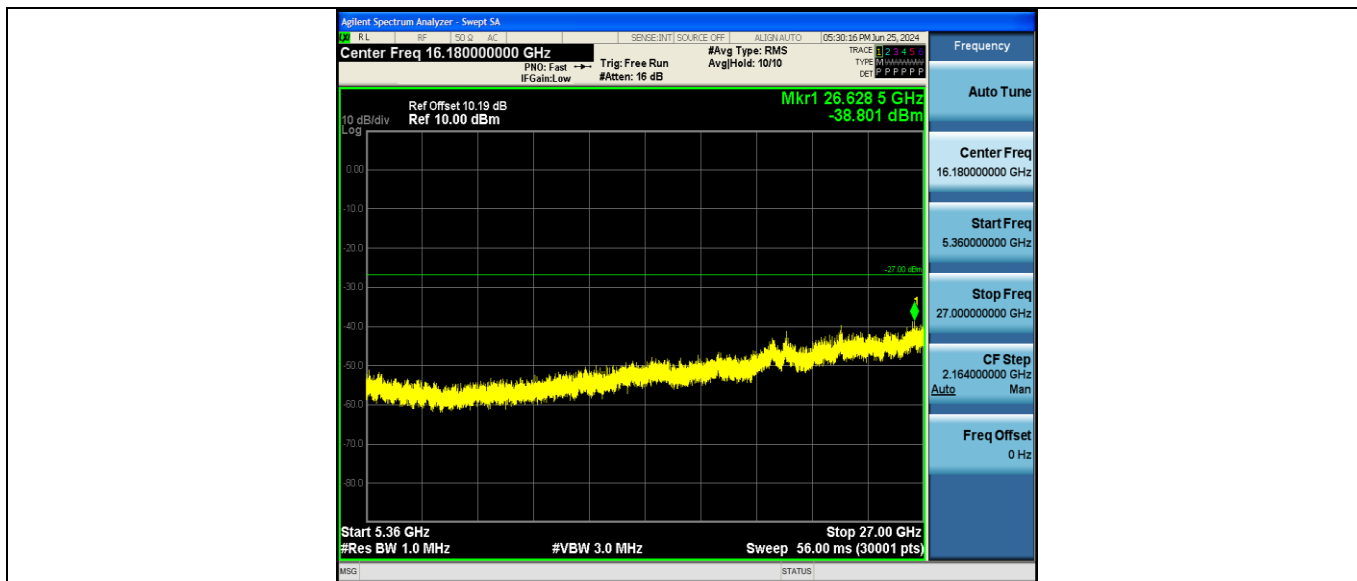
### Test Graphs

1. The antenna gain and cable loss is compensated in the test plot.
2. Test frequency are from 1GHz to 40GHz, the amplitude of spurious emissions which are attenuated more than 20 dB below the limits are not reported.
