## Appendix A: Frequency Error

### Test Result

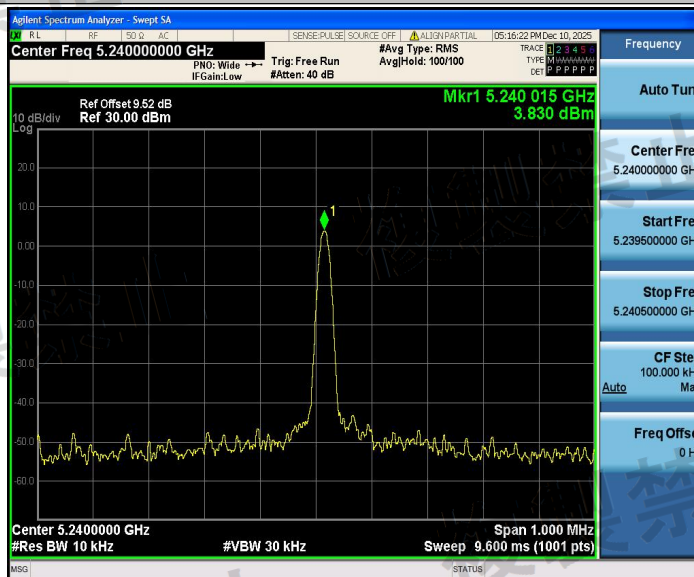
### NTNV\_Ant1\_5240

| TestCondition | TestMode | Antenna | Frequency [MHz] | CenterFreq [MHz] | Result [ppm] | Limit [ppm] | Verdict |
|---|---|---|---|---|---|---|---|
| | | Ant1 | 5240 | 5240.015 | 2.86260 | ±20 | PASS |

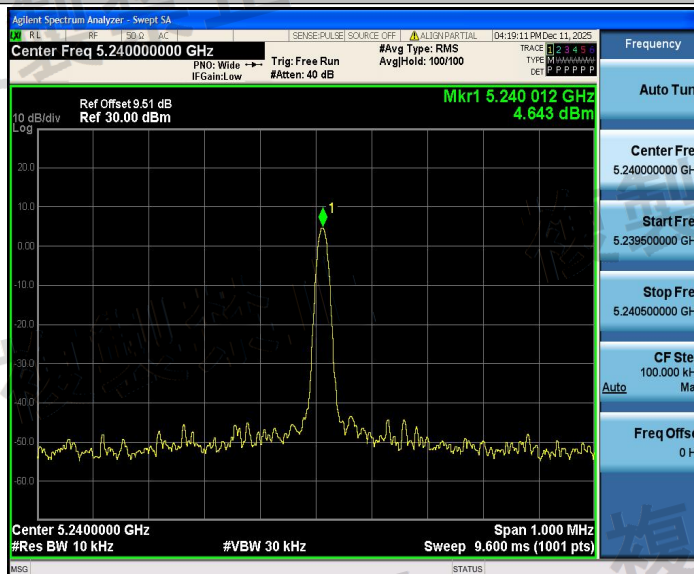
### NTNV\_Ant2\_5240

| TestCondition | TestMode | Antenna | Frequency [MHz] | CenterFreq [MHz] | Result [ppm] | Limit [ppm] | Verdict |
|---|---|---|---|---|---|---|---|
| | | Ant2 | 5240 | 5240.012 | 2.29008 | ±20 | PASS |

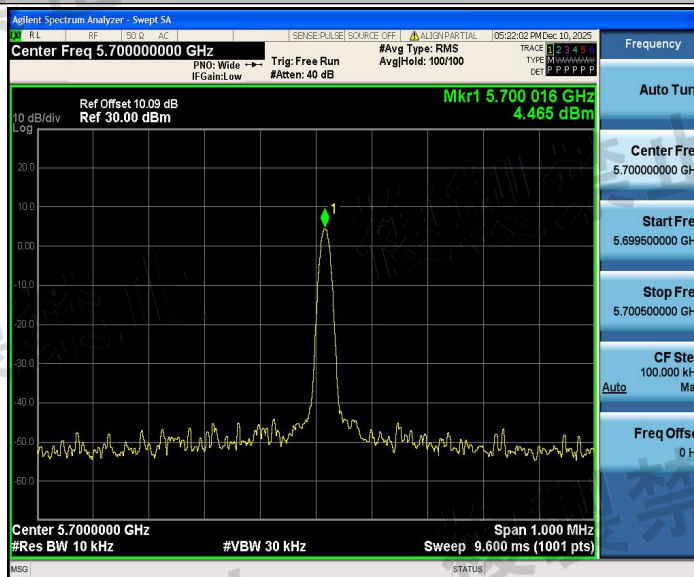
### NTNV\_Ant1\_5700

| TestCondition | TestMode | Antenna | Frequency [MHz] | CenterFreq [MHz] | Result [ppm] | Limit [ppm] | Verdict |
|---|---|---|---|---|---|---|---|
| | | Ant1 | 5700 | 5700.016 | 2.80702 | ±20 | PASS |

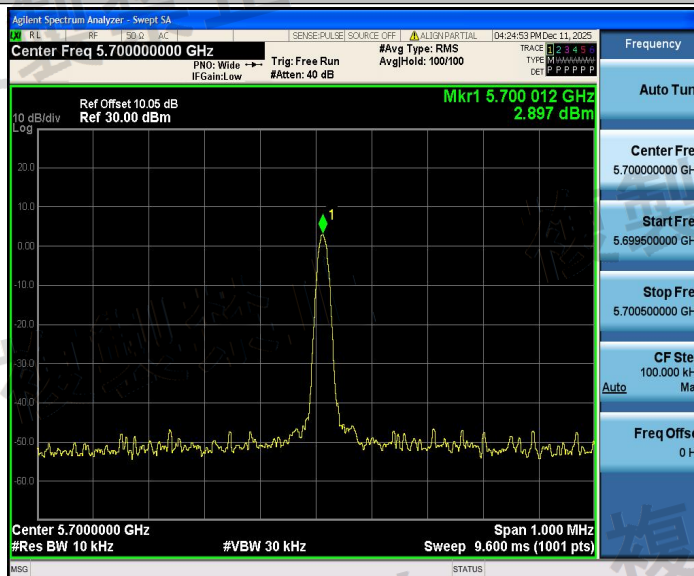
### NTNV\_Ant2\_5700

| TestCondition | TestMode | Antenna | Frequency [MHz] | CenterFreq [MHz] | Result [ppm] | Limit [ppm] | Verdict |
|---|---|---|---|---|---|---|---|
| | | Ant2 | 5700 | 5700.012 | 2.10526 | ±20 | PASS |

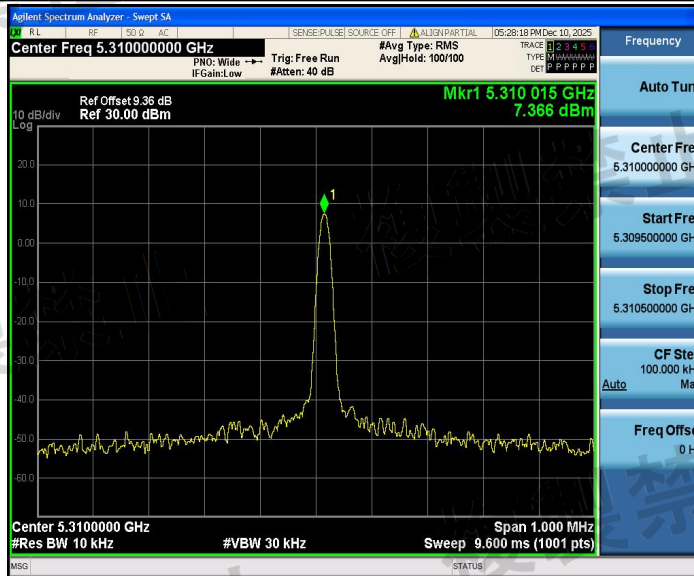
### NTNV\_Ant1\_5310

| TestCondition | TestMode | Antenna | Frequency [MHz] | CenterFreq [MHz] | Result [ppm] | Limit [ppm] | Verdict |
|---|---|---|---|---|---|---|---|
| | | Ant1 | 5310 | 5310.015 | 2.82486 | ±20 | PASS |

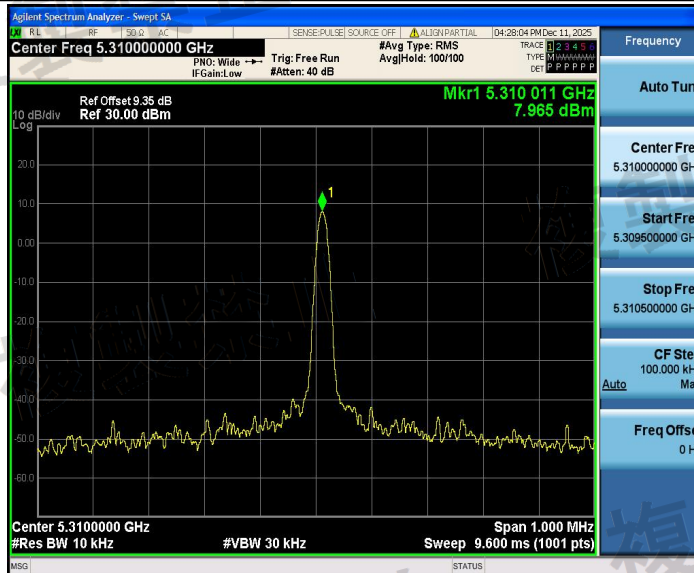
### NTNV\_Ant2\_5310

| TestCondition | TestMode | Antenna | Frequency [MHz] | CenterFreq [MHz] | Result [ppm] | Limit [ppm] | Verdict |
|---|---|---|---|---|---|---|---|
| | | Ant2 | 5310 | 5310.011 | 2.07156 | ±20 | PASS |

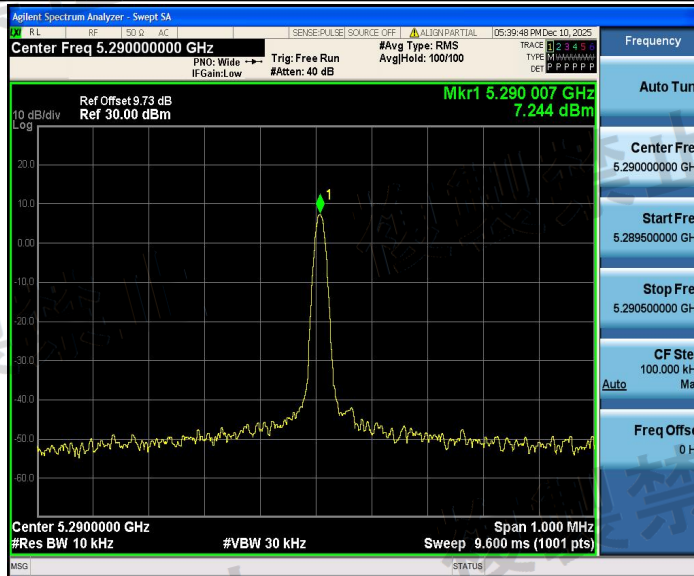
### NTNV\_Ant1\_5290

| TestCondition | TestMode | Antenna | Frequency [MHz] | CenterFreq [MHz] | Result [ppm] | Limit [ppm] | Verdict |
|---|---|---|---|---|---|---|---|
| | | Ant1 | 5290 | 5290.007 | 1.32325 | ±20 | PASS |

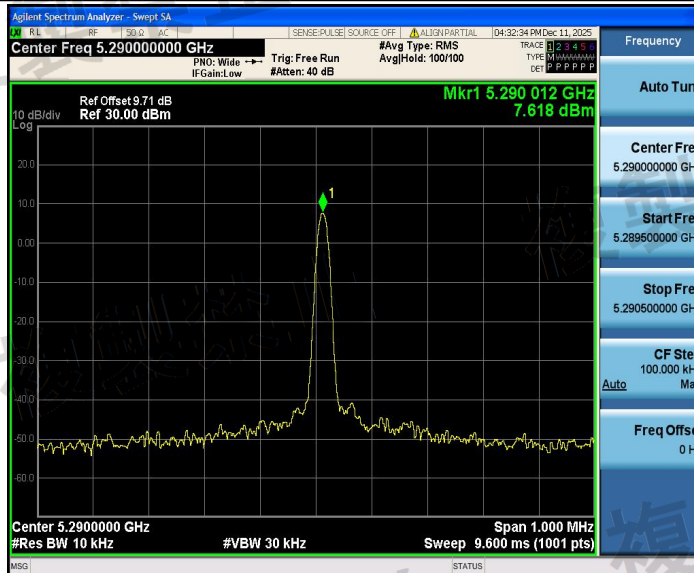
### NTNV\_Ant2\_5290

| TestCondition | TestMode | Antenna | Frequency [MHz] | CenterFreq [MHz] | Result [ppm] | Limit [ppm] | Verdict |
|---|---|---|---|---|---|---|---|
| | | Ant2 | 5290 | 5290.012 | 2.26843 | ±20 | PASS |
