## Test Graphs\_Step2

CN26ANFR 002

Prüfbericht - Produkte  
Test Report - Products

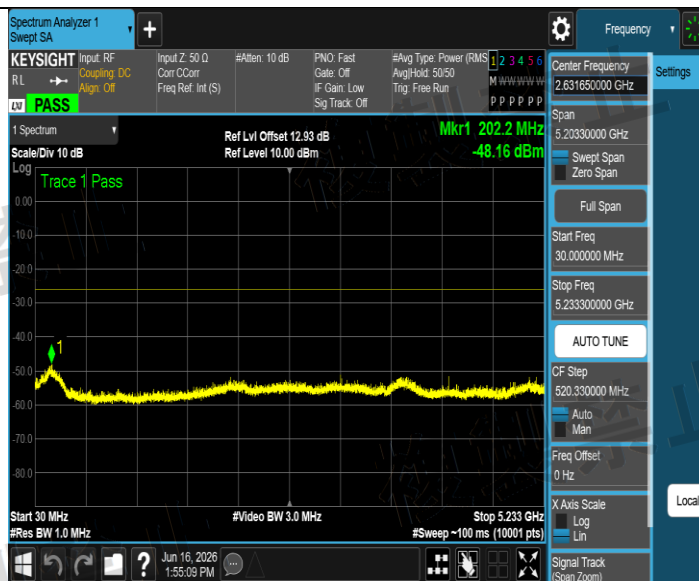
NTHV 11A Ant1 5320 5233.3~5240

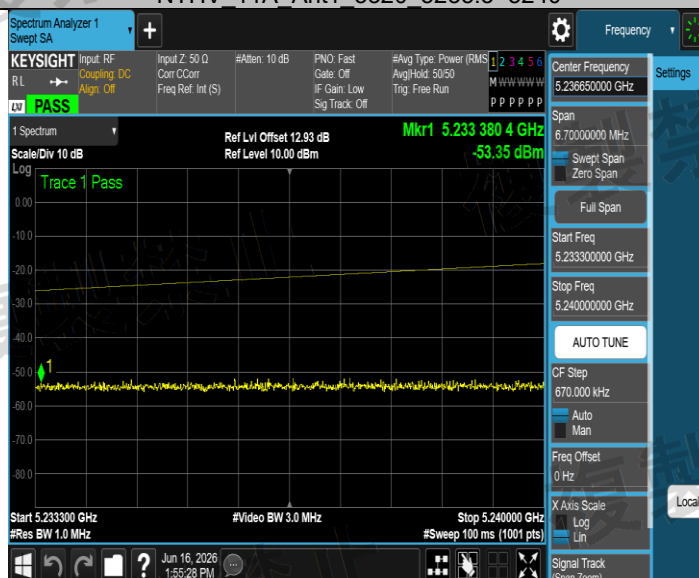
NTHV 11A Ant1 5320 5240~5249

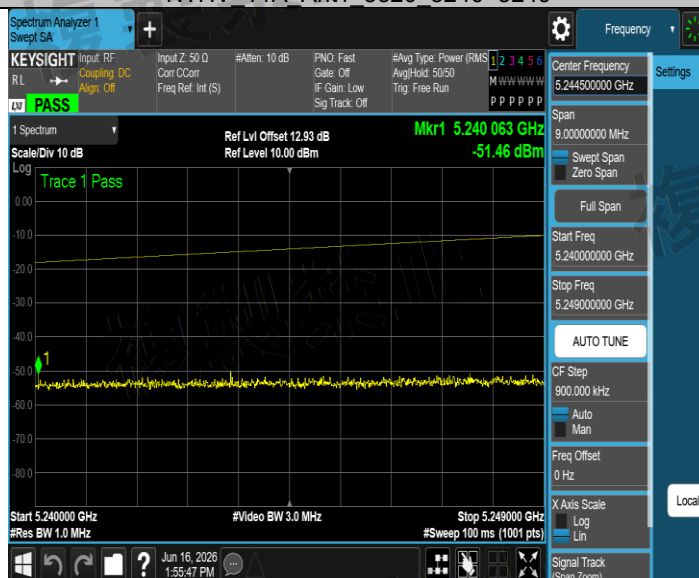
NTHV 11A Ant1 5320 5249~5250

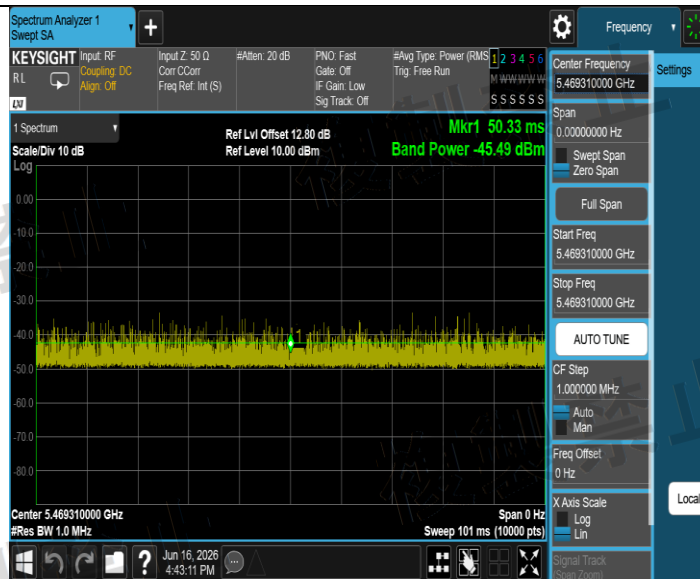
NTNV 11AC40SISO Ant1 5230 5250.17 Ant1

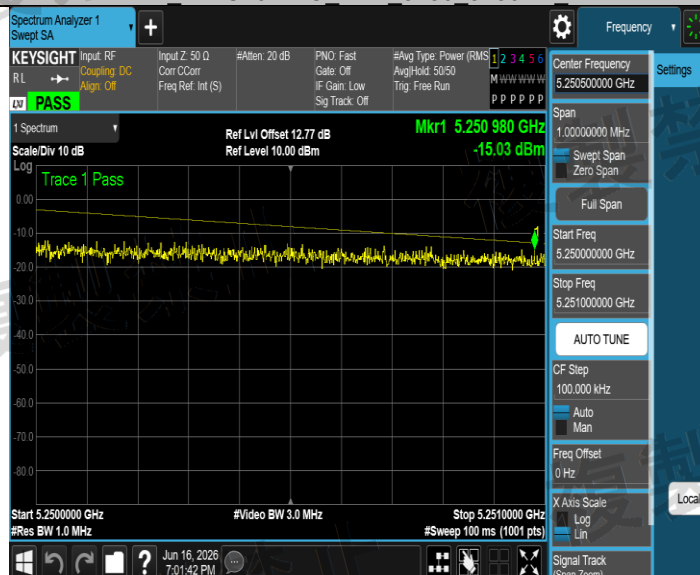
NTNV 11AC40SISO Ant1 5270 5248.53 Ant1
