Dongguan DN Testing Co., Ltd.

**Appendix G: Spurious Emission of RX****Test Result**

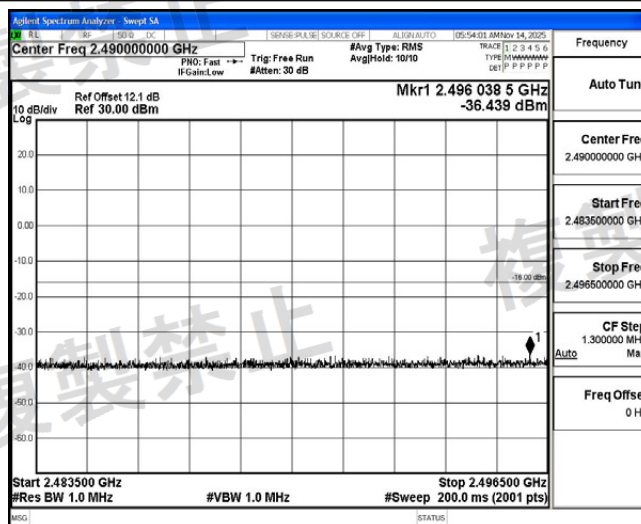
NTHV\_DH5\_Ant1\_2480\_2496.5~13000

Note: SA set to from 2.4965GHz to 13GHz, plot shows from 2.497GHz to 13GHz as of SA's default format.

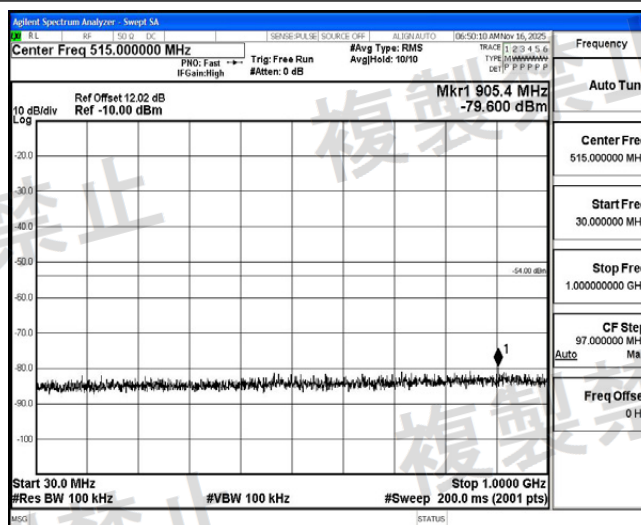
NTNV\_DH5\_Ant1\_2402\_30~1000

| Test Condition | Test Mode | Antenna | Freq(M Hz) | Freq.Range [MHz] | Freq. [MHz] | Result [dBm] | Limit [dBm] | Result [nW] | Limit [nW] | Verdict |
|---|---|---|---|---|---|---|---|---|---|---|
| NTNV | DH5 | Ant1 | 2402 | 30~1000 | 905.43 | -79.60 | ≤-54 | 0.01096 | ≤4 | PASS |

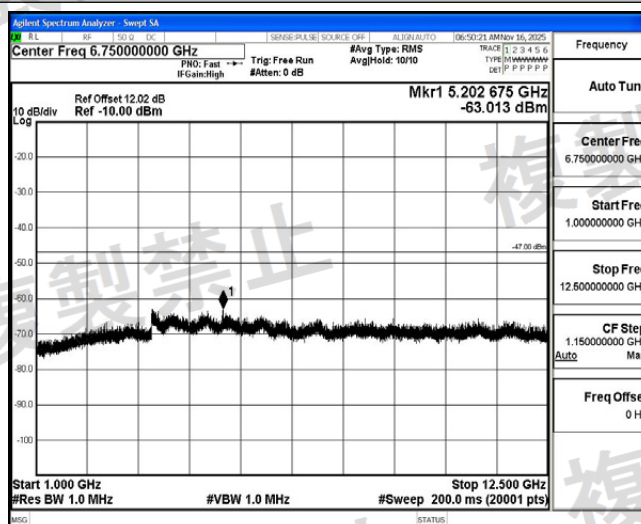
NTNV\_DH5\_Ant1\_2402\_1000~12500

| Test Condition | Test Mode | Antenna | Freq(M Hz) | Freq.Range [MHz] | Freq. [MHz] | Result [dBm] | Limit [dBm] | Result [nW] | Limit [nW] | Verdict |
|---|---|---|---|---|---|---|---|---|---|---|
| | | | | 1000~12500 | 5202.68 | -63.01 | ≤-47 | 0.50003 | ≤20 | PASS |

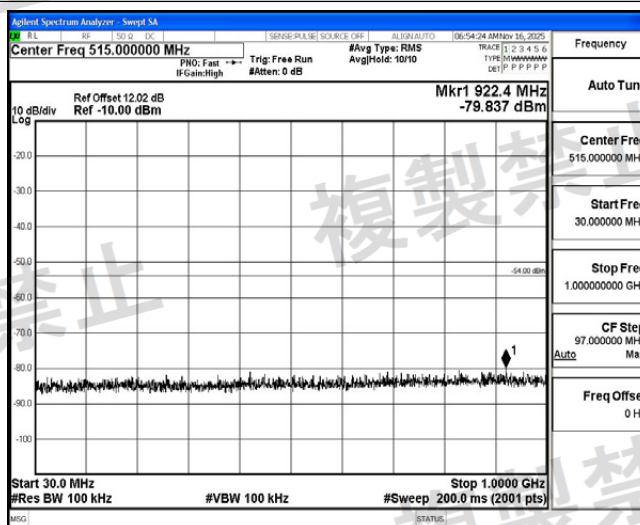
## NTNV\_2DH5\_Ant1\_2402\_30~1000

| Test Condition | Test Mode | Antenna | Freq(M Hz) | Freq.Range [MHz] | Freq. [MHz] | Result [dBm] | Limit [dBm] | Result [nW] | Limit [nW] | Verdict |
|---|---|---|---|---|---|---|---|---|---|---|
| | 2DH5 | Ant1 | 2402 | 30~1000 | 922.40 | -79.84 | ≤-54 | 0.01038 | ≤4 | PASS |

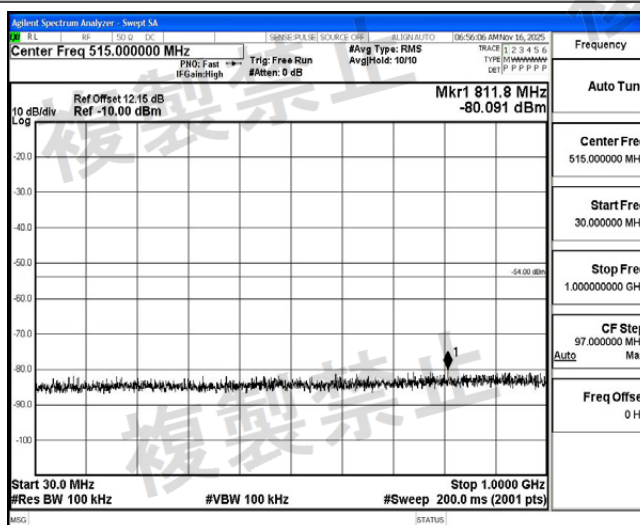
NTNV\_2DH5\_Ant1\_2441\_30~1000

| Test Condition | Test Mode | Antenna | Freq(M Hz) | Freq.Range [MHz] | Freq. [MHz] | Result [dBm] | Limit [dBm] | Result [nW] | Limit [nW] | Verdict |
|---|---|---|---|---|---|---|---|---|---|---|
| | | | 2441 | 30~1000 | 811.82 | -80.09 | ≤-54 | 0.00979 | ≤4 | PASS |

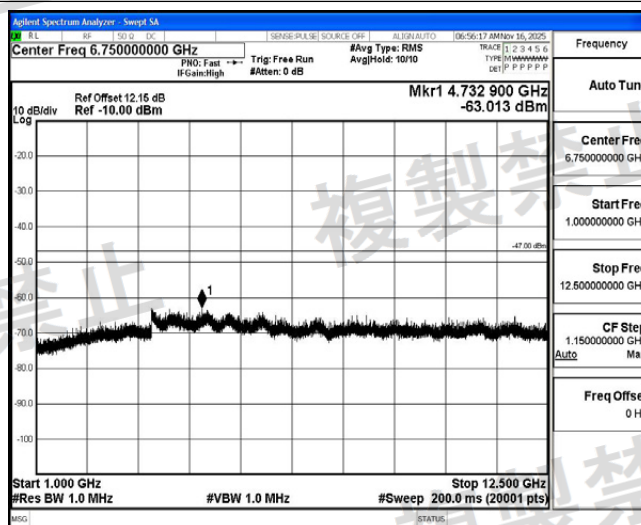
NTNV\_2DH5\_Ant1\_2441\_1000~12500

| Test Condition | Test Mode | Antenna | Freq(M Hz) | Freq.Range [MHz] | Freq. [MHz] | Result [dBm] | Limit [dBm] | Result [nW] | Limit [nW] | Verdict |
|---|---|---|---|---|---|---|---|---|---|---|
| | | | | 1000~12500 | 4732.90 | -63.01 | ≤-47 | 0.50003 | ≤20 | PASS |

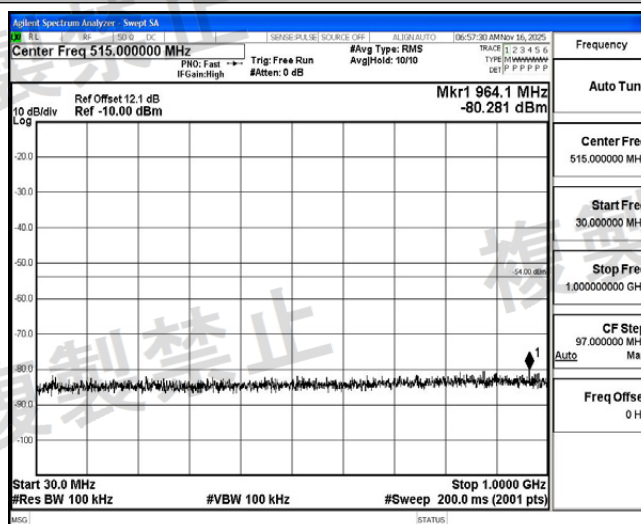
NTNV\_2DH5\_Ant1\_2480\_30~1000

| Test Condition | Test Mode | Antenna | Freq(M Hz) | Freq.Range [MHz] | Freq. [MHz] | Result [dBm] | Limit [dBm] | Result [nW] | Limit [nW] | Verdict |
|---|---|---|---|---|---|---|---|---|---|---|
| | | | 2480 | 30~1000 | 964.11 | -80.28 | ≤-54 | 0.00938 | ≤4 | PASS |

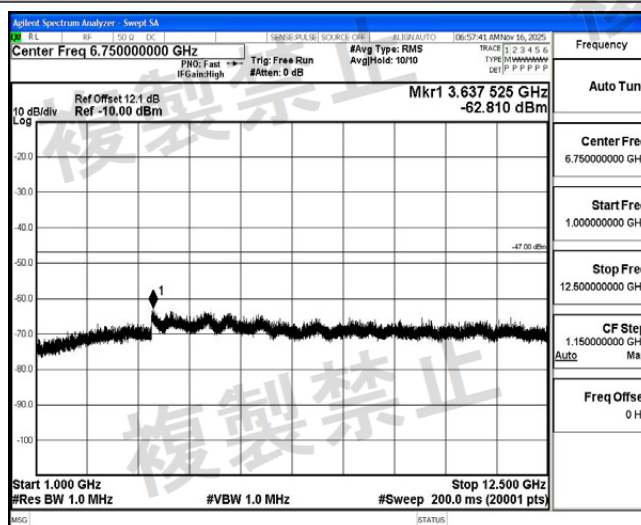
NTNV\_2DH5\_Ant1\_2480\_1000~12500

| Test Condition | Test Mode | Antenna | Freq(M Hz) | Freq.Range [MHz] | Freq. [MHz] | Result [dBm] | Limit [dBm] | Result [nW] | Limit [nW] | Verdict |
|---|---|---|---|---|---|---|---|---|---|---|
| | | | | 1000~12500 | 3637.53 | -62.81 | ≤-47 | 0.52360 | ≤20 | PASS |

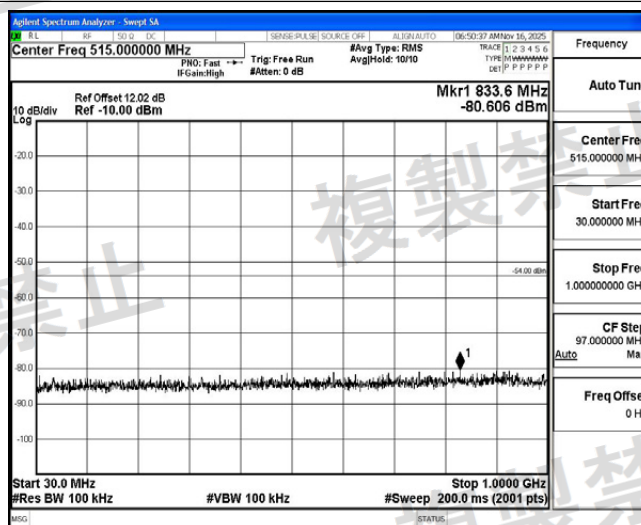
NTLV\_DH5\_Ant1\_2402\_30~1000

| Test Condition | Test Mode | Antenna | Freq(M Hz) | Freq.Range [MHz] | Freq. [MHz] | Result [dBm] | Limit [dBm] | Result [nW] | Limit [nW] | Verdict |
|---|---|---|---|---|---|---|---|---|---|---|
| NTLV | DH5 | Ant1 | 2402 | 30~1000 | 833.65 | -80.61 | ≤-54 | 0.00869 | ≤4 | PASS |

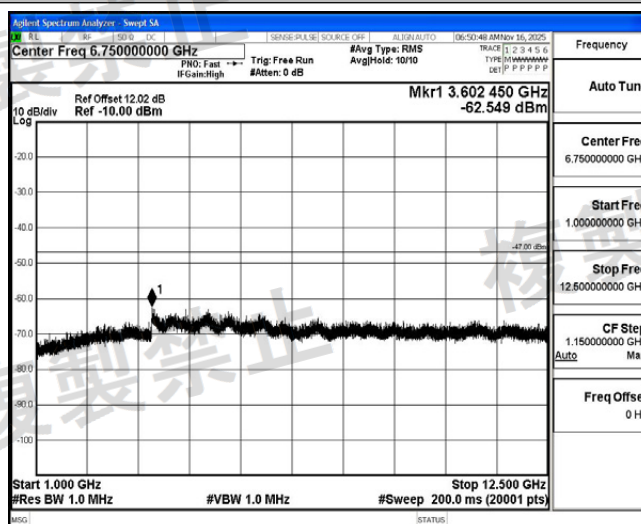
NTLV\_DH5\_Ant1\_2402\_1000~12500

| Test Condition | Test Mode | Antenna | Freq(M Hz) | Freq.Range [MHz] | Freq. [MHz] | Result [dBm] | Limit [dBm] | Result [nW] | Limit [nW] | Verdict |
|---|---|---|---|---|---|---|---|---|---|---|
| | | | | 1000~12500 | 3602.45 | -62.55 | ≤-47 | 0.55590 | ≤20 | PASS |

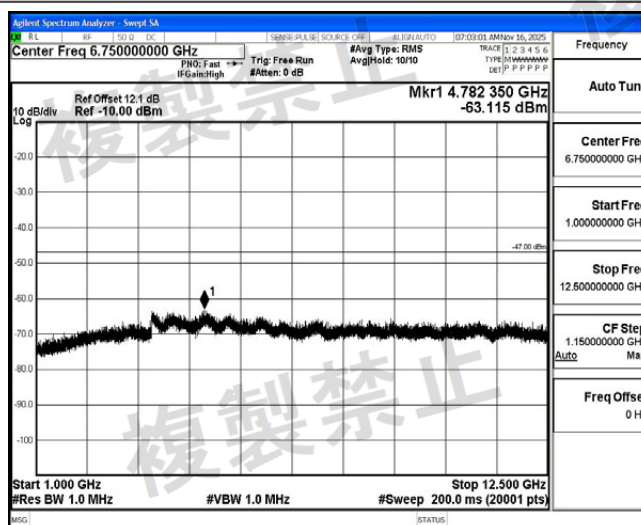
NTHV\_3DH5\_Ant1\_2480\_1000~12500

| | | | 1000~12500 | 4782.35 | -63.12 | $\leq -47$ | 0.48753 | $\leq 20$ | PASS |
